PE16-008

FORD

Appendix G

Non Conf - Engineering
Review

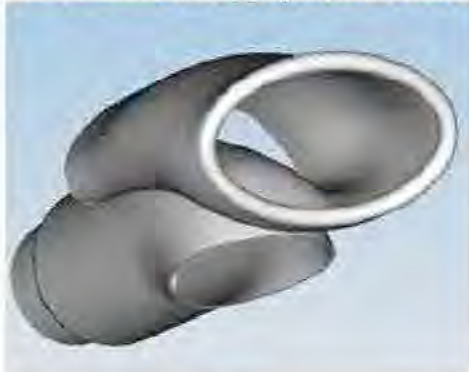
Here is another design proposal with a deco tip similar to the Peugeot tip. We can review with the team.
