PE16-008

FORD

Appendix G

Engineering Review

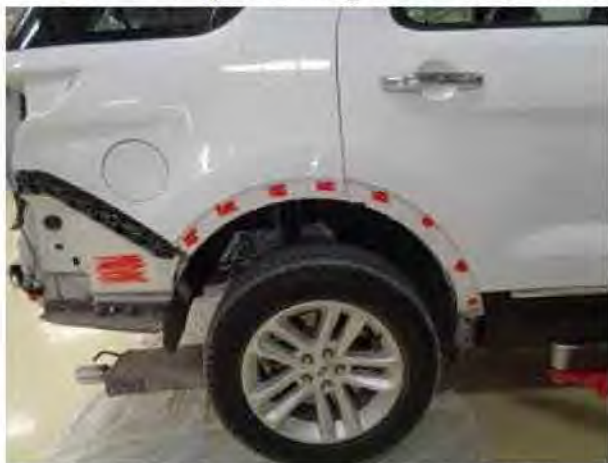
Figure 7 – Article 14-16-NA

- a. Using masking tape, seal the rear air extractors and areas marked in red. Do not need to mask the rear lip molding for vehicle that do not have the rear lip molding removed (Figure 7-8)
