PE16-008

FORD

Appendix G

Engineering Review

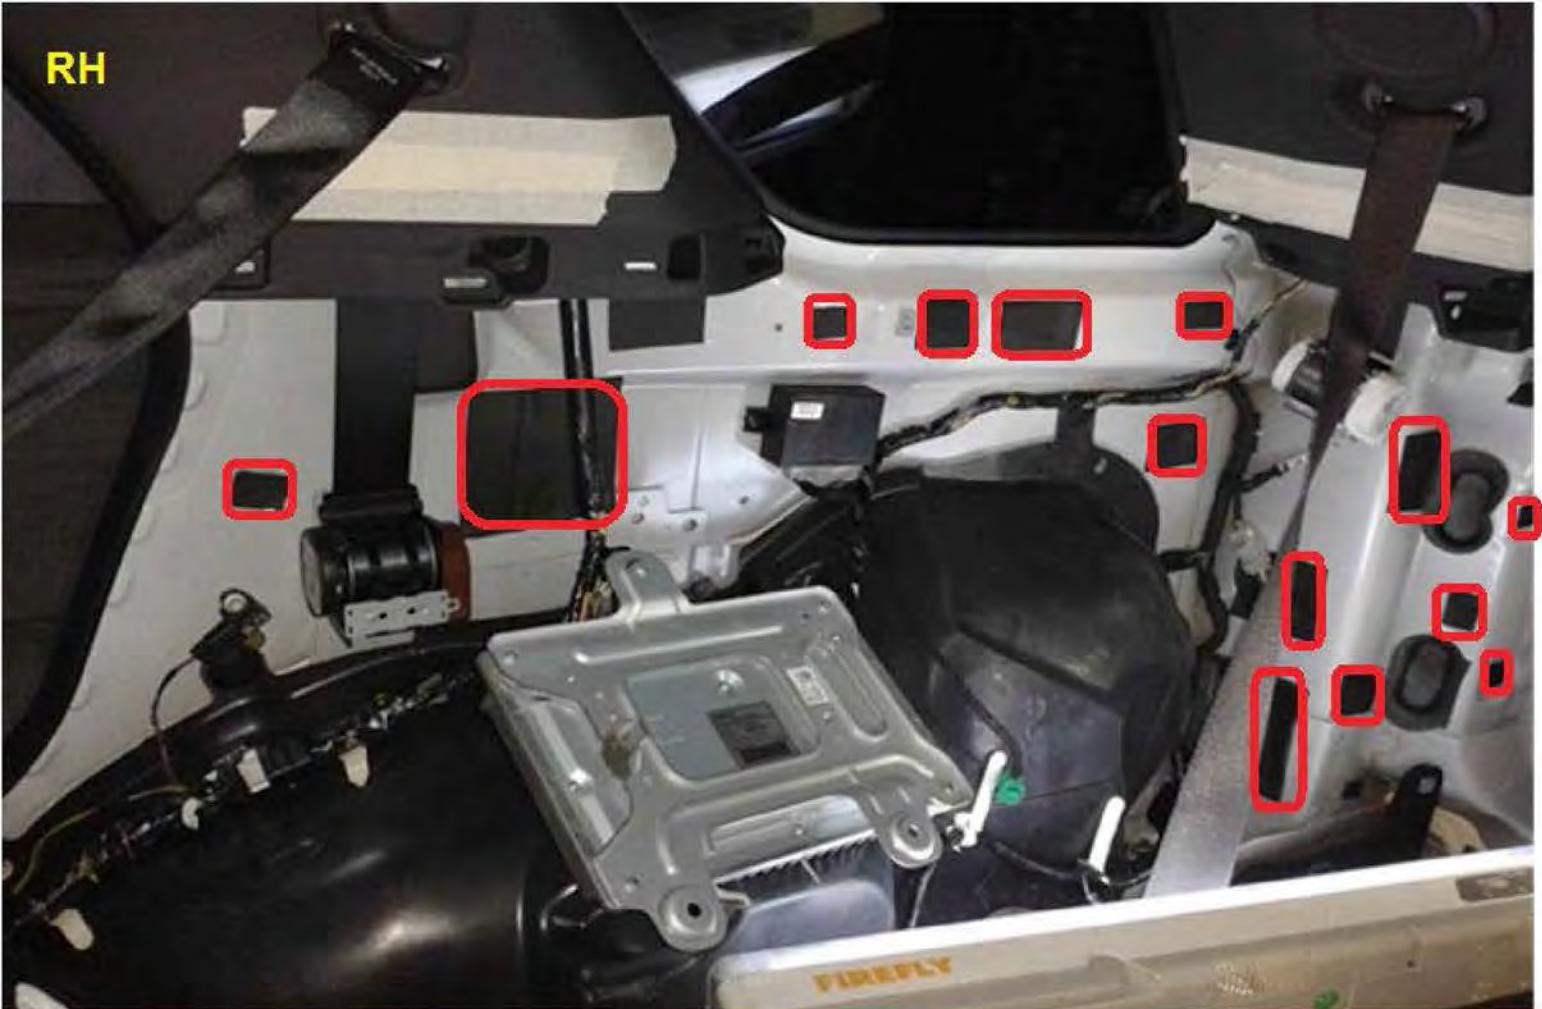
RH

- Remove the third row seat area interior quarter trim panel pieces. Using tape, proceed to tape over all body holes. Locating holes and push-pin holes can be covered but must be cut to allow penetration by the locating pin or push-pin. Gaffer's tape is recommended. It is not recommended to use electrical tape because the adhesion of this type of tape is not sufficient. Do not seal up air extractor holes. Photos attached.

- Also in the area under the third row seat interior quarter trim panels, seal up any body seams using TA-2 Motorcraft sealant.

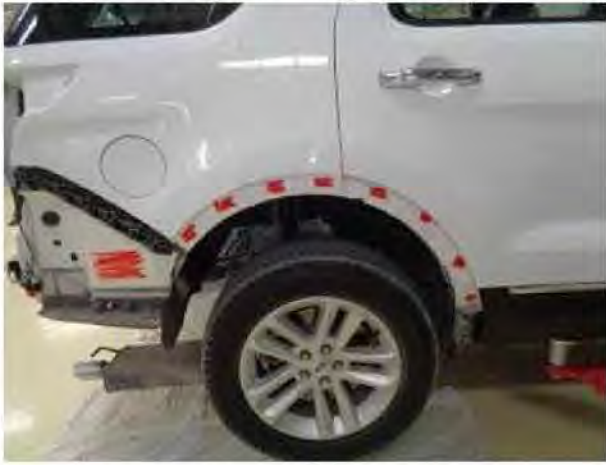
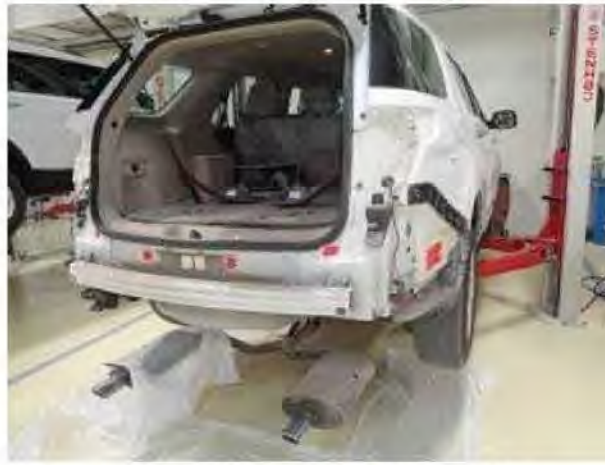
- a. Using masking tape, seal the rear air extractors and areas marked in red. Do not need to mask the rear lip molding for vehicle that do not have the rear lip molding removed (Figure 7-8)
