PE16-008

FORD

Appendix G

Engineering Review

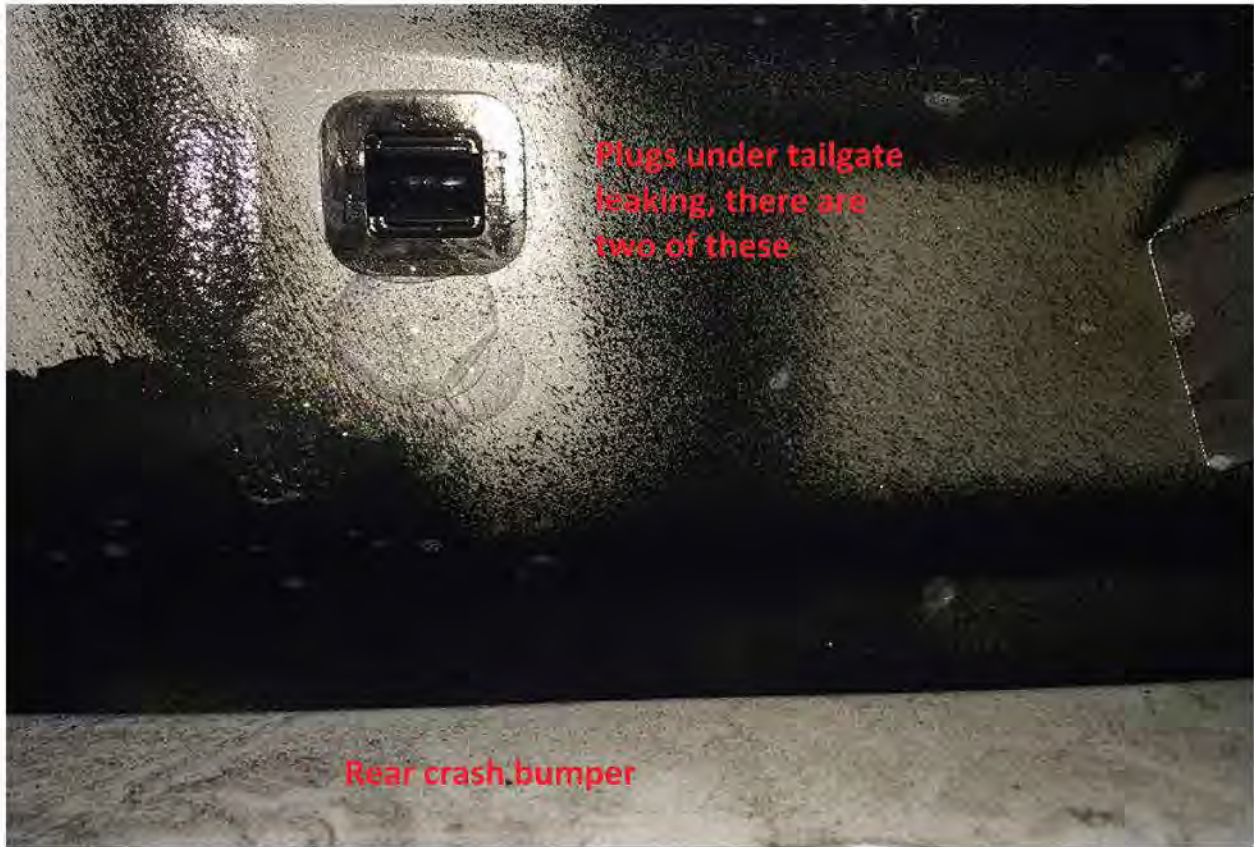
Pic 526

Plugs under tailgate  
leaking, there are  
two of these

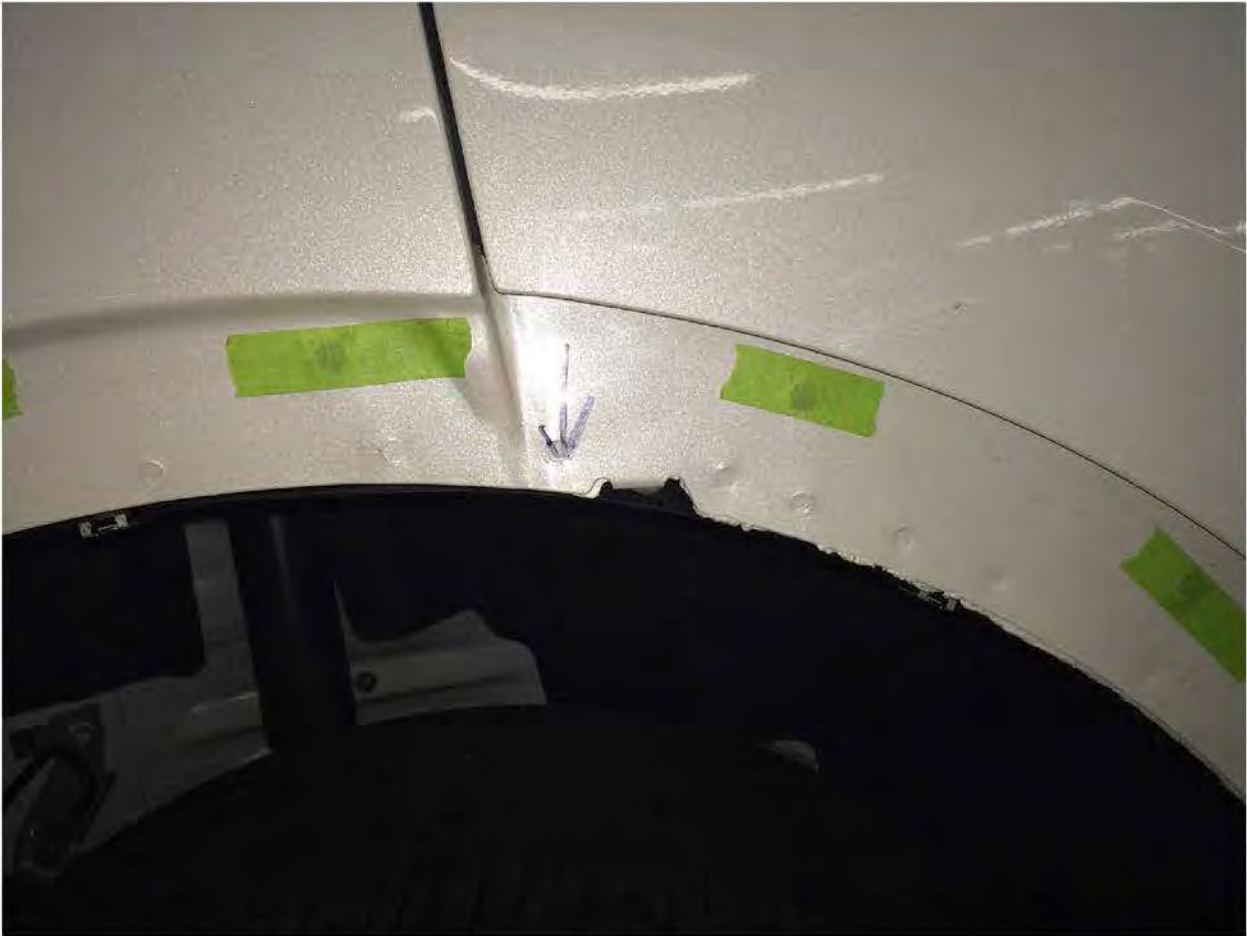
Rear wheel lip gap is missing sealant in various spots

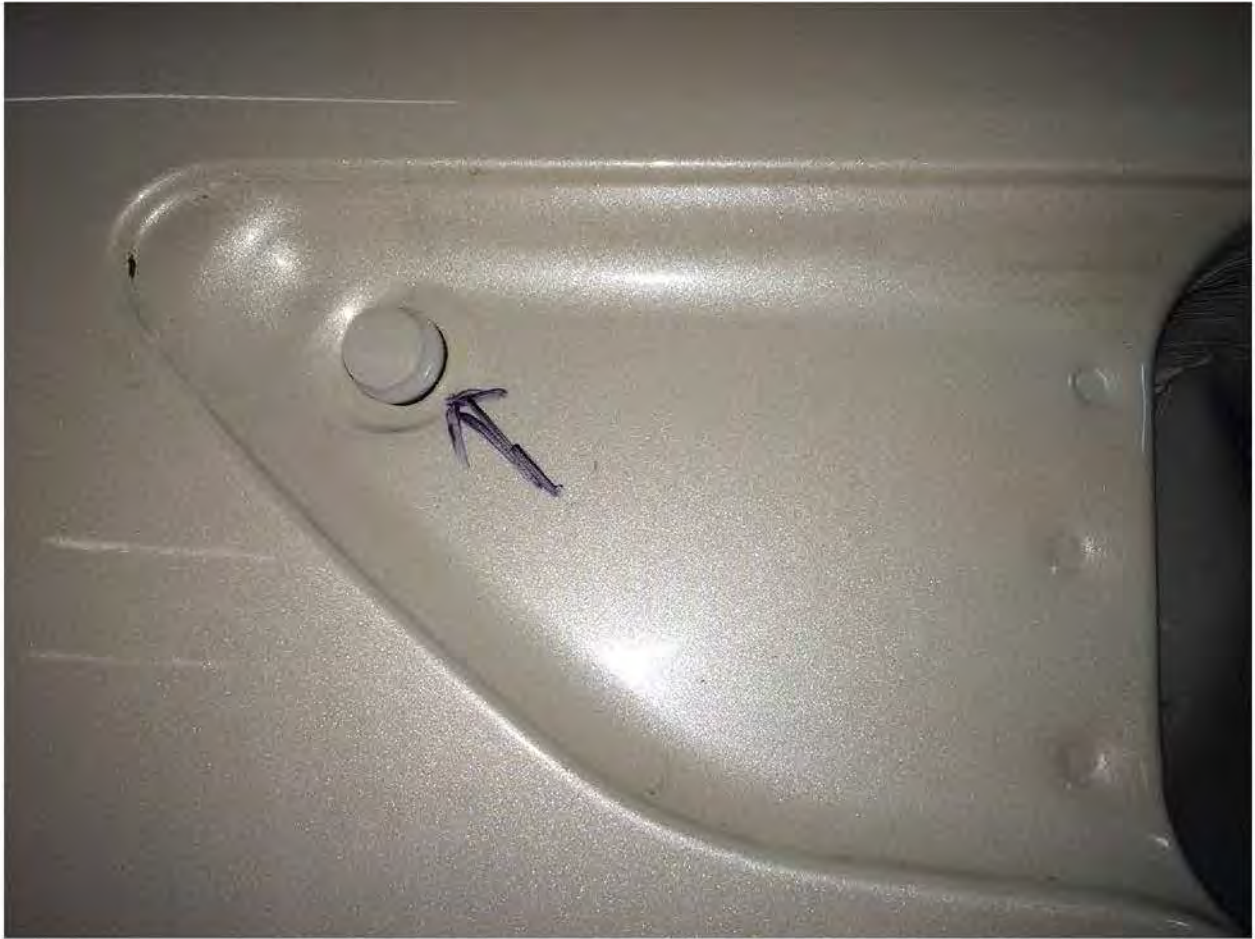
Clip that holds the tail light

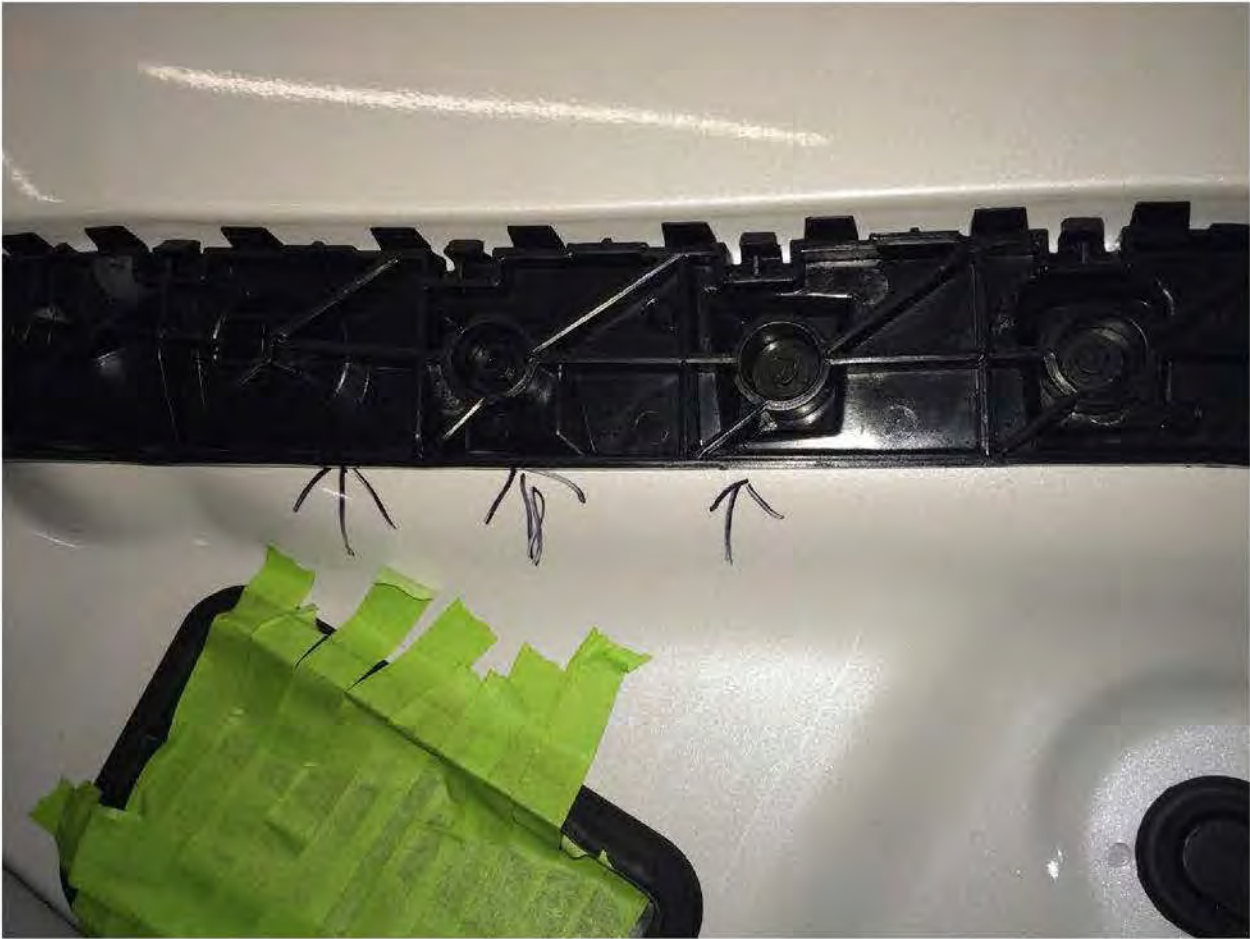
Leak under plastic bar that holds the bumper

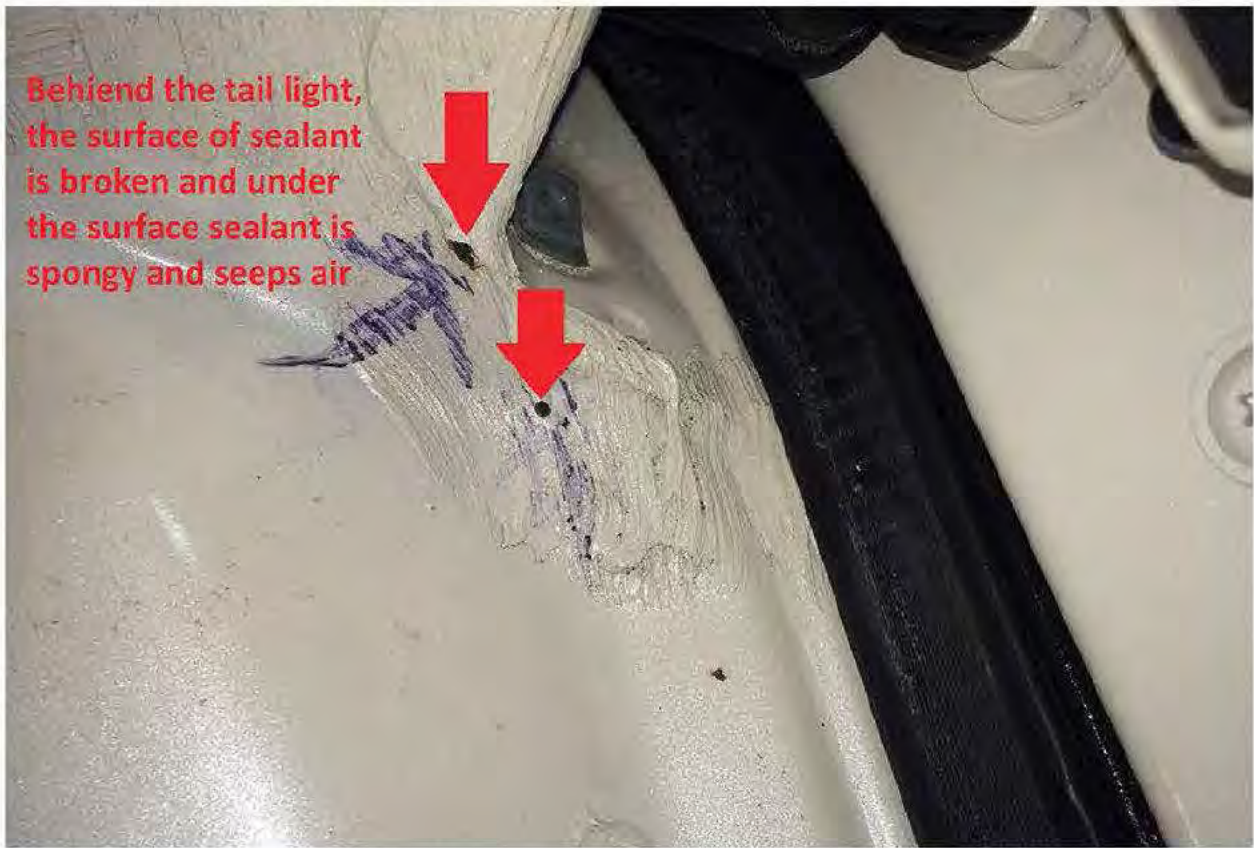
Behiend the tail light,  
the surface of sealant  
is broken and under  
the surface sealant is  
spongy and seeps air
