PE16-008

FORD

Appendix G

Field Communications

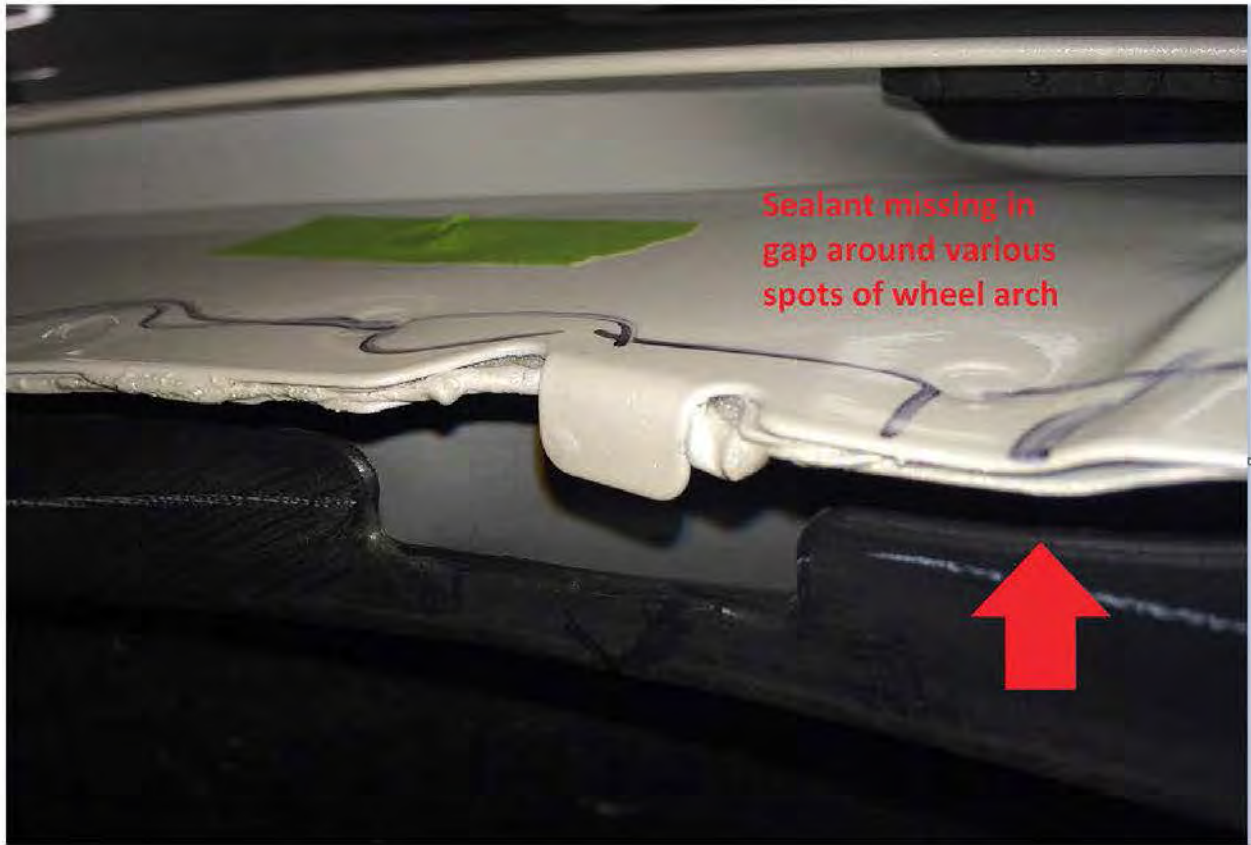
Sealant missing in
gap around various
spots of wheel arch

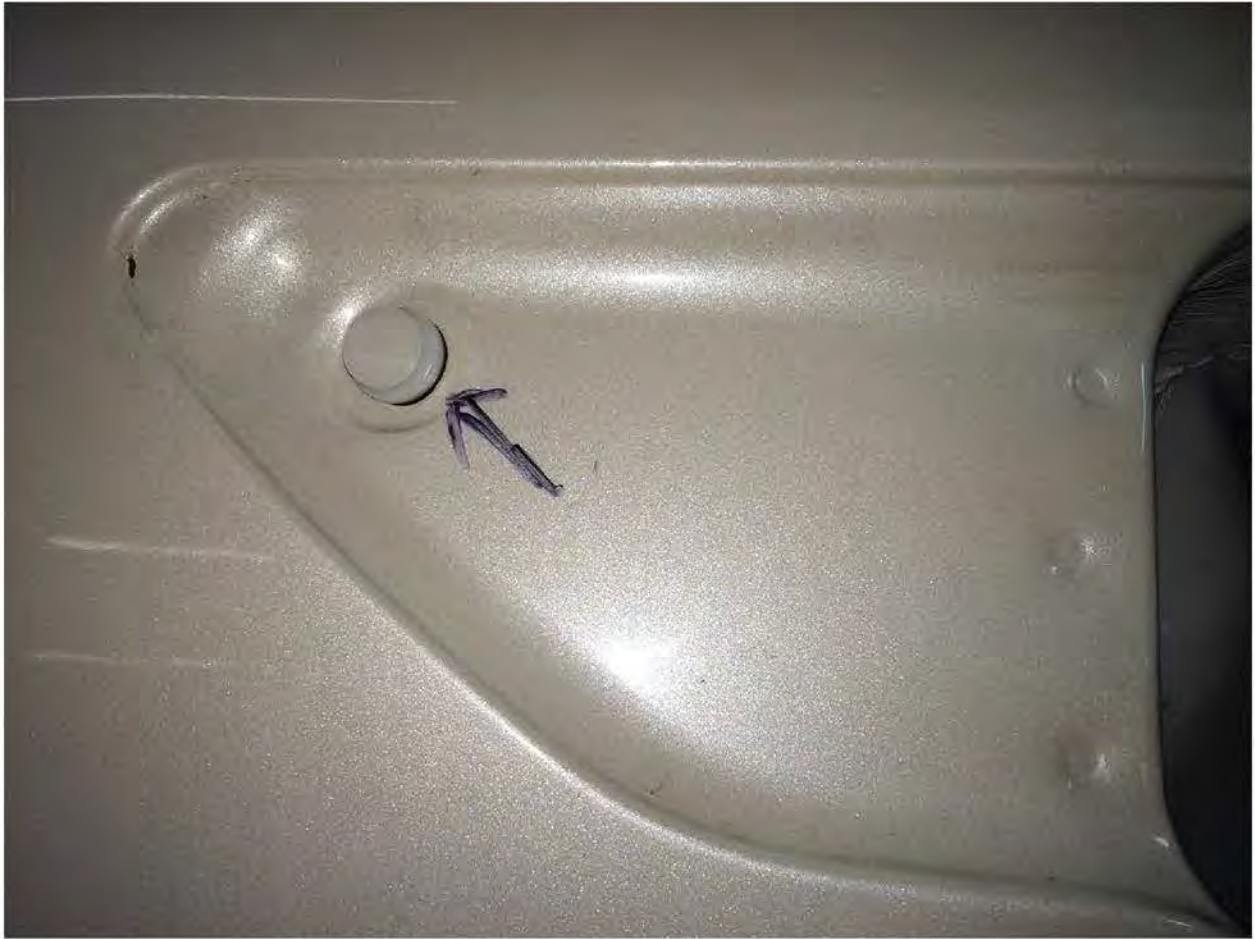
Clip that holds the tail light

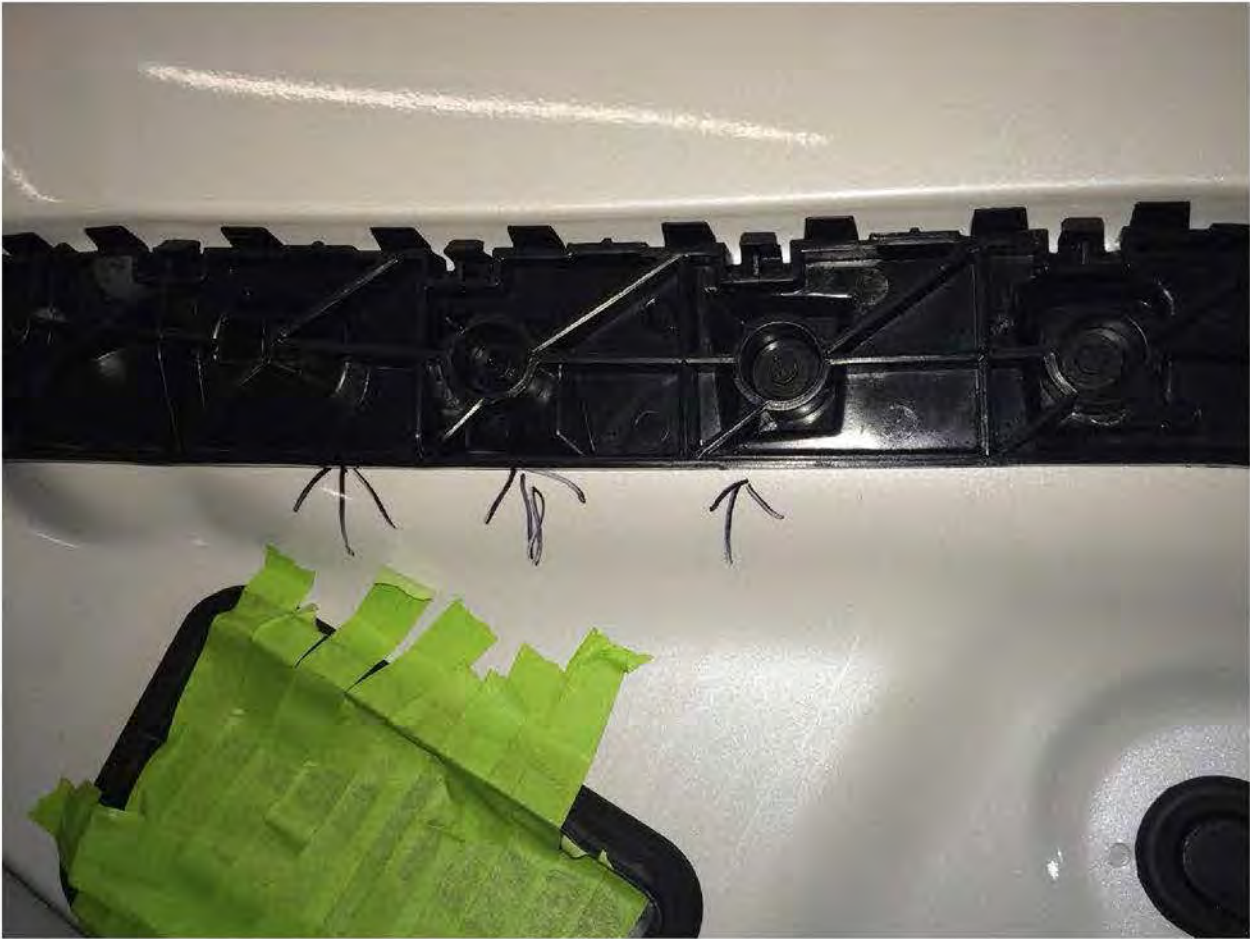
Leak under plastic bar that holds the bumper

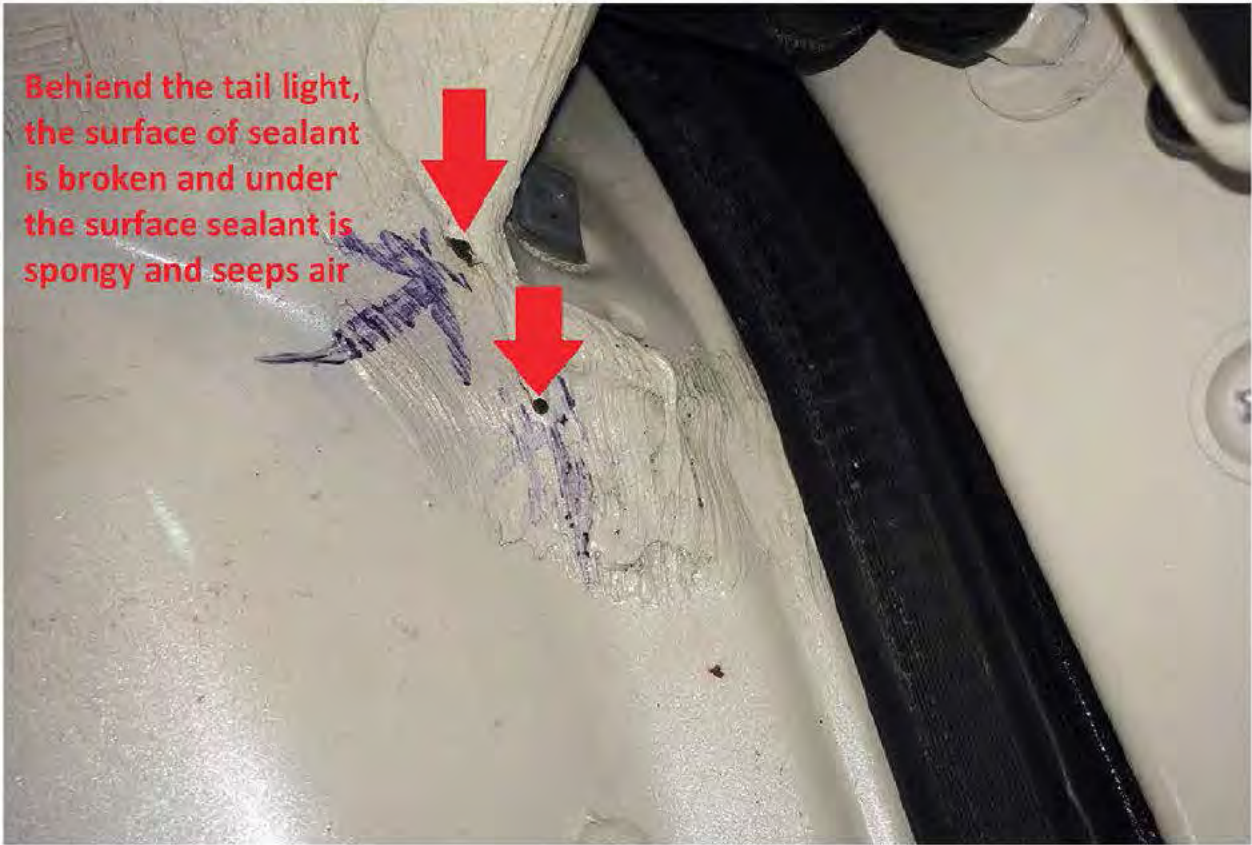
Behiend the tail light,
the surface of sealant
is broken and under
the surface sealant is
spongy and seeps air
