**Expert Report of  
Dr. Michael E. Cundy**

**[REDACTED] v Ford**

Prepared by:  
Michael E. Cundy, Ph.D., P.E.

December 14, 2015

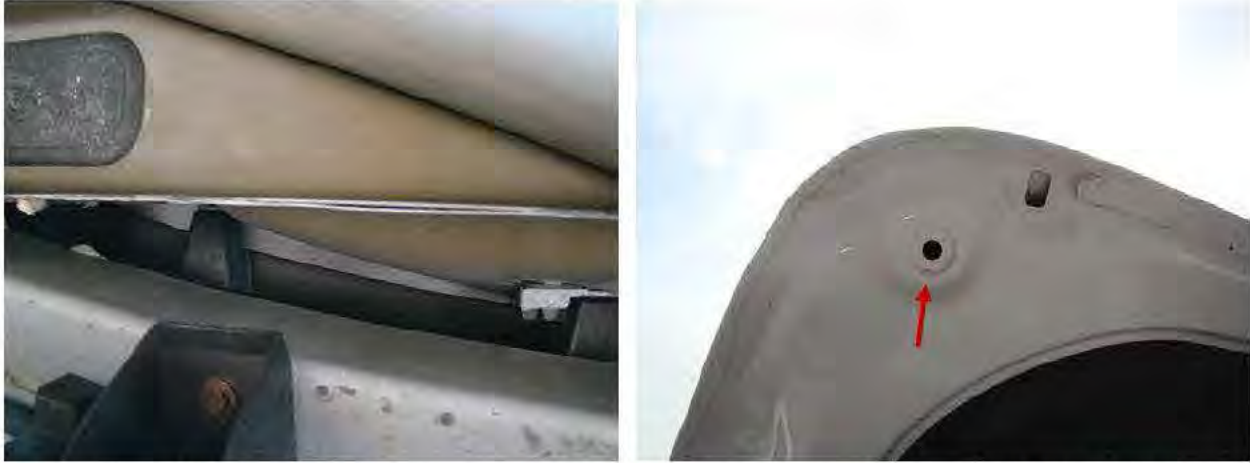
19 The 2013 Ford Explorer XLT with VIN 1FM5K7D87DG [REDACTED] was a Complaint Explorer (Figure 6) previously owned by Dixon (hereafter referred to as the [REDACTED] 2013 Ford Explorer). The odometer read 35,410.1 miles at the start of testing. The vehicle was equipped with a V6. It was visually in good operating condition with no evidence found of current or prior collision damage. The Carfax report was clean. No diagnostic trouble codes (DTCs) were found. Warranty records indicate that TSB 14-0130 had been performed on the vehicle. However, as will be discussed later in the report, there was evidence suggesting that the work was incomplete. For example, there was a lack of sealant on the underbody lap joints forward of the rear bumper (Figure 8).

Figure 8. Lack of underbody seam sealant and liftgate valves on the [redacted] 2013 Ford Explorer 1363. Note the missing liftgate bumper in the right photograph.

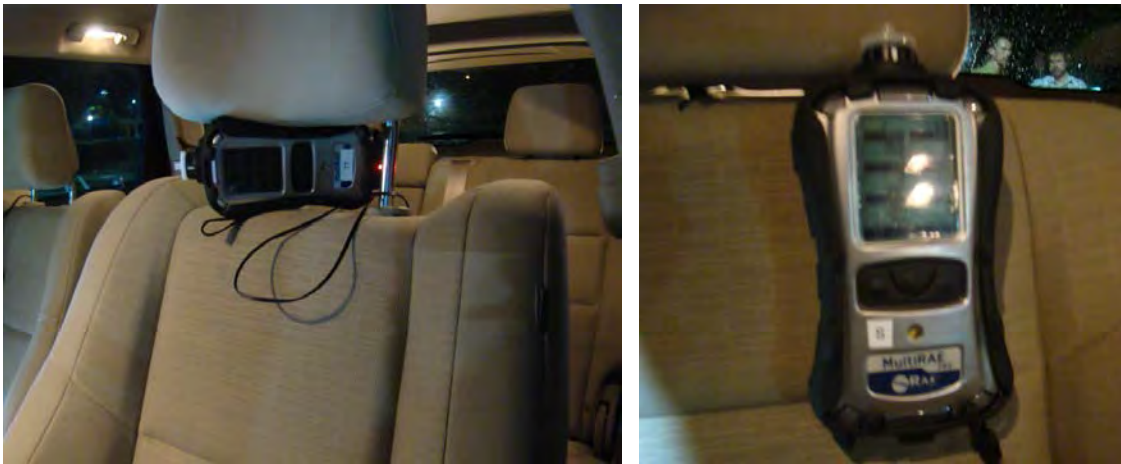
Figure 29: Gas monitor mounted between headrest and seat back in driver's location (left), and second row right side headrest on 2015 Jeep Grand Cherokee [REDACTED]. The calibration check mark is seen in the image on the right. Calibration logs indicate that the meter on the left is in calibration.

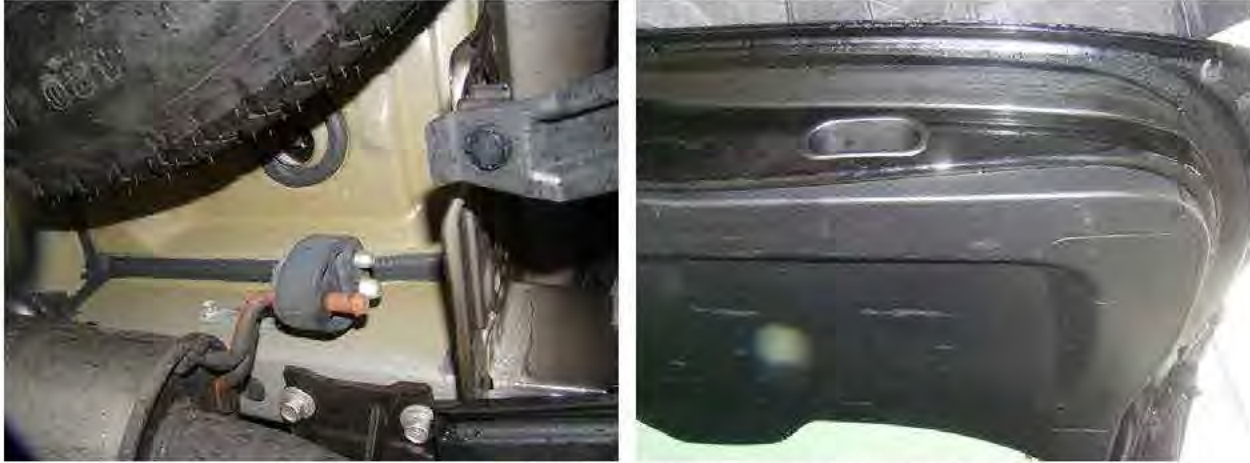
Figure 35. 2014 Toyota Highlander 6397. Underbody sealant at left. Outer drain holes are plugged on the left and right sides at the latch end of the liftgate. Middle hole is open (top of photo).

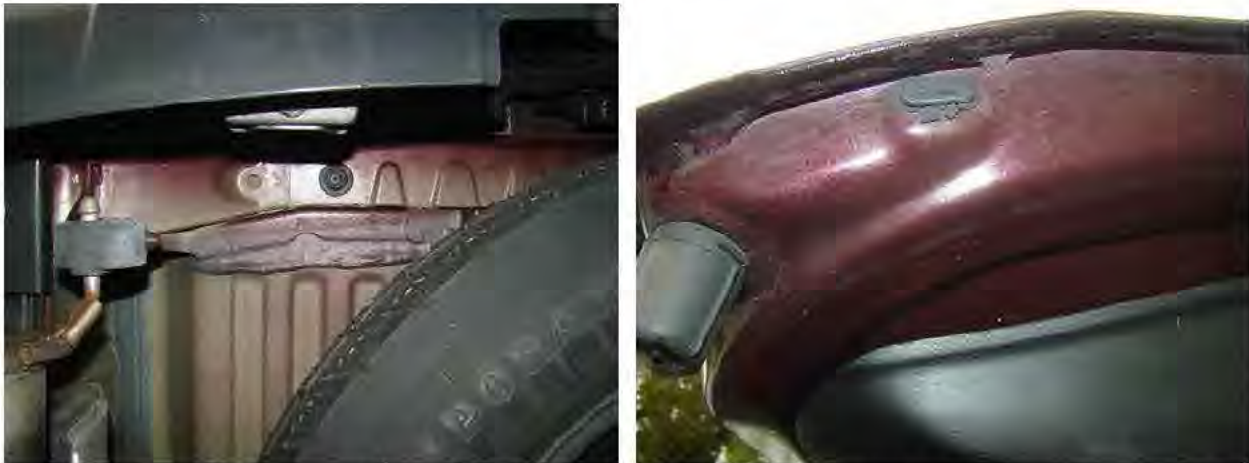
Figure 38. 2011 Honda Pilot [REDACTED]. Intermittent underbody sealant at left. Plugged drain holes on the left and right sides at the latch end of the liftgate.

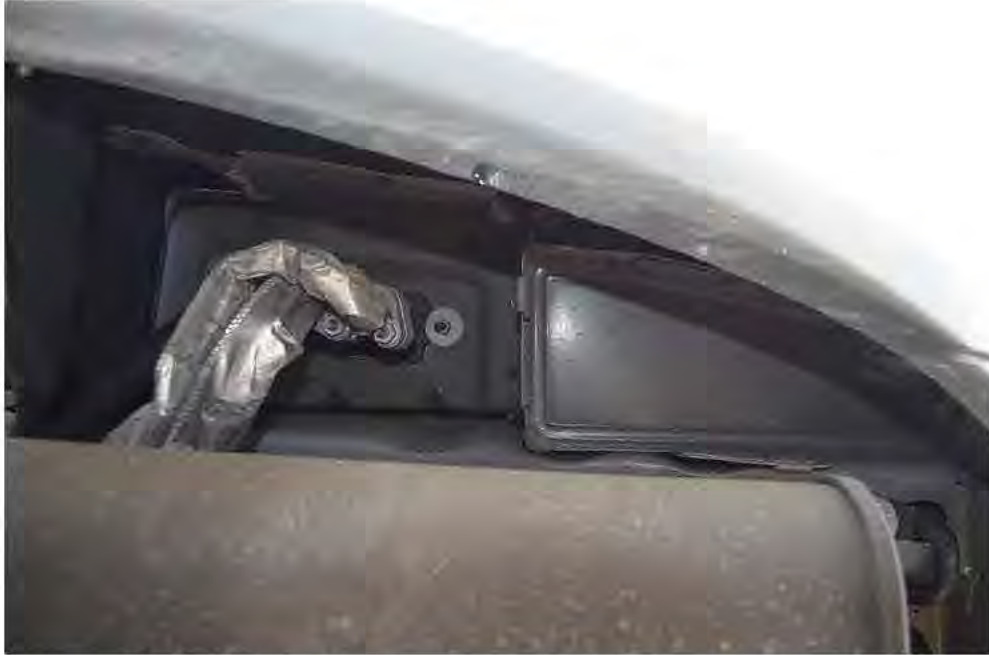
Figure 41. 2015 Ford Explorer Limited 9474 lack of underbody sealing.

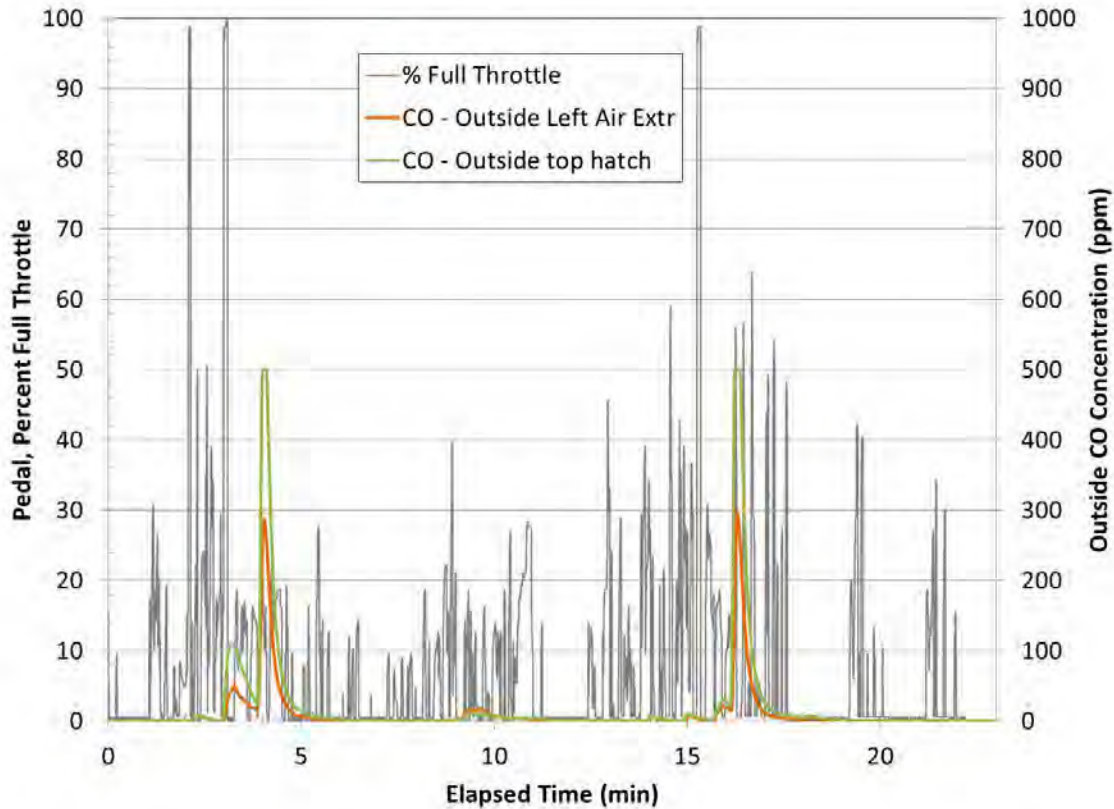
Figure 51: Plot showing the accelerator pedal position with two outside CO concentration measurements for a test with the Complaint 2014 Ford Explorer [REDACTED].

In the current test, the CO concentration outside the top hatch area briefly reached above the 500 ppm measurement range of the instrument on two WOT events. To the extent that peer vehicles have similar turbulence at the rear hatch and have fuel enrichment on high driver demand, elevated CO levels might also result. As stated in paragraph 18 of my July 8, 2015 Declaration, the rear hatch seal was found to be continuous on this vehicle, with the exception of a very small gap along the bottom of the hatch. However, in my inspection of the Sanchez-Knutson vehicle on January 15, 2015, a fog test revealed inadequate sealing of the top side of the rear hatch in the area where the CO sensors detected elevated CO levels.

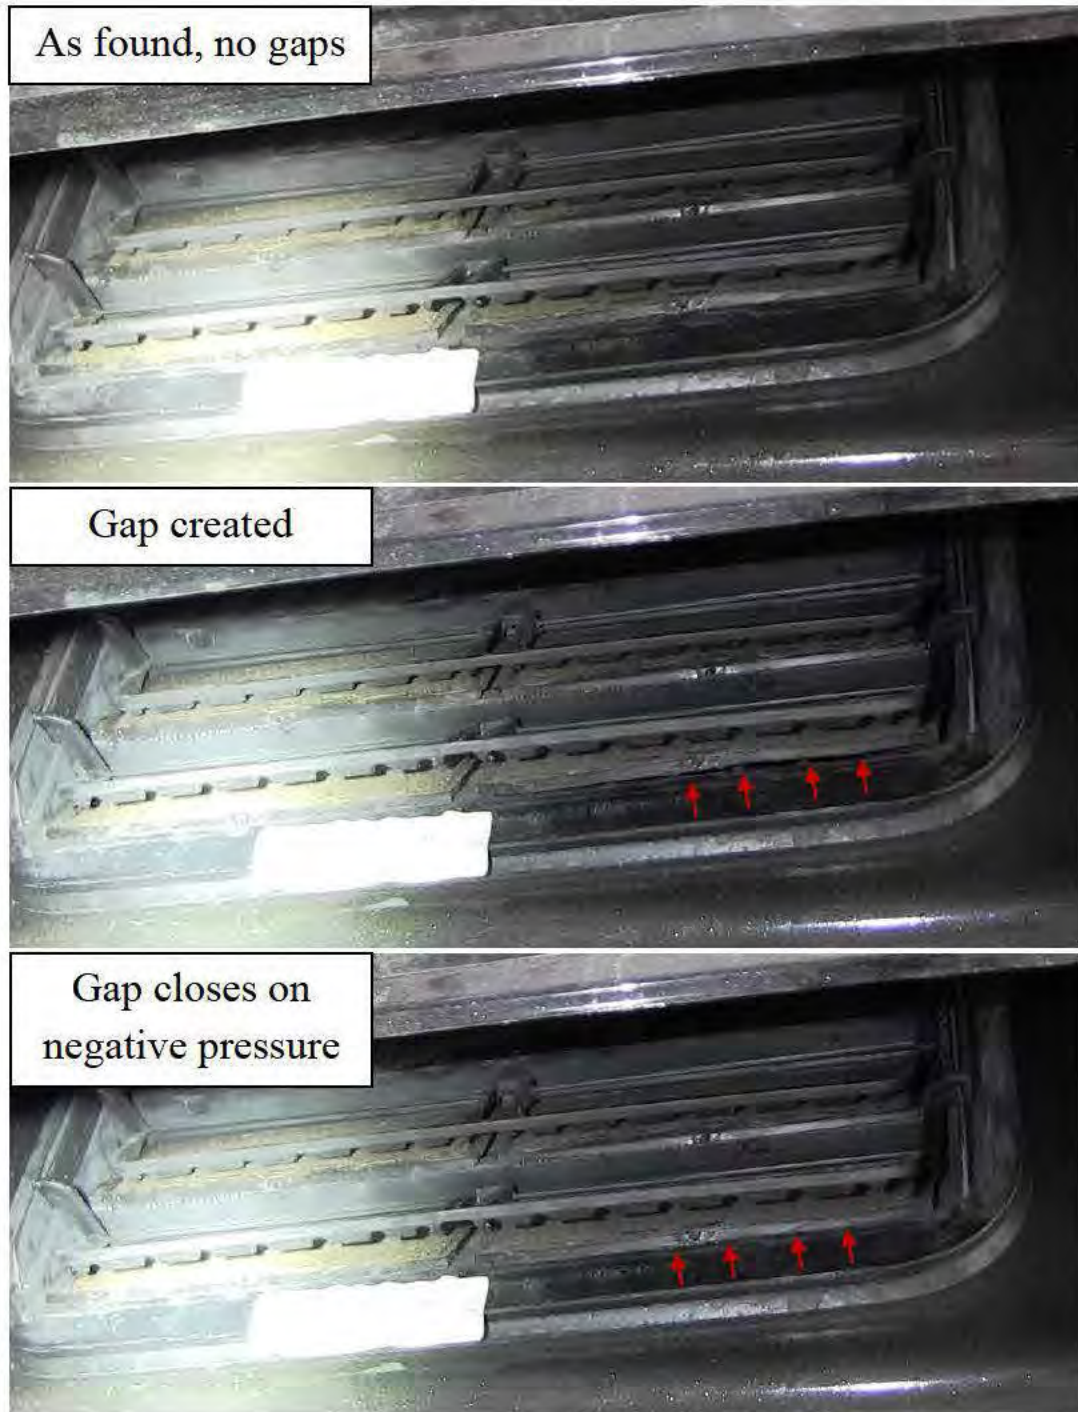
Figure 55: Video screenshot showing no apparent gaps in the left side air extractor as found (Top; 00:01 in video), showing the artificially created gap (Middle; 01:08 in video), and showing the closed gap after a vacuum had been applied (Bottom; 01:12 in video).

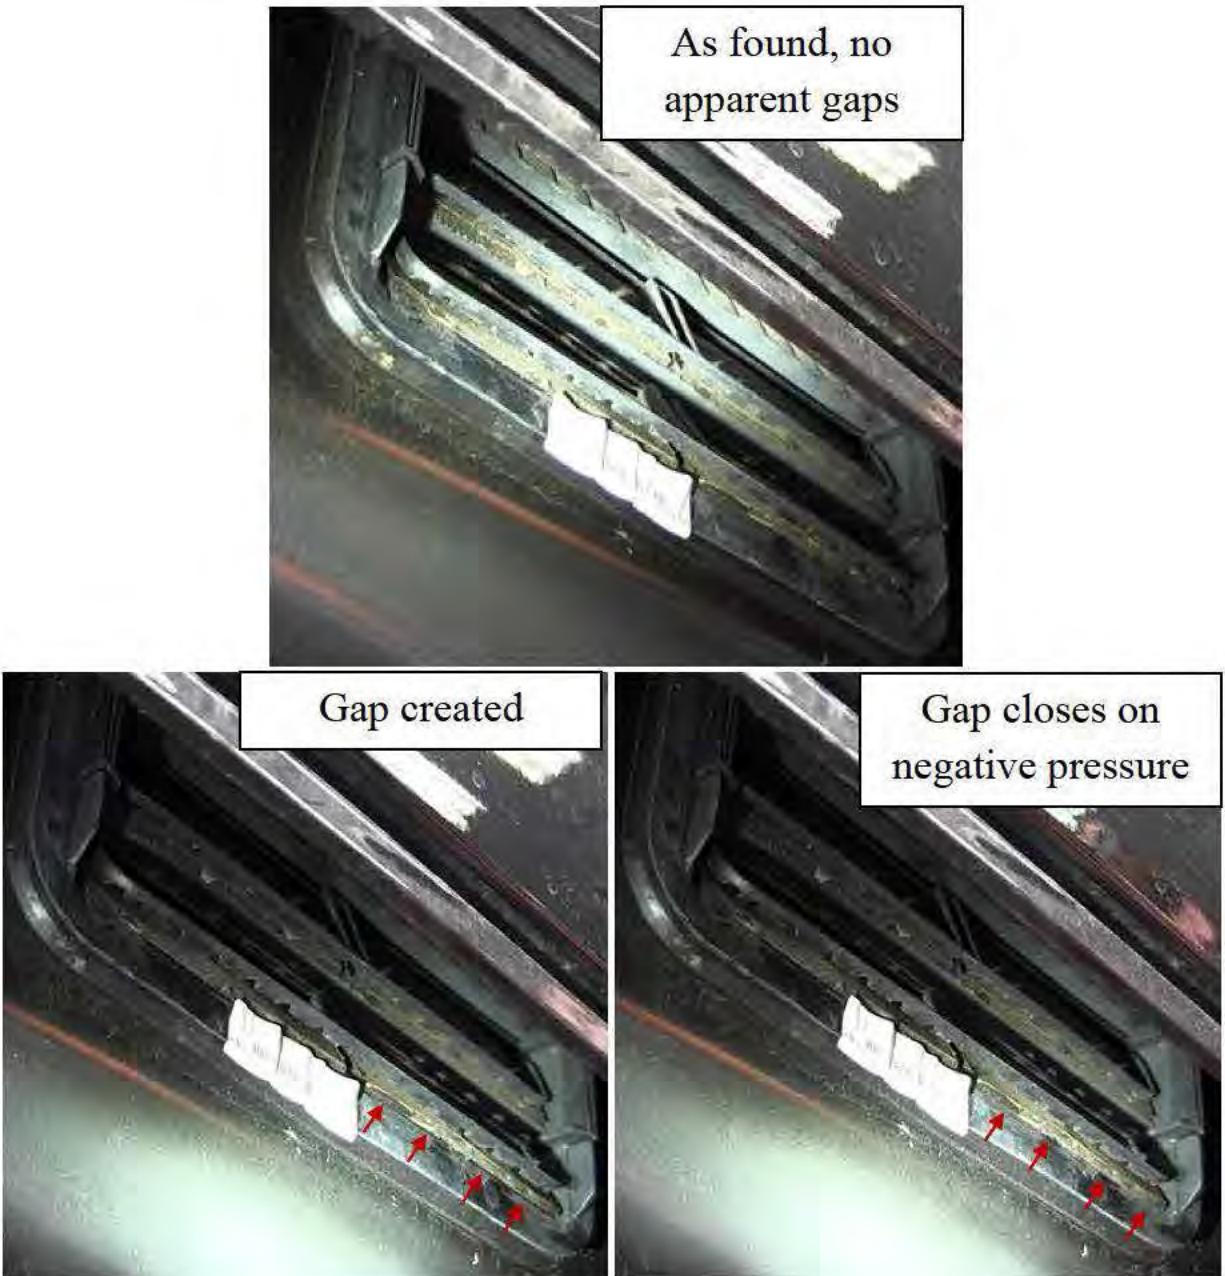
Figure 56: Video screenshot showing no apparent gaps in the left side air extractor as found (top; 00:01 in video), showing the artificially created gap (bottom left; 00:20 in video), and showing the closed gap after a vacuum had been applied (bottom right; 00:22 in video).

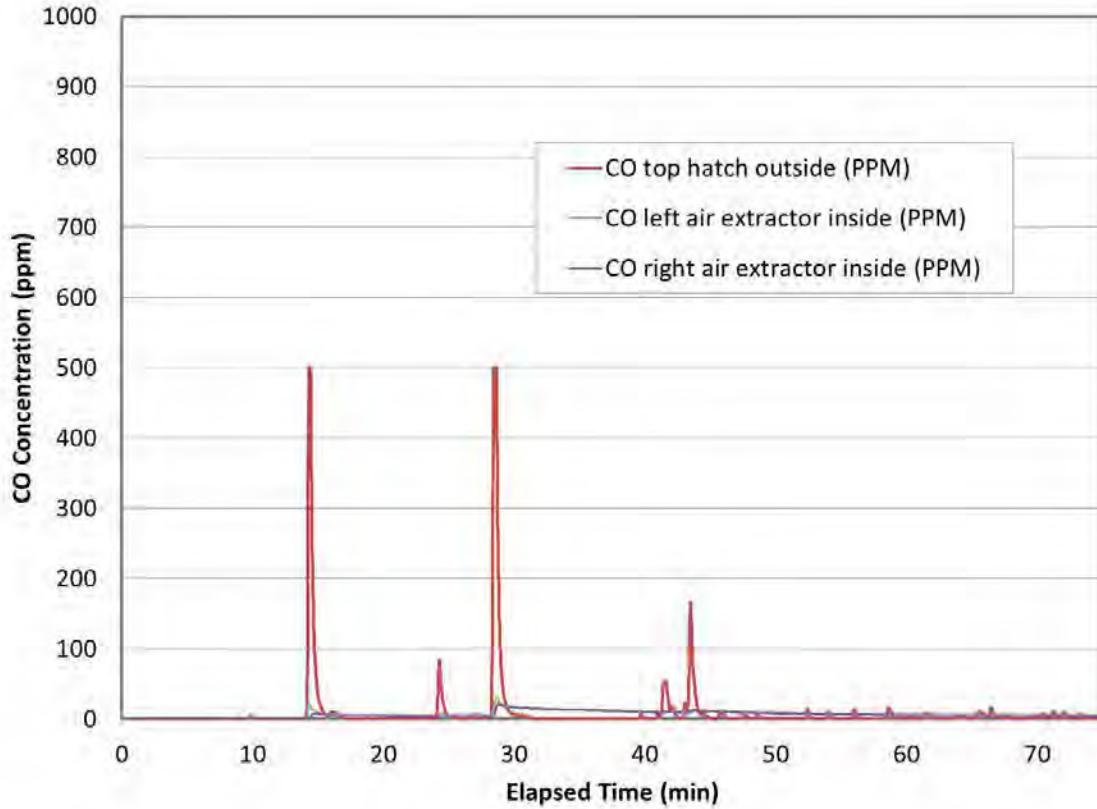
The exterior top hatch CO concentration profile is plotted against the CO concentration measured inside the left and right air extractors, above the underbody lap joints (see Figure 60). A small amount of CO is present at these sampling locations, which correlate with the brief relatively high concentration pulses (and accordingly, the WOT events). After entry into the vehicle, it dilutes and the local concentration decays.

Figure 60: Plot showing the CO concentrations at the outside top hatch location and inside the left and right air extractors, above the underbody lap joints.

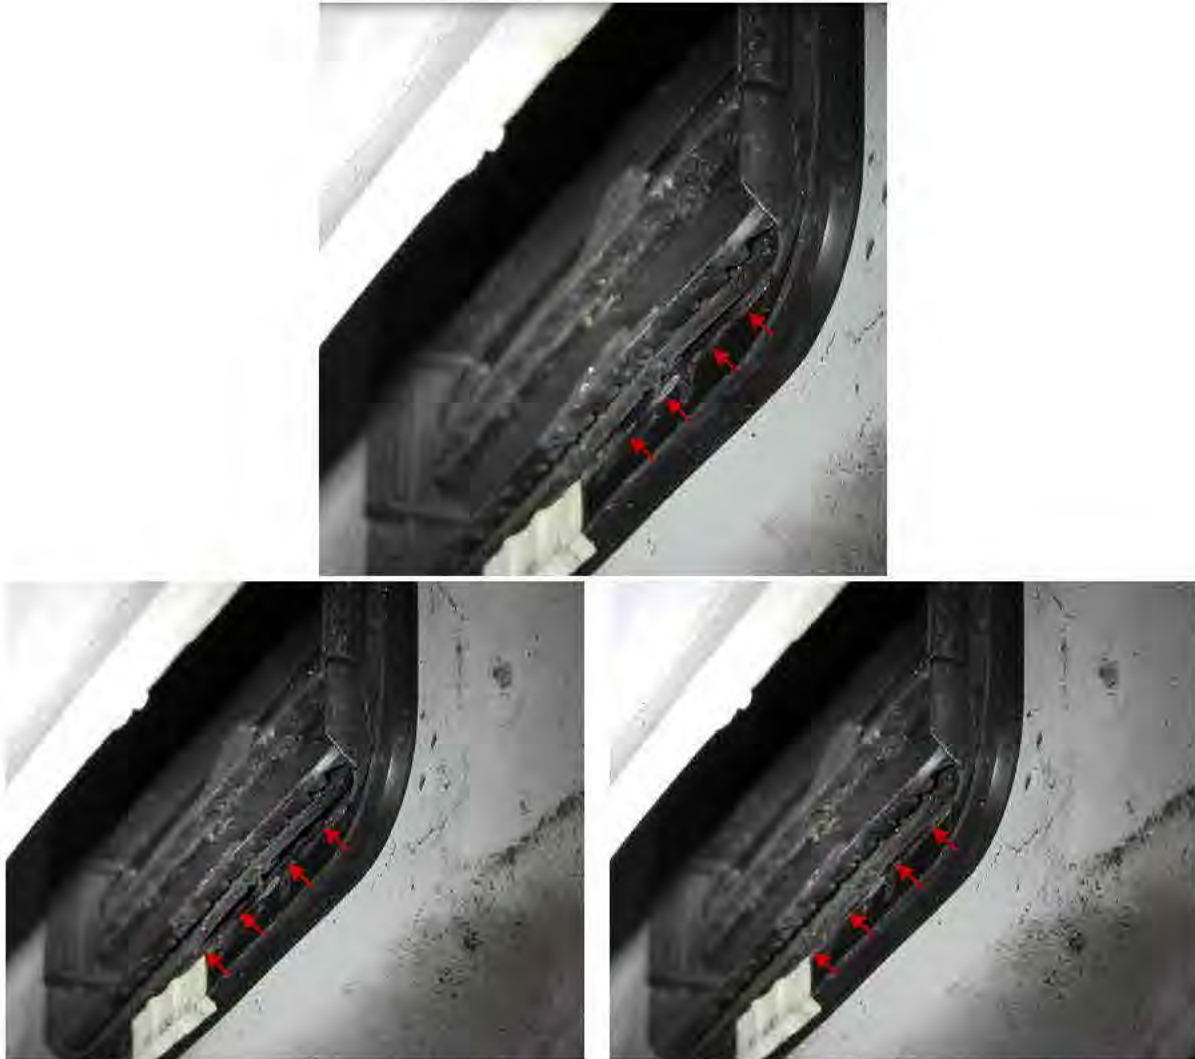
As with the Complaint 2014 Ford Explorer, the functionality of the air extractors were tested on the Dixon 2013 Ford Explorer using the same test methodology described earlier. The left side air extractor was found to be an updated part (p/n BB53 B280B63 AB). The flaps all appeared to rest on the frame prior to the start of the test, with the exception of the lower right flap which

had a very small gap. A more visible gap was created, and the response to a negative pressure in the cabin was observed and video recorded. As with the Complaint 2014 Ford Explorer, the air extractor flap quickly closed due to the negative pressure. Figure 62 shows a screenshot of the gap that was artificially created (left), and the closure of the same gap once a negative pressure was applied in the cabin (right).

Figure 62: Video screenshots showing a small gap in the lower right left side air extractor prior to the test (top; 00:01 in video), showing the artificially created gap (bottom left; 00:15 in video), and showing the closed gap after a vacuum had been applied (bottom right; 00:16 in video).

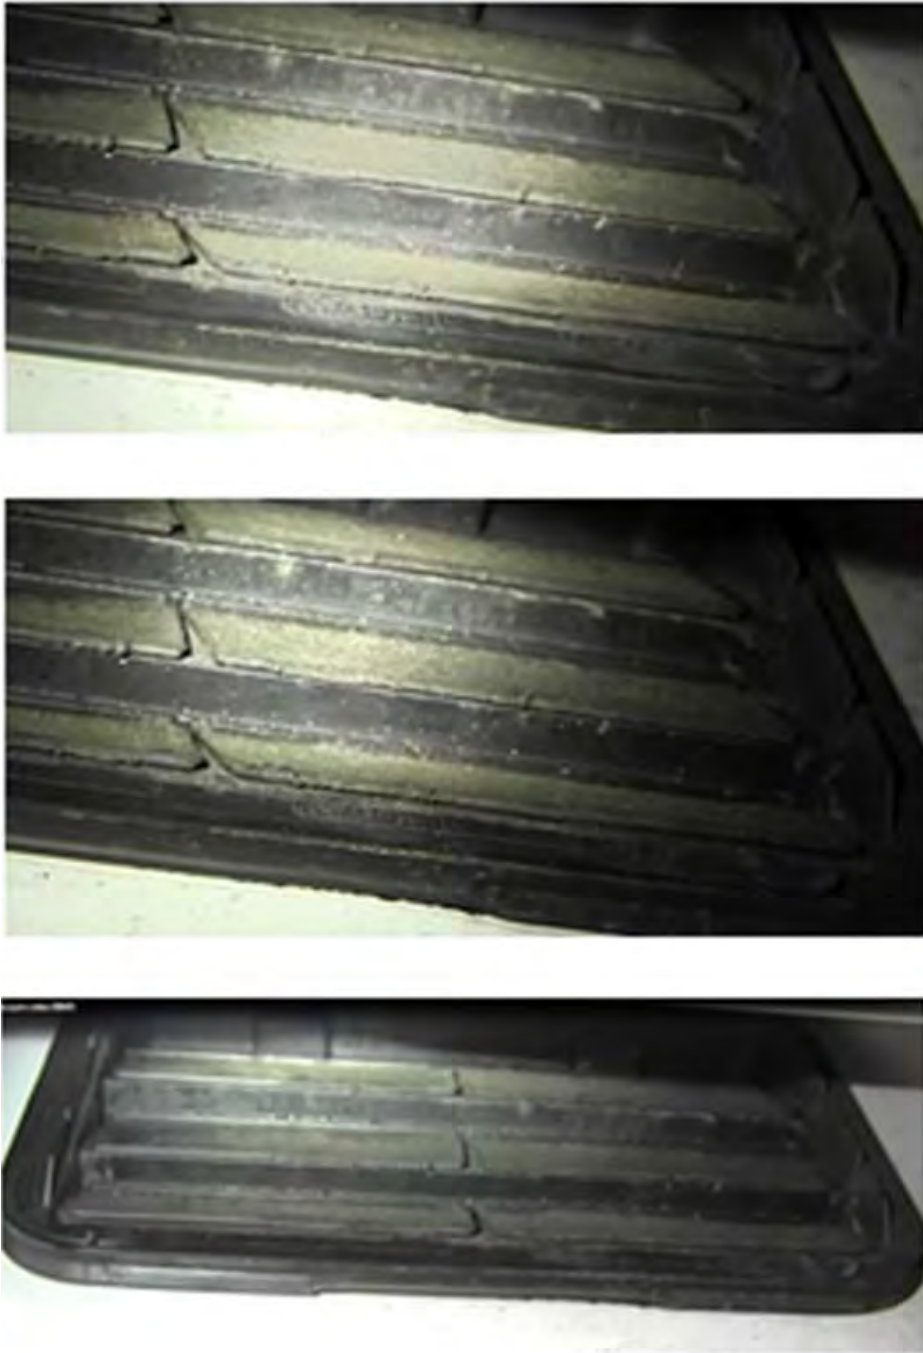
The passenger side of the [REDACTED] vehicle had the original air extractor design and did not visually have gaps. The thin rubber flaps appeared to rest against the frame. Attempts were made to manually create an air gap and the vacuum was applied. To illustrate the effects of the negative pressure, one corner of one of the flaps was lifted during vacuum application, and the flap was observed to move to close the gap. The results of the testing are shown in Figure 63.

Figure 63: Video screenshots showing an artificially created gap in the lower right left side air extractor prior to the test (top; 00:35 in video), showing the closed gap after a vacuum had been applied (middle; 00:39 in video), and showing all of the flaps after the testing concluded (bottom; 01:28 in video).

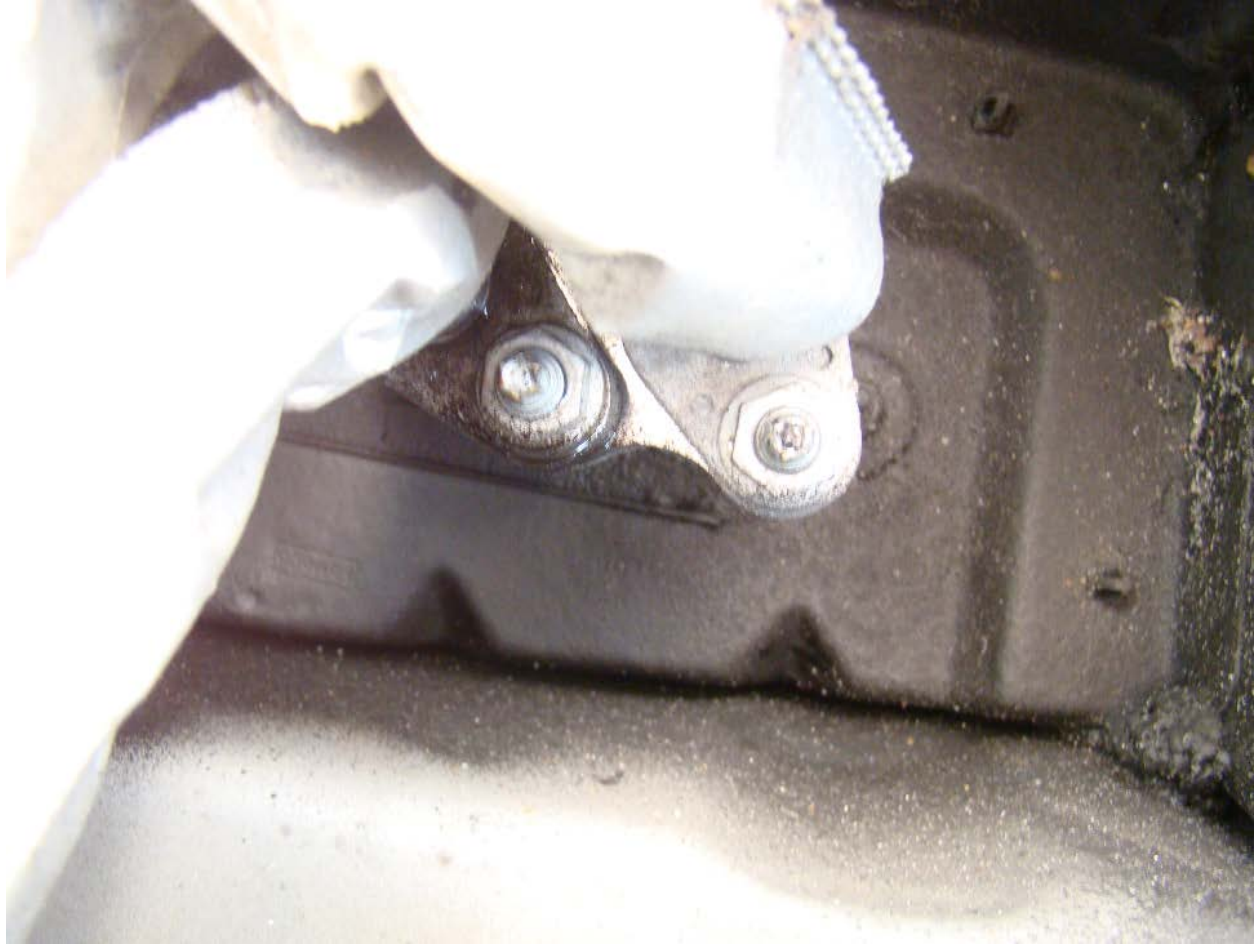
Figure 64: Photographs showing the underbody of the [REDACTED] vehicle. The sealer was not applied to all locations specified in the TSB.

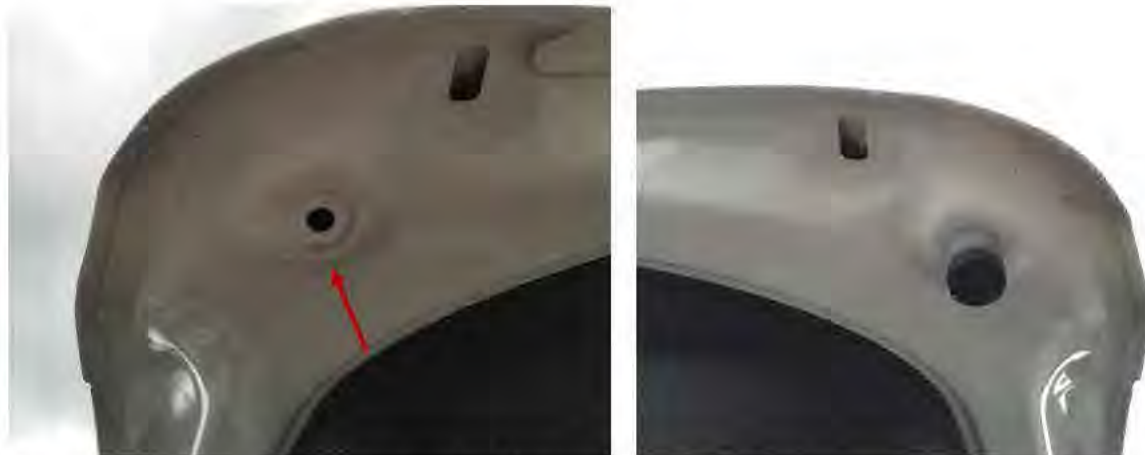
Furthermore, the condensate drain valves were not installed on the [REDACTED] vehicle hatch according to the TSB, and the left side rubber bumper was missing from the hatch, as seen in Figure 65.

Figure 65: Photographs showing that the condensate drain valves were not installed on the left or right sides (left and right photographs, respectively) of the [REDACTED] vehicle. Additionally, the rubber bumper was missing from the left side of the hatch (left photograph, red arrow), creating an additional entry path.

- D The Dixon 2013 Ford Explorer [REDACTED] was missing a rubber bumper on the left side of the rear hatch, which is a point of exhaust gas ingress. This vehicle also did not have all of the changes associated with TSB 12-12-04 or TSB 14-0130 made, including the condensate drain valves and the reprogramming of the HVAC system.

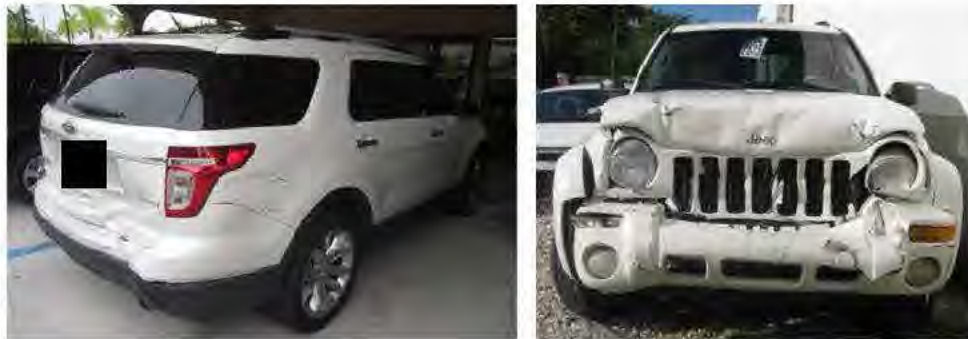
**Figure 3** Photographs showing the external damage to the Ford Explorer (left; SKZ3-000802) and Jeep Liberty (right; SKZ3-000848) which occurred during the collision on or around June 5, 2013.

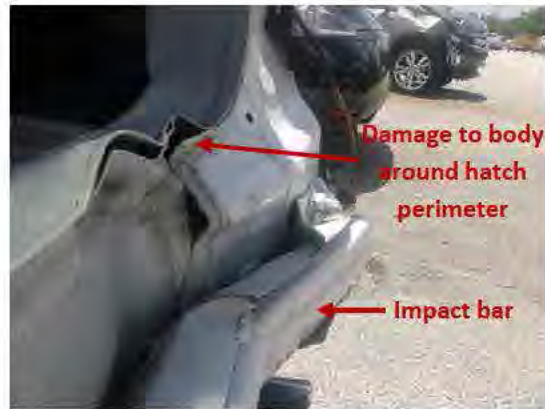
**Figure 4** Photograph (SKZ3-000759) showing damage to the impact bar and the body at the hatch perimeter.

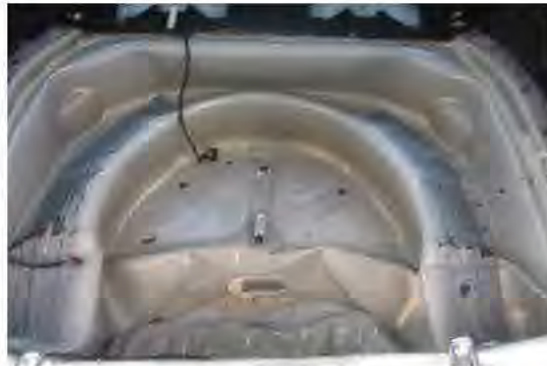
**Figure 5** Photograph (SKZ3-000784) showing buckling of the rear floor pan area, where the spare tire resides.

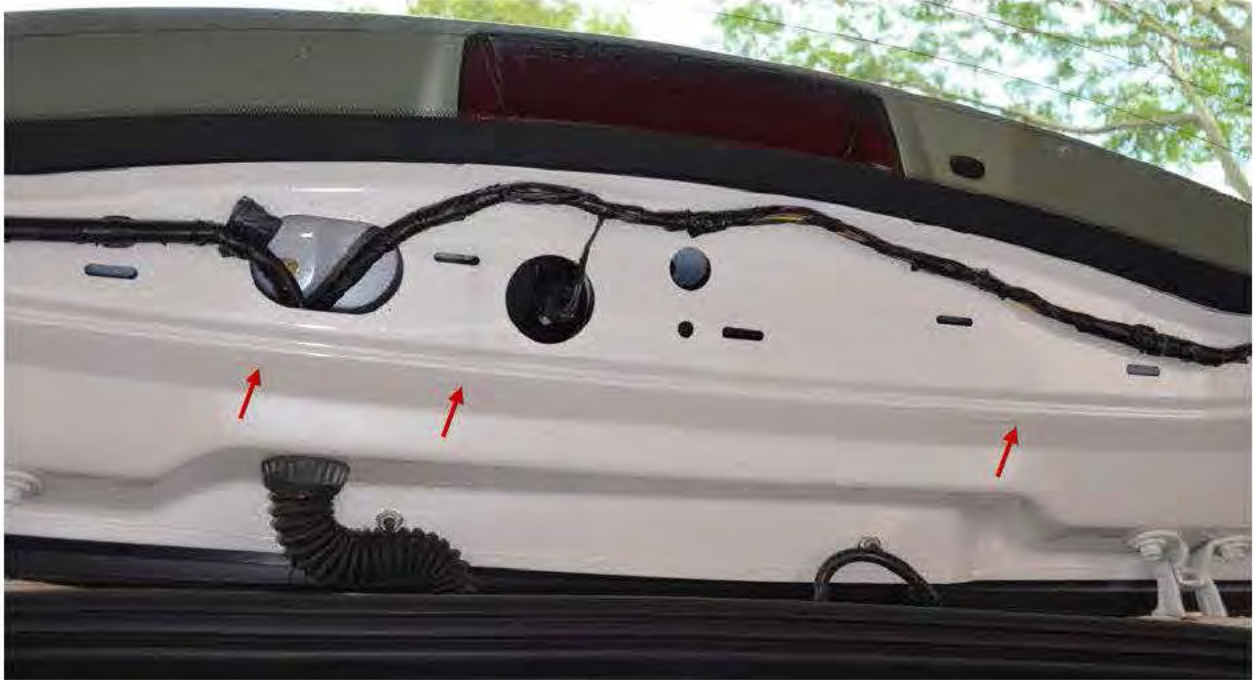
**Figure 6** Witness marks from the seal on the top side of the rear hatch on the Subject Vehicle. Gaps are present.

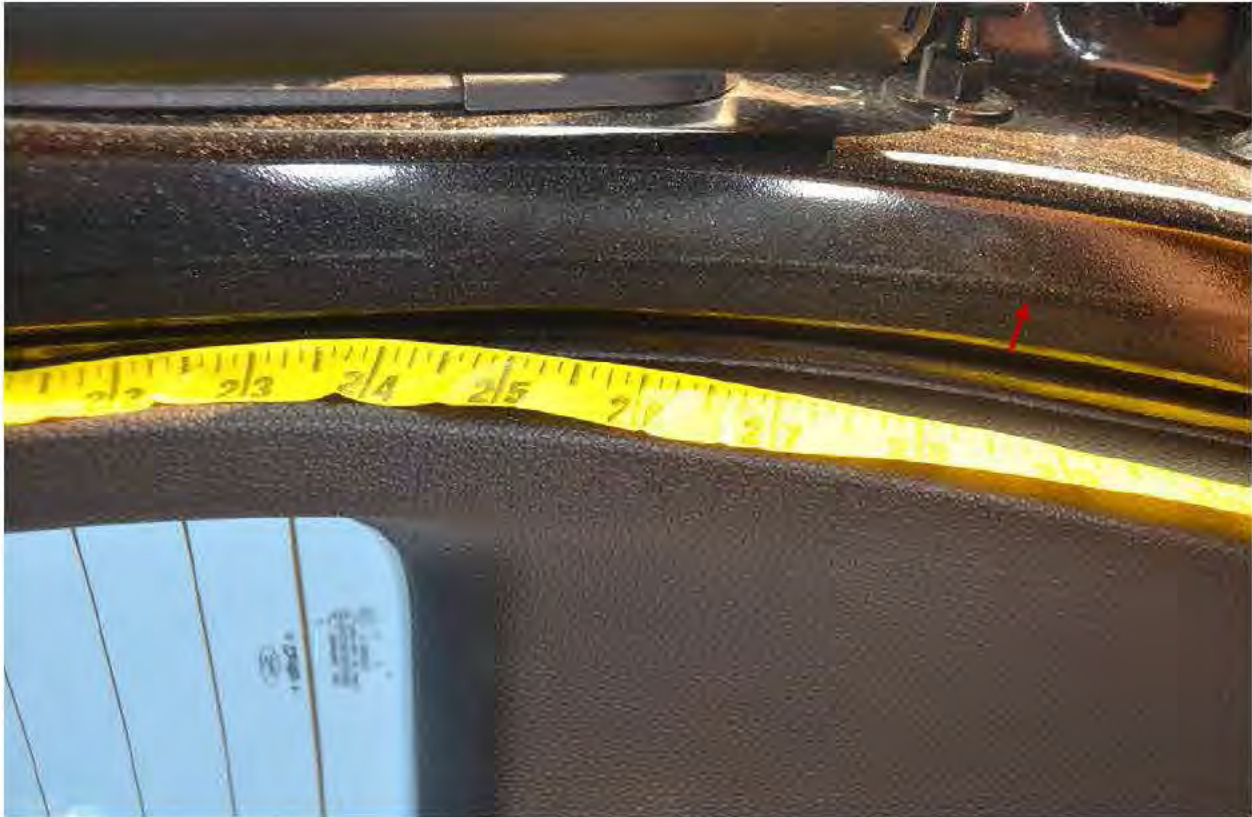
**Figure 7** Photograph showing the witness marks on the repurchased vehicle. The witness marks appeared to be continuous along the perimeter of the hatch, with the exception of a small 0.1"-0.2" gap near the bottom.

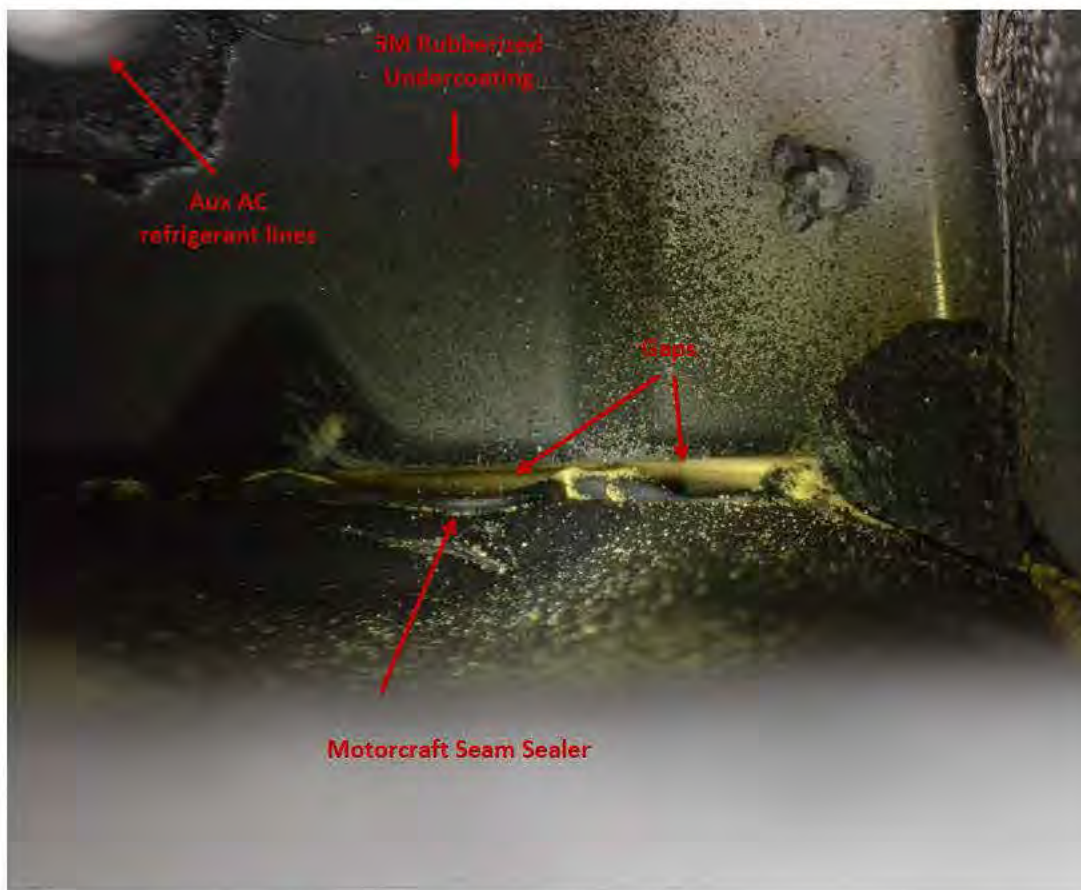
**Figure 10** Photograph of the underbody of the Subject Vehicle near the auxiliary air conditioner refrigerant inlet showing gaps that the seam sealer was intended to seal, and incomplete coverage of the 3M Rubberized Undercoating.

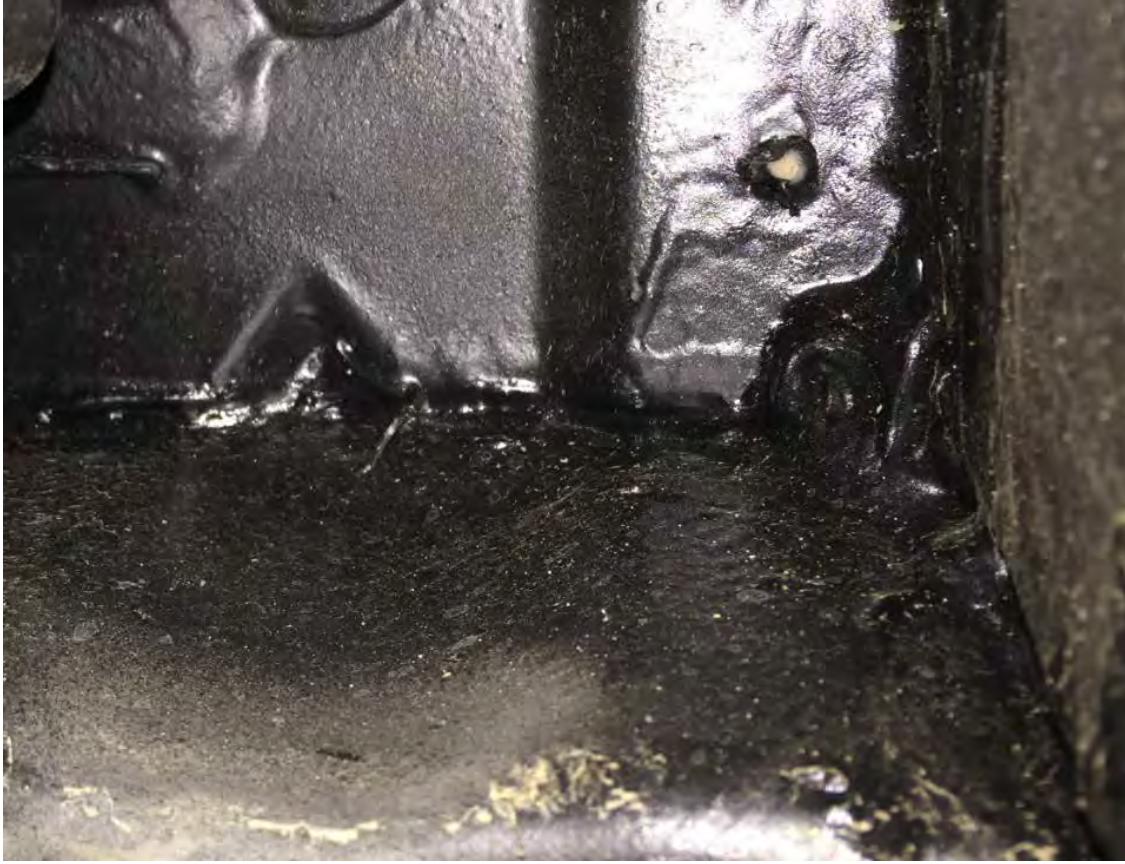
**Figure 11** Photograph of the repurchased Explorer with the same field of view as in Figure 10 showing adequate application and coverage of the Motorcraft Seam Sealer and 3M Rubberized Undercoating.

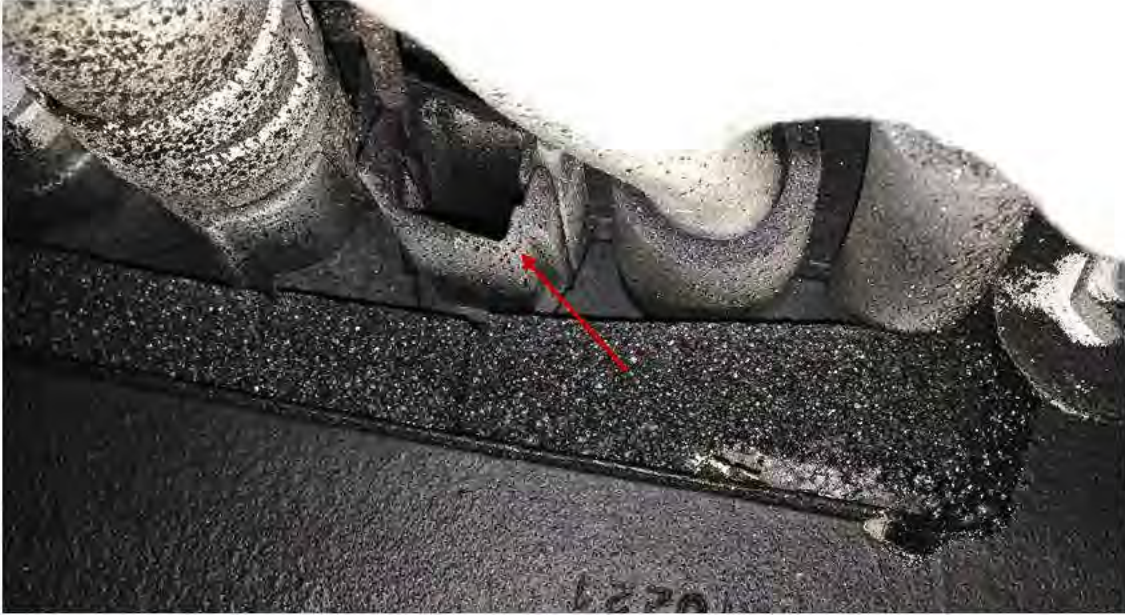
**Figure 12** Photograph of the underbody of the Subject Vehicle showing the auxiliary climate control drain with 3M Rubberized Undercoating on it.
