**HYUNDAI**NEW THINKING.  
NEW POSSIBILITIES.**Technical Service Bulletin**

**17-01-025**

**Sonata (YF)  
Sonata Hybrid (YF HEV)****SUBJECT:****2011-2014 SONATA (YF) AND 2011-2015 SONATA HYBRID (YF HEV)  
ANCHOR PRETENSIONER INSPECTION (RECALL CAMPAIGN 160)****\* IMPORTANT****\*\*\* Retail Vehicles \*\*\***

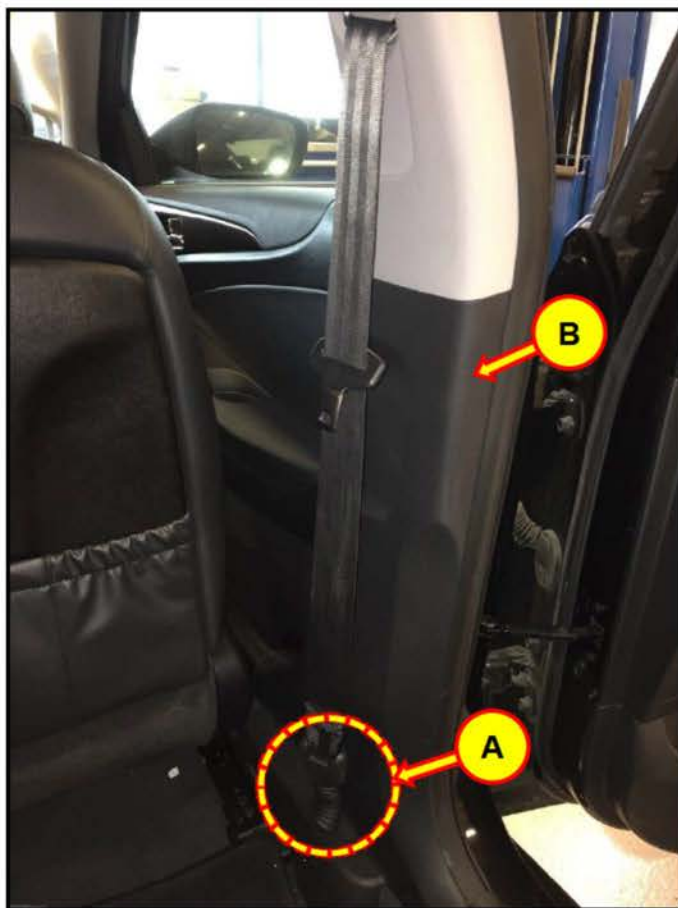
1. Move the passenger seat forward and locate the passenger anchor pretensioner (A) near the lower B pillar trim (B).

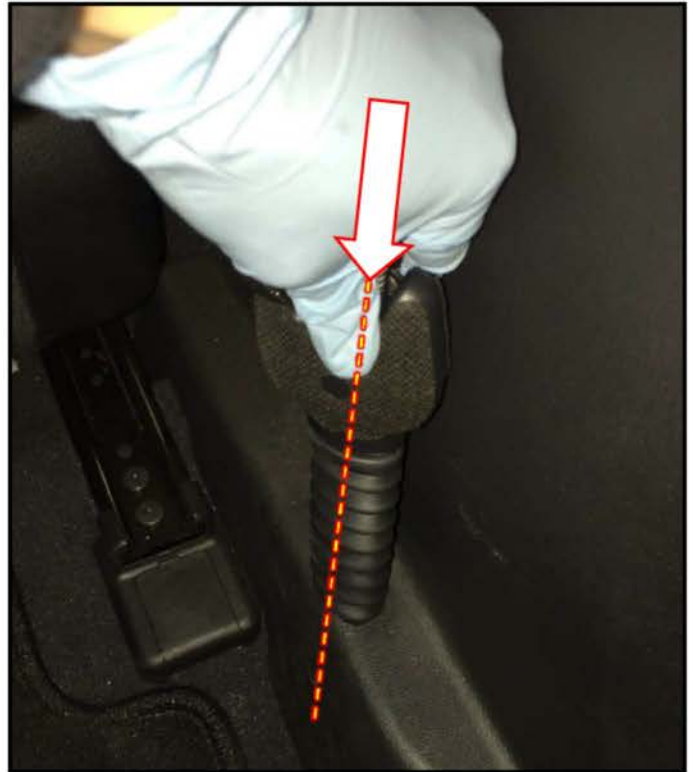
4. Push the linkage element down again.

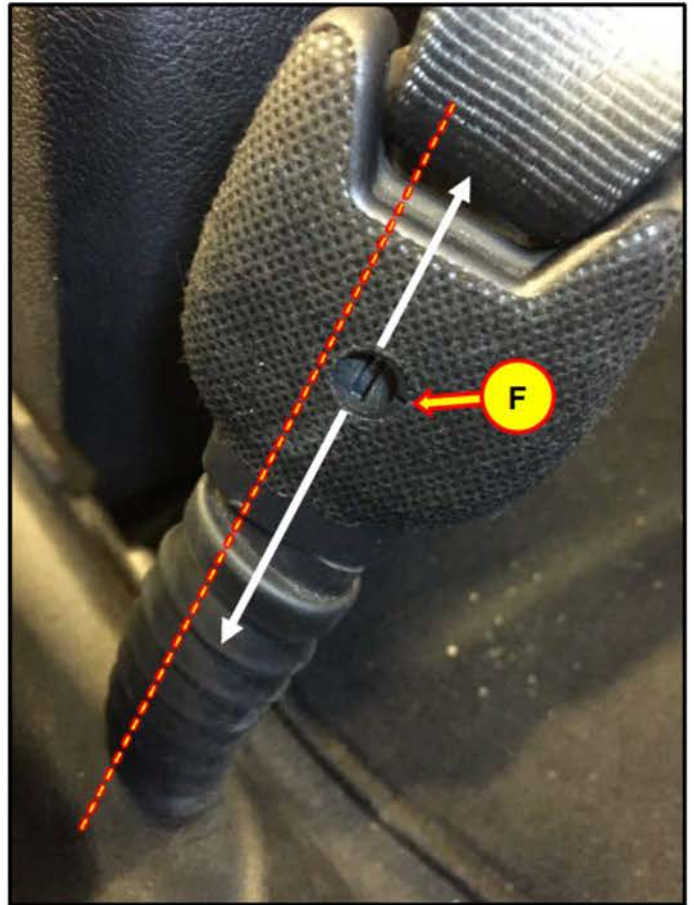
5. Visually inspect the center hole (F) on the outboard side of the linkage element to confirm that it is fully locked.  
**Note: When fully locked, the latch slot in the center hole is parallel to the anchor pretensioner cable.**
