**National Highway
Traffic Safety
Administration**

ODI RESUME

Investigation: EA 17-002
Prompted by: PE16-008, Consumer Reports
Date Opened: 07/27/2017 **Date Closed:** 01/17/2023
Investigator: Brian Smith **Reviewer:** Bruce York-B
Approver: Stephen Ridella
Subject: Exhaust Odor in Passenger Cab

EA17-002 Closing Report

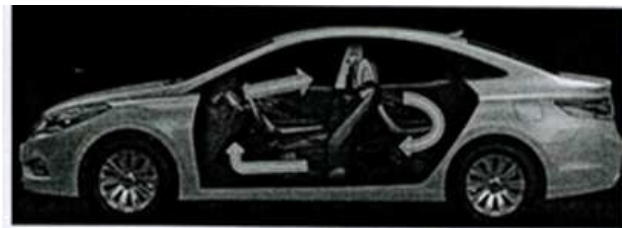
< Recirculation mode >

- ✓ When cars highly accelerate with the condition on internal circulation mode, exhaust gases could enter the passenger compartment due to pressure difference in cabin and vortex flow in back part of the car.

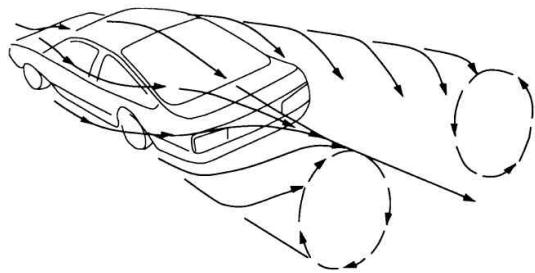
<Vortex flow in back part of vehicle>

- ✓ The vortex flow occurs in the back part of sedan vehicles depending on vehicle speed

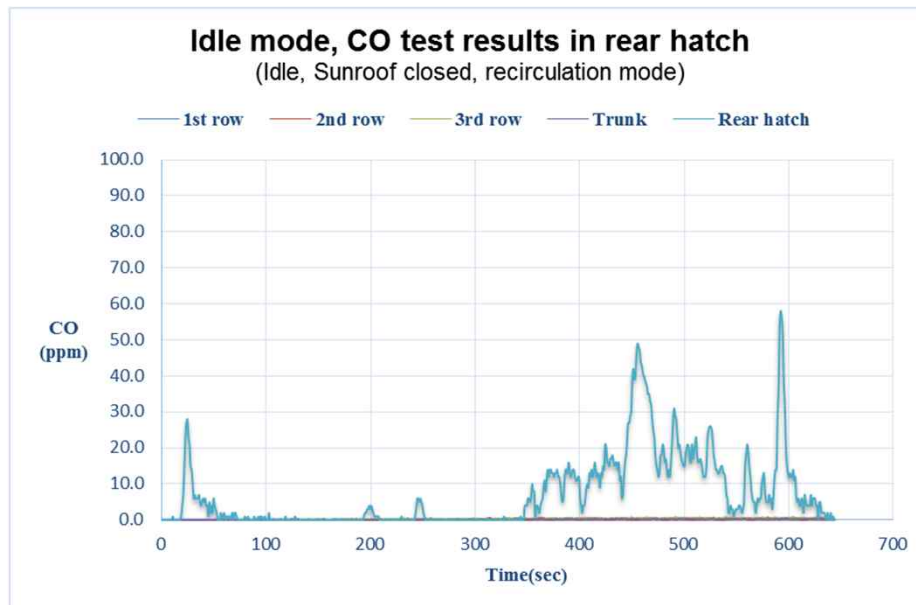
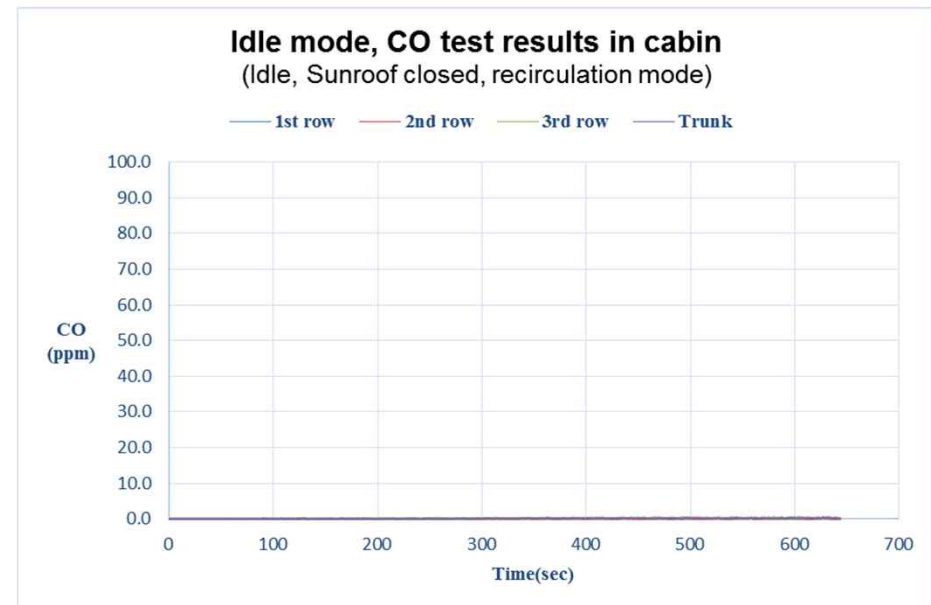
- ✓ Engine idling in normal condition, not moving
- ✓ Total test time : 10 min
- Stabilizing time : 5 min, Measuring time : 5 min
- ✓ CO was detected in the rear hatch, but not detected in cabins

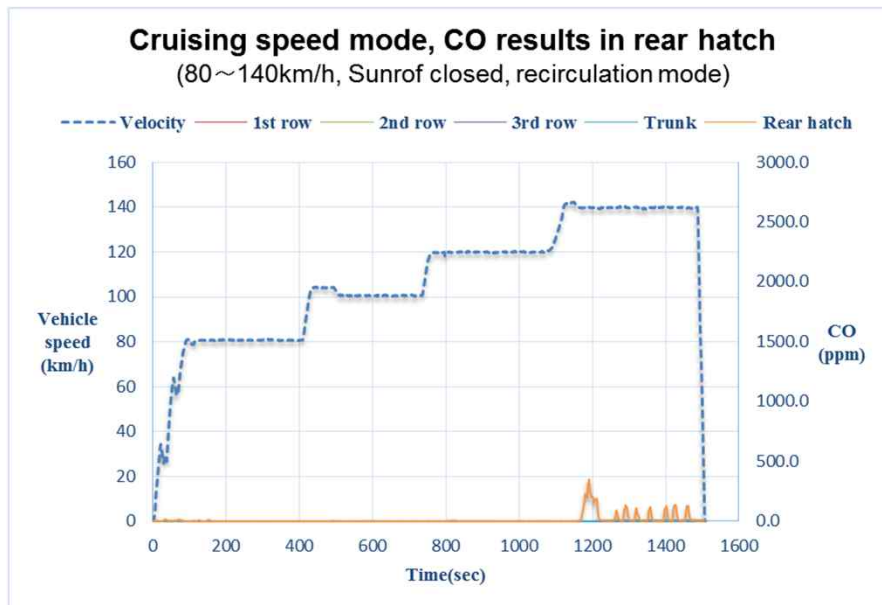
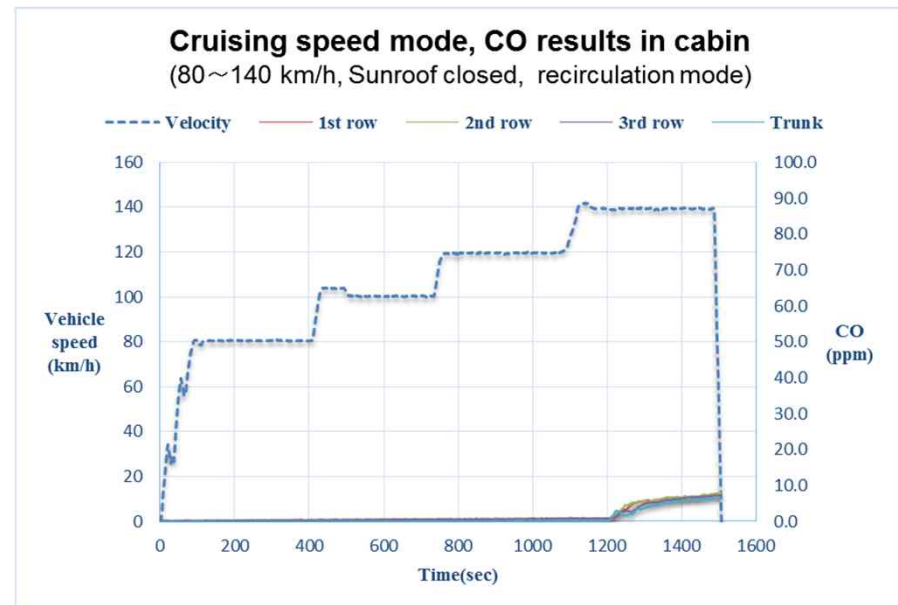
- 80 ± 5 km/h, 100 ± 5 km/h, 120 ± 5 km/h, 140 ± 5 km/h
- Each test time in stated speed : 5 min
- If CO is detected in test speed, test again that speed in 20 min
- CO was detected in 140 km/h,

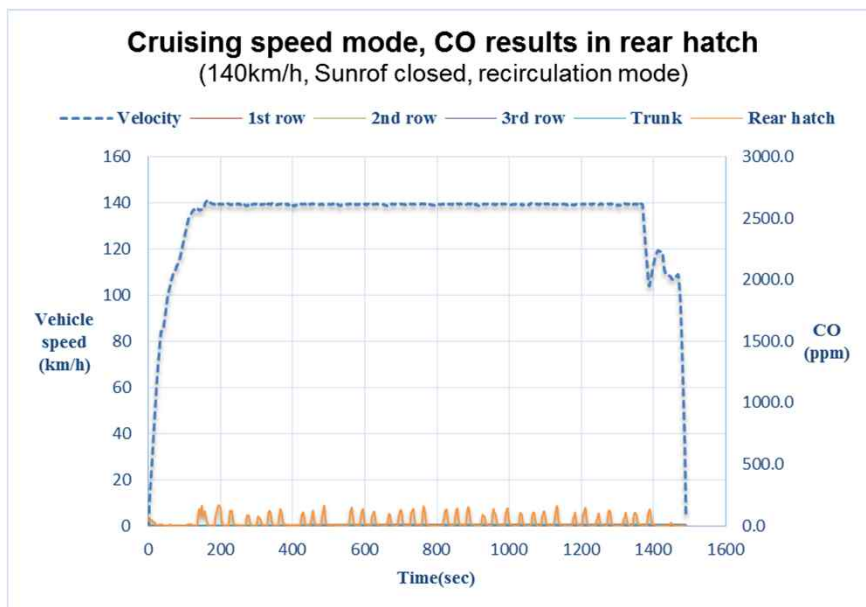
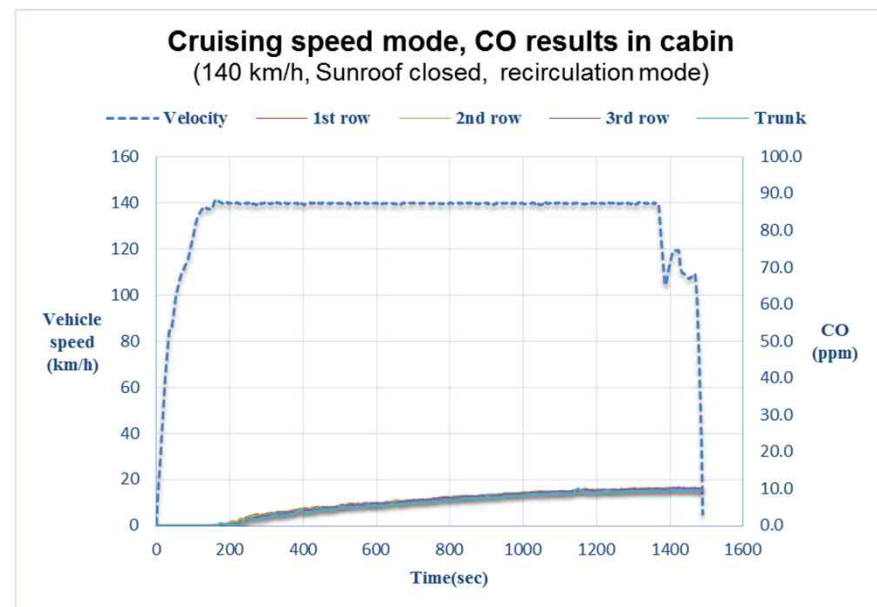
- 140 ± 5 km/h
- Total test time : 20 min (stabilizing time 10 min, measuring time 10 min)
- CO was detected in cabin with 140 km/h (8 ~ 9 ppm)

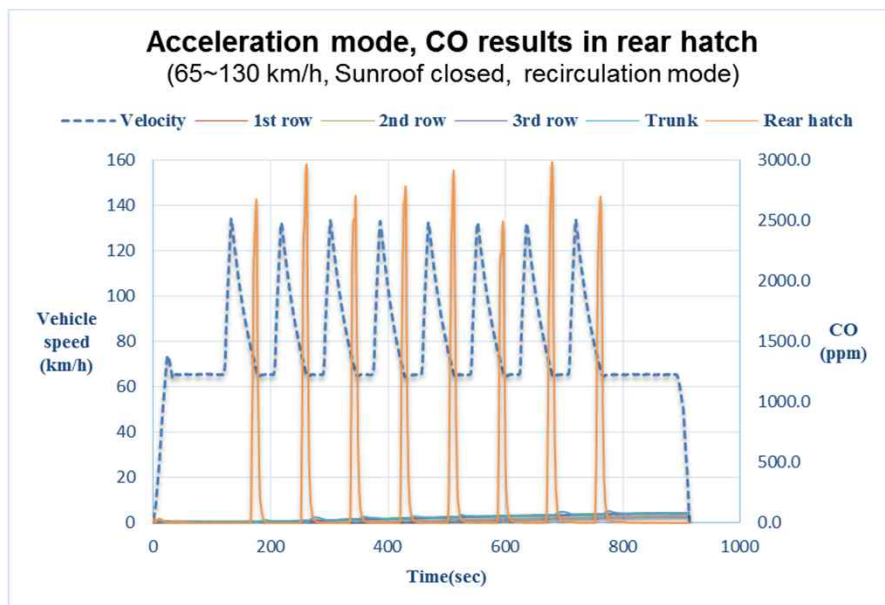
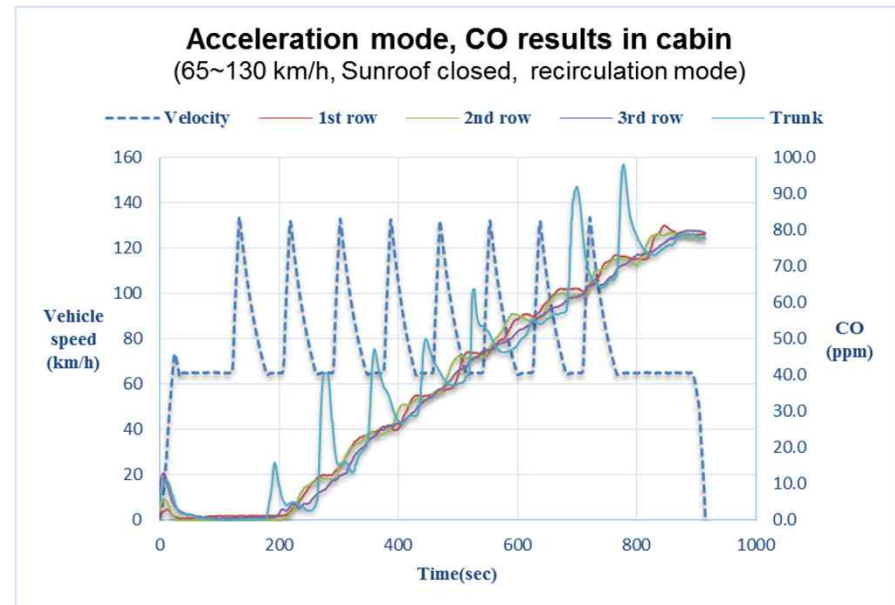
- When accelerating, high concentration of CO was detected in rear area (max 3,000 ppm)
- When accelerating, CO enter into the trunk zone through the rear of hatch (max 100 ppm)
- CO concentration was increased gradually from 40 ppm to 80 ppm

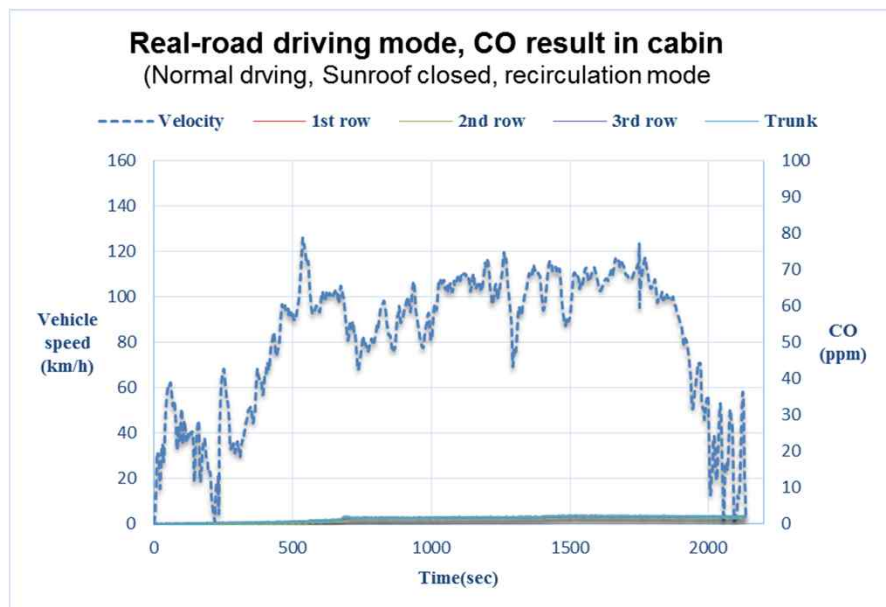
- Real-road driving test in same course without acceleration
- Smoothing driving, Throttle open not more than 50%
- CO was not detected in cabin

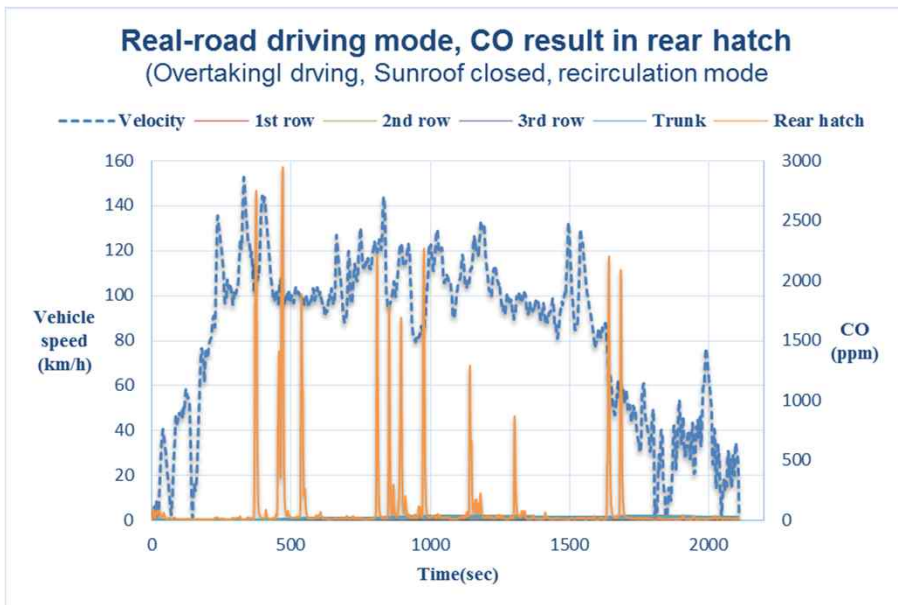
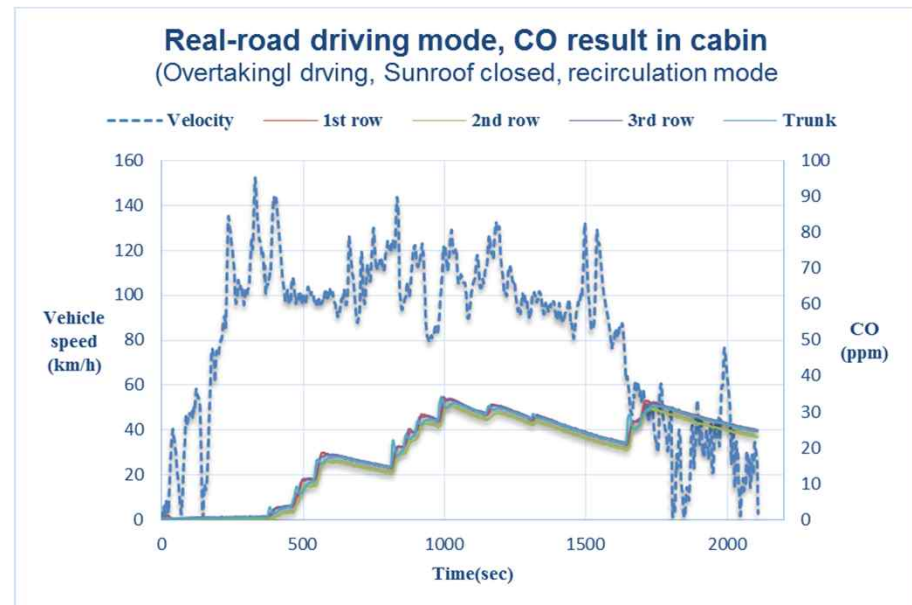
- Real-road driving test in same course with acceleration (near WOT)
- Overtaking driving depending on road traffic
- CO was detected in cabin 20 ~ 35 ppm
