# ODI RESUME

**Investigation:** PE 17-005  
**Date Opened:** 09/18/2017  
**Investigator:** Peter Kivett  
**Approver:** Stephen Ridella  
**Subject:** Seatbelt Retractor Failure

**Manufacturer:** Polaris Industries, Inc.  
**Products:** 2015 - 2019 Model Year Polaris Slingshot  
**Population:** 10,658

**Problem Description:** Seatbelt retractor failed.

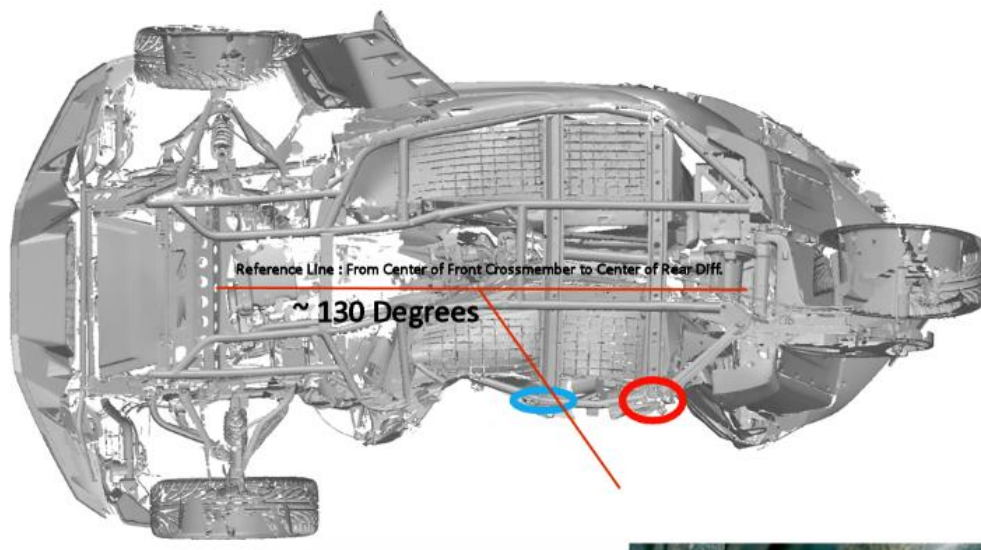
In April 2018, ODI took possession of the subject vehicle and transported it to NHTSA's Vehicle Research and Test Center (VRTC) in Marysville, Ohio for further study and nondestructive testing. A 3D scan of both the crashed vehicle and an exemplar vehicle were conducted. Damage to the motorcycle body included significant intrusion into the side of the motorcycle that displaced the tubular steel frame by an average of 21.2 inches on the passenger side (See Figure 1.). Crash modeling and data collected from the passenger car event data recorder (EDR) involved in the crash estimate a severe change in velocity of the Polaris Slingshot motorcycle from 45mph to 0mph. ODI concluded that the Polaris vehicle's seatbelt retractor worked properly and was locked initially, but due to the severity of the crash, was then compromised as a result of lateral loading of the belt. In addition, the retractor frame was bent, the locking pin pulled from the cam slot and the seat belt released to maximum extension of 16+ inches. In this specific instance, as discussed more fully below, the evidence indicates that the installed seatbelt retractor failed due to the severity of the crash.

Figure 1. Depicting the angle and level of intrusion into subject vehicle.

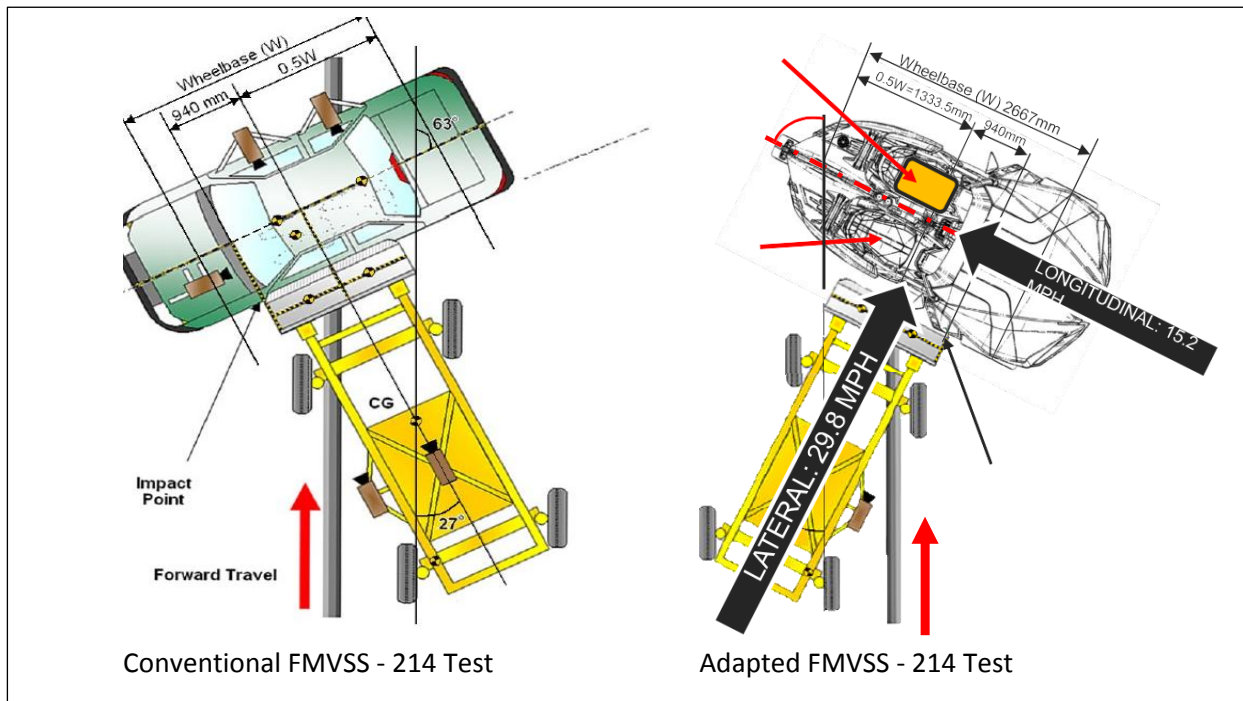
Seatbelts are not required by law to be installed on motorcycles. Therefore, to determine if the seatbelts installed on the Polaris motorcycles would withstand the forces of a lower severity crash, ODI first had to determine what test could be conducted that might best represent that scenario. ODI determined that a standard crash test FMVSS 214 (Side impact protection for passenger cars) modified slightly to better test the durability of the driver side seatbelt would represent an industry accepted repeatable test for analyzing the seatbelt forces. FMVSS 214 was modified to have a mechanically drawn sled hitting the subject vehicle on the passenger side in the forward travel position at a 28-degree angle as shown in Figure 2.
