# ODI RESUME

**Investigation:** RQ 17-005  
**Date Opened:** 08/04/2017  
**Investigator:** Frederick Lamance  
**Approver:** Stephen Ridella  
**Subject:** Door Latch Open While Driving  
**Date Closed:** 07/03/2018  
**Reviewer:** Jeff Quandt

**Manufacturer:** LAND ROVER  
**Products:** 2013-2016 Range Rover and 2014-2016 Range Rover Sport  
**Population:** 119,183 (Estimated)  
**Problem Description:** Consumers report incidents of doors opening while driving or failure to latch.

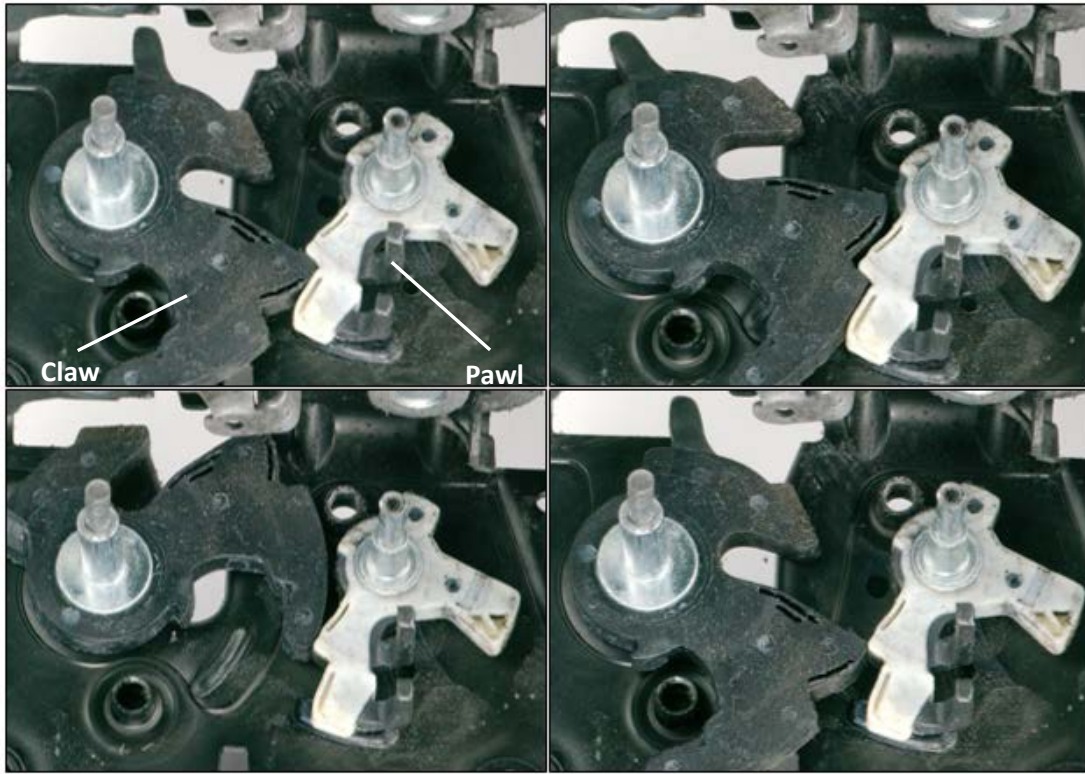
The KV lever is spring biased to return to its home position after each passive entry actuation. As stated by JLR in its IR response, if the KV lever does not return to its home position, the latch pawl may not be able to engage the claw latch detents as designed, possibly resulting in "Failure-to-Latch" or "False-Latch" conditions (see Figure 1, "False-Latch"). Forces that may resist the KV lever spring force and cause the lever to stick before reaching its home position, include the motor back emf condition addressed by JLR's recall remedy and conditions that introduce mechanical frictional forces in the KV drive unit. For example, increased motor bearing friction may occur due to water intrusion into the KV drive unit, which has resulted in motor bearing corrosion.

Figure 1. Clockwise from upper left: 1) fully latched position (pawl on claw primary latch; 2) door ajar position (pawl on claw secondary latch); 3) “False-Latch” position (pawl in “tip-to-tip” engagement with claw primary latch); 4) unlatched position.

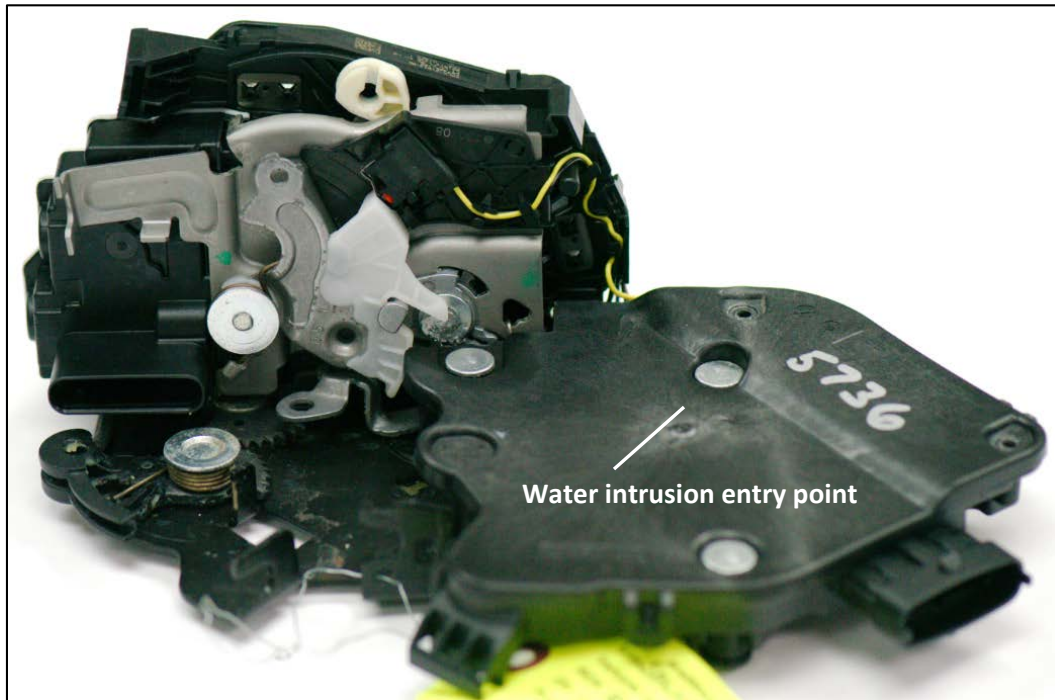
Incidents of doors opening while in motion have occurred in vehicles with motor bearing corrosion after the recall remedy software update had been applied. For example, VOQ 10983285 reported a left-front door opened while in motion on May 2, 2017 in a 2014 Range Rover Sport vehicle that had the 15V-385 recall remedy completed January 28, 2016. Field return analysis of the latch assembly found the KV lever had not returned to the home position and evidence of motor bearing corrosion (Figures 2-5). A design countermeasure to seal the water intrusion path was introduced in production in February 2015. In addition, binding of components in the KV clutch unit may also prevent the latch pawl from properly engaging with the claw. In addition, sticking or binding components in the KV clutch unit or other door latch assembly components may also interfere with free movement of the latch pawl. Incidents occurring after the motor control and water intrusion countermeasures were implemented are likely to be caused by other such mechanisms.

Figure 2. KV latch assembly field return (VOQ 10983285).

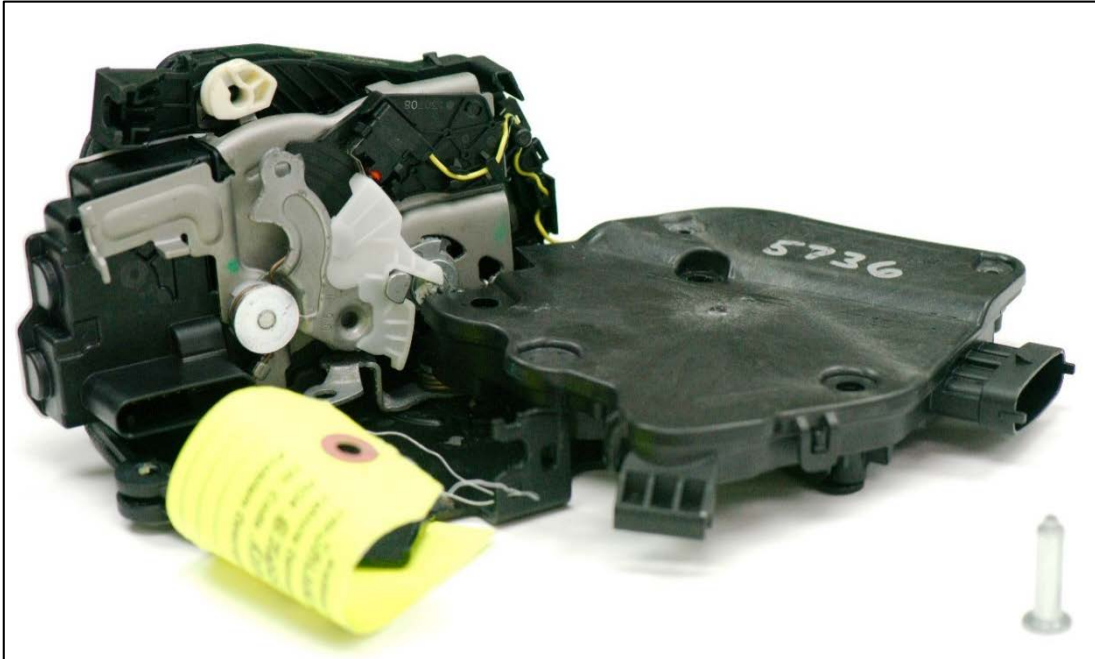
Figure 3. KV latch assembly, drive unit cover rivets removed (VOQ 10983285).

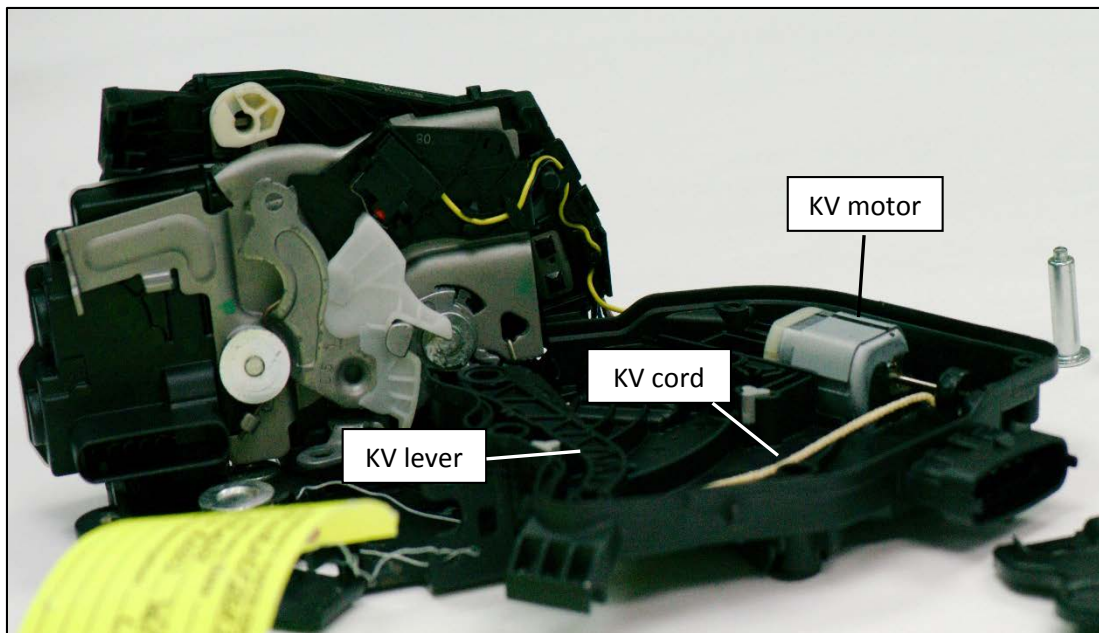
Figure 4. KV drive unit components, cover removed (VOQ 10983285).

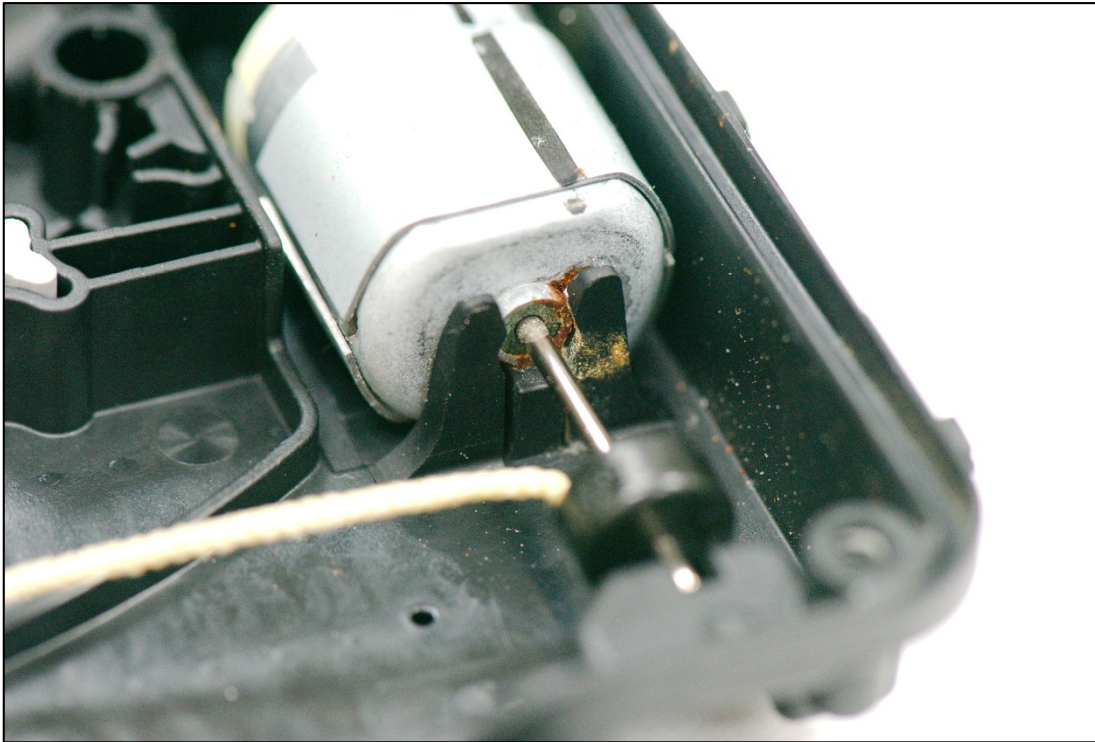
Figure 5. KV motor bearing corrosion (VOQ 10983285).
