ENGINEERING ANALYSIS CLOSING REPORT

SUBJECT: Power Steering Failure

EA No.: EA17-004

SUBJECT VEHICLES: All MY 2010 Ford Fusion vehicles manufactured for sale or lease in the United States.

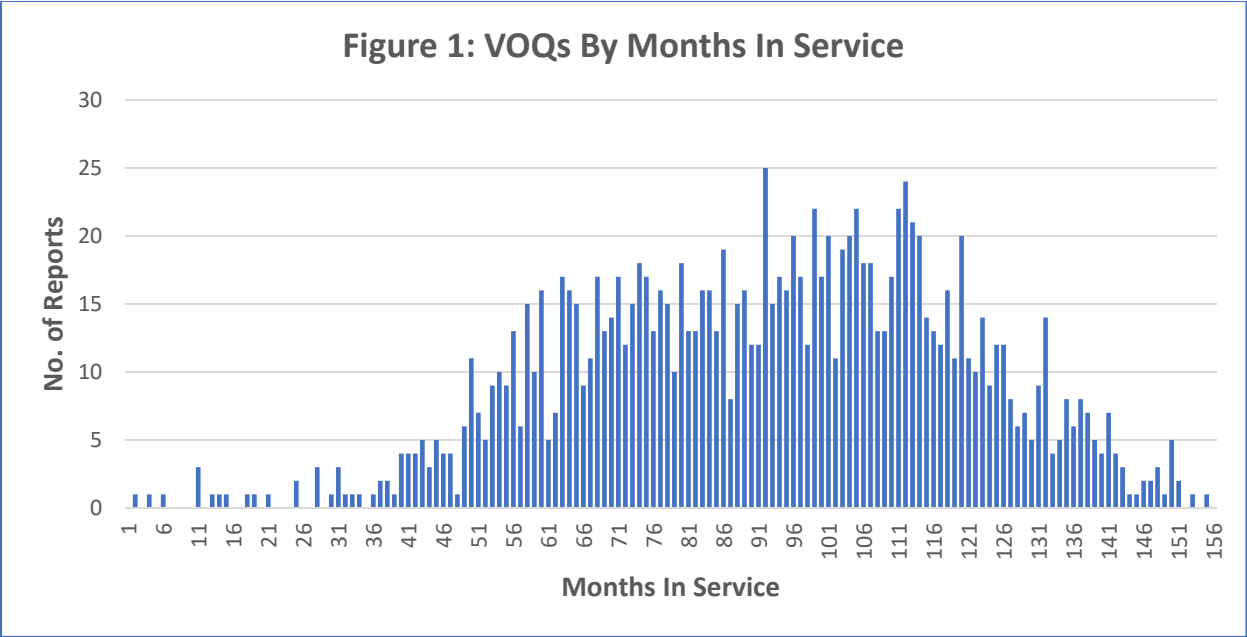
As shown in Table 1, reporting of the 1,236 VOQs on the subject vehicles peaked around 2017-2019 and has been declining since then. Also, as shown in Figure 1, the failures by months-in-service peaked at around 85-120 months (or 7-10 years). It should be noted that the subject vehicles are currently about 13 years old. Some of the more recent VOQs and Ford’s customer complaints indicated a concern about the high repair cost (approximately \$1,500 or more for a new steering gear), and not necessarily a safety concern.
