# RQ17-001 Cap Screw Failures

## MY 2016-2017

## RQ17-001 DTNA Cap Screw Failures

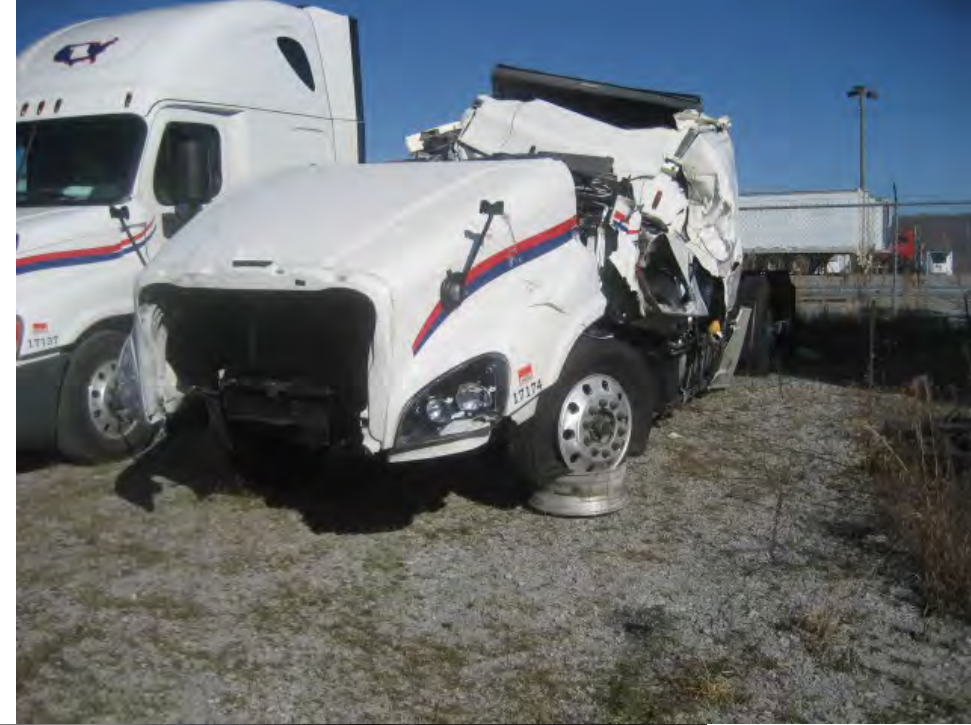
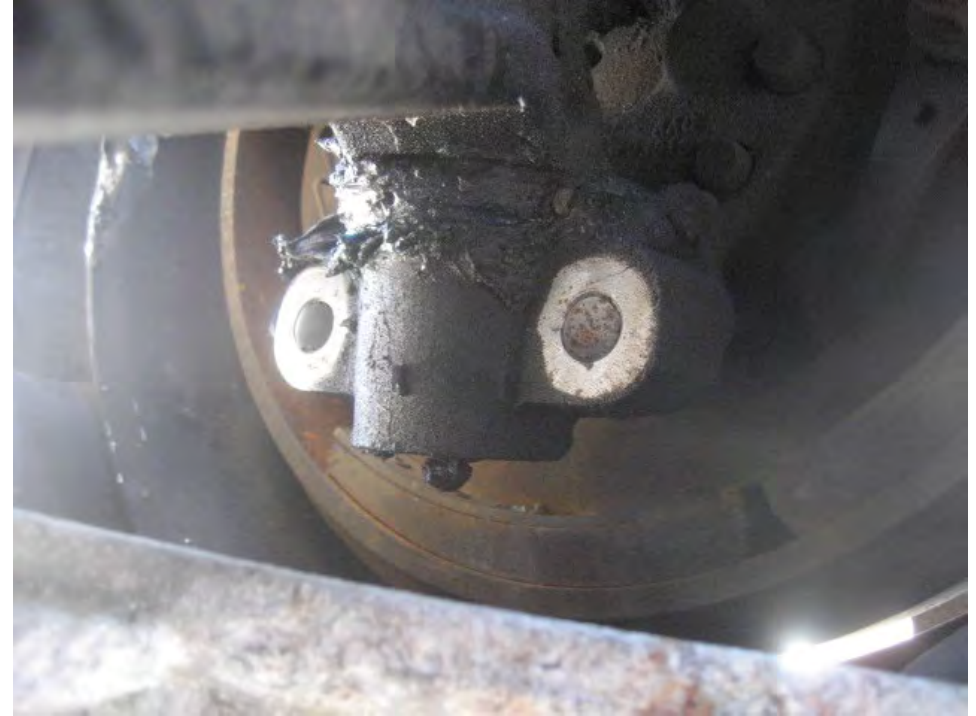
# Assessment of IL Crash Truck

VRTC collected steering axle

- determined capscrew failure was result of the crash
- passenger side capscrews exhibited low torque after crash
- conducted field survey to determine if low torque was possible precursor to crash

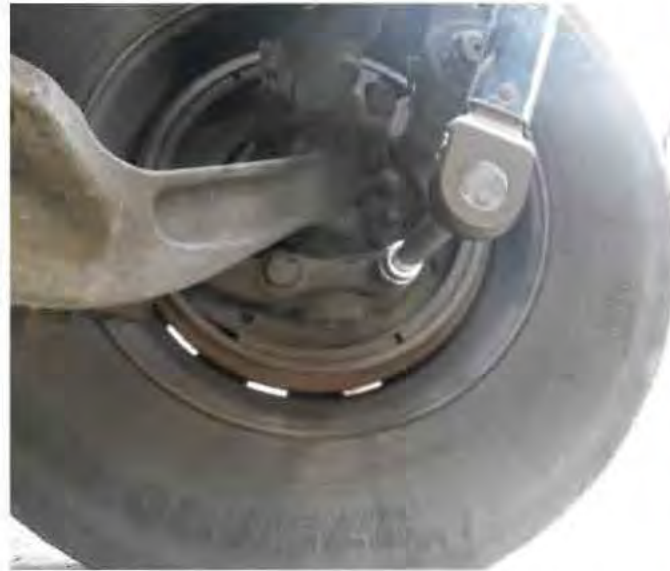
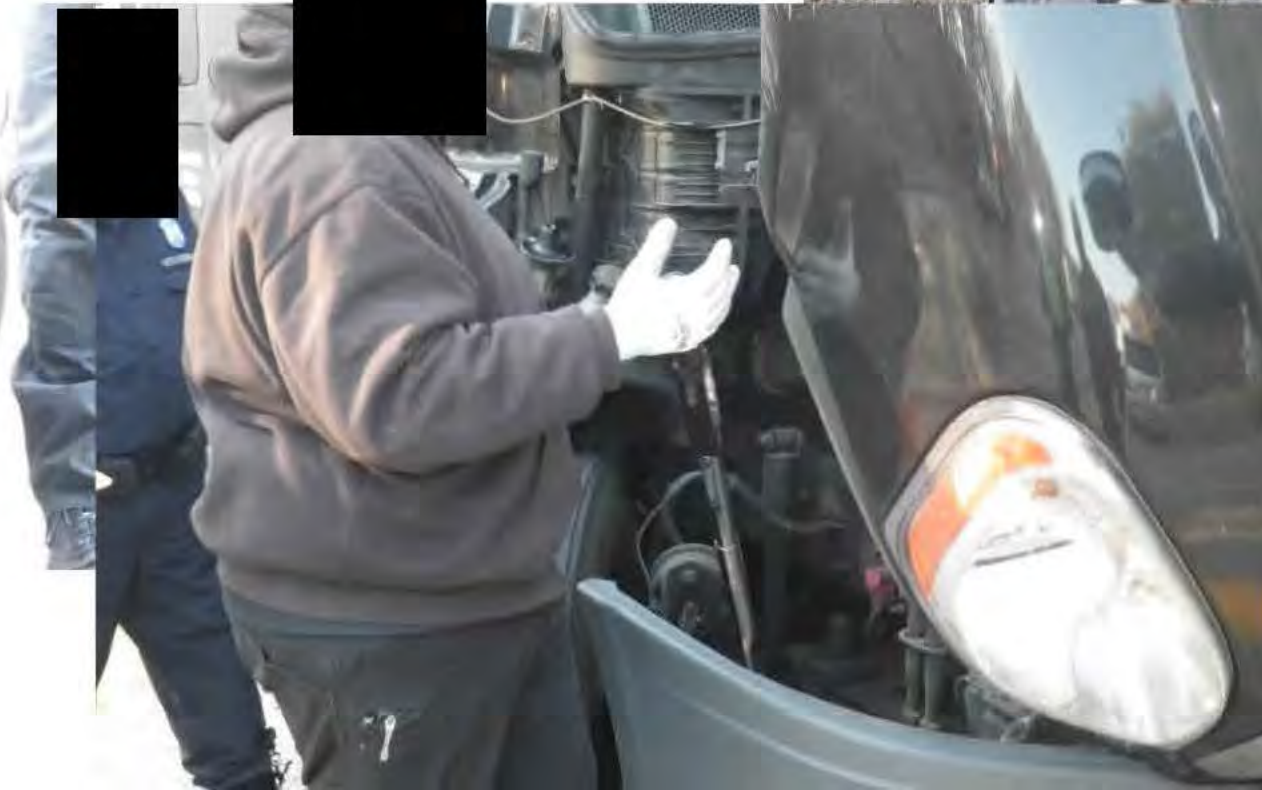
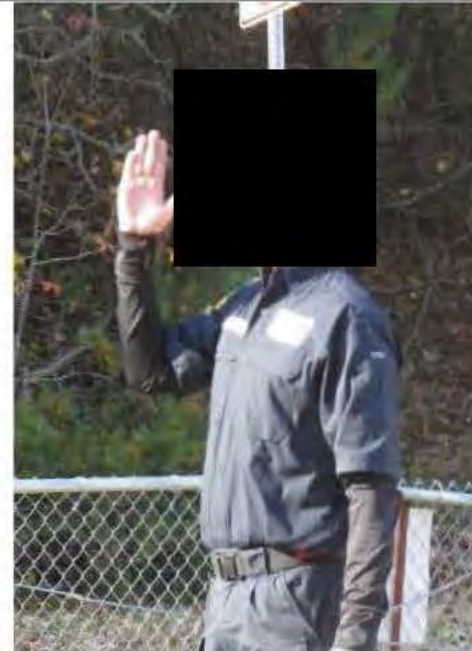
# *Level IV Roadside Inspections with: Virginia State Police, DTNA, & Detroit Axle*

39 Trucks inspected

156 capscrews

None found to be under torqued
