EA17-002

APPENDIX H

TECHNICAL SERVICE
BULLETINS

**2011-2017 EXPLORER/2013-2017 POLICE INTERCEPTOR UTILITY -
CUSTOMER COMPLAINTS OF CARBON MONOXIDE (CO) AND/OR EXHAUST
ODOR AFTER FSA 17B25 OR 17N03 :**

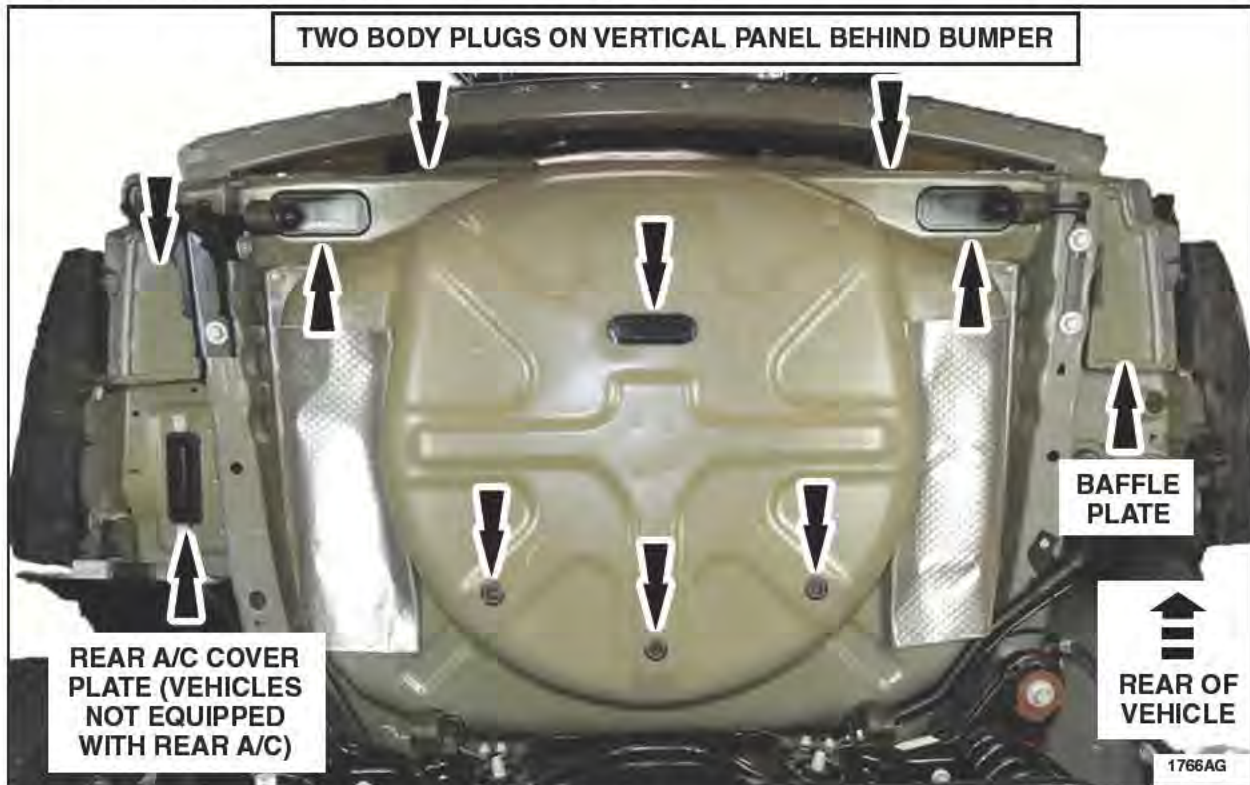
FIGURE 1

1. With the vehicle in NEUTRAL, position it on a hoist. Please follow the Workshop Manual (WSM) procedures in Section 100-02.
2. Inspect the rear underbody for damaged or missing body plugs, punctured/damaged floor pan sheet metal and baffle plates, damaged wiring harness grommets, aftermarket fasteners, and pass throughs (holes) created for aftermarket wiring/equipment. See Figures 1, 2a and 2b.
 - Seal all aftermarket wiring and equipment pass throughs using Motorcraft® TA-2 seam sealer or equivalent, and Foil-Backed Mastic Patch as needed.

NOTE: Do not use silicones, RTVs or caulks during this repair.

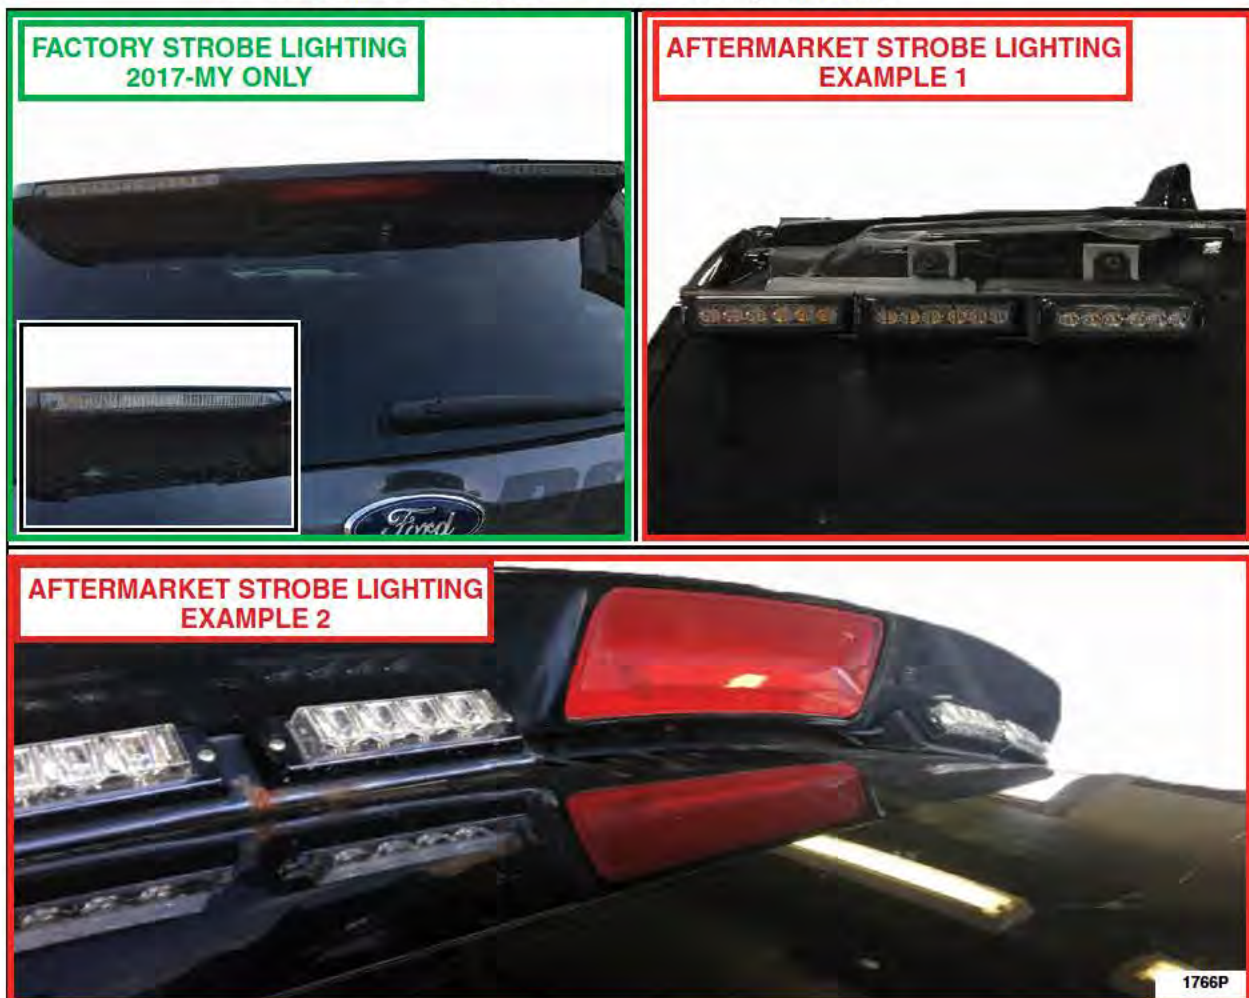
FIGURE 9

NOTE: Aftermarket lighting and/or equipment mounted to the liftgate spoiler can compromise vehicle sealing and create a leak path for exhaust to enter the vehicle. Ford recommends removal of any aftermarket lighting and/or equipment mounted to the spoiler to prevent a potential path for exhaust to enter the vehicle. Any removed equipment must be returned to the customer.

- a. Is there aftermarket lighting or other equipment mounted to the spoiler? See Figure 9.
- b. Has the spoiler or vehicle been painted?
NOTE: All Police Interceptor Utility Spoilers are painted black from the factory.
- c. Is the spoiler damaged or have any holes drilled through it?
- d. Is any aftermarket wiring routed to the spoiler?

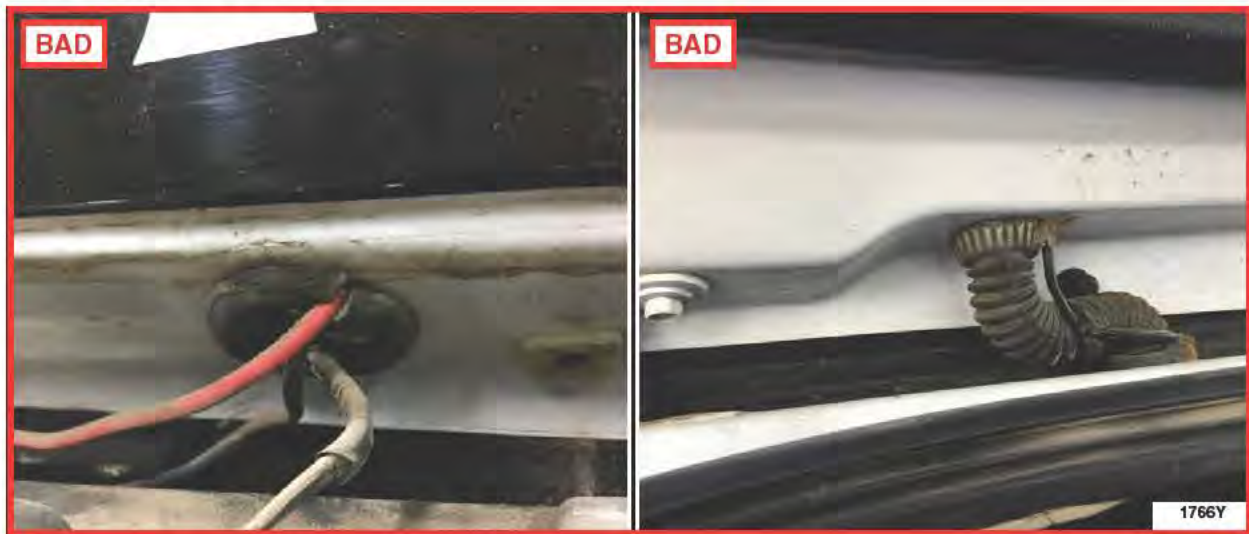
FIGURE 11a

2. Inspect for any aftermarket wiring pass throughs/holes that could affect the sealing ability of the spoiler. See Figures 11a and 11b.

3. Seal any leak paths created by the aftermarket wiring pass throughs/holes in the spoiler area with Motorcraft® TA-2 seam sealer or equivalent.
4. Remove the liftgate spoiler tower foam seal. See Figure 12.

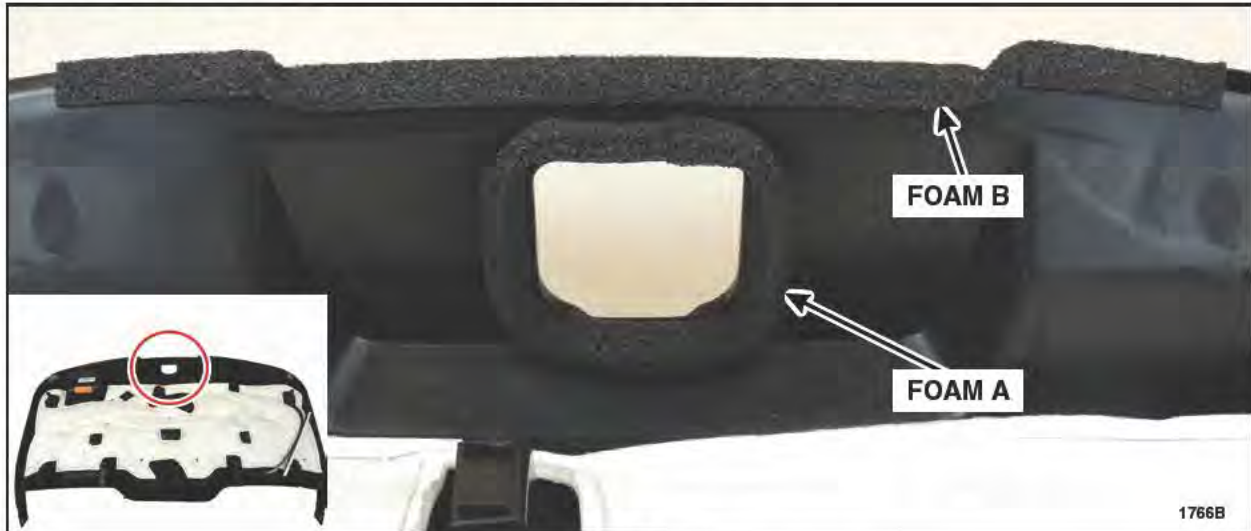
FIGURE 18

4. Inspect the liftgate trim panel clips for any damage to the clips or clip mounting towers. Replace any clips that are found to be damaged or deformed. If a clip mounting tower is found to be damaged, replace the trim panel.
5. Using isopropyl alcohol and a clean cloth, clean the liftgate trim panel where foam A and B will be installed. See Figure 18.
6. Install foam A and B on the liftgate trim panel. See Figure 18.

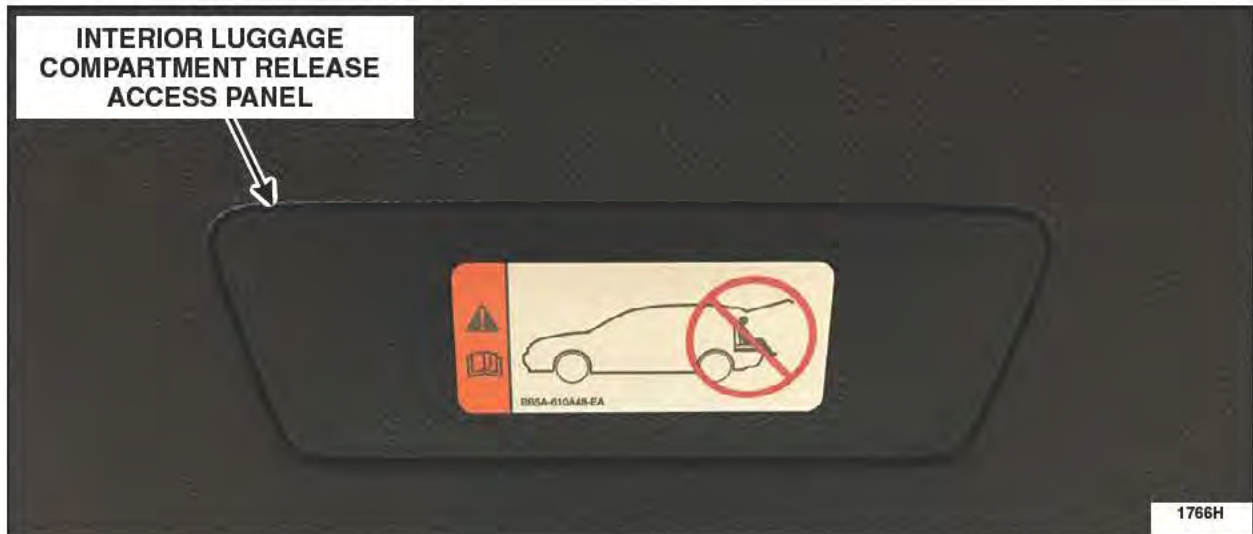
FIGURE 24

11. Inspect the liftgate trim panel for lights, pass throughs/holes and/or aftermarket equipment that could compromise the seal of the liftgate trim panel. Seal any breaches of the liftgate trim panel using mastic patch, left over foam tape, Dow Corning® 7091 Adhesive/Sealant, or other robust sealing methods.
12. Ensure the interior luggage compartment release access panel is properly installed in the lower liftgate trim panel. See Figure 24.

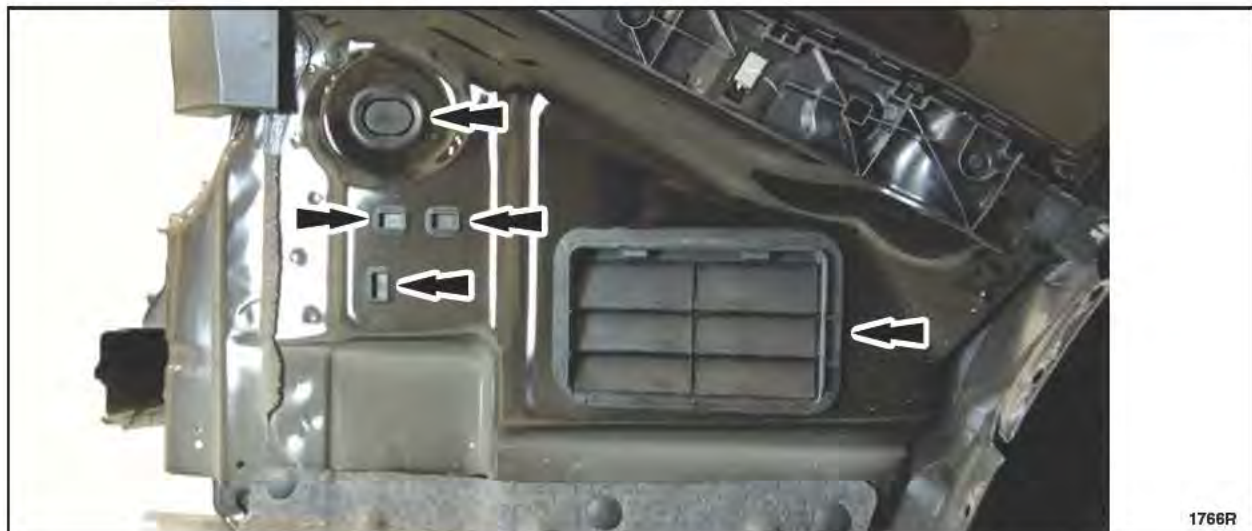
FIGURE 3

2. Using a telescoping mirror and flashlight, inspect the 4 body plugs and air extractor through the wheelhouse openings on each side of the vehicle. See Figure 3.
3. Replace body plugs or air extractors that are missing or damaged. Rear bumper cover removal is required to replace the air extractor. Please follow the WSM procedures in Section 501-19.

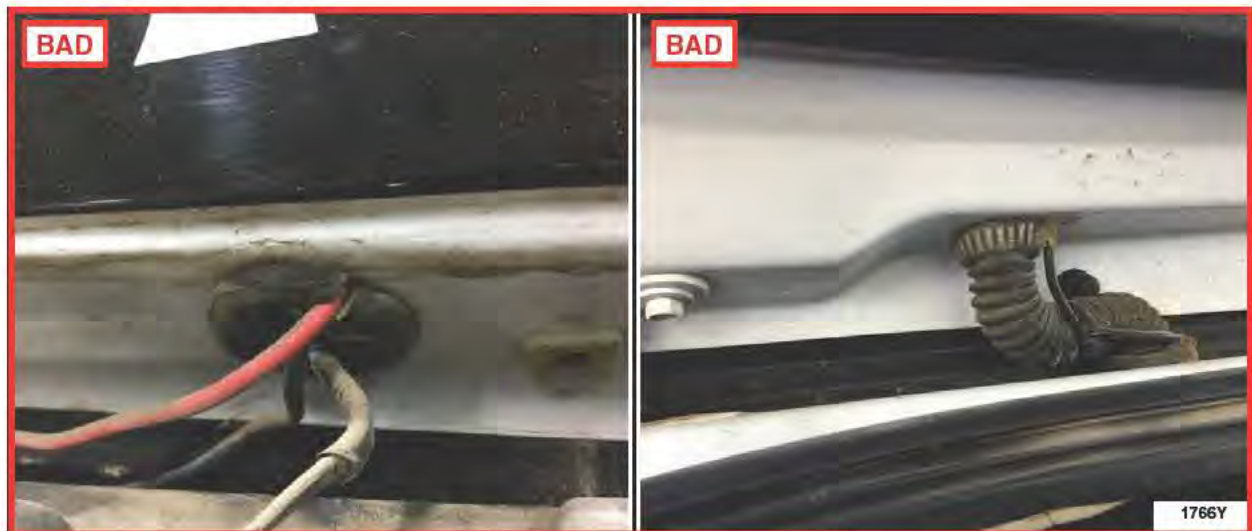
FIGURE 9a

2. Inspect for any aftermarket wiring pass throughs/holes that could affect the sealing ability of the spoiler. See Figures 9a and 9b.

3. Seal any leak paths created by the aftermarket wiring pass throughs/holes in the spoiler area with Motorcraft® TA-2 seam sealer or equivalent.
4. Remove the liftgate spoiler tower foam seal. See Figure 10.
