Web Form Data Description of Vehicle Concern: CUST STATES ON HARD ACCELERATION BAD EXHAUST ODOR IN CAB. Please list any diagnostics already performed: CUSTOMERS CONCERN WAS VERIFIED AND TSB 14-0130 WAS PERFORMED. THE VEHICLE HAD CAME BACK MULTIPLE TIMES FOR THIS CONCERN. THE VEHICLE WAS RETESTED PER THE TSB. Parts Replaced: AS LISTED IN THE TSB 14-0130 Your Question: WE HAVE HAD OTHER VEHICLES WITH SIMILAR CONCERN, WE HAVE ADVISED THE CUSTOMER THAT UNDER CERTAIN CONDITIONS SOME EXHAUST SEMLL MAY SEEP INTO THE CABIN AREA. IS THERE ANY UPDATES TO THE CONCERN. THAT WOULD HELP ALLEVIATE THIS CONCERN OF EXHAUST SMELL IN THE CAB ?

Report# :	G6TFM015 NHL	Received:	06/20/2016
CCRG/EPRC:	<input type="text" value="v"/>	Reviewed Status:	Date:
Vehicle:	2015,EXPLORER 4X4 (U502) ,SPORT ,4 DOOR ,MPV ,1FM5K8GT5FGA41945	Build Date:	07/22/2014
Odometer :	25,456 M	Engine:	3.5L-GTDI
Transmission:	6F55	Axle:	A/C: YES
Dealer:	USA 20301 Don Sanderson Ford	Phone#:	623-842-8685
City:	Glendale	State:	Arizona
Originator:	RANDY HANSEN	Country :	USA
Symptom:	4 48 2 39 ST/RN/MV,NOISE,MOVE/DRIVE,INTERMITTENT		
Status:			
VFG:	V49 POWERTRAIN GOOD SOUND AND NVH		
Additional Symptom:	DROAN NOISE		
Fix:	Causal Comp

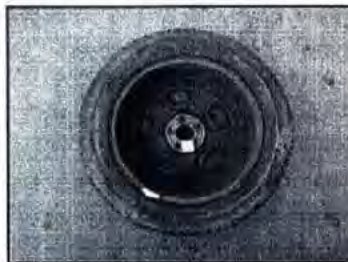
Figure 6. Inboard side of the left-front tire and wheel

The inboard side of the left-front tire and wheel was unremarkable.

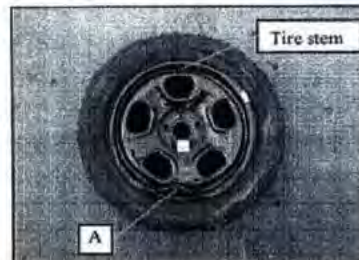
Figure 7. Outboard side of the right-front tire and wheel.

The right-front tire and wheel assembly had two defined areas of damage.

- Radial collapse of the outboard rim flange at the 6 o'clock position (Figure 7: A).
- Radial collapse of the inboard rim flange between the 8 o'clock and 12 o'clock positions (Figure 8: A).

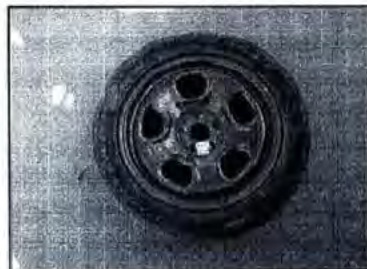
Figure 9. Outboard side of the right-rear tire and wheel.

The outboard side of the right-rear tire and wheel was unremarkable (Figure 9).

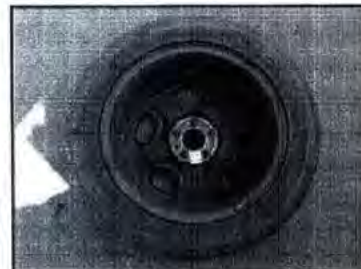
Figure 12. Inboard side of the left-rear tire and wheel.

The inboard side of the left-rear tire and wheel was unremarkable (Figure 12).

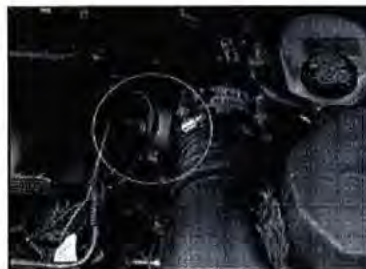
Figure 15. Engine throttle electric motor.

The throttle system utilized an electronic accelerator pedal assembly. The accelerator pedal assembly was mounted to the bulkhead within the right side of the driver's foot well. The pedal (Figure 13) was manually operated throughout its range of motion with no deficiencies. The pedal assembly was still attached to the control module and return spring (Figure 14). The engine throttle valve utilized an electric motor mounted to the right-side of the throttle body (Figure 15).

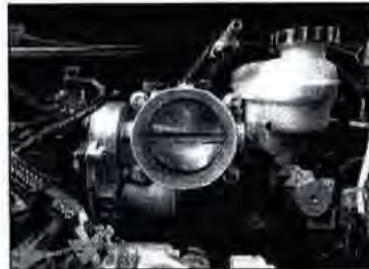
Figure 16. Throttle body (idle position).

The throttle valve was observed in the closed (idle) position (Figure 16) and was manually operated throughout its range of motion with no deficiencies (Figure 17). The throttle valve return spring, located on the right-side of the throttle body, was intact and had sufficient tension to return.

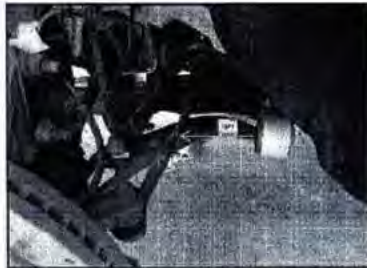
Figure 18. Left side tie-rod.

The left tie-rod assembly, consisting of a tie rod and threaded tie-rod end, was attached to the steering gear rack on one end and to the left steering knuckle on the other via a ball-socket joint (Figure 18).

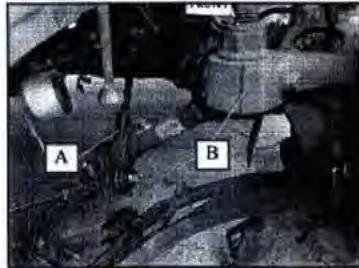
Figure 19. Right side tie-rod.

The right tie-rod assembly (Figure 19: A), consisting of a tie rod and threaded tie-rod end, was attached to the steering gear rack on one end and was broken away from the right steering knuckle, at the ball-socket joint (Figure 19: B).

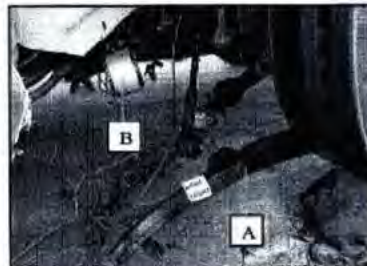
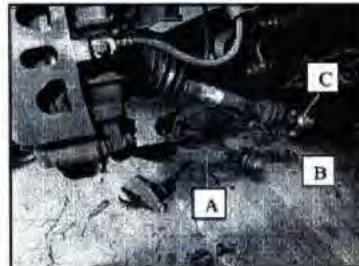
The right lower control arm assembly (Figure 20: A and Figure 21: A), was pulled out of the rear body mount bushing (Figure 20: B), and front body mount bushing (Figure 21: B). The right front axle shaft was detached from the transaxle side CV (constant velocity) joint (Figure 21: C).

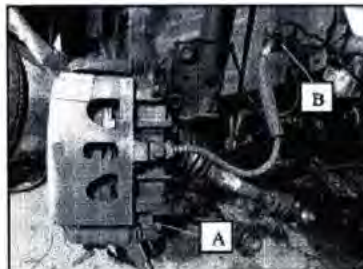
Figure 24. Right-front brake caliper

Each brake assembly on this axle consisted of a steel brake caliper, brake pads, a brake rotor, and related hardware. Each sliding, dual-piston brake caliper was attached to its caliper mounting bracket with two sliding pins. Each brake caliper support bracket was attached to its respective steering knuckle with two bolts. The aluminum caliper pistons moved freely within their individual bores and their rubber piston dust boots were dry with no indication of fluid contamination. The disc brake hardware and sliding pins were intact. The right-front caliper casting was broken at the lower sliding pin threaded ear (Figure 24: A). The flexible hydraulic brake lines were attached to the rigid lines, and to their respective brake calipers. The right-side rigid brake line to flexible brake line bracket was pulled away from its body attachment position (Figure 24: B).

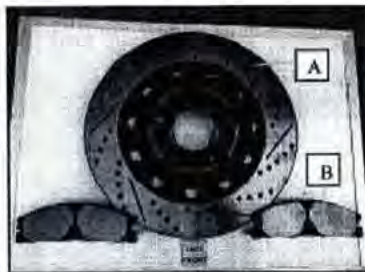
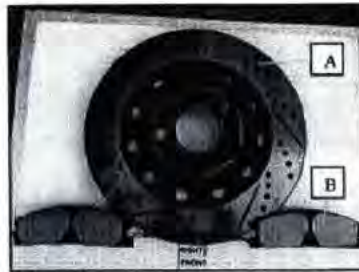
The front brake pads were composed of a bonded semi-metallic friction material that had an overall thickness above the manufacturer's minimum recommended thickness of 2 millimeters.³ The friction surfaces of the brake pads were slightly glazed and had minor surface scoring (Figure 25: B and Figure 26: B).

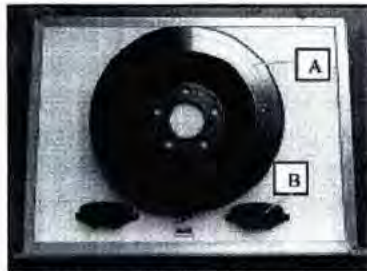
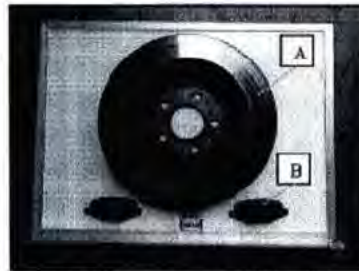
The swept areas on the friction surfaces of the ventilated full-cast brake rotors were lightly scored and discolored to a reddish-gray tint (Figure 29: A and Figure 30: A). There were minor discernible ridges about the inner and outer circumferences of the friction surfaces of the brake rotors. The brake rotors had overall minimum thicknesses above the manufacturer's minimum specification of 17.5 millimeters, which was indicated on the inside hat of each brake rotor. The left- and right-side hub assemblies rotated freely with no discernible end play in either assembly. The left- and right-side ABS wheel speed sensors, exciter rings, and wiring were generally unremarkable.

The rear brake pads were composed of a bonded ceramic friction material that had overall thicknesses above the manufacturer’s minimum recommended thickness of 2 millimeters.* The friction surfaces of the brake pads were slightly glazed and had minor surface scoring (Figure 29: B and Figure 30: B).

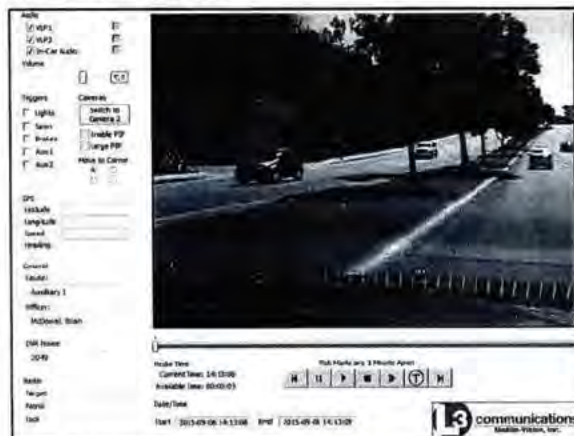
The video recorded by the in-car video system installed in the Ford driven by Officer McDowell began at 1413:06 hours and ended at 1413:09 hours and was recorded at 29.97 frames per second. The video began near where the left-front tire of the vehicle impacted the west curb of the median separating the northbound and southbound lanes of Jamboree Road. The video ended near where the right-front tire began entering the handicap ramp on the east sidewalk bordering the northbound lanes of Jamboree Road.

Figure 31. At time 1413:06 hours, the left-front tire of the Ford had mounted the west curb of the median separating the northbound and southbound lanes of Jamboree Road.

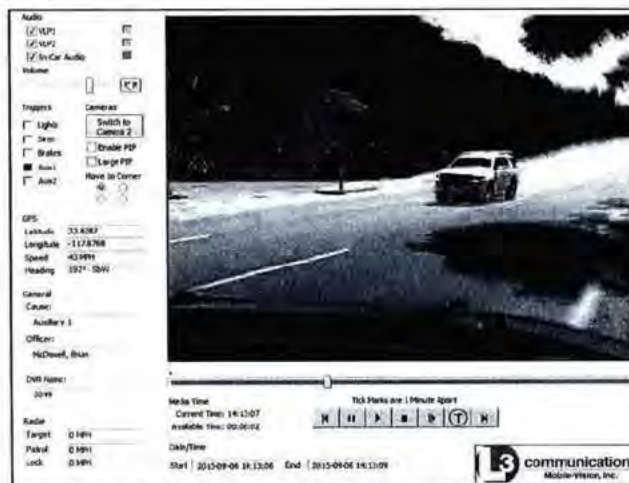
The event that triggered the recording was Auxiliary 1, which was the flashback sensor. The flashback sensor was a G-force sensor that activated the video recorder when an acceleration threshold was met. The threshold was met and the trigger activated when the left-front tire of the Ford dismounted the east curb of the median separating the northbound and southbound lanes of Jamboree Road.

Figure 32. At time 1413:07 hours, the left-front tire of the Ford had dismounted the east curb of the median

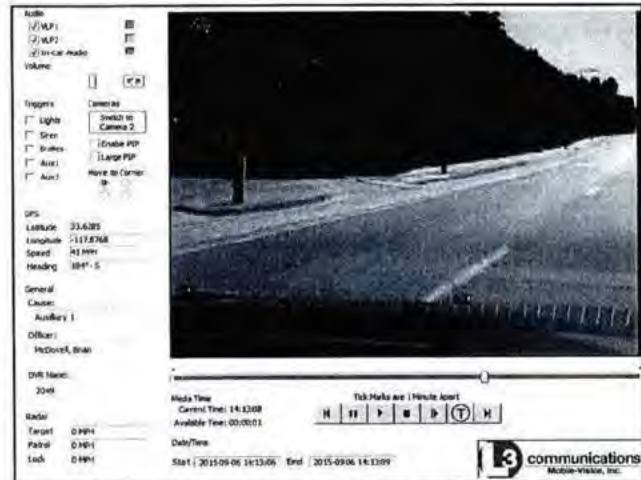
Figure 33. At time 1413:08 hours, the Ford narrowly missed colliding with the white sport utility vehicle depicted in Figure 32.

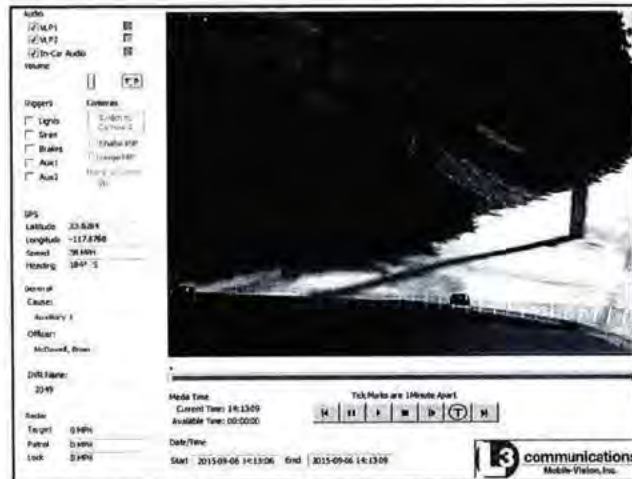
Figure 35. At time 1413:09 hours, the Ford entered the handicap ramp on the south sidewalk. The tree that the Ford impacted can be seen.

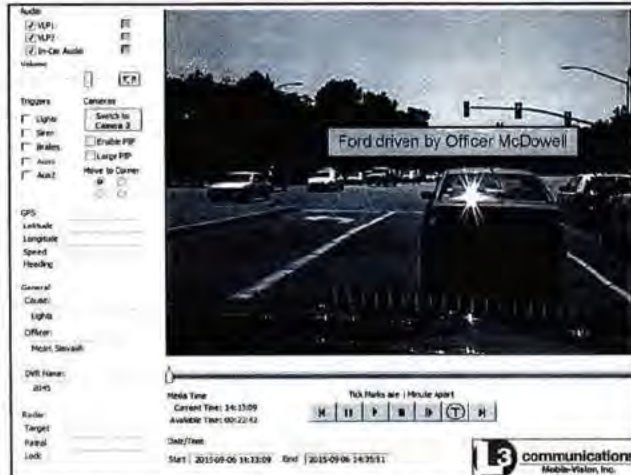
Figure 36. At time 1413:09 hours, Officer Mesri is stopped for a red traffic signal on Jamboree Road at Eastbluff Drive. The Ford driven by Officer McDowell can be seen in the #2 lane ahead of Officer Mesri.

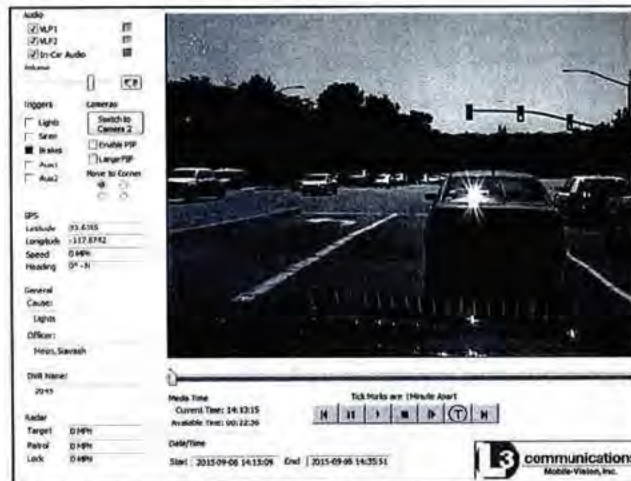
The following image depicts the video captured at 1413:15 hours, the traffic signal light had turned green and Officer McDowell began to accelerate the Ford.

Figure 37. At time 1413:15 hours, Officer McDowell accelerated the Ford.

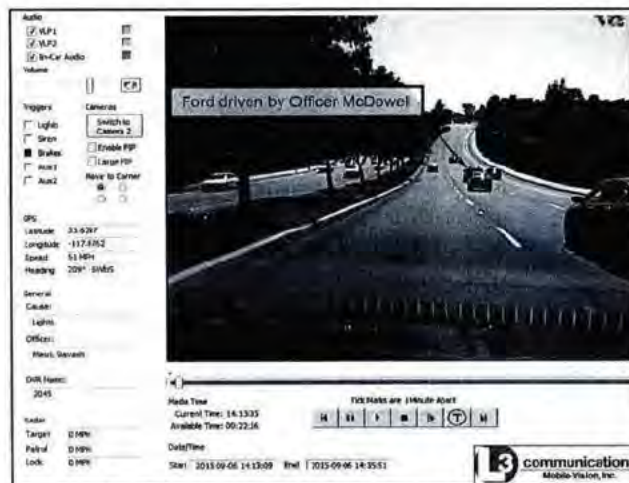
The following image depicts the video captured at 1413:35 hours, after drifting slightly to the right, the Ford driven by Officer McDowell began drifting to the left. Prior to the Ford drifting slightly to the right, Officer McDowell had maintained a position near the middle of the #2 lane since accelerating from a stop at Eastbluff Drive and had been traveling at a speed similar to that of Officer Mesri.

Figure 38. At time 1413:35 hours, Officer McDowell allowed the Ford to drift to the left after he had allowed the vehicle to drift slightly to the right.

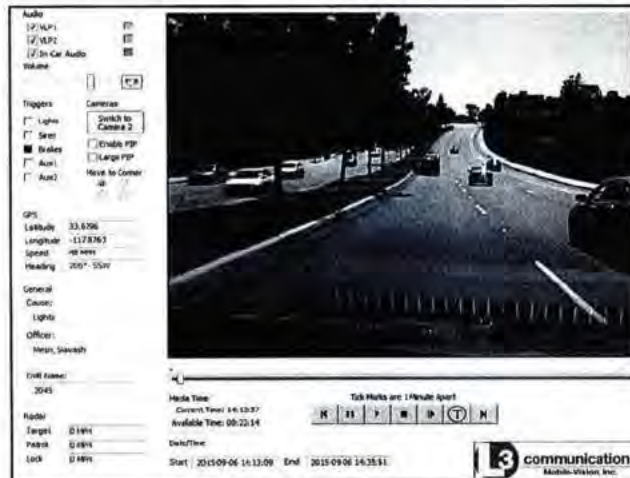
The following image depicts the video captured at 1413:37 hours; the left-front tire of the Ford driven by Officer McDowell impacted the west curb of the median separating the northbound and southbound lanes of Jamboree Road. Officer McDowell did not apply the brakes, nor did he attempt to steer the Ford to prevent the Ford from impacting the curb.

Figure 39. At time 1413:37 hours, the left-front tire of the Ford driven by Officer McDowell impacted the west curb of the median.

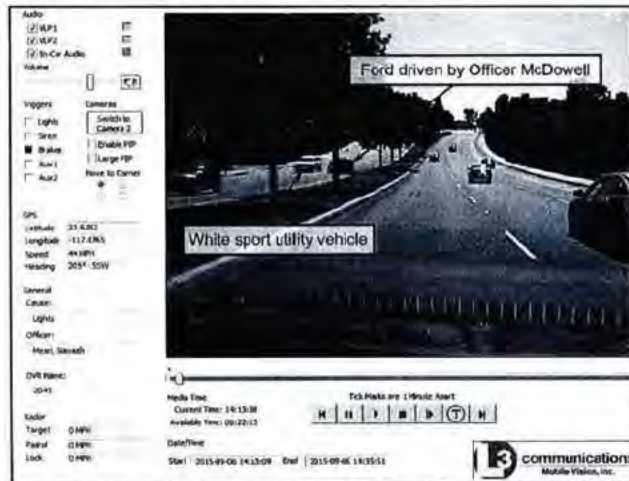
The following image depicts the video captured at 1413:38 hours; the Ford driven by Officer McDowell had entered the northbound #1 lane of Jamboree Road and nearly collided with a white sport utility vehicle traveling north in the #2 lane. Between the location where the Ford impacted the curb and the location it nearly collided with the white sport utility vehicle there was no evasive steering or braking on the part of Officer McDowell.

Figure 40. At time 1413:38 hours, the Ford driven by Officer McDowell nearly collided with a white sport utility vehicle traveling north in the #2 lane of Jamboree Road.

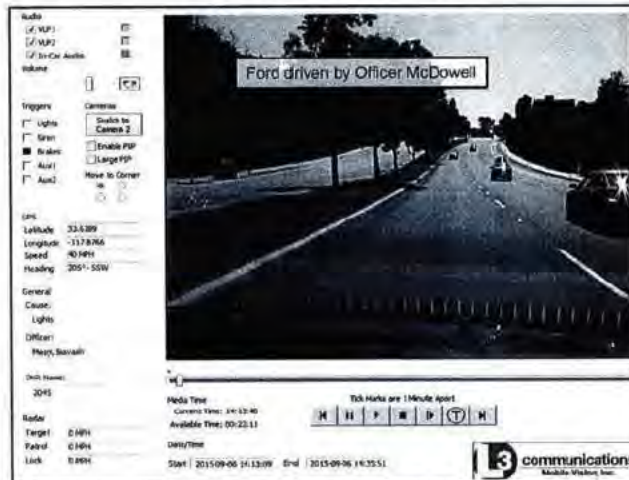
The following image depicts the video captured at 1413:40 hours; the Ford driven by Officer McDowell had entered the sidewalk east of Jamboree Road and began ascending the dirt slope east of the sidewalk. There had been no evasive steering or braking on the part of Officer McDowell despite the vehicle being on a collision course with a tree.

Figure 41. At time 1413:40 hours, the Ford driven by Officer McDowell had entered the sidewalk and began to ascend the dirt slope.

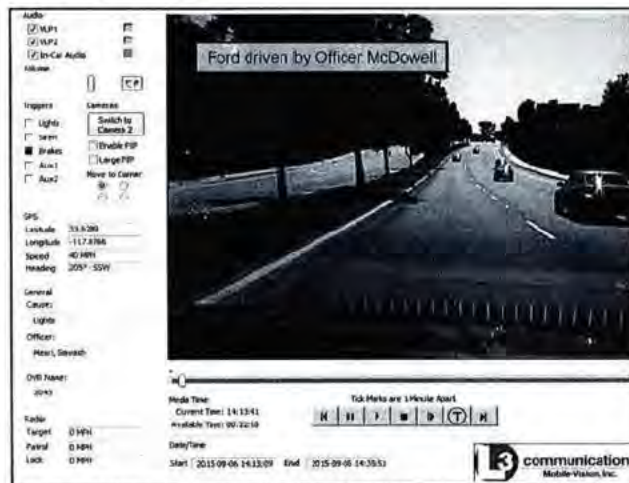
The following image depicts the video captured at 1413:41 hours; the Ford driven by Officer McDowell impacted the tree located on the slope east of the sidewalk. At the moment of impact, the brake lamps and the overhead emergency lights of the Ford activated. The activation of the brake lamps and overhead emergency lamps was most likely the result of the impact and not an overt action on the part of Officer McDowell.

Figure 42. At time 1413:41 hours, the Ford driven by Officer McDowell had impacted a tree and the brake lamps and overhead emergency lights activated.

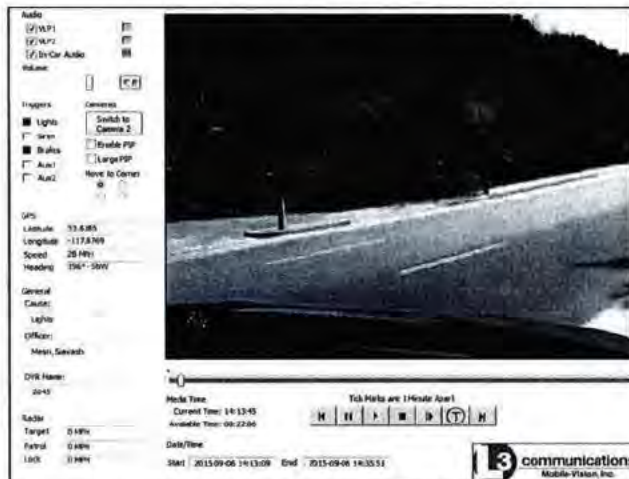
The following image depicts the video captured at 1413:45 hours; the Ford driven by Officer McDowell had come to rest with the brake lamps and overhead emergency lights activated.

Figure 43. At time 1413:45 hours, the Ford driven by Officer McDowell had come to rest and the brake lamps and overhead emergency lights remain activated
