STATE OF CALIFORNIA
DEPARTMENT OF CALIFORNIA HIGHWAY PATROL

MULTIDISCIPLINARY ACCIDENT INVESTIGATION TEAM NARRATIVE/DIAGRAM

DATE OF COLLISION (MONTH-DAY-YEAR)	TIME (2400)	NCIC	OFFICER I.D.	NUMBER	MAIT CASE NUMBER	PAGE
05-13-2017	0818	9465	18410			44

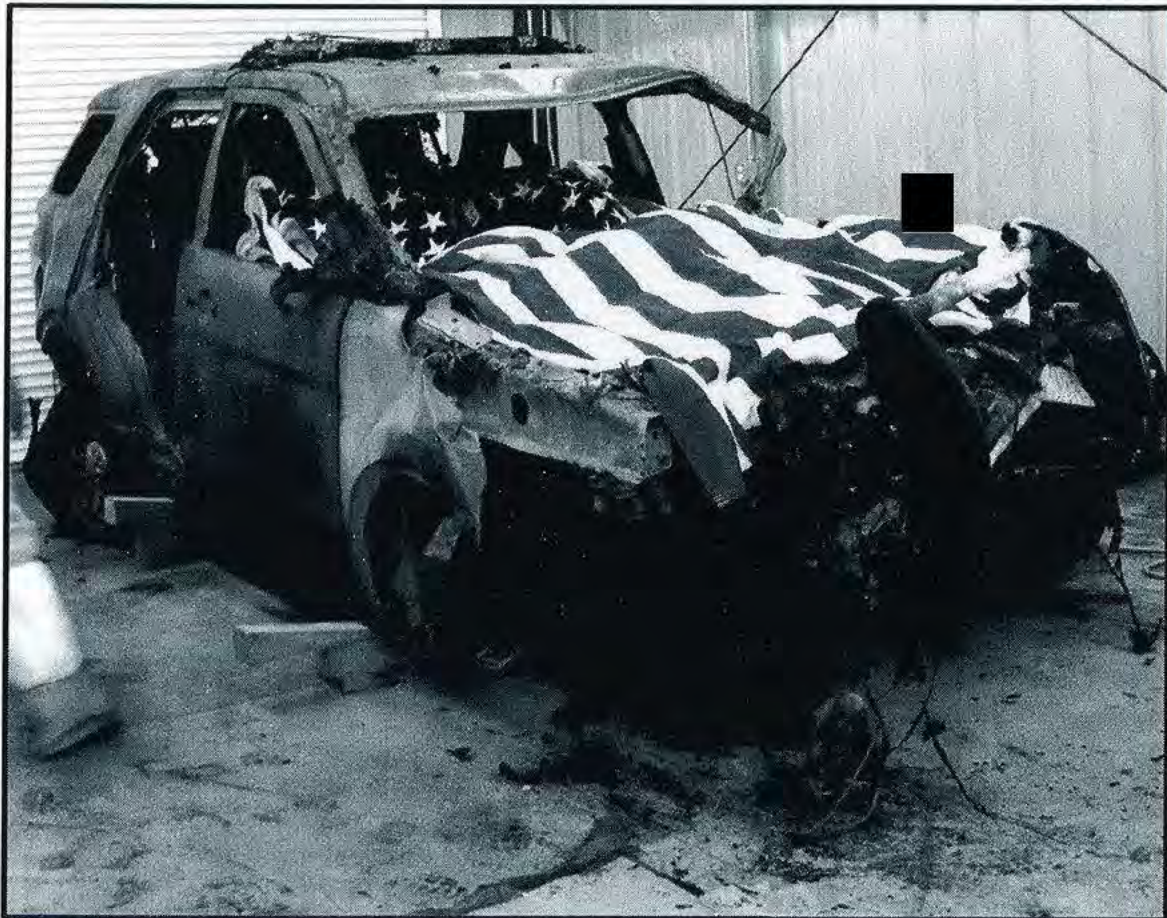
All references to direction are oriented from the driver's seat of the vehicle looking forward through the windshield. Vehicle 1 (Ford) sustained major collision damage to its front-end, and thermal damage throughout the vehicle. The Principal Direction of Force²⁷ (PDOF) applied to Vehicle 1 (Ford) was from front to rear.

The overall damage to Vehicle 1 (Ford).
[REDACTED] B (45) cropped

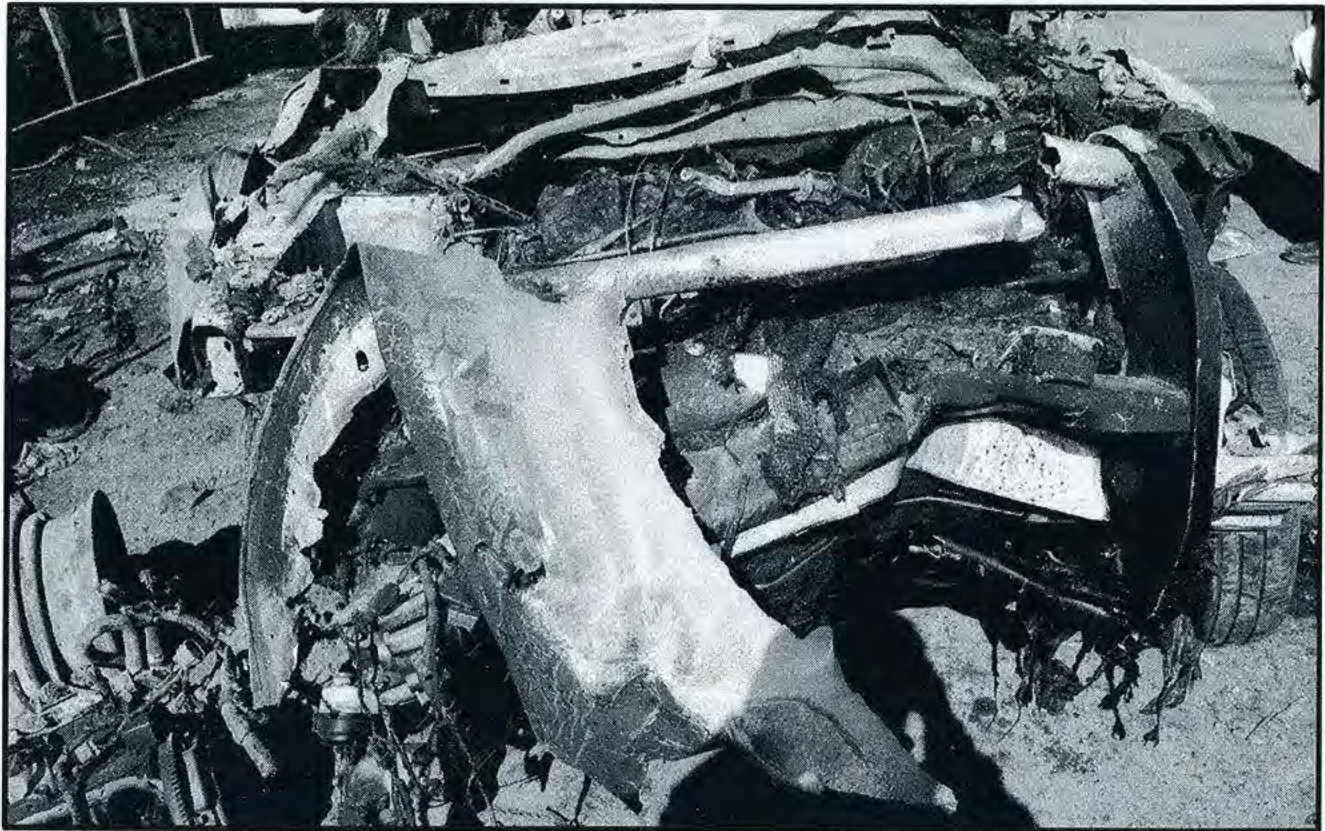
The front end was burned. The bumper cover was missing. The bumper and push bumper were pushed rearward and upward due to contact damage. The left side of the upper and lower push bumper tubes were broken. The left side of the push bumper shelf was dented rearward. There was wood debris embedded in the left side of the push bumper assembly. There were orange paint transfers on the leading edge of the left side of the push bumper and the left front of the bumper fascia. The hood was partially consumed by the fire. The grille was missing. The headlamp assemblies were destroyed. The windshield was melted from the roof and A-pillars. Thermal damage consumed a large portion of the engine compartment.

The damage to the front of Vehicle 1 (Ford).
CL-012-17 05-13-17 RS-B (35)

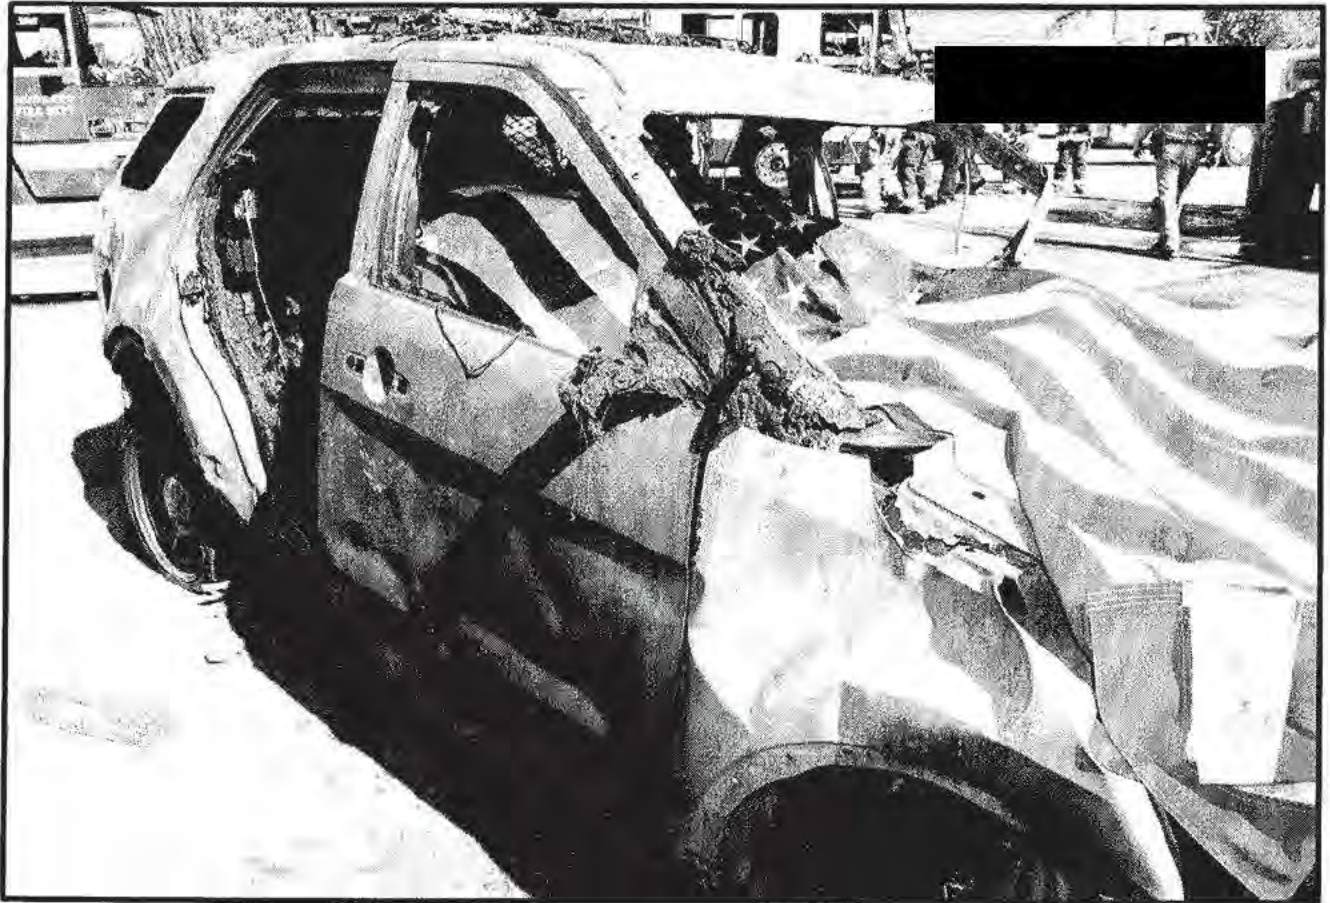
The entire right side was burned. The fender sustained contact damage and the leading edge was pushed rearward. The fender was buckled from the middle to the trailing edge. The front tire was torn, flat and partially melted. The leading edge of the rocker panel was pushed upward. The side mirror was missing and its mount was melted. The spot lamp was missing. The sheet metal of the right front door was crumpled. The right rear door was removed by emergency personnel. The C-pillar was dented. The rear quarter panel was buckled. The gas lid was missing. The right side windows were missing. The rear tire was torn, flat and partially melted. The rear wheel was dented.

The damage to the right side of Vehicle 1 (Ford).
CL-012-17 05-13-17 RS-A (282)

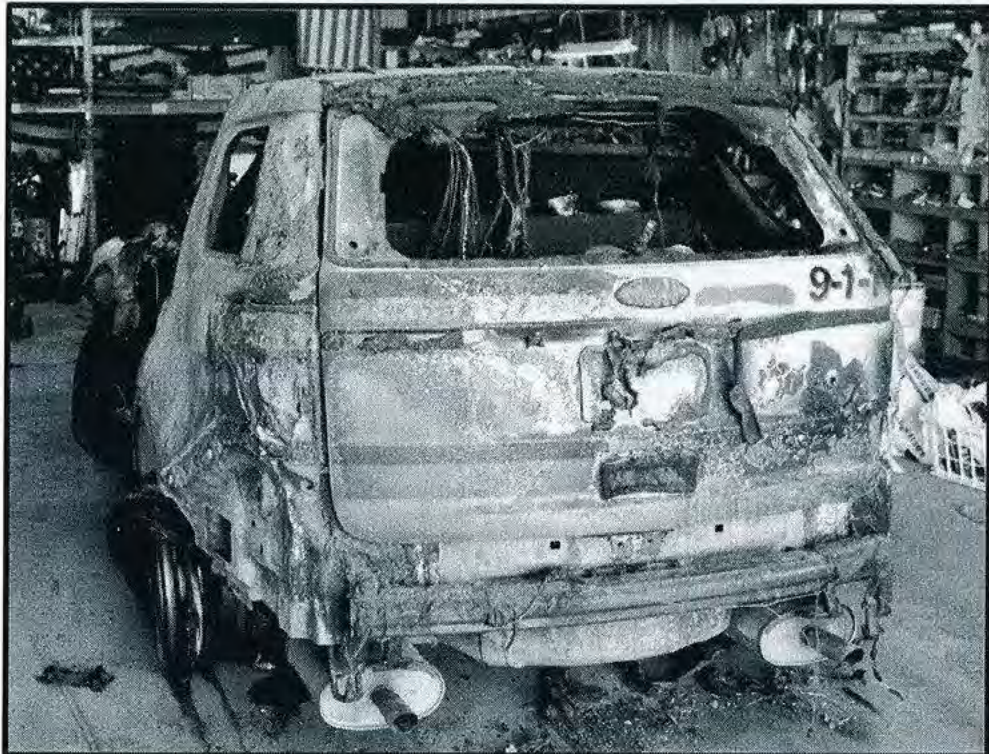
The entire rear end was burned. The rear window was missing. The right tail lamp assembly was missing. The left tail lamp cover was melted. The bumper fascia was missing.

The damage to the rear of Vehicle 1 (Ford).
CL-012-17 05-18-17 RS (1) cropped

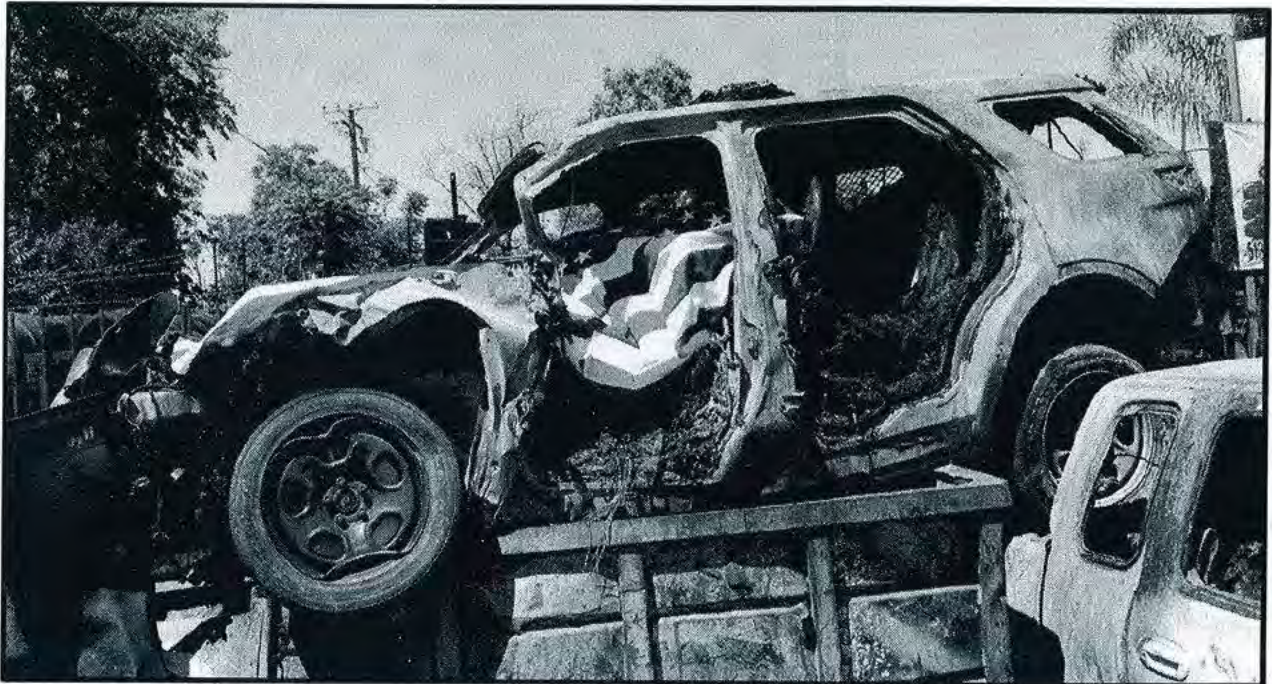
The entire left side was burned. The fender was pushed rearward. The leading edge of the fender was folded toward the rear. The bottom of the A-pillar was pushed inward and rearward. The front tire was flat and partially melted. The front wheel was misshapen. The side mirror was missing. The leading edge of the driver door frame was pushed rearward. The doors were removed by emergency personnel. The driver's door window was shattered. The bottom of the B-pillar was dented. The rear window was missing. The rear tire was torn, flat and partially melted.

The damage to the left side of Vehicle 1 (Ford).
CL-012-17 05-13-17 RS-A (222) cropped

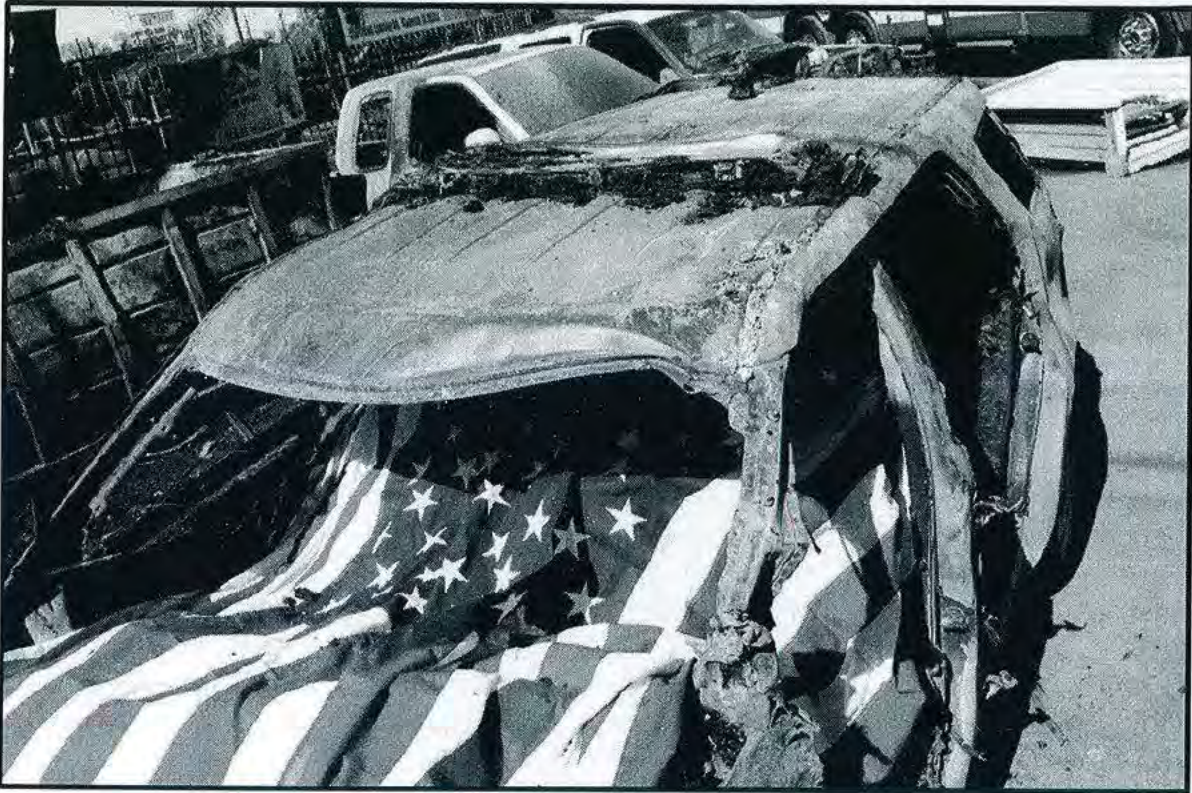
The roof was burned and buckled. The left side of the leading edge of the roof was pushed downward. The overhead lights and antennas were melted.

The damage to the roof of Vehicle 1 (Ford) at the scene.
CL-012-17 05-13-17 RS-A (285) cropped

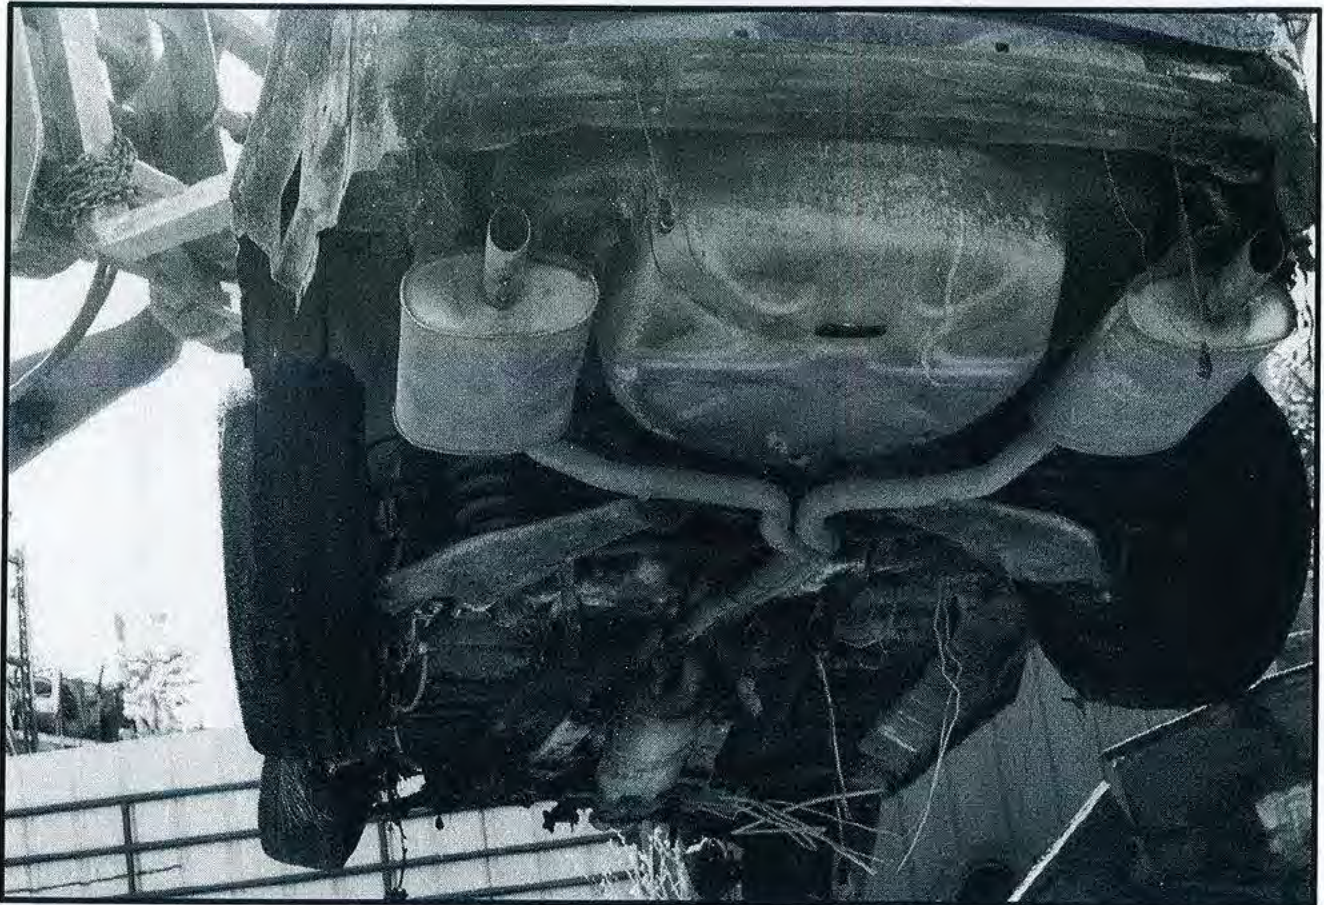
The right front tie rod was separated. The right and left front half shafts were separated from the transaxle. The right front lower control arm was broken. The left rear stabilizer bar link was broken.

The undercarriage of Vehicle 1 (Ford).
CL-012-17 05-13-17 RS-A (273)

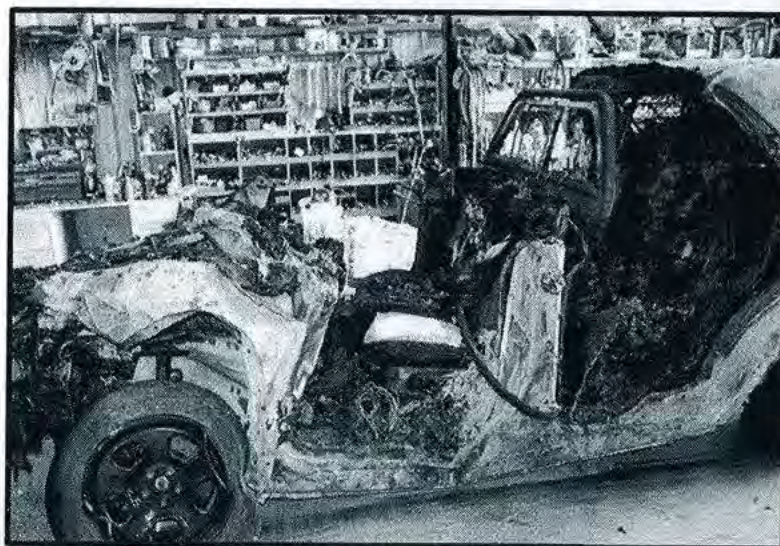
The interior sustained considerable thermal damage. The dashboard, instrument panel, and patrol vehicle computer unit assembly were melted. The steering wheel was bent and in an upright position. The driver and front passenger frontal airbags were deployed. There was one automatic vehicle transmission from Modesto Auto Wreckers #2 located on Party 1 (Deputy Garner), and another automatic transmission from Modesto Auto Wreckers #2 located on Passenger CSO Johnson.

The electromechanical lock for the Stanislaus County Sheriff's Department issued rifle was open and bent downward. The rifle was located on top of Passenger CSO Johnson's lower legs with the safety in the on position. The rifle had a full magazine loaded in its magazine well and no round in the chamber. The magazine appeared undamaged. There was another rifle magazine located between the front seats of the vehicle. The magazine sustained thermal damage, and the magazine spring was expended from the damaged magazine case.

The light control board and electromechanical lock release button were located in the center console between the driver and right front passenger seat. The center console was covered with miscellaneous items, all of which sustained thermal damage. The driver's latch plate and the right front passenger's latch plate were found inserted into their respective buckles assemblies. Party 1's (Deputy Garner) departmentally issued pistol was located in his right thigh holster. The lower rear portion of the pistol grip was positioned between the fastened seat belt buckle and Party 1's (Deputy Garner) right thigh. A bullet was located on the driver seat. A cartridge was located on the driver's floorboard adjacent to the center console, in front of the driver's seat.

The interior of Vehicle 1 (Ford) with the front of the roof removed.
CL-012-17 05-18-17 RS (2)

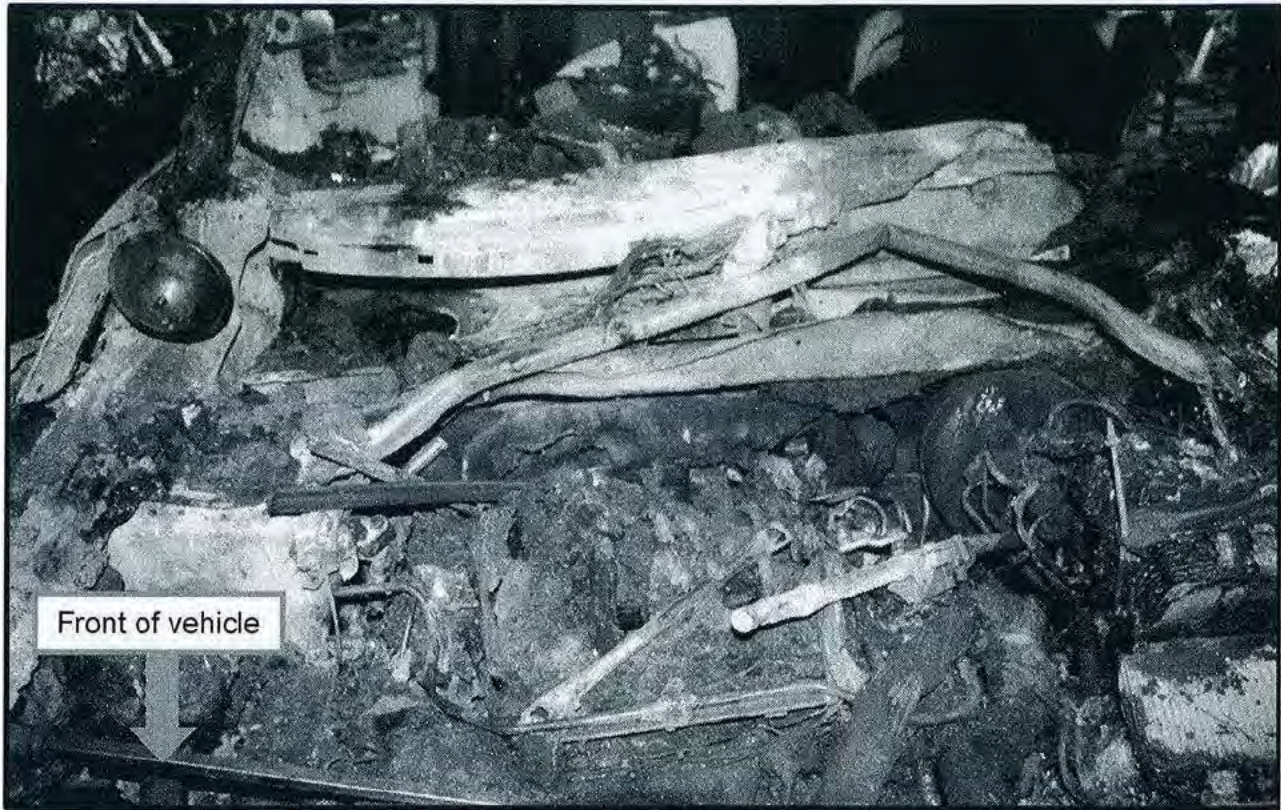
- The engine compartment, and all the associated components, sustained major thermal damage.
- The front right and left half shafts were detached from the transaxle.
- Due to the damage of the vehicle, the Diagnostic Trouble Codes (DTC) were unable to be checked.

The engine compartment of Vehicle 1 (Ford) at E Towing.
CL-012-17 06-06-17 KW (19) cropped

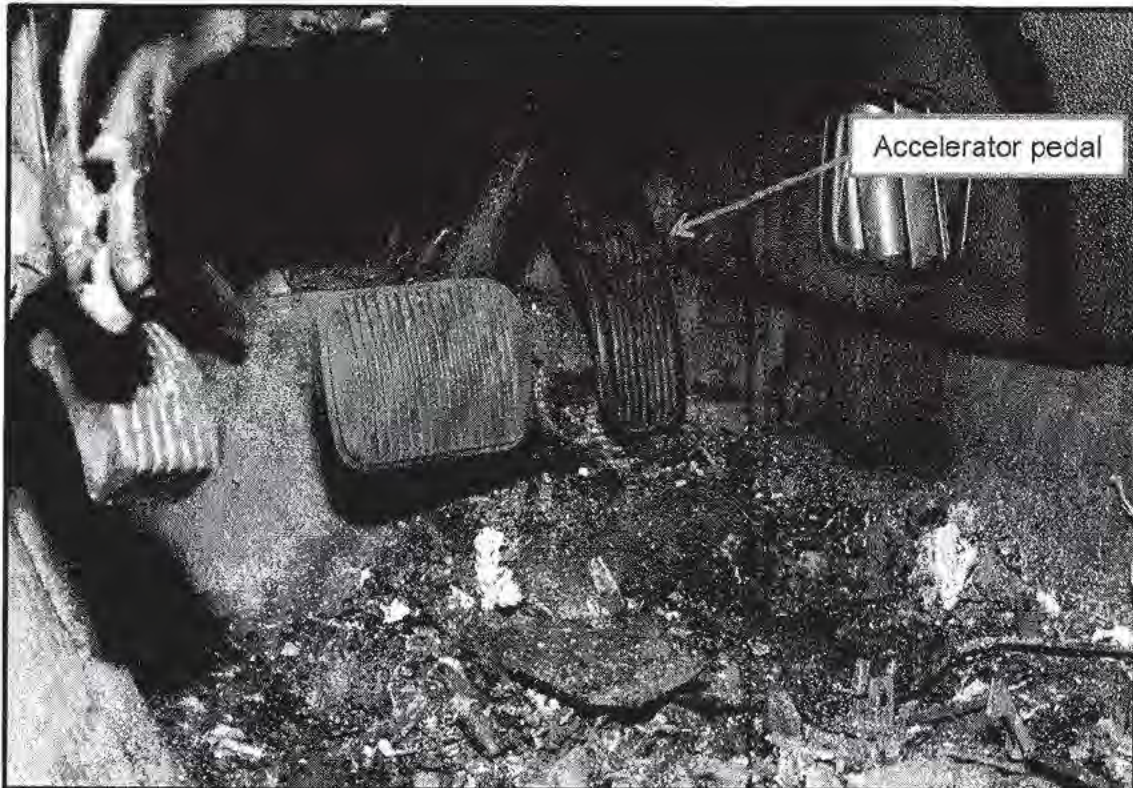
- The accelerator pedal was intact but not functional due to displacement of the bulkhead.
- The throttle body was detached from the air intake manifold.
- The throttle body was found with the throttle plate in an open position. The cover to the throttle control motor was missing and the internal gears were exposed. The internal gears were found in a charred and melted state.
- The fuel tank was found to be compromised and sustained thermal damage.
- The driver's side floorboard was free of debris and there were no objects in the vicinity of the accelerator or brake pedals that would have interfered with the movement of either pedal.
- The accelerator pedal movement was free and no obstructions, binding, or restrictions were noted.

The driver side floorboard and pedals of Vehicle 1 (Ford).
CL-012-17 05-13-17 RS-B (117) cropped

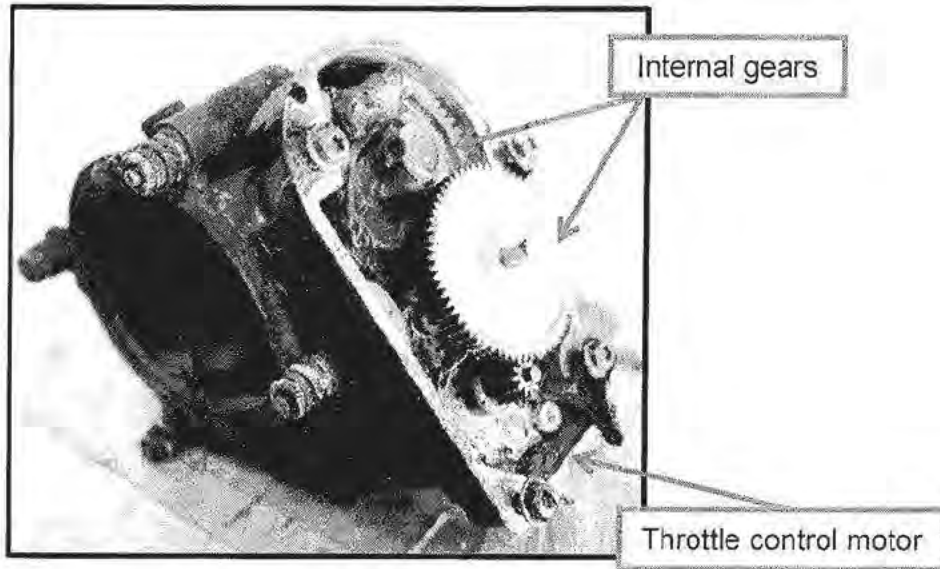
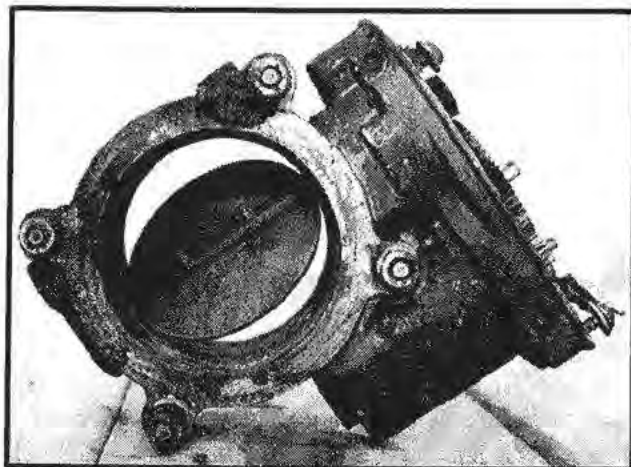
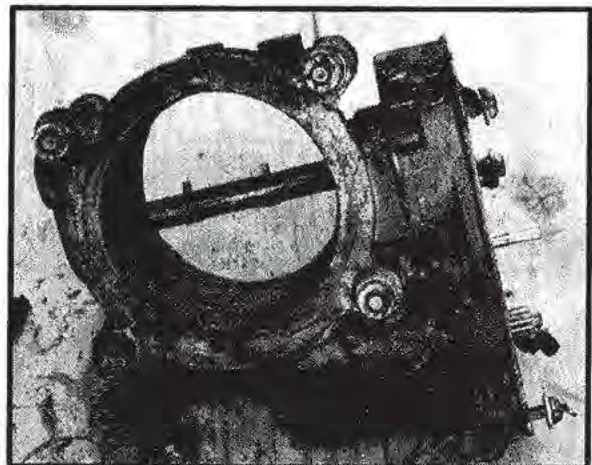
The throttle body was found detached from the engine as a result of collision and thermal damage. The throttle plate was found in an open position with the internal gears of the throttle control motor melted. The throttle return spring was melted to one of the gears. Each of the throttle control motor gears was removed for further inspection. The throttle return spring and one of the gears was removed as one piece. After each gear was removed, the throttle plate was able to move freely from a wide open position to a closed position without restrictions or binding.

The throttle body of Vehicle 1 (Ford) after its removal.
CL-012-17 02-08-18 KW (8) cropped

The throttle plate position with the internal gears still attached.
CL-012-17 02-08-18 KW (13) cropped

The throttle plate position with the internal gears and return spring removed.
CL-012-17 02-08-18 KW (36) cropped

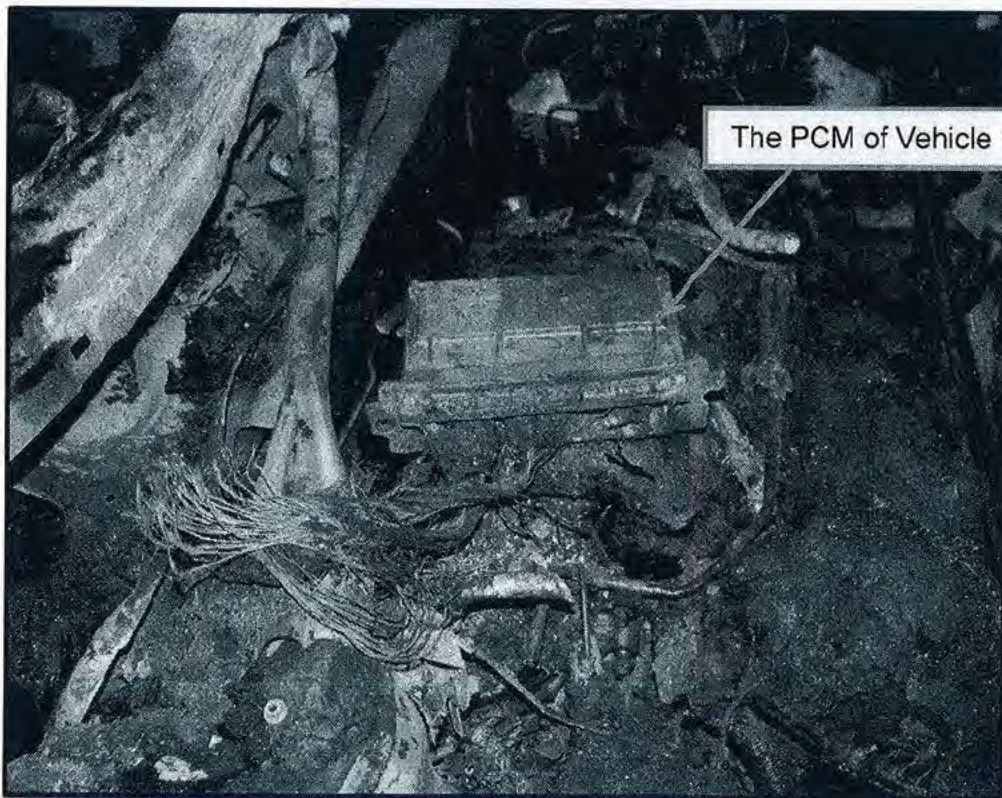
- The PCM and its associated wire harness were melted.
- The alternator was securely attached but along with the associated wiring, sustained thermal damage.
- The majority of the electrical system was melted due to the post-collision vehicle fire.

The PCM and associated wire harness of Vehicle 1 (Ford).
CL-012-17 06-06-17 KW (23) cropped

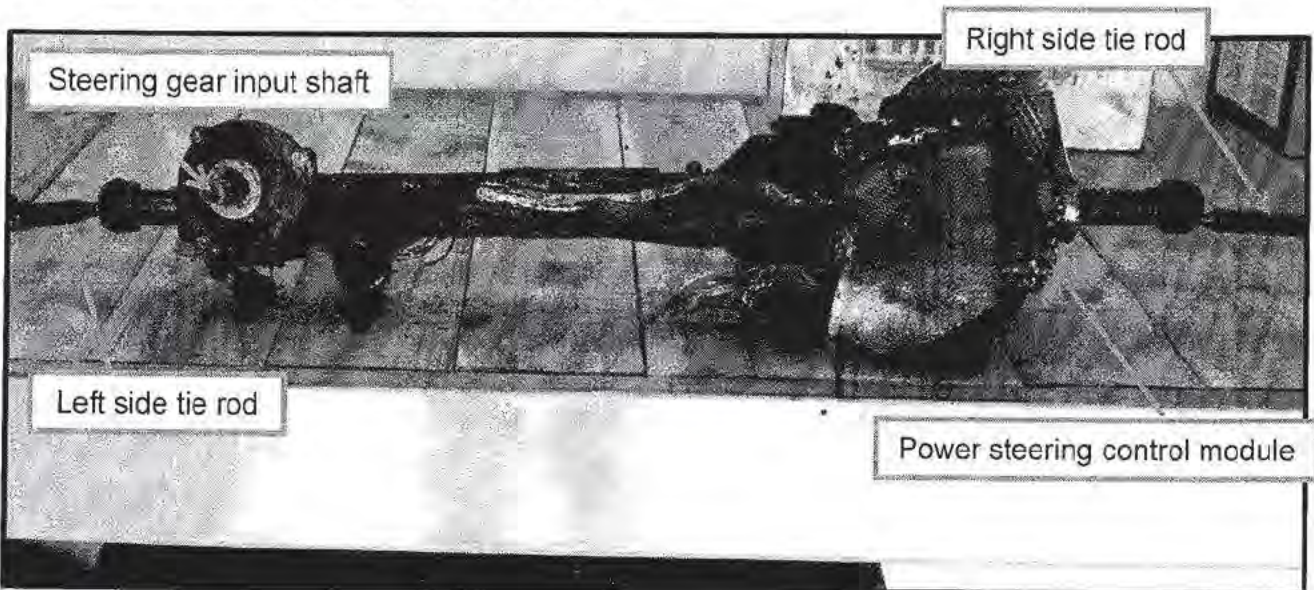
- The steering column was cut just below the steering wheel during the extrication of Party 1 (Deputy Garner).
- The right outer tie rod was bent and broken.
- The wire harness to the PSCM and steering torque sensor were melted due to thermal damage.
- Rotational movement of the input shaft of the rack and pinion steering gear box resulted in correlating lateral movement of the right and left tie rods.

The EPAS steering gear box assembly of Vehicle 1 (Ford) after removal.
CL-012-17 02-08-18 KW (44) cropped

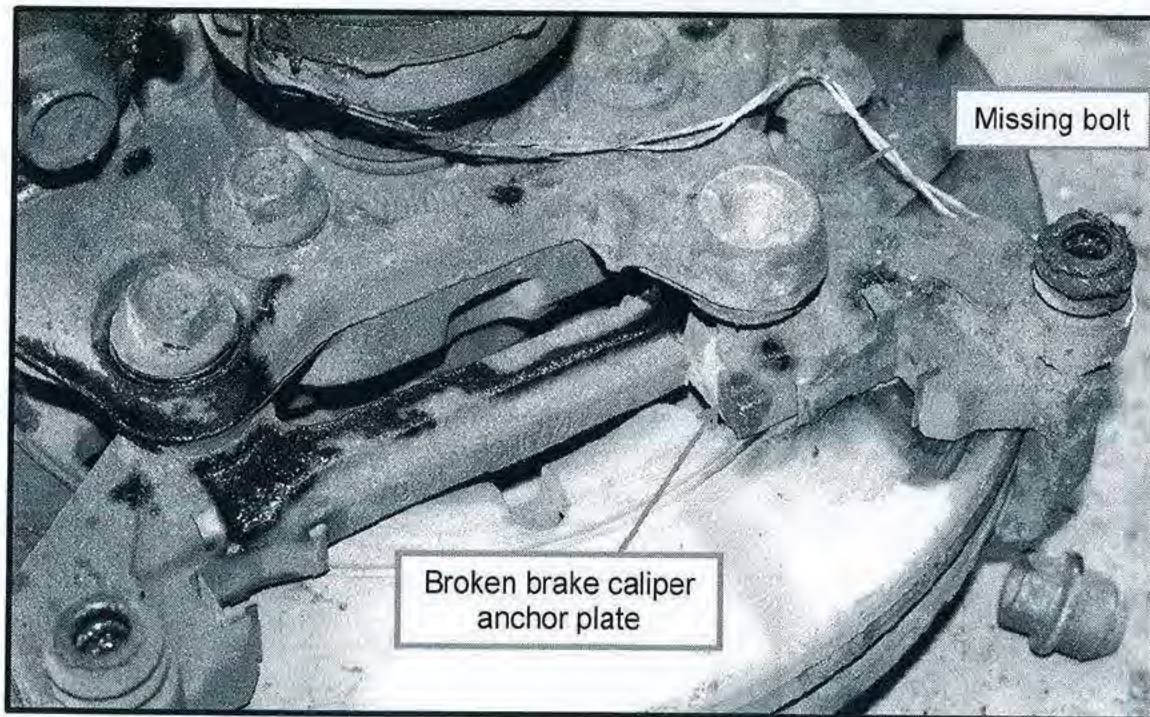
- The brake hoses between the frame mounted fittings and the brake calipers at all four wheel ends were consumed due to fire damage.
- The right front brake caliper anchor plate was missing the lower bolt.
- The right front brake caliper anchor plate was broken between the brake caliper slides.
- The parking brake did not apply at the right rear brake assembly. Manual operation of the parking brake at the brake assembly locked the hub in place.

The right front brake assembly of Vehicle 1 (Ford).
CL-012-17 06-06-17 RS (96) cropped

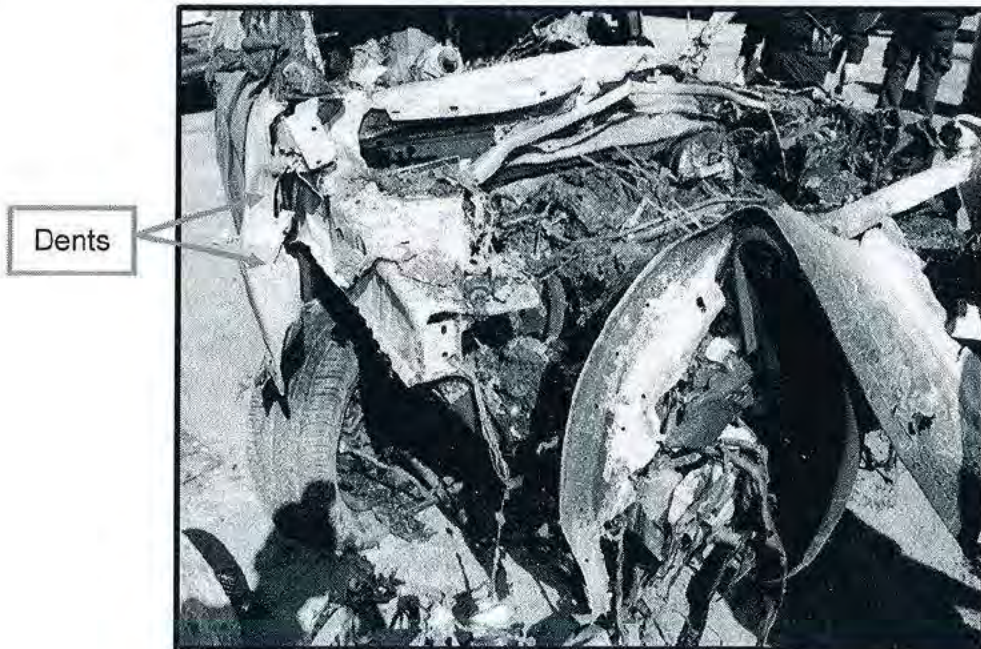
The upper portion of the right fender sustained contact damage consisting of dents and the leading edge was displaced outward, and bent inward. The damage was consistent with the damaged metal pole (physical evidence item 15). The right front end of Vehicle 1 (Ford) struck the south metal pole. Based on the contact damage to the front of Vehicle 1 (Ford), the PDOF applied to the front of Vehicle 1 (Ford) was from front to rear.

The damage to the right front of Vehicle 1 (Ford).
CL-012-17 05-13-17 RS-B (34) cropped

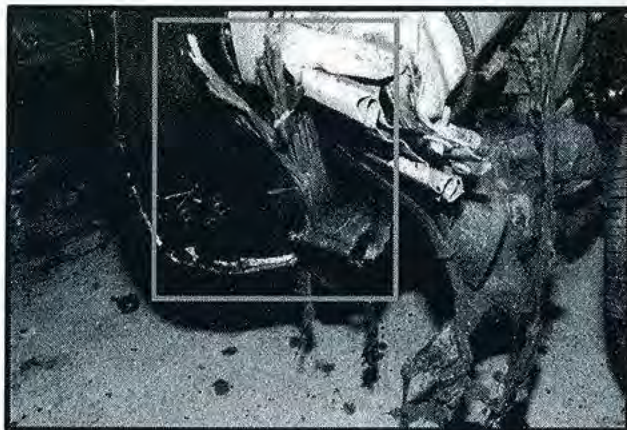
There was wood debris embedded in the left side of the push bumper assembly (indicated in the red rectangle).

The wood debris embedded into the front push bumper assembly of Vehicle 1 (Ford).
CL-012-17 05-13-17 RS-B (56)

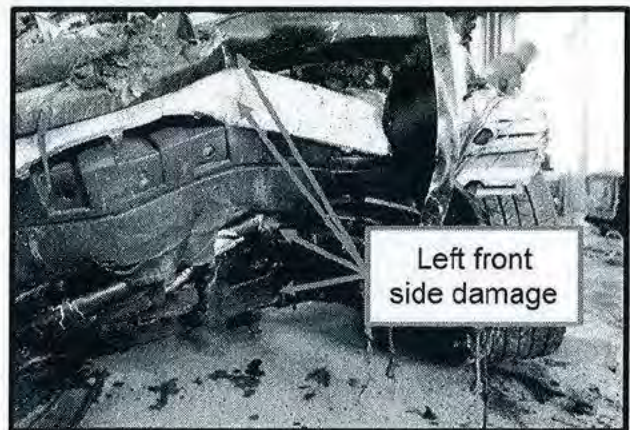
The damage to the left front side of Vehicle 1 (Ford).
CL-012-17 05-13-17 RS-B (49)

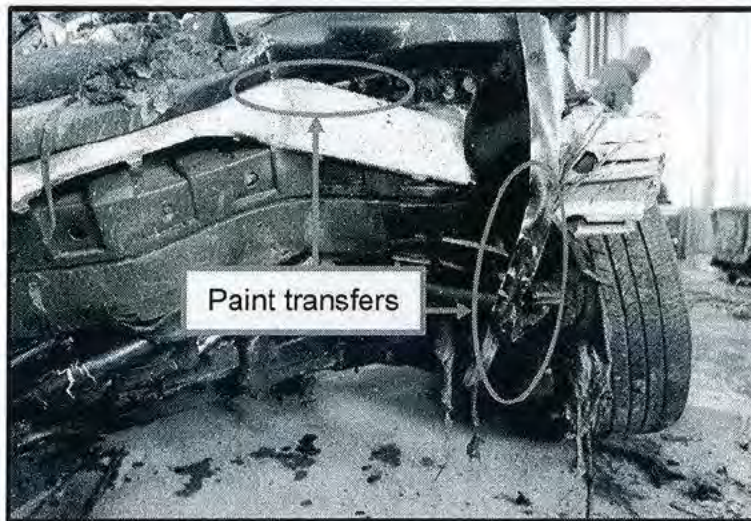
There were orange paint transfers (indicated by red arrows) on the leading edge of the left side push bumper and left front side of the front bumper fascia. There was one damaged orange metal bin (physical evidence item 17) resting on the south facing side of the damaged roll-off container (physical evidence item 18). There was one pickup truck bed (physical evidence item 12) which sustained damage to its right side. The front of Vehicle 1 (Ford) struck the orange bin and then the pickup truck bed during the collision sequence.

The orange paint transfers to the left side of Vehicle 1 (Ford).
CL-012-17 05-13-17 RS-B (49)

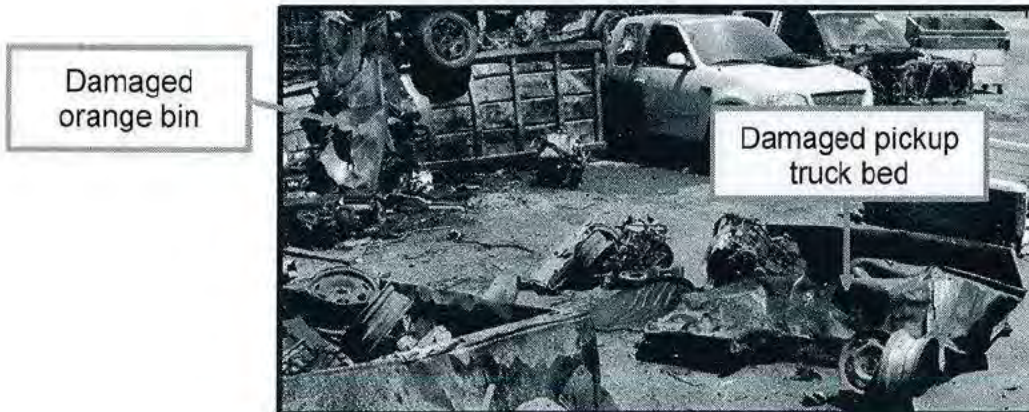
The damaged orange bin and pickup truck bed.
CL-012-17 05-13-17 RS-A (112)

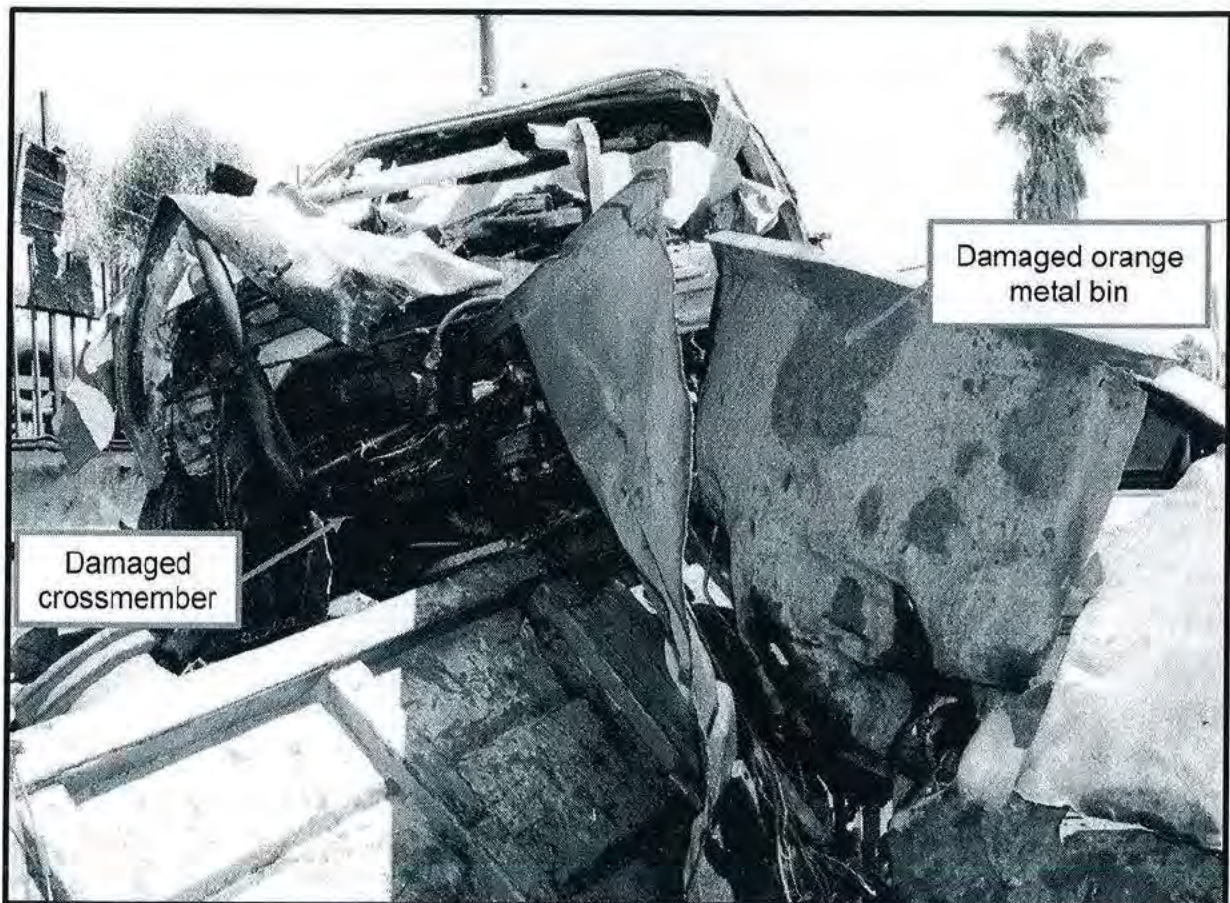
There was damage to the undercarriage and right side wheels of Vehicle 1 (Ford). The leading right edge of the push bumper was pushed rearward and to the right. The right side of the front bumper fascia was pushed rearward. The right front of the engine cross member was pushed rearward. The upper edge of the south facing side of the damaged roll-off container (physical evidence item 18) was pushed inward and downward. A damaged orange metal bin (physical evidence item 17) was resting on the south facing side of the damaged roll-off container (physical evidence item 18). As a result of the collision, Vehicle 1 (Ford) and the orange metal bin were projected airborne and the undercarriage of Vehicle 1 (Ford) and the orange metal bin struck the roll-off container. This caused the roll-off container to turn in a counterclockwise direction and it struck the wrought iron fence (physical evidence item 20).

The damage to the roll-off container, orange metal bin, and Vehicle 1 (Ford).
CL-012-17 05-13-17 RS-A (160)
