CD3 2010MY Fusion VOQ Results

02 November 2016

Background

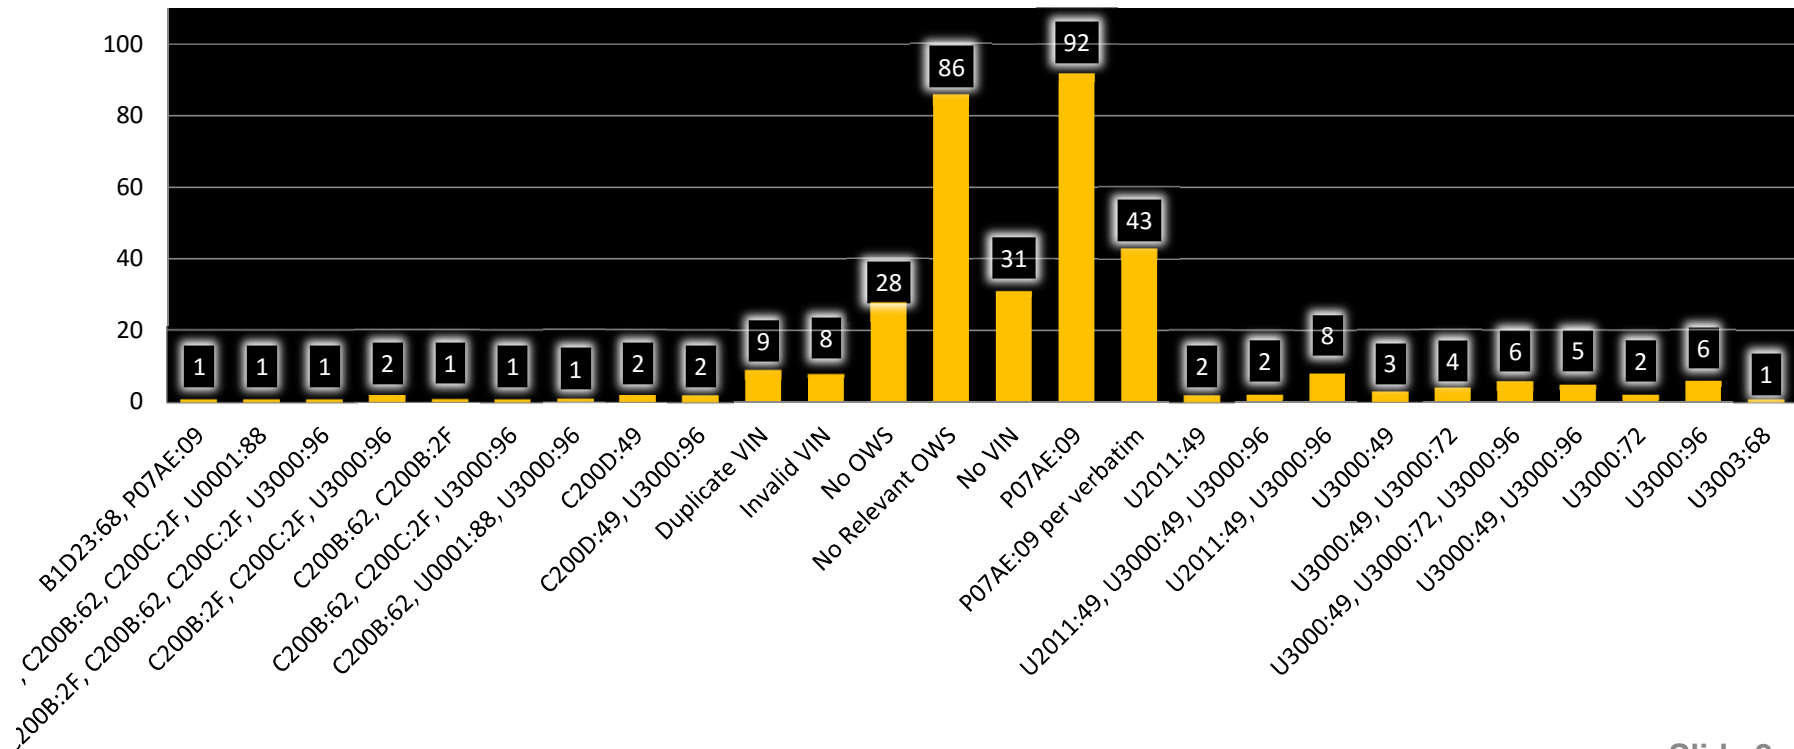
Count of Claims with Identical DTCs

- Ford received a VOQ summary from NHTSA, which was filtered to find claims after PE14-030 (10/22/14) for 2010MY Fusion
- After filtering, there were 348 new claims, each claim was looked-up in OWS to find the DTC read-out at the dealership
- The Pareto below groups the number of VINs that had a particular grouping of DTCs

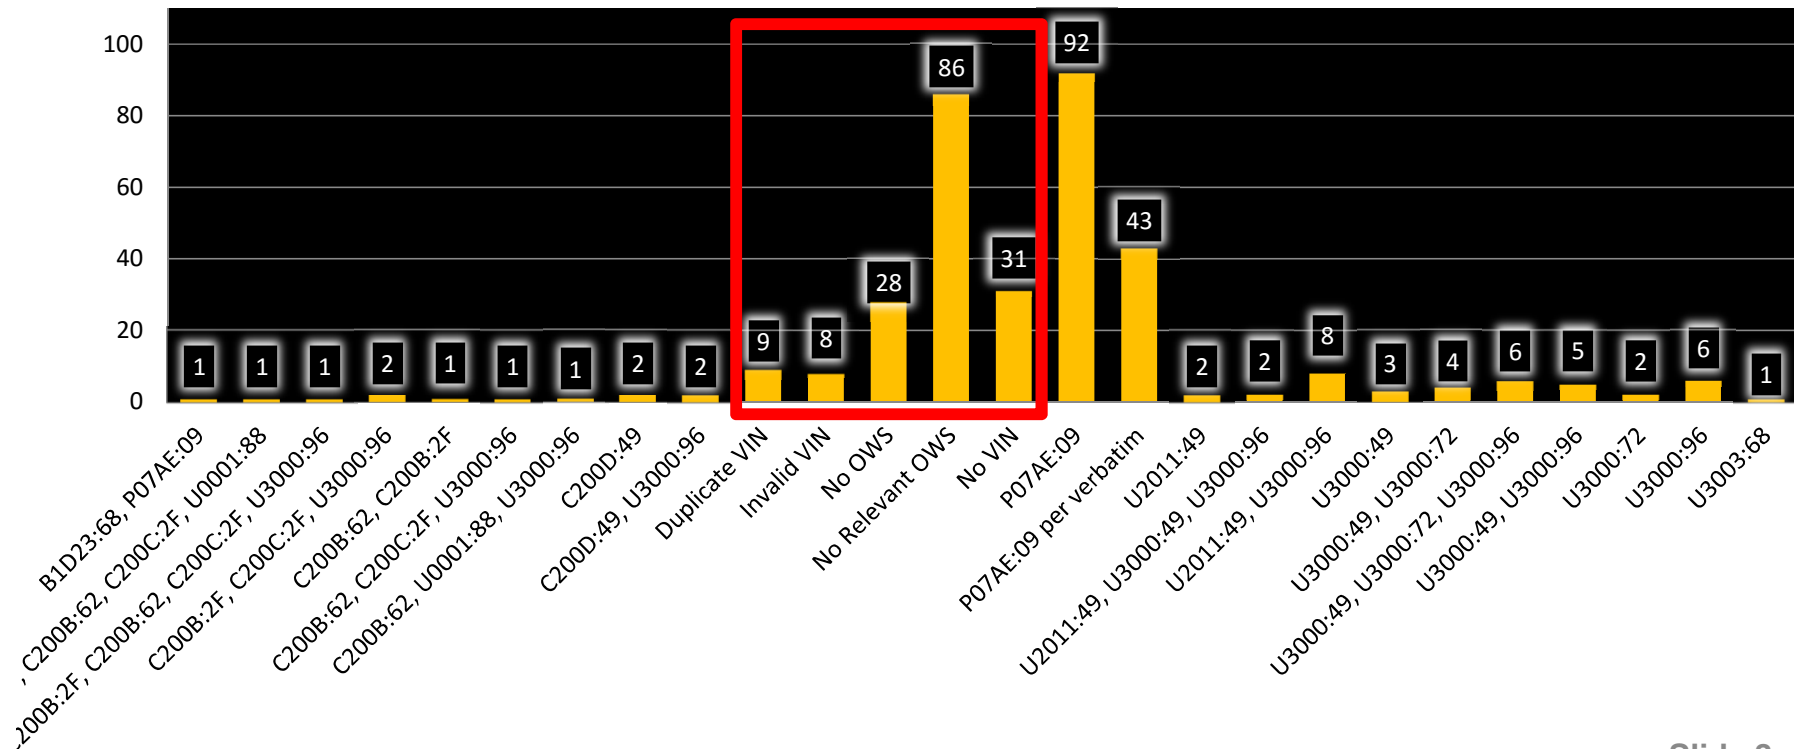
Count of Claims with Identical DTCs

- Of the 348 claims, 162 had no information available. Reasons include:
 - Duplicate VIN listed (VIN listed twice in spreadsheet)
 - Invalid VIN listed (not 17 characters long)
 - No OWS information available
 - No Relevant OWS information available
 - No VIN listed

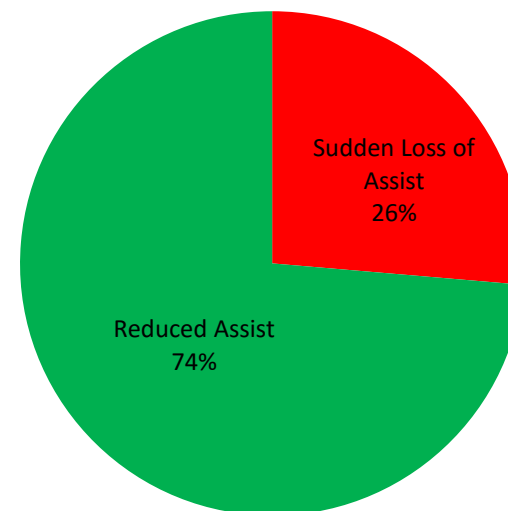
Sudden Loss of Assist VS Reduced Assist

- Of the 186 claims in which Ford was able to pull data from OWS:
 - **74% (137)** were reduced assist cases in which the customer would not experience manual steering while driving

- **26% (49)** were cases in which the customer would experience, worst case scenario, manual steering while driving
 - If data is extrapolated to the entire 348 population, **92** claims are predicted to be manual steering cases

Reduced Assist	137	74%
Sudden Loss of Assist	49	26%

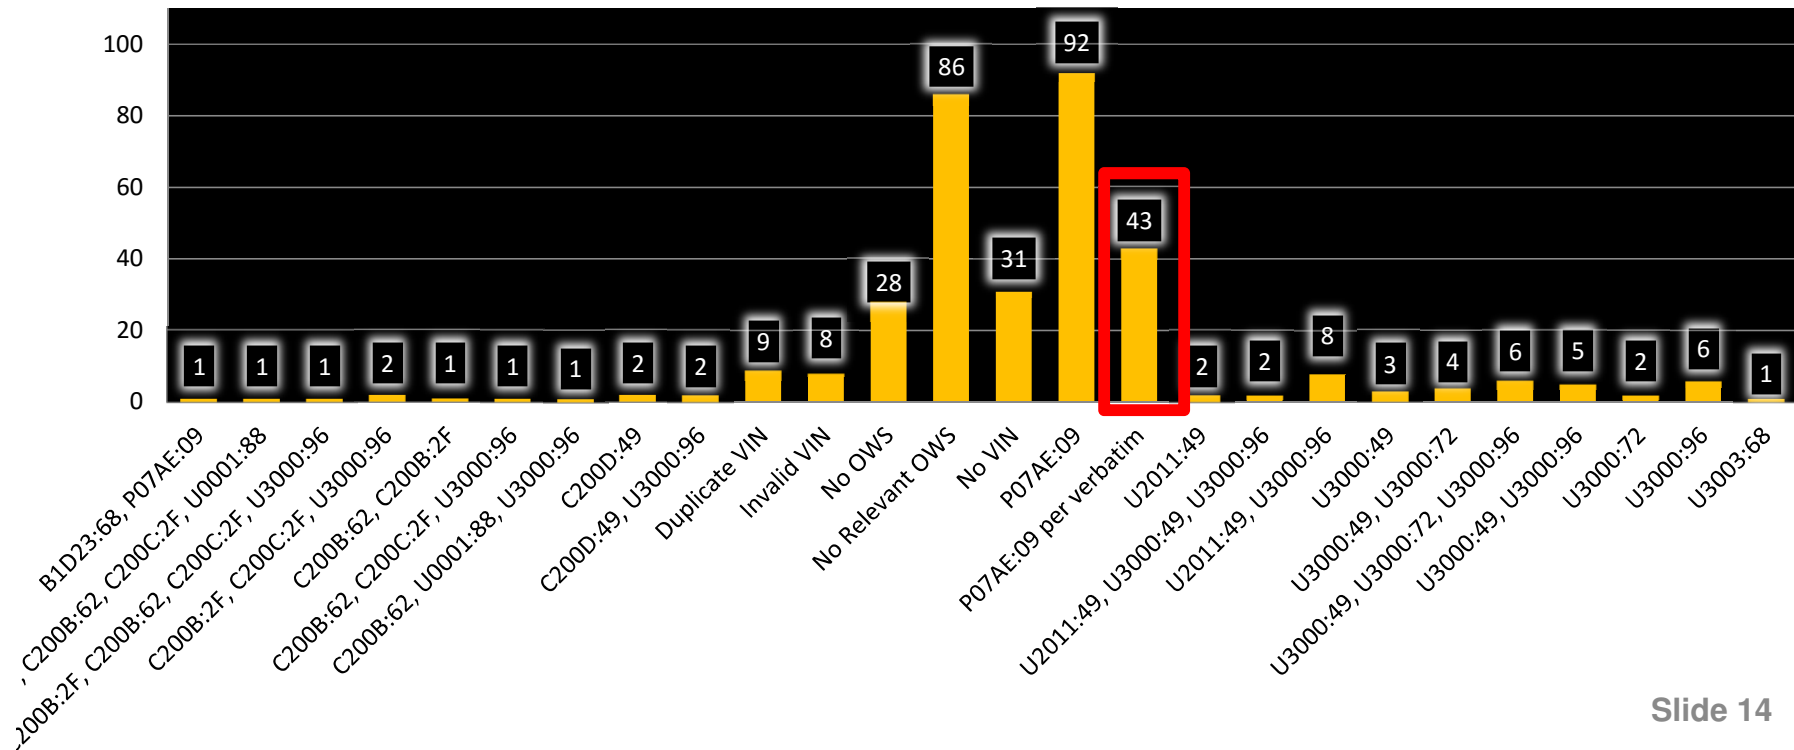
Count of Claims with Identical DTCs

- For 2010MY Fusion with production gears, the ONLY DTC that can cause the IPC to display “SERVICE POWER STEERING” or “SERVICE POWER STEERING NOW” in the message center is P07AE:09. Newer service gears (P/N AE5Z-3504-CF and beyond) contain the C200D:49 software fix that allows the PSCM to provide assist for the remainder of the drive cycle. For these gears, C200D:49 can also cause the IPC to display the message above.
- The data below assumes that when the customer saw the IPC display “SERVICE POWER STEERING” the DTC that flagged this message is P07AE:09, and is titled “P07AE:09 per verbatim” in the Pareto below.

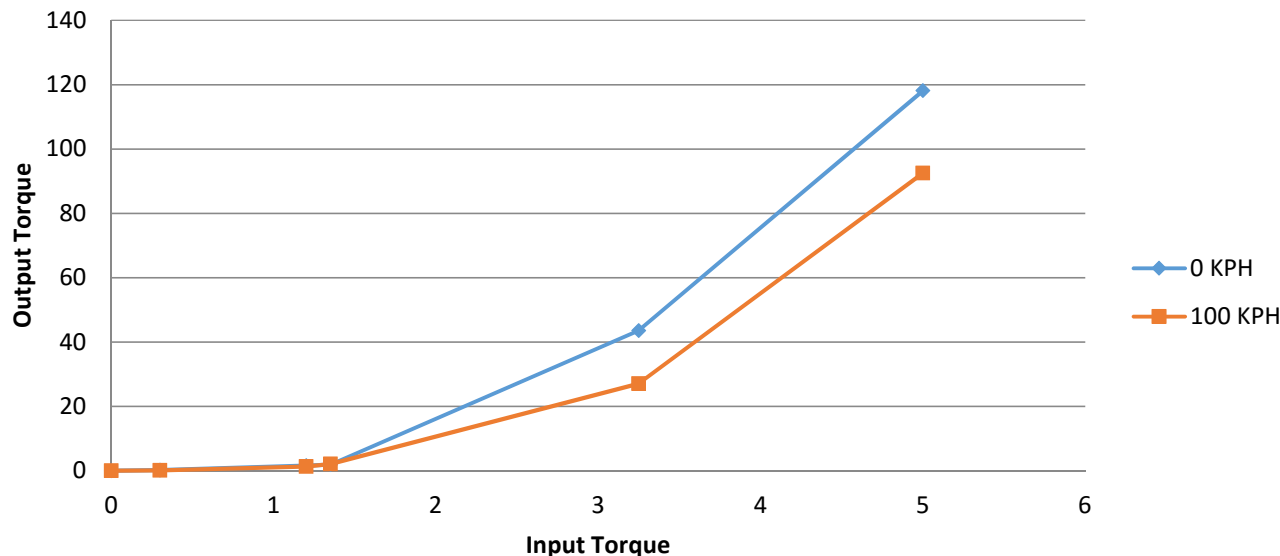
Boost Curves at Various Vehicle Speeds

- The amount of assist that is removed when the “default vehicle speed boost curve” is used depends on the input torque of the driver, and the current vehicle speed that the vehicle is operating.
- Below plot compares the boost curve at 100 kph (default vehicle speed) to that of parking maneuvers

**One parameter from 2010 Fusion calibration file was not readily available for boost curve calculation. This parameter was used from a different vehicle line (MKC). Boost curves are approximate and give a general understanding of operation (+/- 5% accuracy).
