Subject: Upcoming Safety Recall 14291 - Update
Population Expansion

Part 573 Safety Recall Report**15V-519****Manufacturer Name :** General Motors LLC**Submission Date :** NOV 05,2015**NHTSA Recall No. :** 15V-519**Manufacturer Recall No. :** 14291

Subject: 14291 - Safety Recall
Low Beam Headlamps and Daytime Running Lamps (DRL)
Could Fail To Illuminate

14291 Low Beam Headlamps and Daytime Running Lamps (DRL) Could Fail To Illuminate

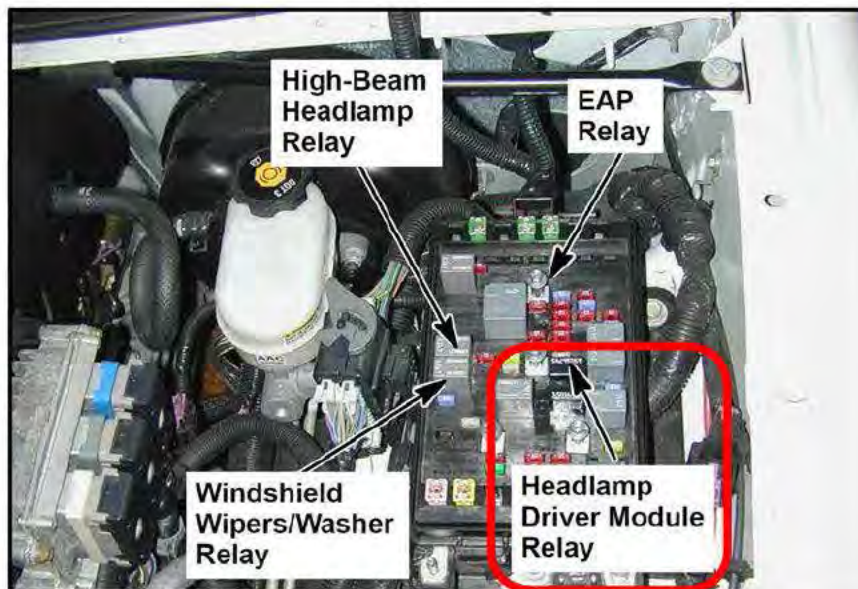
1. Locate the Headlamp Driver Module (HDM) in the under hood fuse block. Refer to *Electrical Center Identification Views* in the service manual.

2. Replace the HDM. Refer to *Relay Replacement (Within an Electrical Center)* in the service manual.
3. Proceed to Applying the Campaign Label.

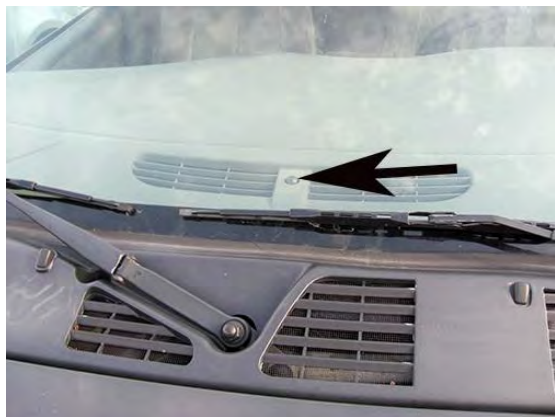
4788385

With the vehicle running and the headlamp controls in the "AUTO" position, verify that the headlamp dimmer switch, located on the steering column stalk, is placed on the Low Beam position.

Apply a light source to the Daytime Running Lamp (DRL) Ambient Light Sensor, located on the top of the instrument panel (Envoy shown, other vehicles are similar). With the foot brake applied, and the park brake released, put the vehicle transmission selector in DRIVE. Verify that both DRL's are inoperative.
