14291 population
expansion_dealer notice

Subject: Upcoming Safety Recall 14291 - Update
Population Expansion

Part 573 Safety Recall Report**15V-519****Manufacturer Name :** General Motors LLC**Submission Date :** NOV 05,2015**NHTSA Recall No. :** 15V-519**Manufacturer Recall No. :** 14291

Subject: 14291 - Safety Recall
Low Beam Headlamps and Daytime Running Lamps (DRL)
Could Fail To Illuminate

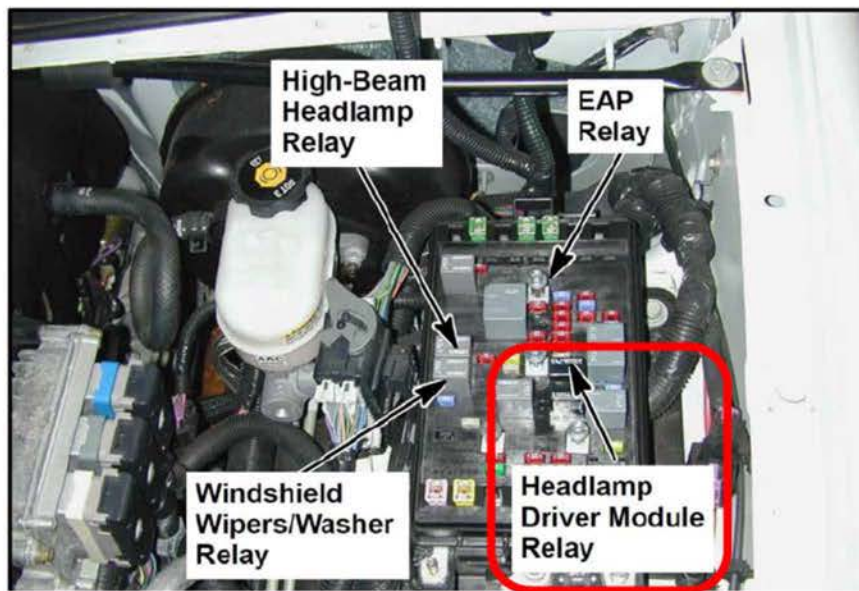
1. Locate the Headlamp Driver Module (HDM) in the under hood fuse block. Refer to *Electrical Center Identification Views* in the service manual.

2. Replace the HDM. Refer to *Relay Replacement (Within an Electrical Center)* in the service manual.
3. Proceed to Applying the Campaign Label.

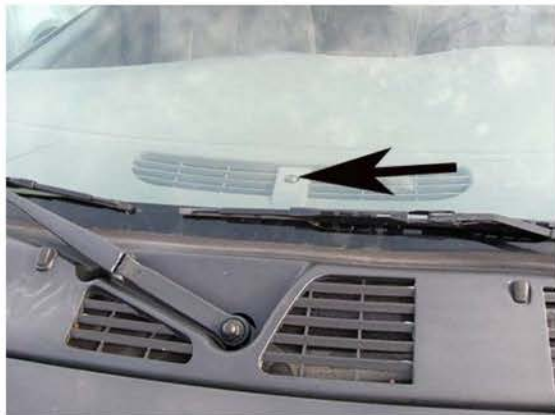
4788385

With the vehicle running and the headlamp controls in the "AUTO" position, verify that the headlamp dimmer switch, located on the steering column stalk, is placed on the Low Beam position.

Apply a light source to the Daytime Running Lamp (DRL) Ambient Light Sensor, located on the top of the instrument panel (Envoy shown, other vehicles are similar). With the foot brake applied, and the park brake released, put the vehicle transmission selector in DRIVE. Verify that both DRL's are inoperative.
