31 MAY 2013

SECTION: 501-14

Soft Door Close Lock Functionality

Range Rover (LG)

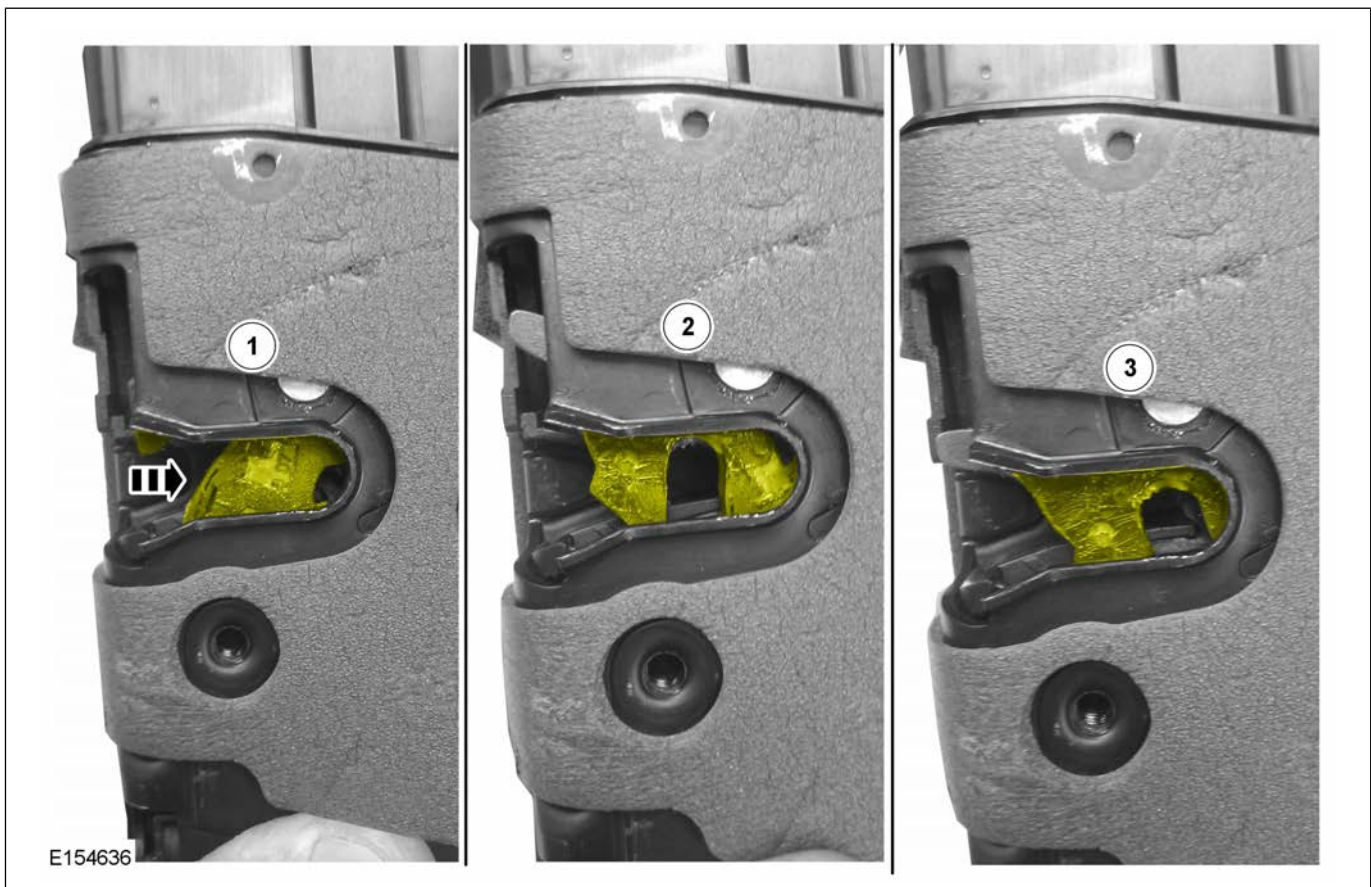
Situation: The soft door close function may operate intermittently or will not fully close.

This may be caused by the soft door close mechanism spring becoming dislocated.

- Open the door.
- Using a suitable tool, carefully move the door latch from position 1 to position 2.
- The latch should automatically move from position 2 to position 3 due to the soft door close function.
 - If the latch operates correctly in all three positions, carry on to step 2.
 - If the soft door close function moves the door latch to position 3, wait for two (2) seconds. Operate the internal or external door handle and observe the door latch movement. If the door latch is slow to return to position 1 or if it stops at position 2 and then returns to position 3, carry out steps 4-6.
- If the door latch does not automatically move to position 3 **AND** cannot be manually moved to position 3, carry out steps 4-6.

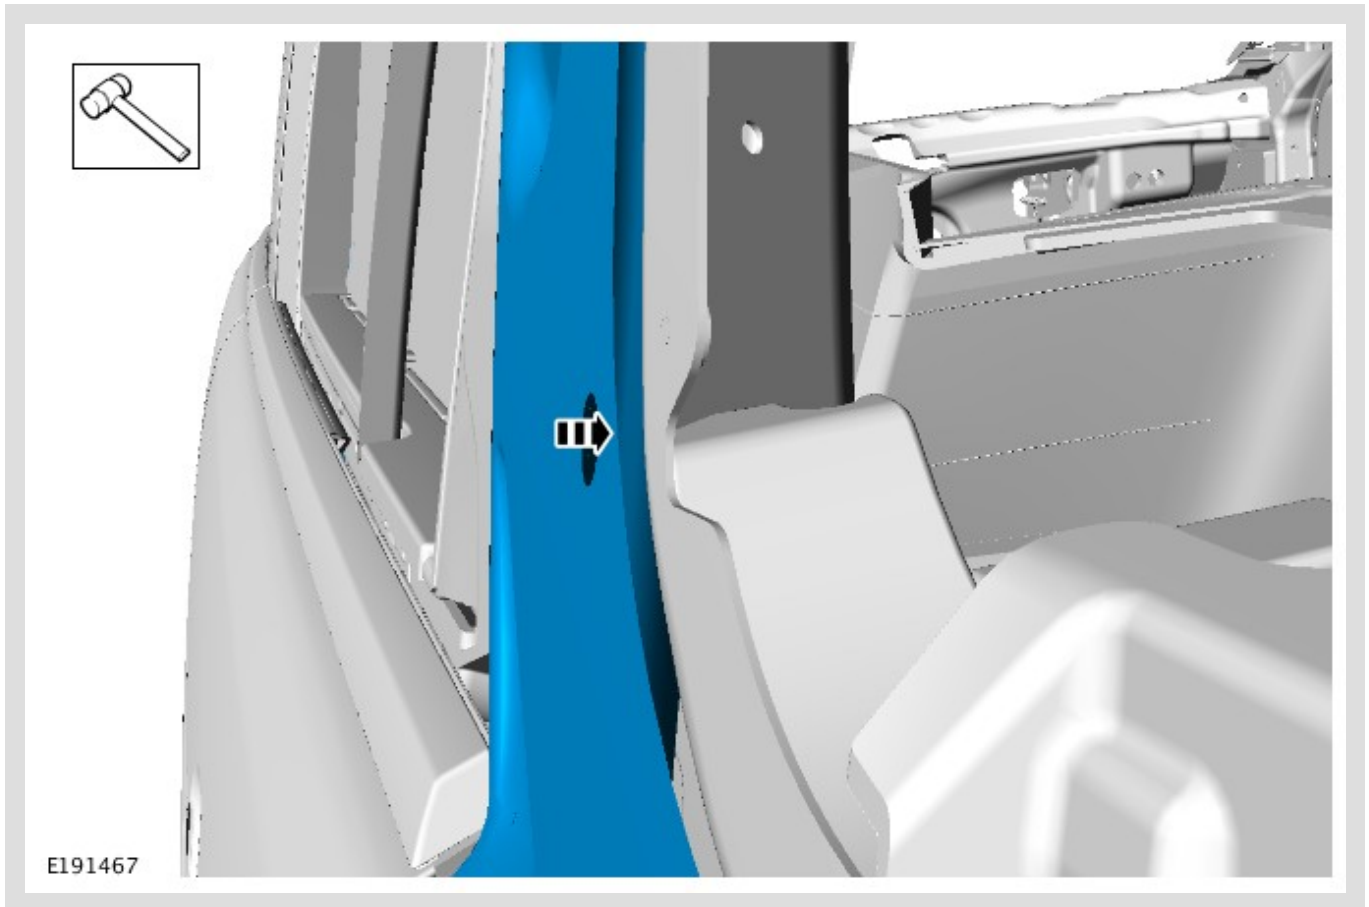
Visually check the body panel.

Using a suitable tool, dress the body panel until the gap between the body panel and reinforcement panel has been closed.
