MCI RESPONSE TO ODI

RQ17-007

CONSUMER COMPLAINTS

FIELD REPORTS PAGE 56

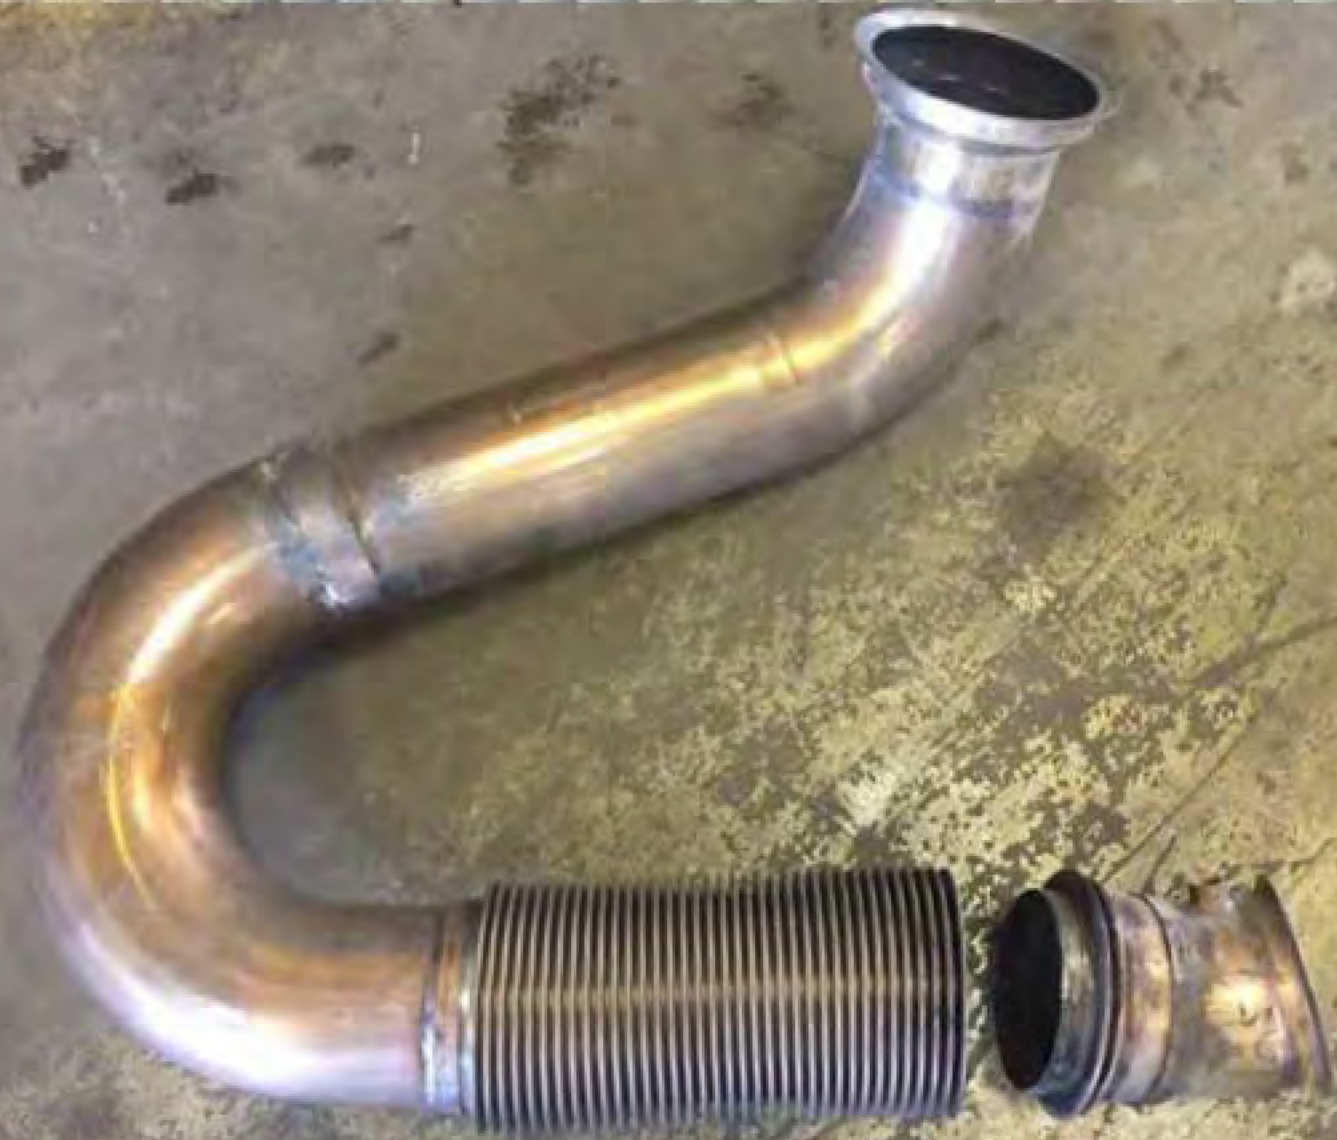
IMG_5643.JPG

MCI Category: 08. Engine		<u>ERSA Related Details</u>	
MCI Sub-Category: 08.20 Muffler		Is Coach	
Detected at: Post-Delivery		Out of Service?	No
Incident Date: 03/27/2017		Is Coach Down?	No
Complaint: Customer stated that 5 of their D4505's were experiencing failures of the exhaust pipe bellows			
Solution: Assisted customer in filing claim for P8-34. Customer will receive new pn 08-28-2855

Code Type:	
Cause:	
Causal Part No.	08-20-1786
Did any other parts fail as a result of the causal part failing ?	No
Correction:	Solution: Assisted customer in filing claim for P8-34. Customer will receive new pn 08-28-2855

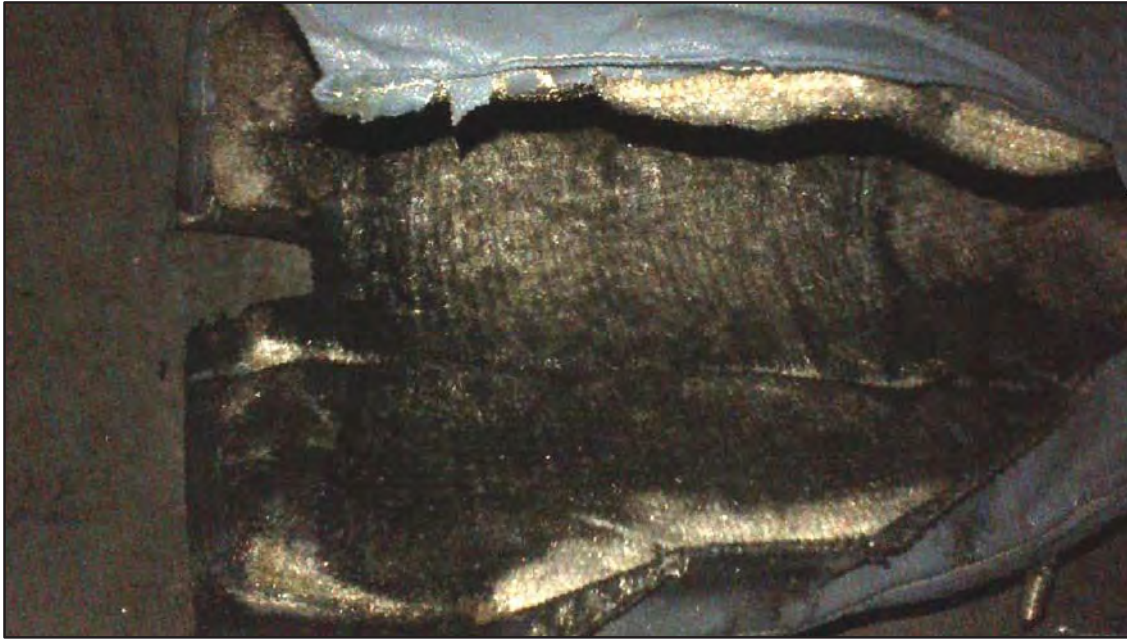
Figure 2.

1. the interior jacket of the blanket has evidence of smoke leaks and soot (refer to Figure 2); or

If any one (1) of the above three (3) conditions exists, a new bellows pipe, p/n 08-20-1786, is required to be installed in Step 8. of this procedure.

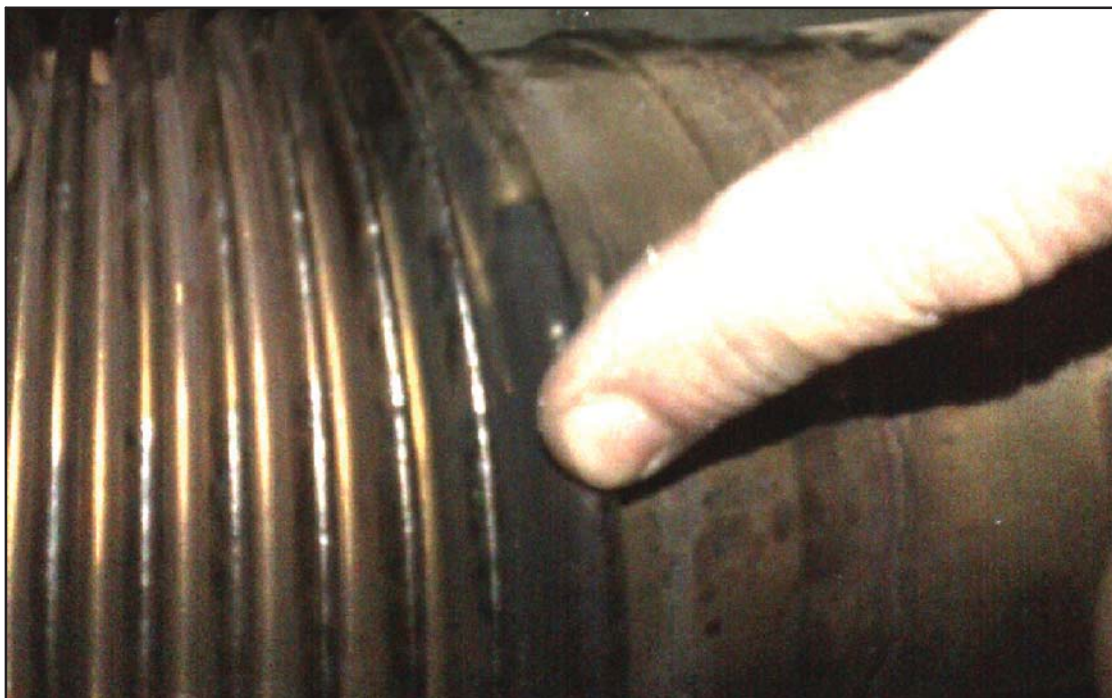
Figure 3.

2. the bellows pipe has a crack or evidence of breakage (refer to Figure 3); or

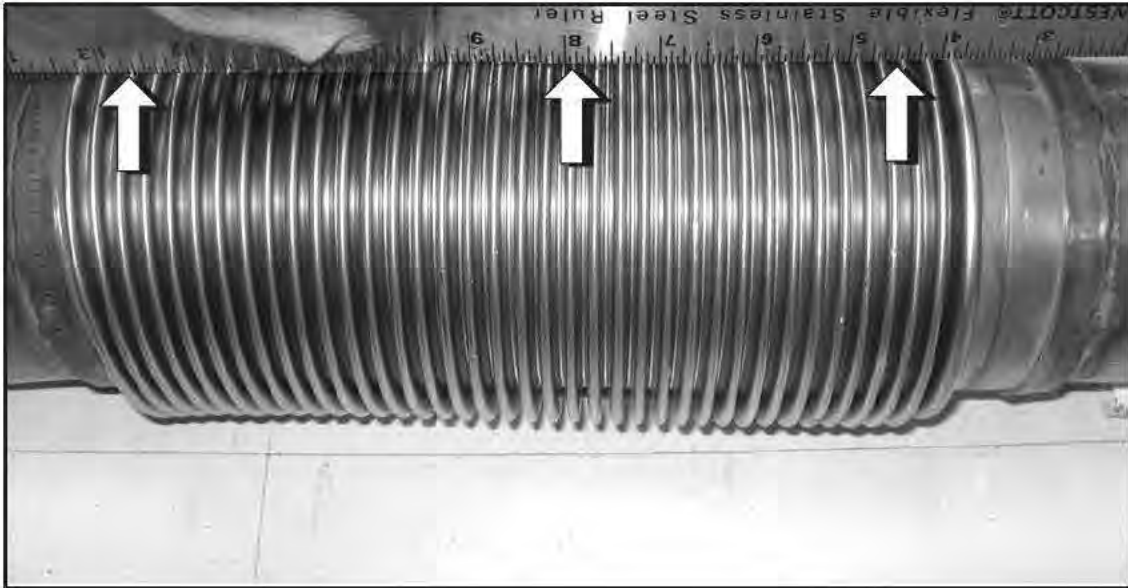
Figure 4.

3. the bellows pipe has a gap of more than 0.250 inch between a straight edge and the bellows due to permanent deformation, when a straight edge is positioned over the bellows at multiple positions around the circumference (refer to Figure 4).

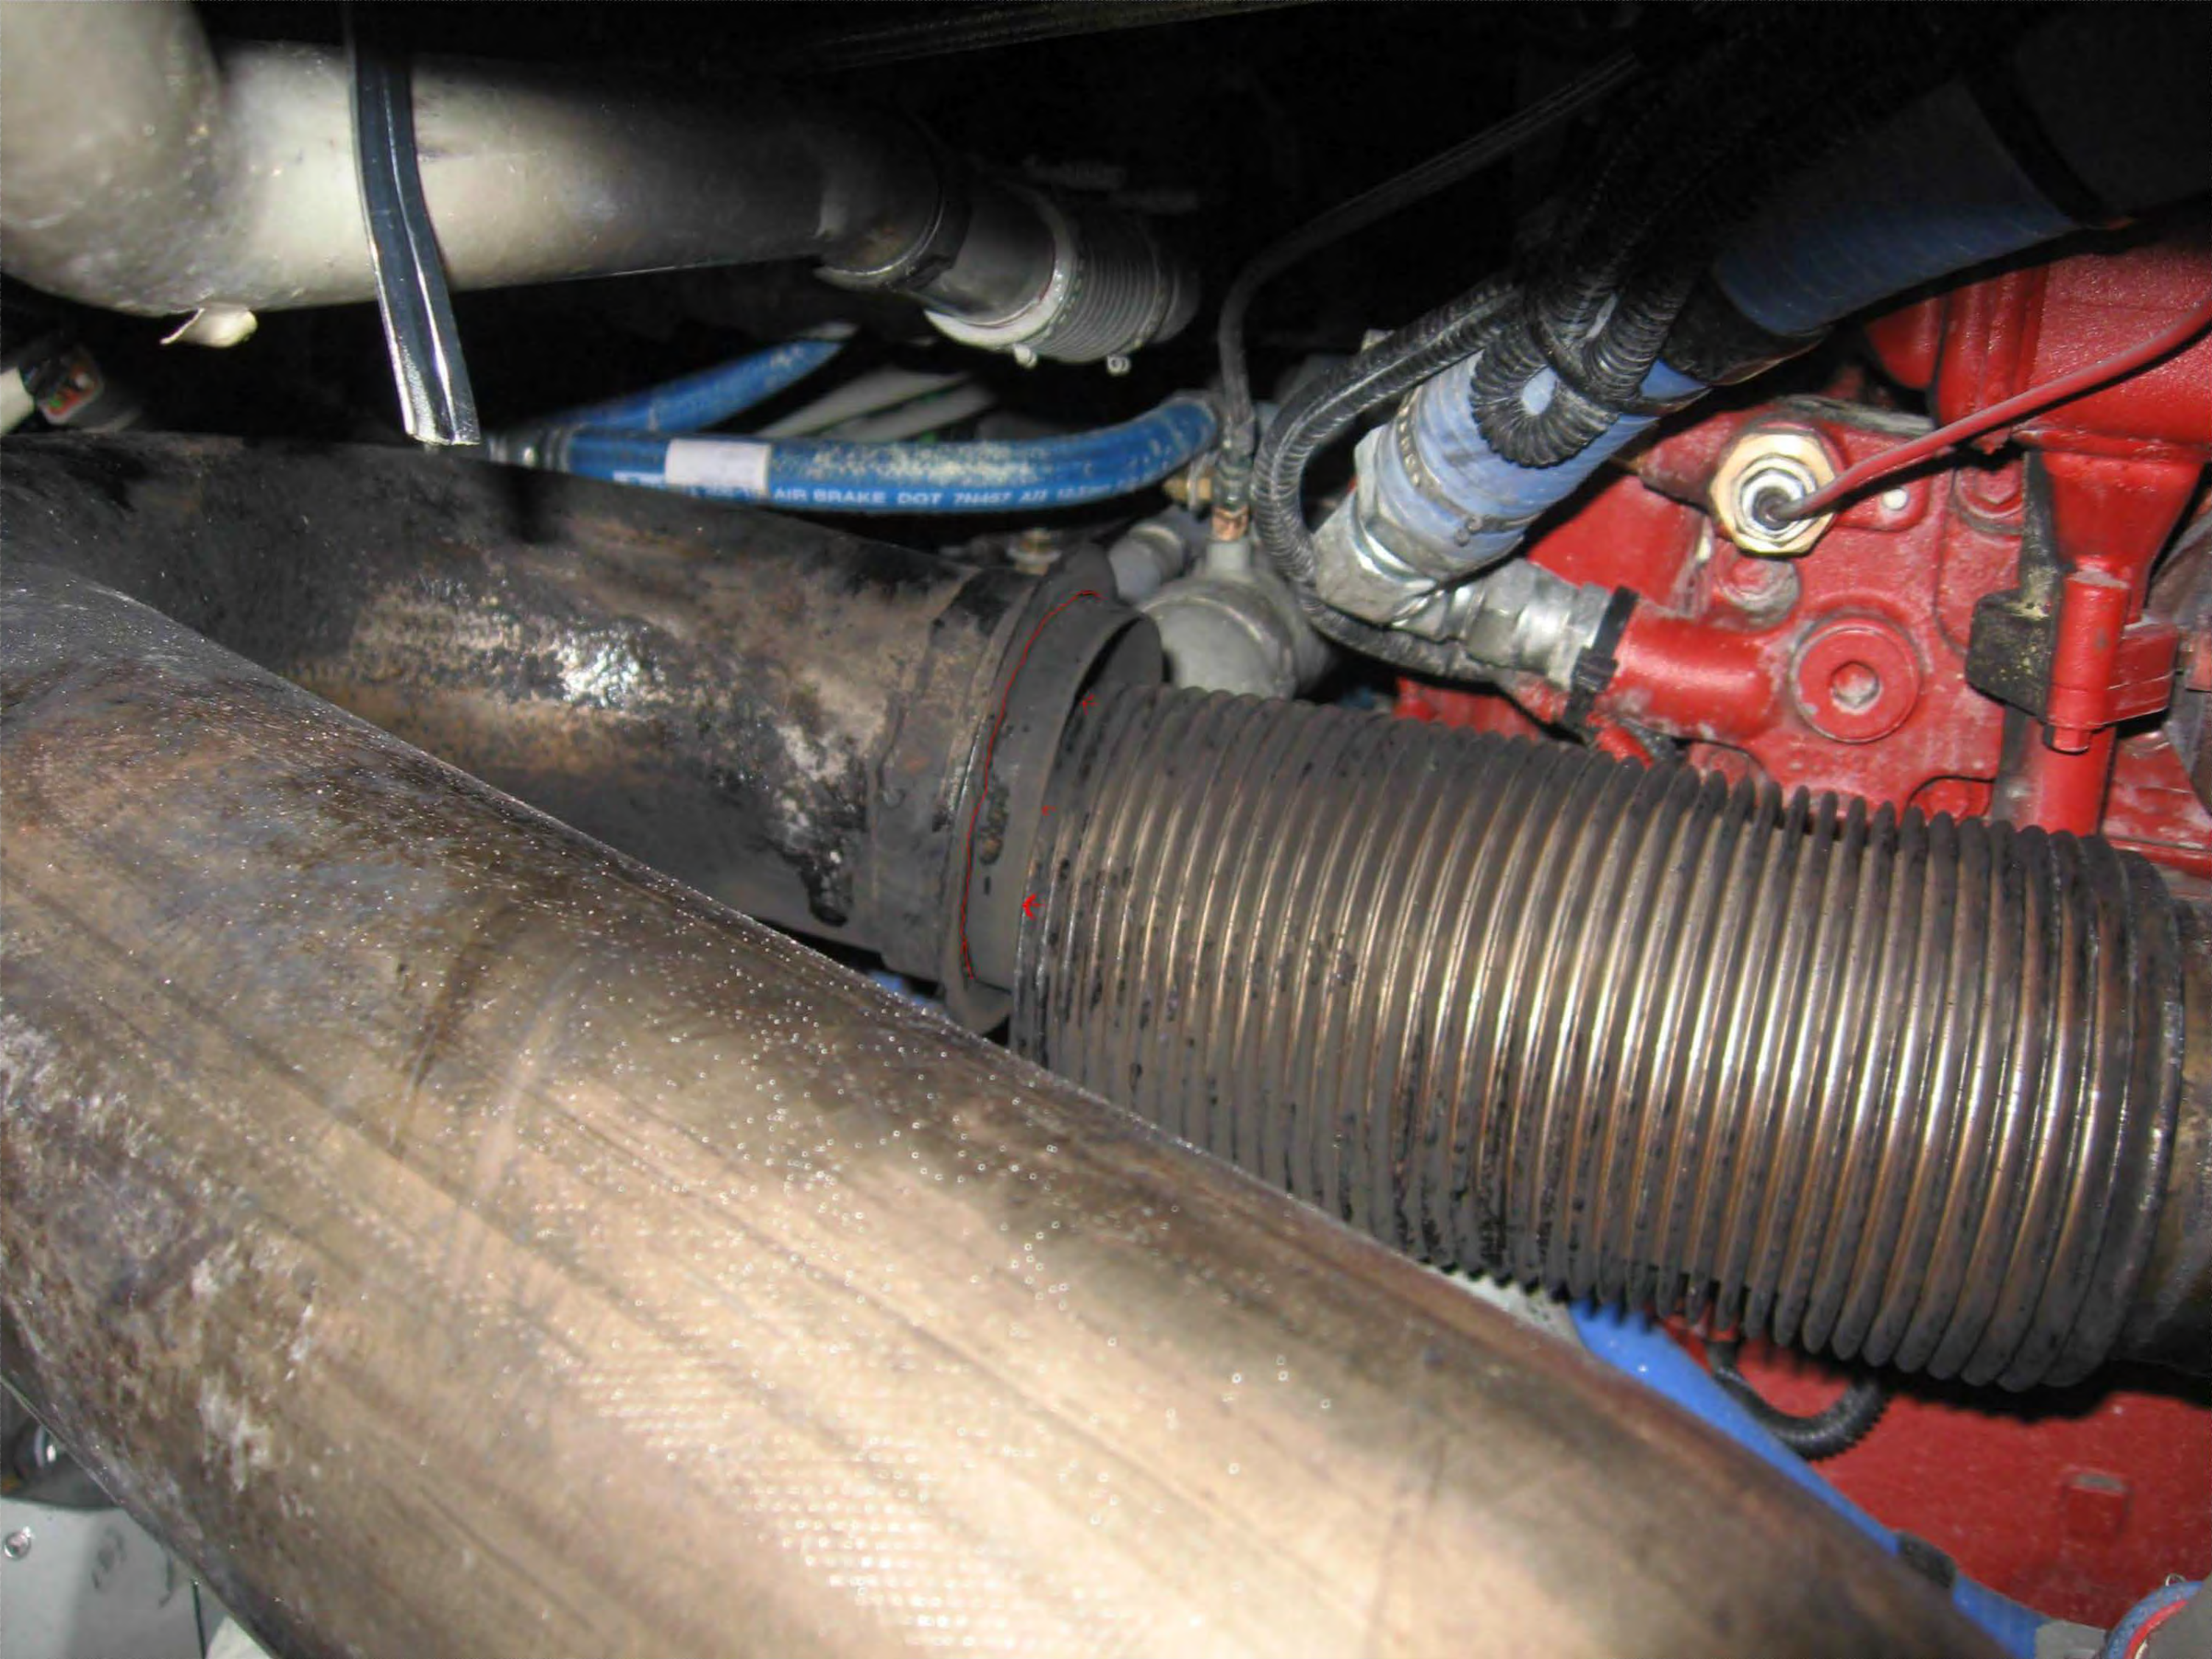
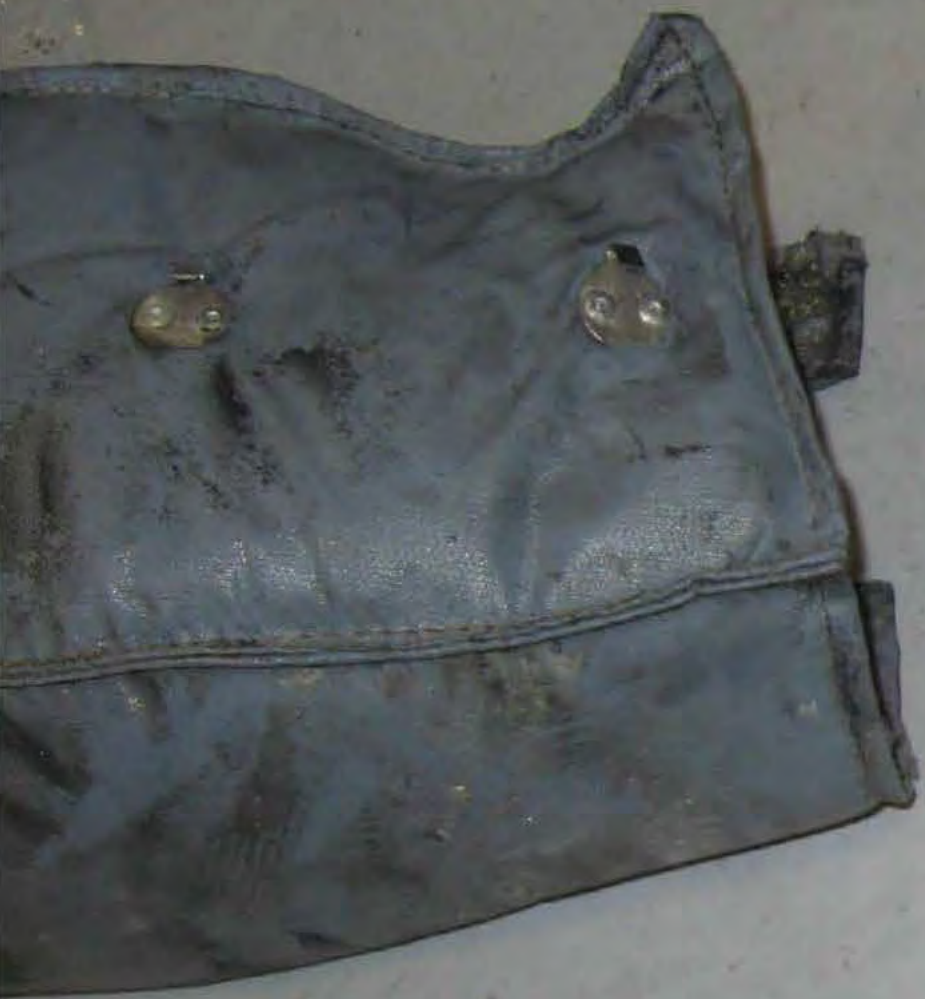
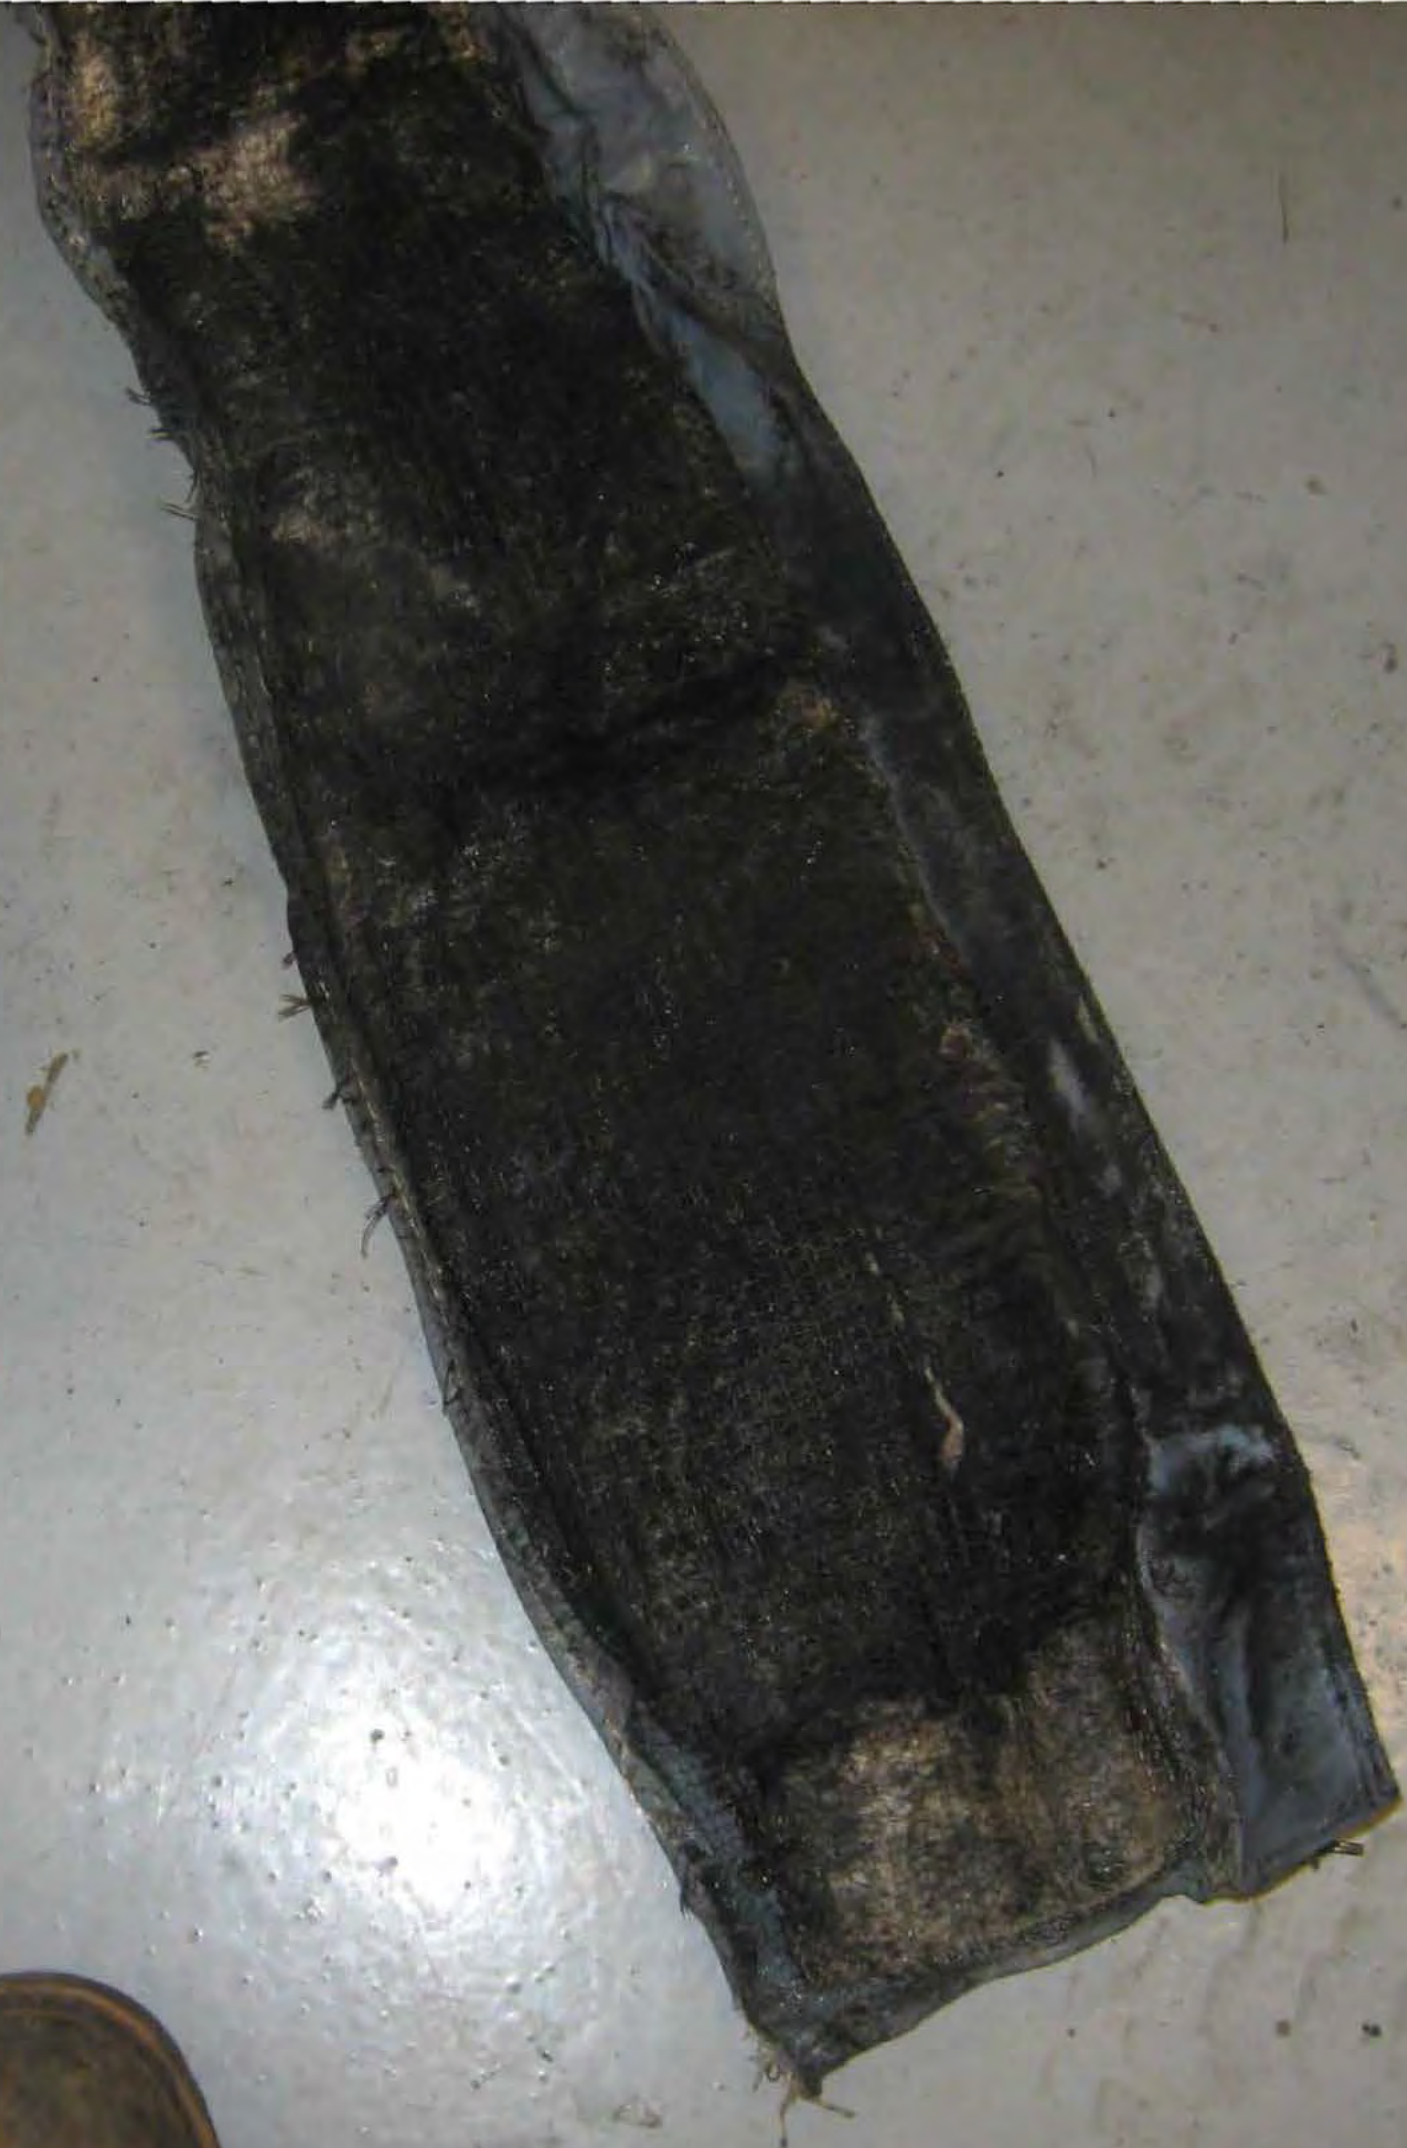
12737 exhaust pipe a.JPG 12737 exhaust b.JPG Southwest Metro Transit 12737.docx

This morning we had one of our 2012 MCI's (unit #237, VIN #12737, and 11,500 miles) parked in our garage after the completion of its morning route. After sitting for 1 – 2 minutes with the ignition power off, a fire developed in the LS rear engine compartment area, 12 inches behind the turbo. Luckily one of our technicians just happen to be working on another bus next to it and noticed a light coming from behind the rear side panel door. He grab a fire extinguisher when he realized it was flames, and extinguished it (total burn time was about 30 seconds). The insulation covering the turbo outlet pipe caught on fire. During our investigation it was determined that the fire was the result of a broken exhaust pipe (see attached photo's). I believe the exhaust leak, along with this engine having a dozer valve setup contributed to the problem.
