RQ17-007

MCI

12-27-2017

TITLE: Exhaust Bellows Failure Investigation

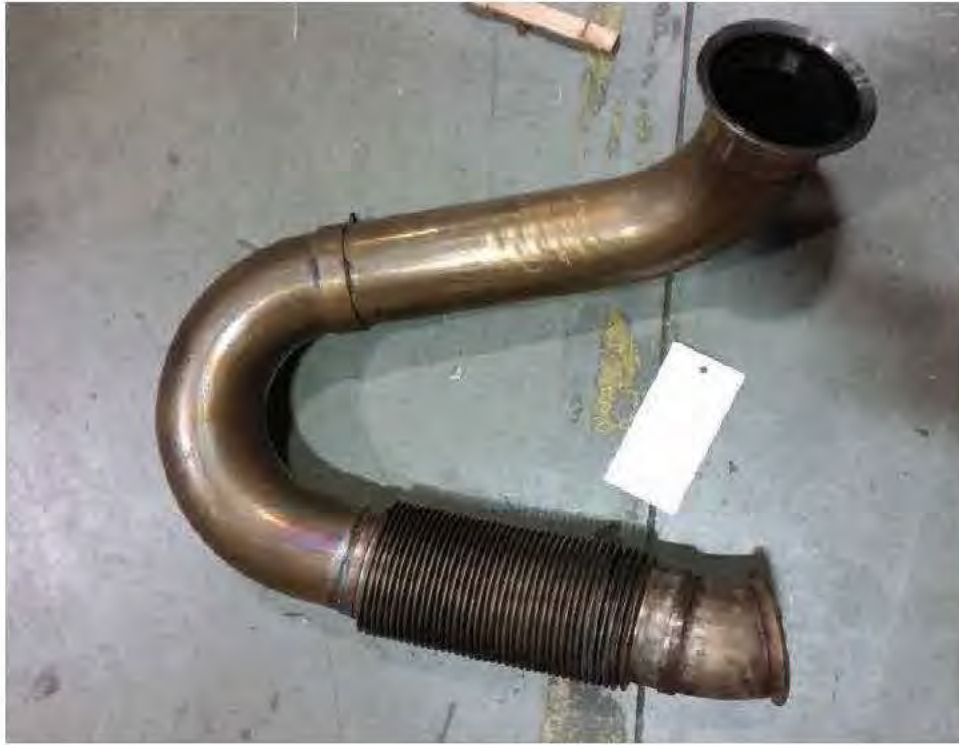
Figure 1 is an overall view of the submitted bellows. To assess the bellow material, chemical analysis, hardness and metallography were performed to assess the alloy, grade, and microstructure. Chemical analysis indicated both the inner and outer bellows sheet materials were out of specification for Type 321 SS, with the nickel and chromium low. Allowable product over check analysis variations specified in ASTM A480 are +/- 0.20 for chromium and +/- 0.15 for nickel. See Table 1 for the chemical analysis results. Hardness test results indicated the Type 321 SS exhibited Rockwell C (HRC) of 28.5 in the bends, while the straight sections were HRC 23, consistent with a $\frac{1}{4}$ to $\frac{1}{2}$ hard temper.

Figure 1 Overall view of the submitted bellows.

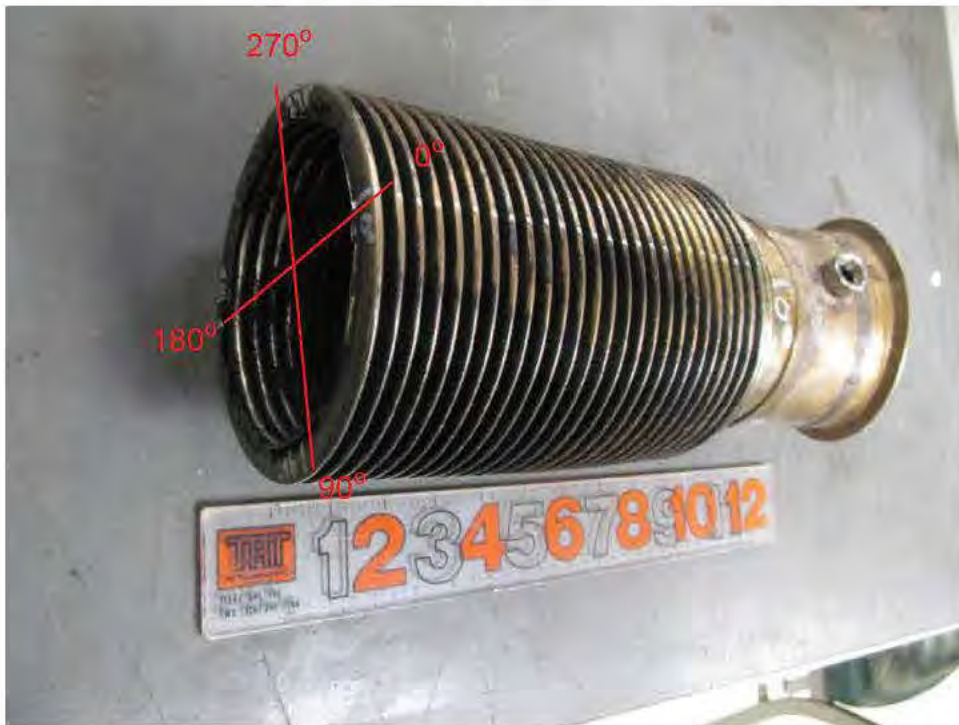
Figure 2 is a close up view showing the primary fracture surface, with orientations that shows the cracking was concentrated in the 270° quadrant relative to the oxygen sensor port. Figure 3 is another close up view showing multiple cracks located at the apex of the inside corrugation bend of the 270° orientation.

Figure 2 Close up view showing the primary fracture surface with orientations that shows all cracking was concentrated in the 270° quadrant.

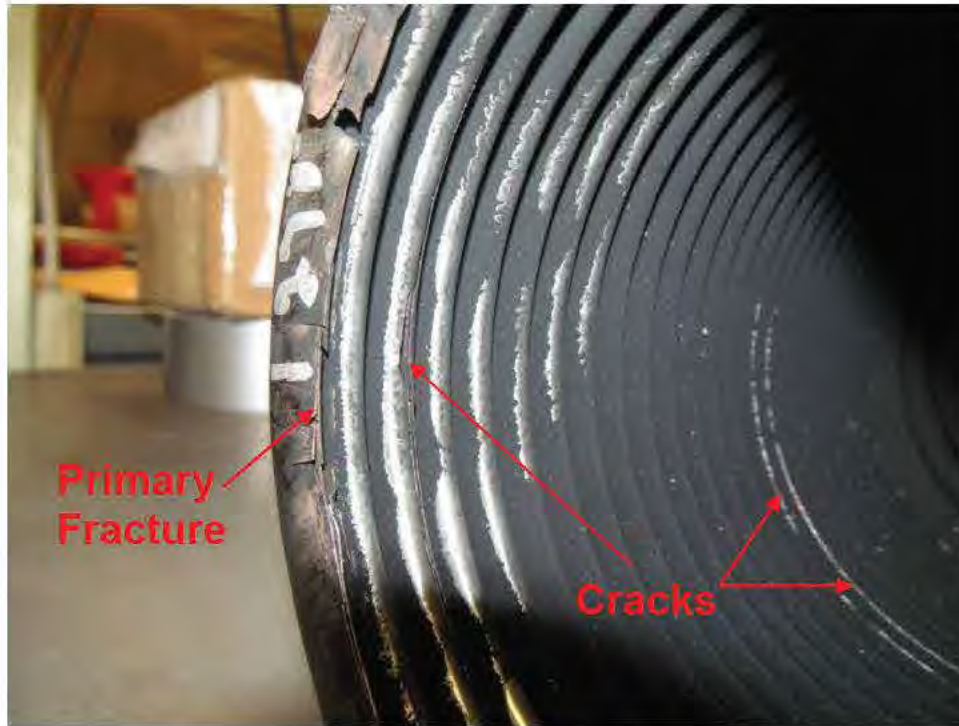
Figure 3 Close up view showing multiple cracks located at the inside corrugation bend at the 270° orientation.

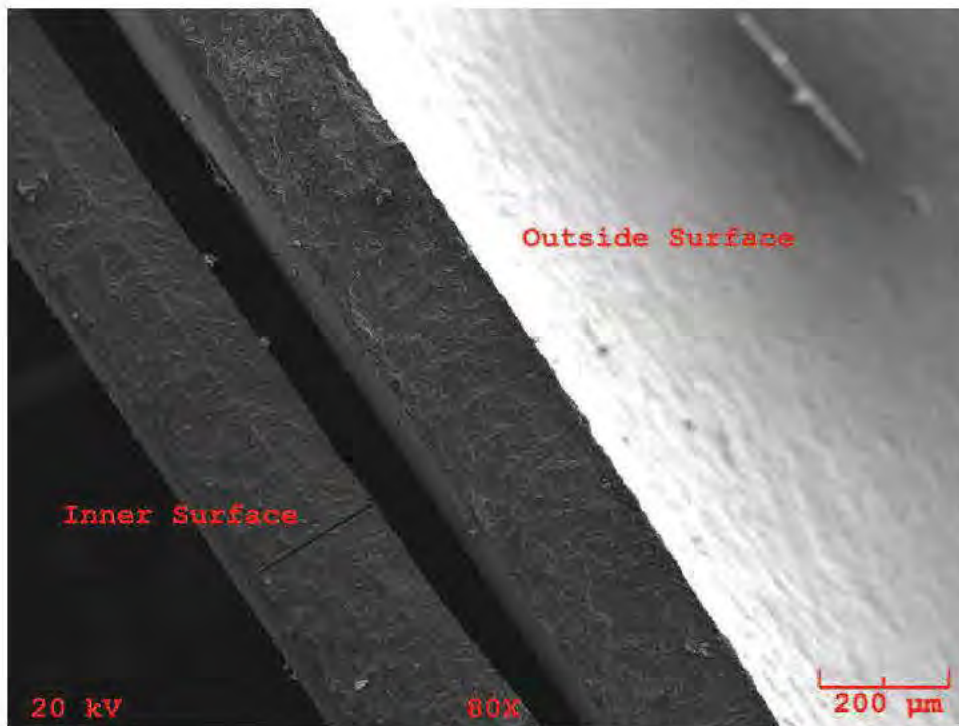
Fracture examinations were performed using a scanning electron microscope (SEM). Figure 4 is a low

Figure 4 Low magnification SEM image showing fracture surfaces in the double wall bellows.

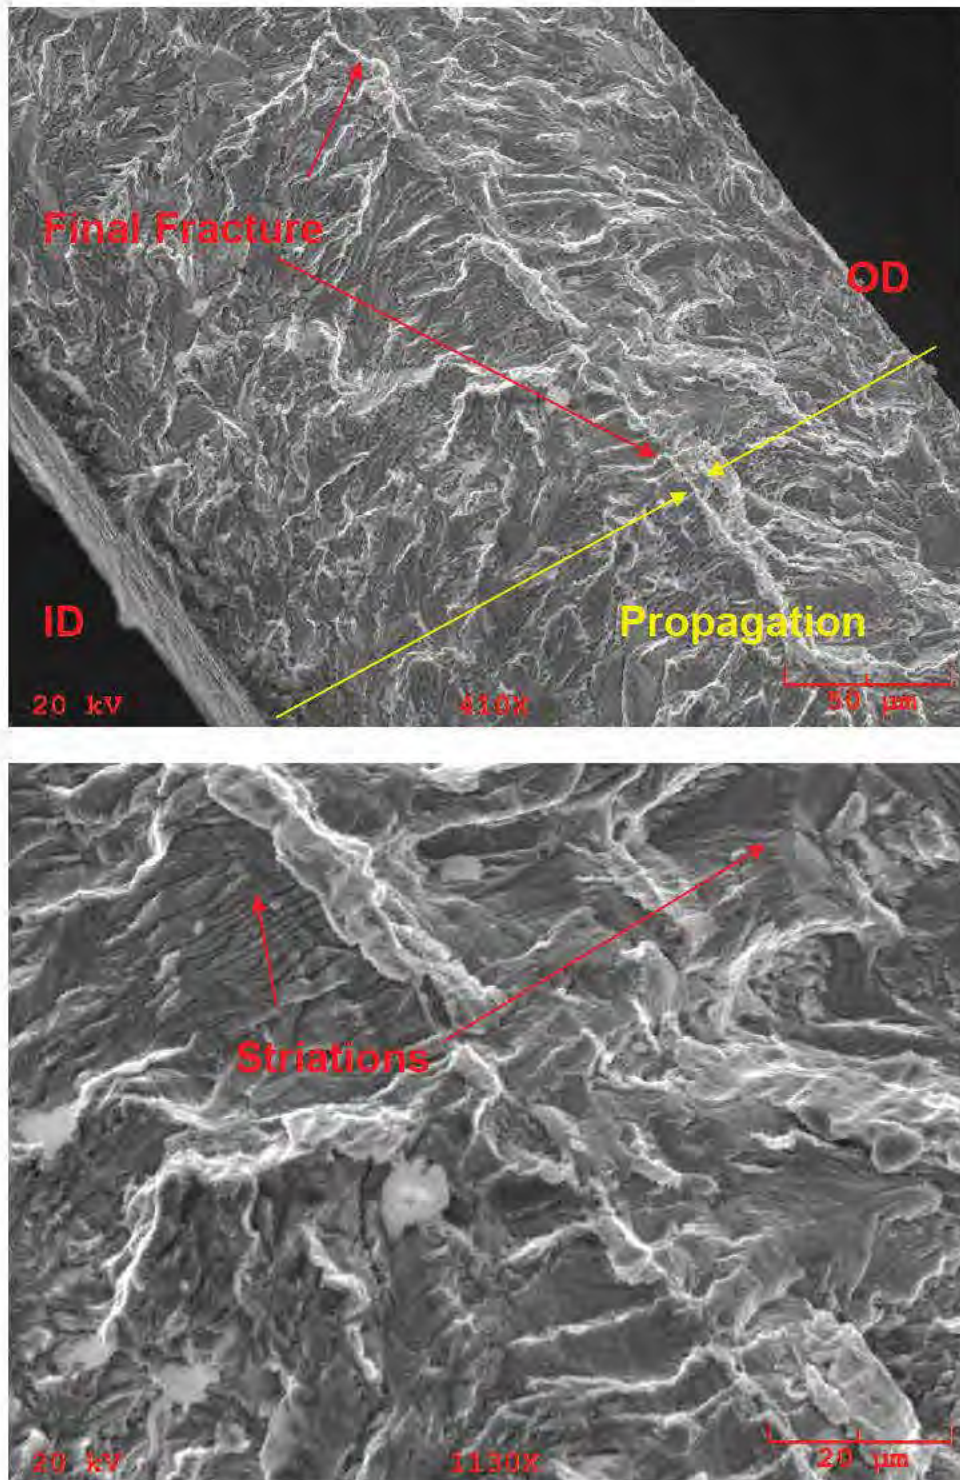
magnification SEM image showing the fracture surfaces in the double wall bellows. Figure 5 shows intermediate and high magnification SEM images of the inner sheet fracture surface indicating cracks initiated simultaneously at both the inner and outer surfaces and confirms propagation by high cycle fatigue. Striation step size was measured at 0.4 microns, indicating failure occurred at approximately 500 cycles. Figure 6 shows intermediate and high magnification SEM images of the outer sheet fracture surface where fatigue cracks again were seen to have initiated at both the inner and outer sheet surfaces, and confirms propagation by high cycle fatigue. Striation step size was 0.4 microns, the same as the inner sheet.

Figure 5 Intermediate and high magnification SEM images of the inner sheet fracture surface showing cracks initiated at both the inner and outer surfaces and confirms propagation by high cycle fatigue. Striation step size was 0.4 microns.

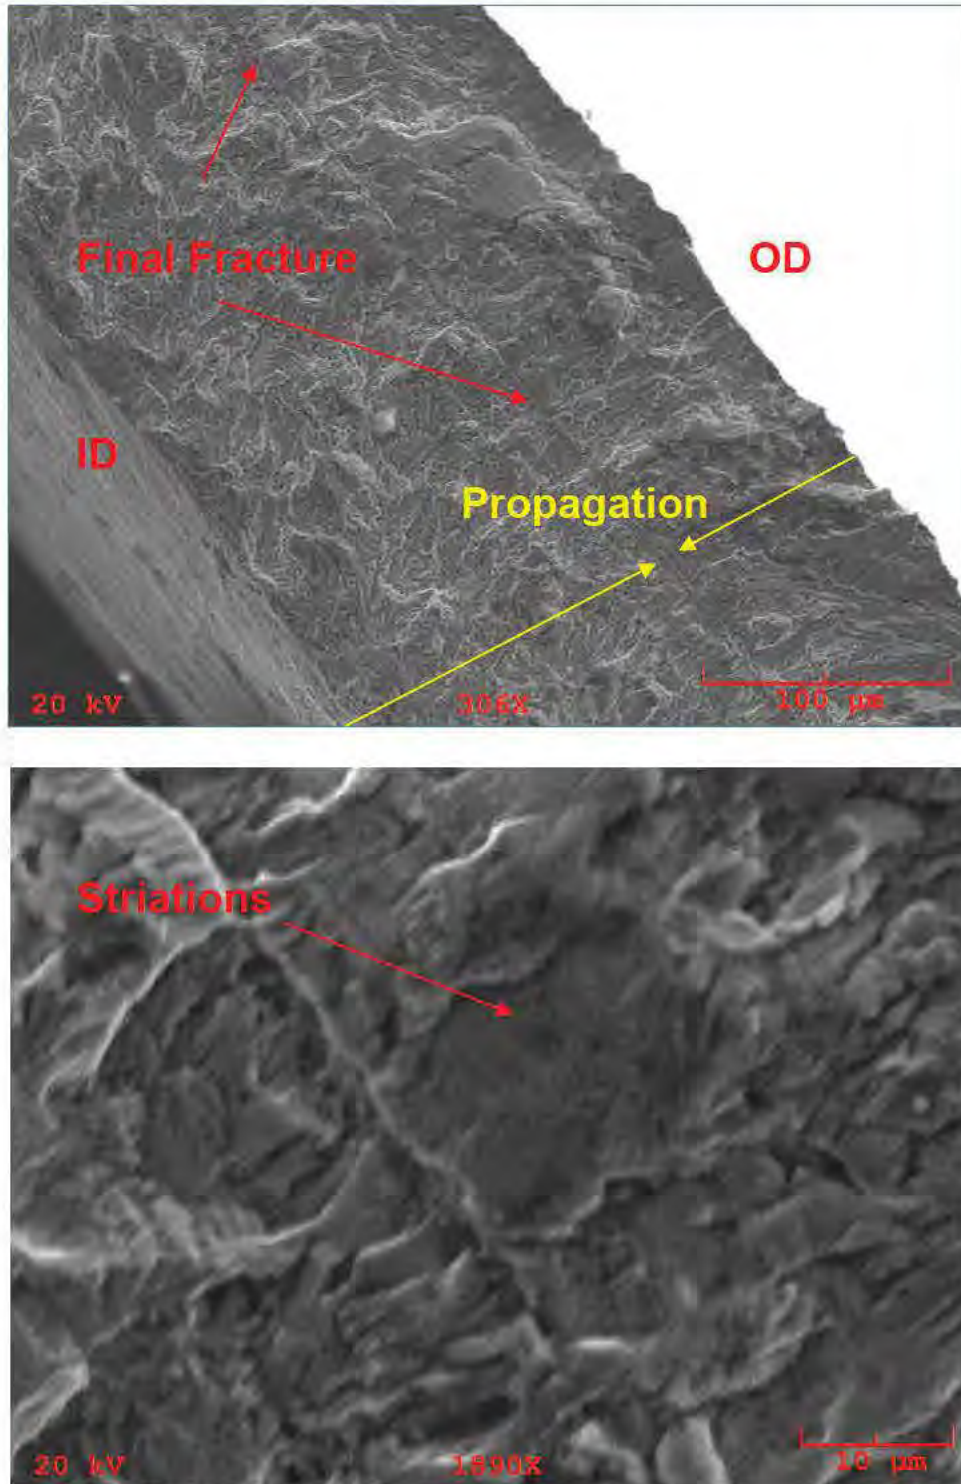
Figure 6 Intermediate and high magnification SEM images of the outer sheet fracture surface showing cracks initiated at both the inner and outer surfaces and confirms propagation by high cycle fatigue. Striation step size was 0.4 microns.

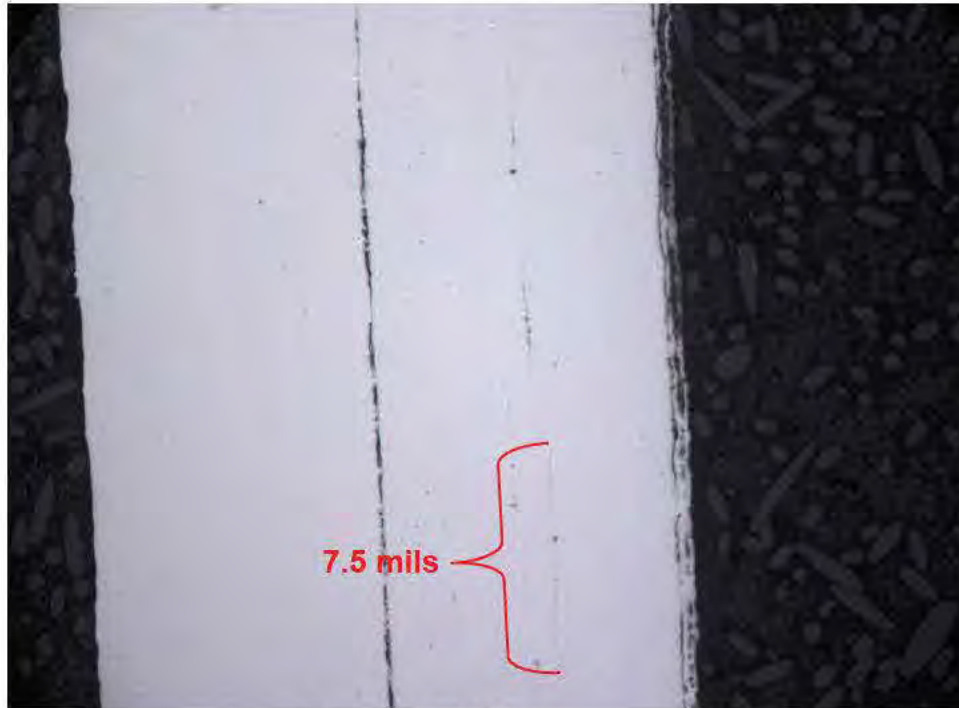
Figure 7 shows cross section micrographs that identify numerous inclusion stringers up to 7.5 mils in length in both Type 321 SS sheets. These stringers were present throughout the sheet thickness. Figure 8 shows Ti(CN) inclusion stringers near the corrugation bend surface that opened up during forming. These stringers produced notches that concentrated service stresses, initiating the fatigue cracking that lead to failure.

Figure 7 Micrographs showing numerous inclusion stringers up to 7.5 mils in length.

- Modify ordering data to include microstructural requirement to limit inclusion stringers to 2 mils or less, and perform chemistry over check to verify composition.

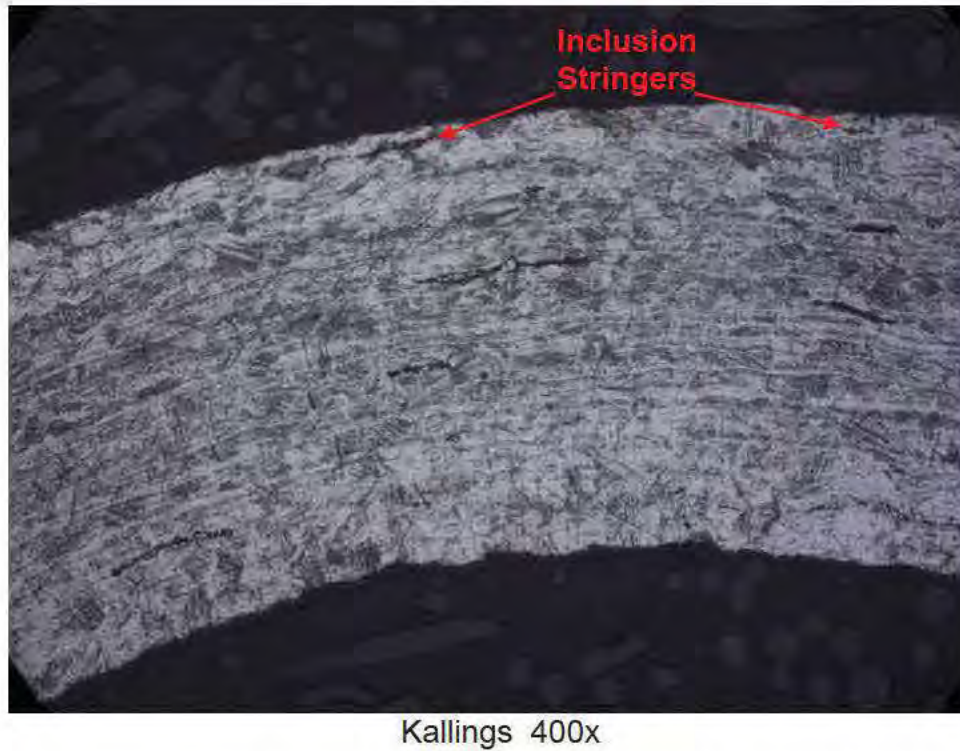
These Ti(CN) stringers are not coherent with the matrix, and are effectively a void from a structural perspective. As sheet materials become thinner, internal defects exert greater influence due to both plane strain conditions and reduced material load bearing cross section. These coarse Ti(CN) inclusions typically form during the casting process, but can be remedied by cropping the top section of the ingot prior to rolling. Also, these carbide stringers can easily be identified by simple metallurgical examinations. Critical flaw sizes for high cycle, low amplitude, reversed bending fatigue due to vibration has been established at 4.5 mils in similar components, and a metallurgical examination prior to material purchase is warranted to ensure stringers are below 2 mils.

Figure 8 Inclusion stringers near corrugation bend surface that are likely fatigue initiation sites.

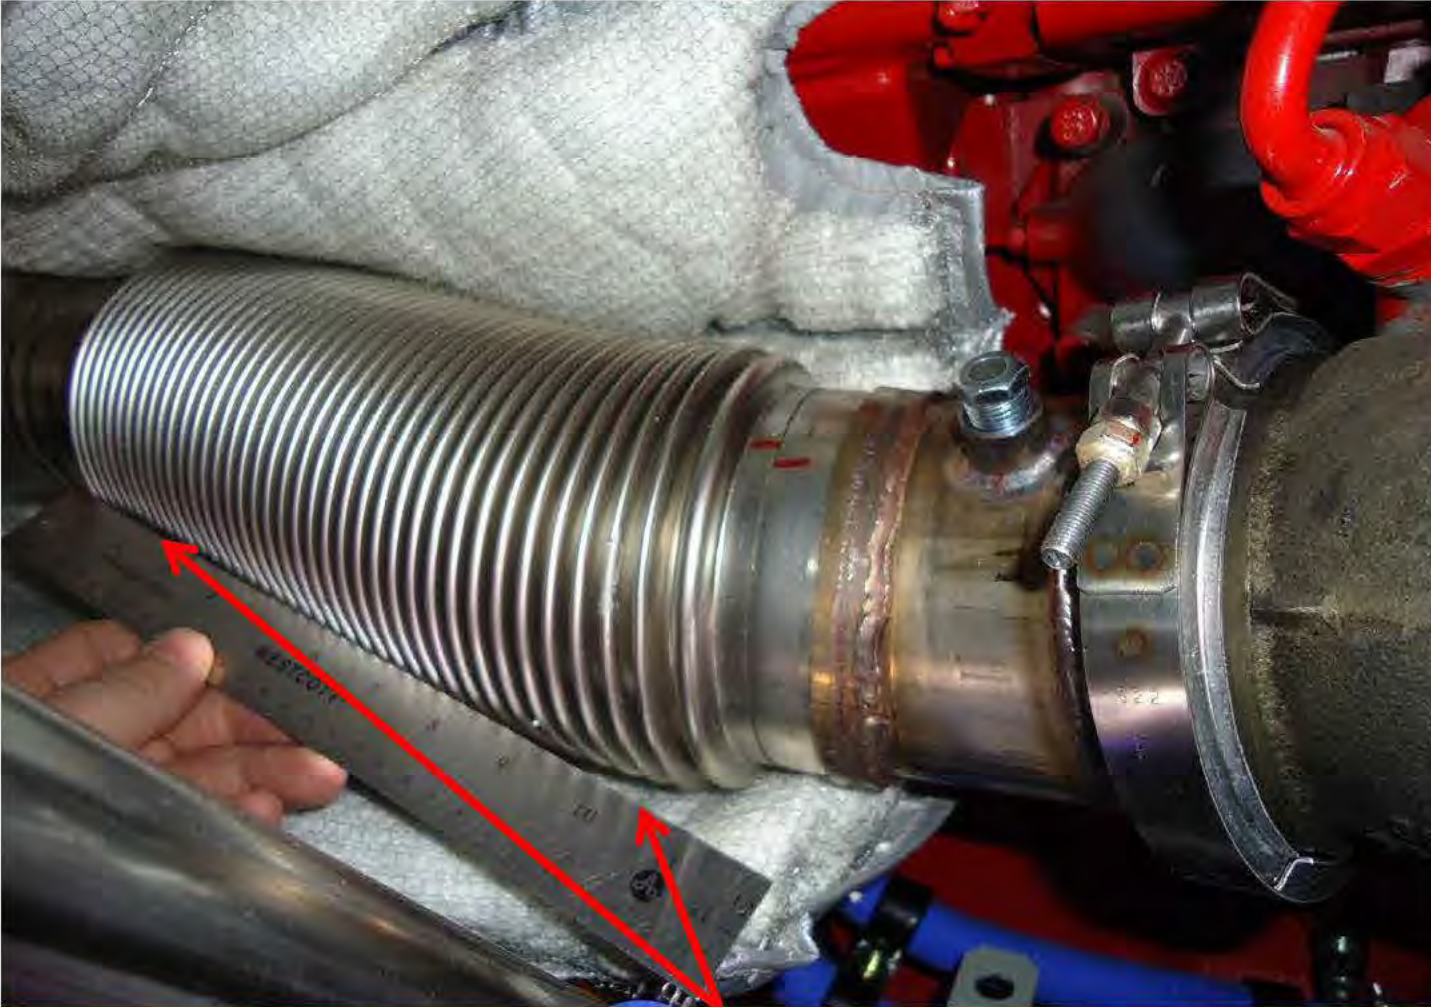
Torsional bellows is flexed in two areas after install to engine and DPF.

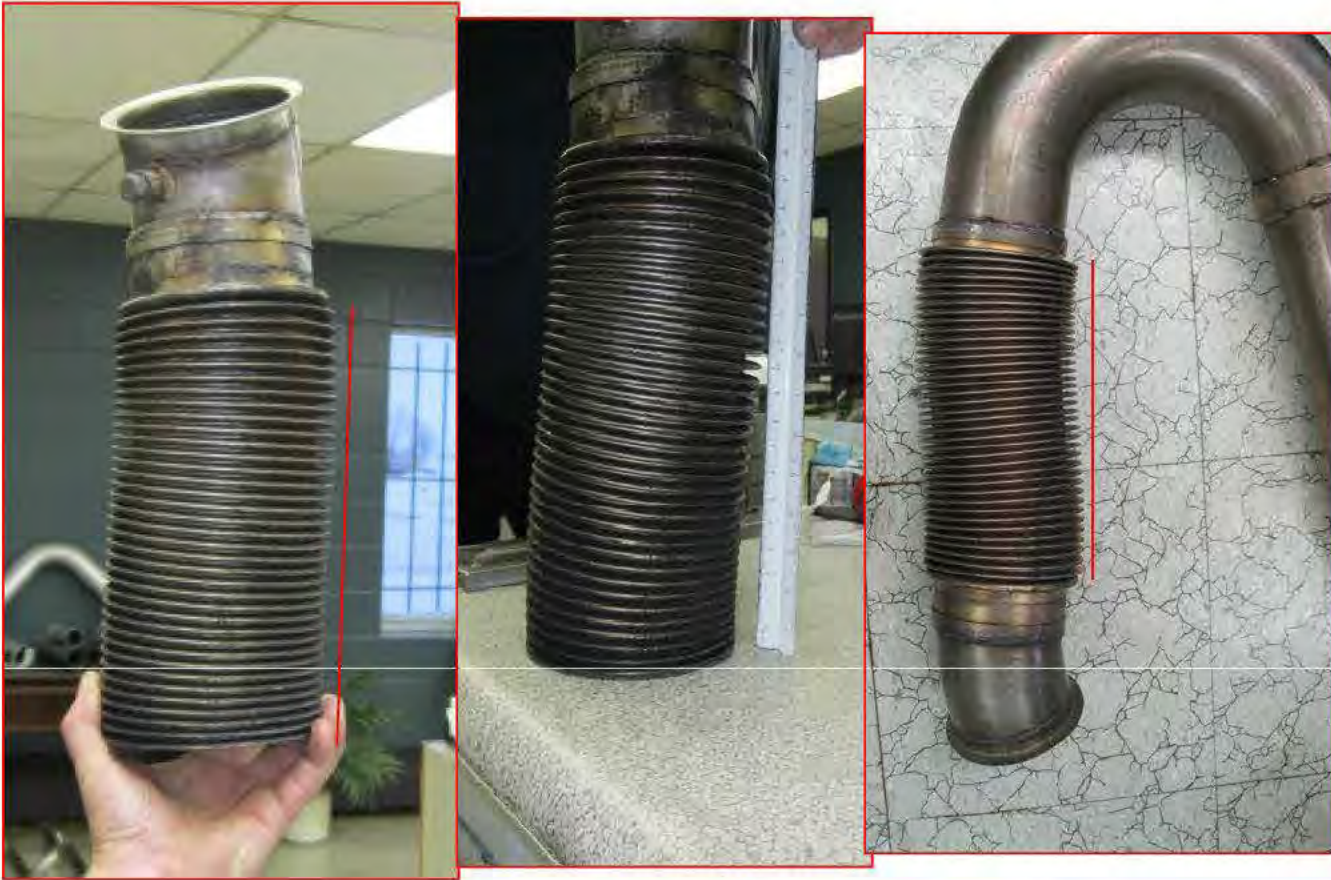
Plastically Deformed bellow

THIS PART APPEARS TO BE EXPERIENCEING EXCESSIVE MOVEMENT, POSSIBLY CAUSED BY A ROTATION OF INLET FLANGE. IT IS UNCLEAR IF ROTATION HAS OCCURRED DURING INSTALLATION OR DURING OPERATION.

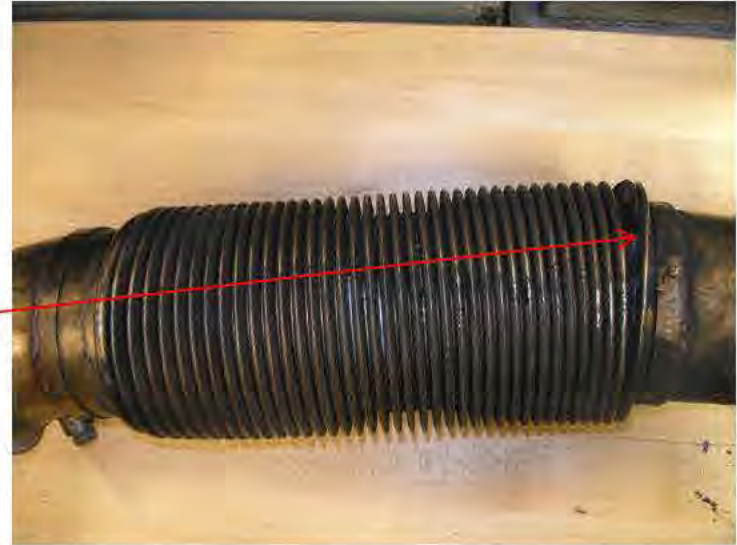
Part #1 – showed signs of a large installation misalignment. Appears to have been on the order of 1" to 1.5". This bellows failed at the outlet end of the bellows and had completely separated.

The misalignment on Part#1 indicates that more bending was occurring from the misalignment at the outlet end. It also appears from the amount of soot on this part that it is possible that it ran for a period of time before it was detected.

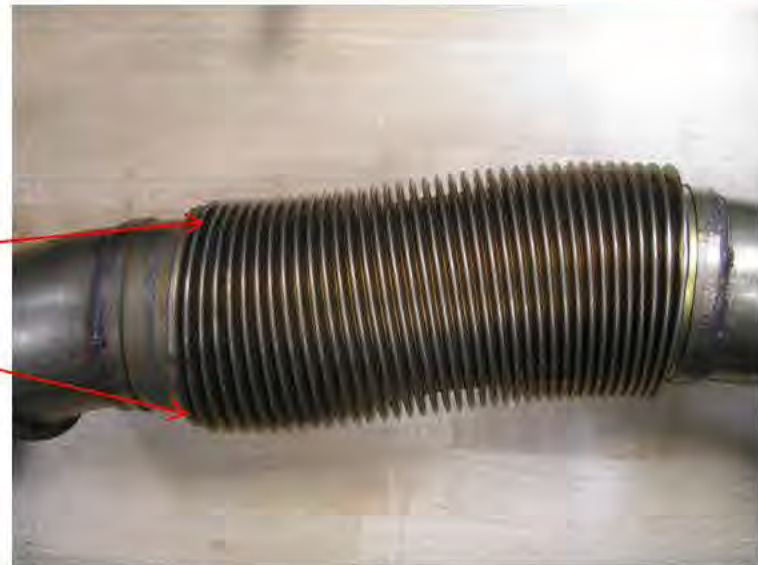
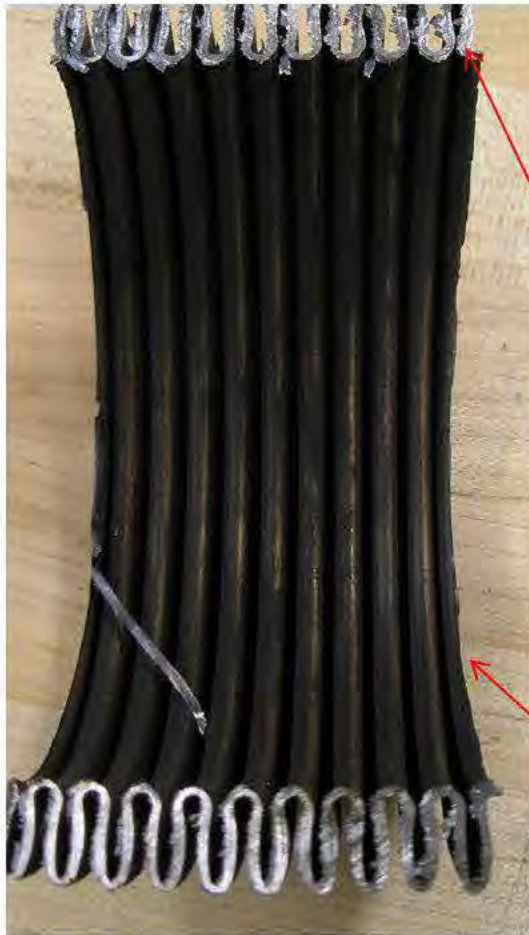
Part #1

Note amount of deformation in second corrugation.

Section from inside of bend at outlet end. Crack propagated around entire circumference.

Wear area on bellows is most likely from post-failure contact with the exhaust tube.

Section from outside of bend at outlet end. Crack propagated around entire circumference.

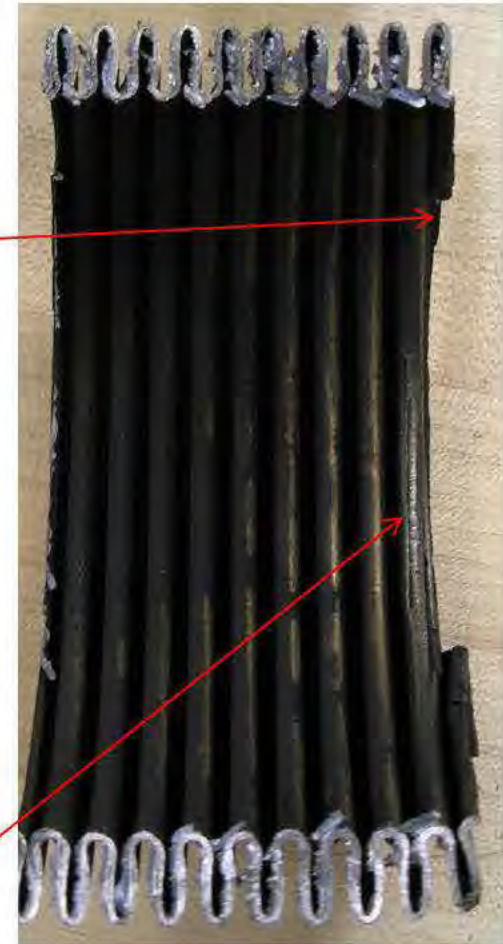
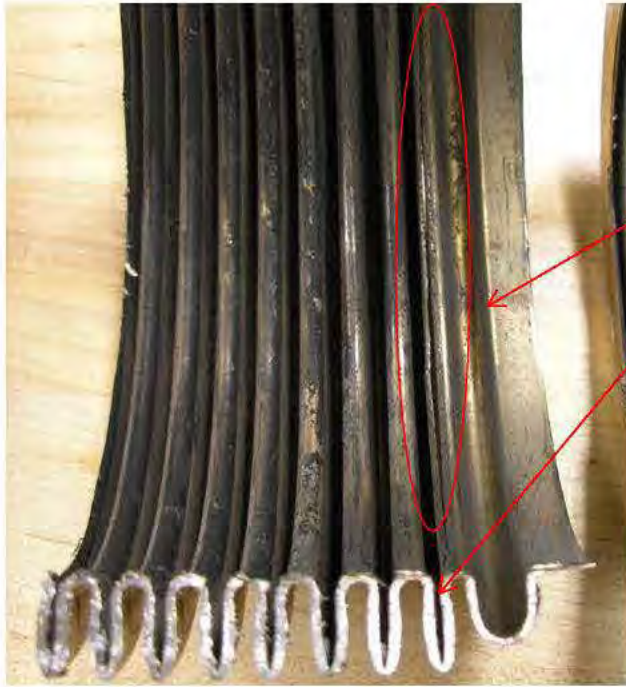
Part #2

Cracking on
inside of bend at
inlet.
Note amount of
compression in
second
corrugation.

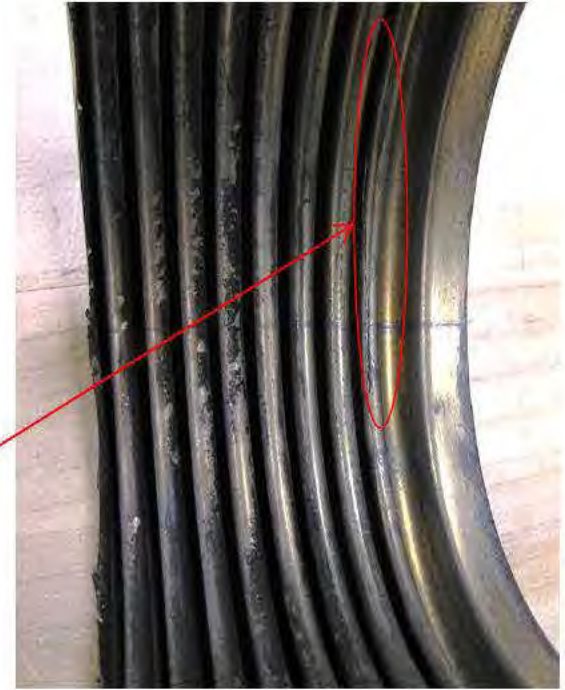
Cracking on
outside of bend.

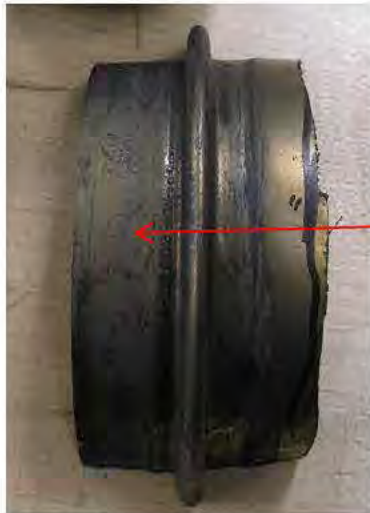
There were no indications of contact
or wear between the torsional sleeve
And the bellows. This is further
indication that the failure was purely
fatigue from misalignment and
motion.

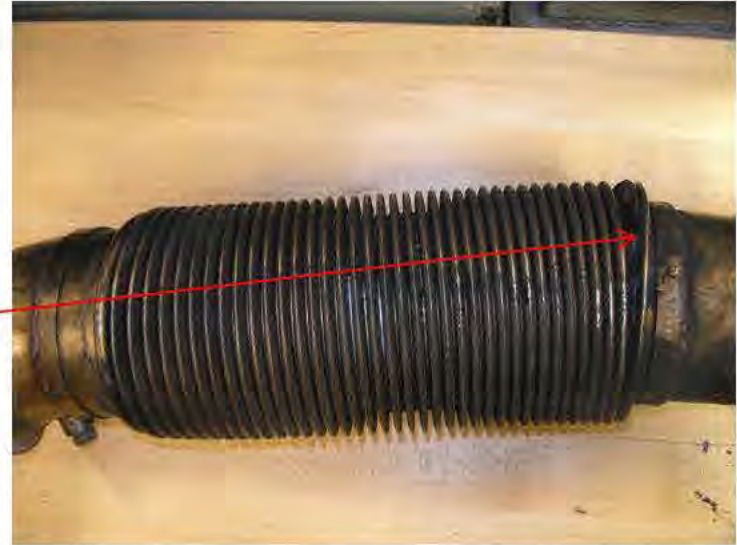
Part #1 – showed signs of a large installation misalignment. Appears to have been on the order of 1" to 1.5". This bellows failed at the outlet end of the bellows and had completely separated.

The misalignment on Part#1 indicates that more bending was occurring from the misalignment at the outlet end. It also appears from the amount of soot on this part that it is possible that it ran for a period of time before it was detected.

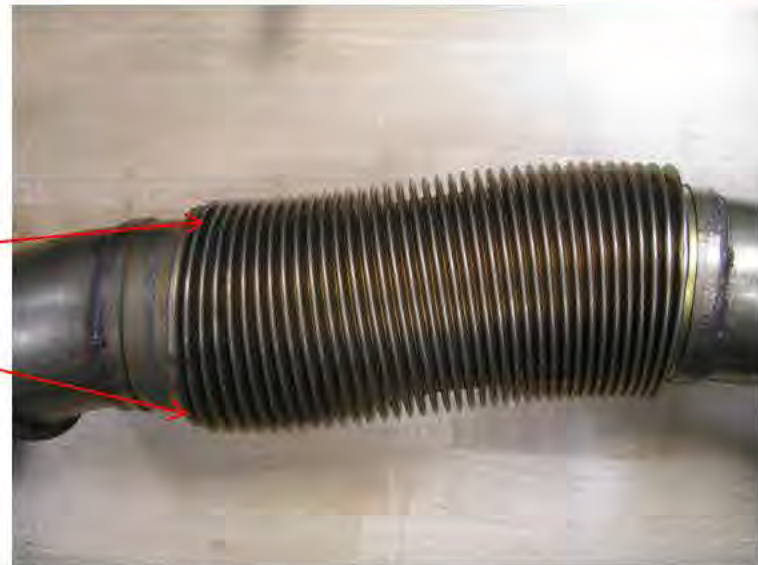
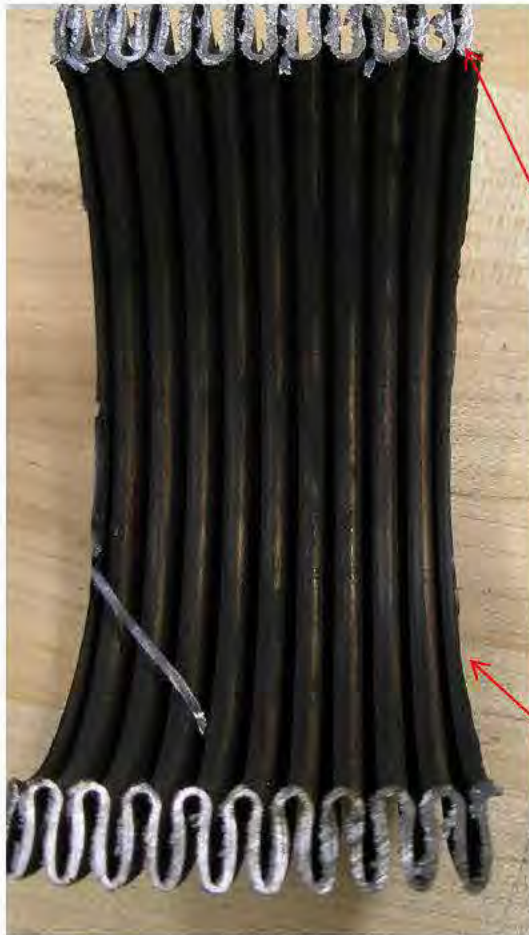
Part #1

Note amount of deformation in second corrugation.

Section from inside of bend at outlet end. Crack propagated around entire circumference.

Wear area on bellows is most likely from post-failure contact with the exhaust tube.

Section from outside of bend at outlet end. Crack propagated around entire circumference.

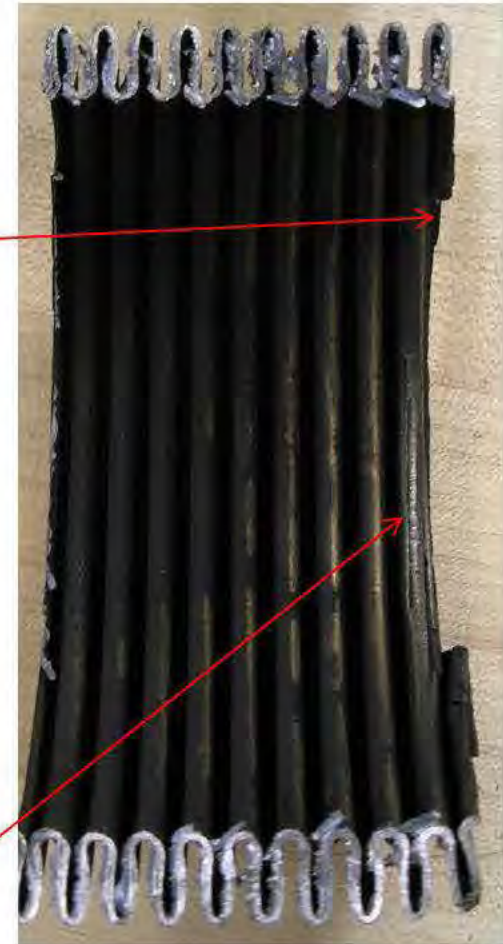
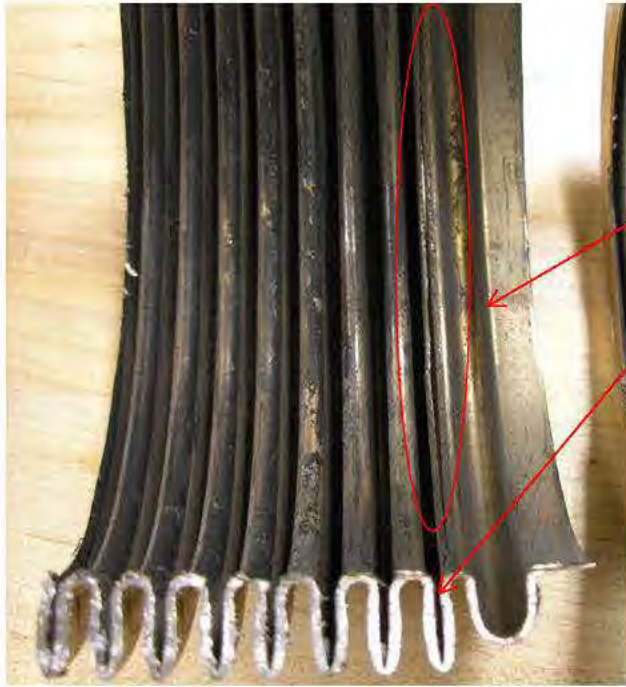
Part #2

Cracking on
inside of bend at
inlet.
Note amount of
compression in
second
corrugation.

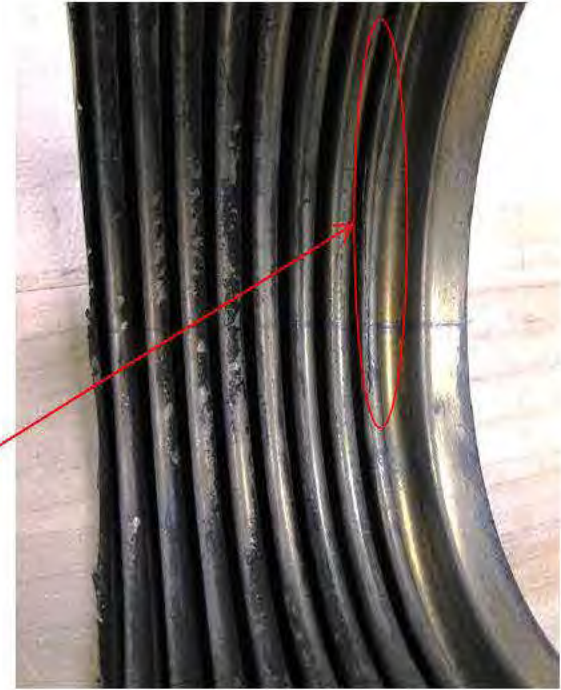
Cracking on
outside of bend.

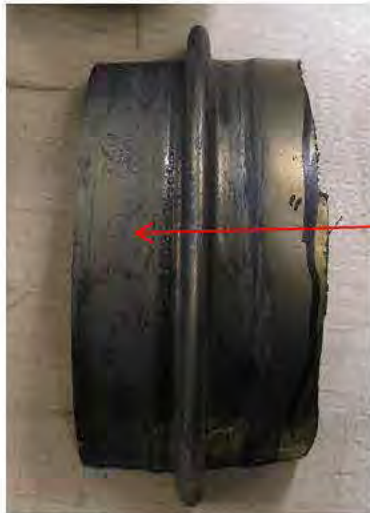
There were no indications of contact
or wear between the torsional sleeve
And the bellows. This is further
indication that the failure was purely
fatigue from misalignment and
motion.
