GENERAL MOTORS LLC  
Global Vehicle Safety

NEF-101  
RQ17-002

**Re: General Motors LLC's Responses to Information Requests 8 and 13 of NHTSA  
RQ17-002**

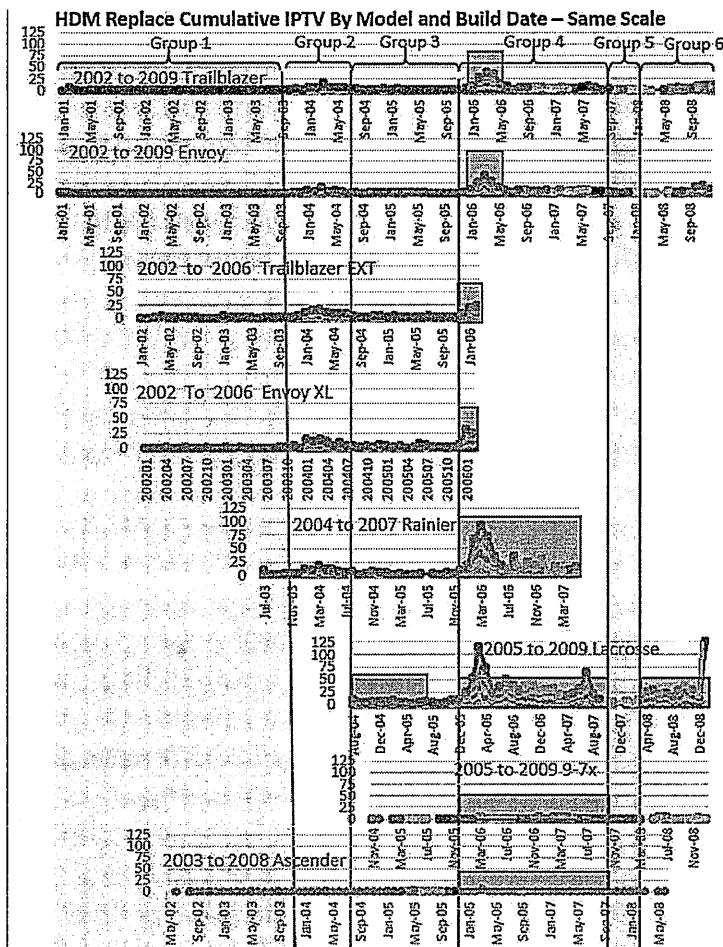
TABLE 13-1: WARRANTY RATES OF THE SUBJECT COMPONENT IN THE SUBJECT VEHICLES

The HDM in the subject vehicles is located inside the vehicle's underhood bussed electrical center, or UBEC. This HDM was designed to operate at an ambient temperature of 105 degrees Celsius (221 degrees Fahrenheit) without overheating. The temperature inside the UBEC can be affected by different vehicle design and operational factors, including, among other things, the electrical load in the HDM, the type of headlamp bulbs in the vehicle, and the heat generated by other UBEC components. These factors can, depending on the vehicle, cause the thermal environment inside the UBEC to exceed 105 degrees Celsius. Over time, higher-than-expected operating temperatures in the UBEC can damage the FET and solder joints inside the HDM, which can cause the HDM to fail.

GM's warranty data demonstrates that HDM failures relating to this condition are heavily concentrated in certain of the subject vehicles and in certain vehicle build windows (pink boxes approximate build windows included in the subject recall):

On November 18, 2014, GM’s SFADA reviewed vehicle test results, warranty data, TREAD data, VOQs, and other data, and decided to conduct a safety-related recall on certain subject vehicles. As shown in Table 13-1 above, SFADA defined the scope of the subject recall based on the frequency of HDM failures in certain vehicle populations. As GM has received additional field data, GM has acted to expand the subject recall and extend special-warranty coverage to certain other potentially affected subject-vehicle populations. In August 2015, GM expanded the original recall by 159,584 vehicles. In March 2017, GM extended a 12 year/150,000 mile special warranty coverage to additional 777,640 vehicles.<sup>1</sup>

As shown in the warranty chart in Table 13-1 above, warranty data enabled GM to exclude non-GM aftermarket components from its field-data analysis, and to identify and recall specific build periods in which the subject component, and only the subject component, was experiencing higher-than-expected failure rates in the field.<sup>2</sup> At present, GM believes that the warranty data supports the conclusion that the subject recall has adequately captured this population:
