## ODI RESUME

| <b>Investigation:</b> | PE 18-001 | <b>Date Closed:</b> | 07/03/2018 |
| <b>Subject:</b> | Seat Belt Webbing Failure | | |

| <b>Products:</b> | 2018 Volkswagen Tiguan |

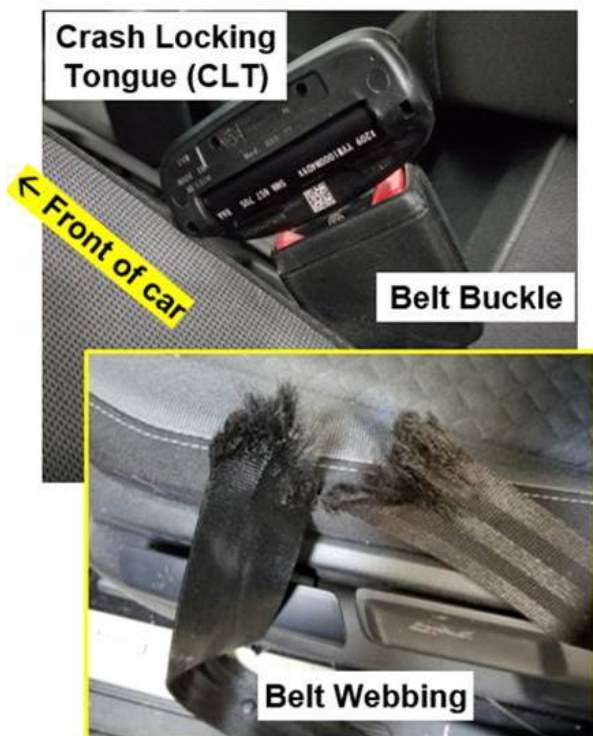
TRC

During both crash tests, the driver seat belt webbing completely separated in tension where it looped through the seat belt latch tongue (see attached photos). Based on its analysis of the NCAP test results, VW asserted that the test dummy umbilical cord exerted additional forces on the seat belt system causing the separation. To support this theory, VW conducted several sled tests.

The Office of Defects Investigation (ODI) opened a Preliminary Evaluation (PE18-001) on 01/10/2018 to evaluate the two (2) incidents of seat belt separation. ODI and NCAP reviewed the sled test data submitted by VW in support of their theory. Micro analysis, conducted by the Materials Laboratory at the National Transportation Safety Board (NTSB), verified the seat belts failed in tension and not due to cuts or abrasion.

PE18-001 has been upgraded to an Engineering Analysis (EA18-005) to further examine seat belt behavior in the subject vehicles and to determine, among other things, a root cause for the seat belt separation. ODI will perform a thorough review of any vehicle and seat belt design changes for the new 2018 MY Tiguan platform and their effects on the performance of the seat belt system.
