## **ENGINEERING ANALYSIS CLOSING SUMMARY**

### **SUBJECT VEHICLES: 2008-2013 Toyota Highlander**

**EA No.: 18-006**

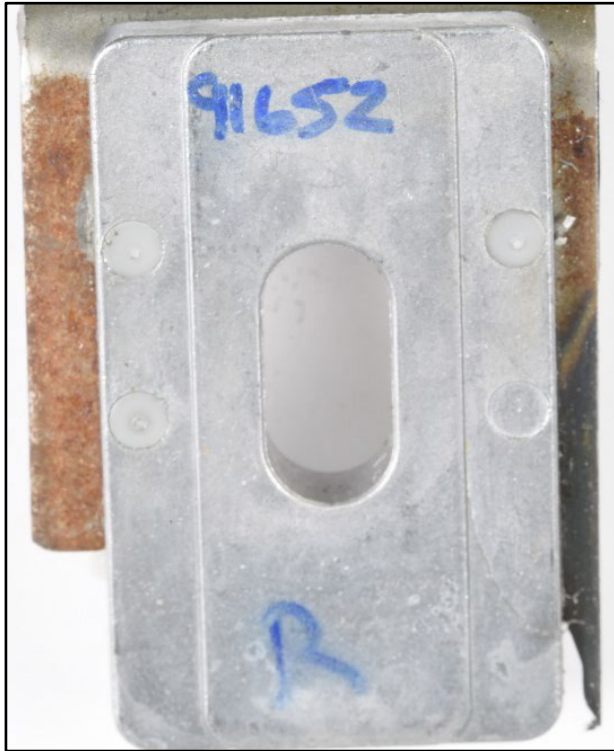
**Figure 3. Right Shear Capsule**

VRTC obtained a field shear capsule from an automotive used parts facility and sectioned it to verify the condition of the injection molded pins (Figure 3). Both the right and left shear capsules were sectioned,

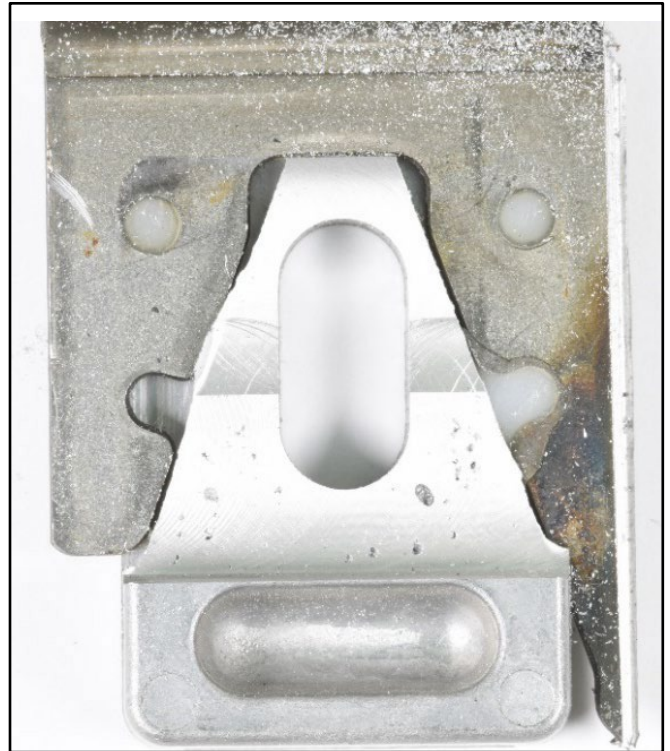
**Figure 4. Sectioned Right Shear Capsule**

with the right capsule shown below in Figure 4. A visual inspection with a microscope found no voids, foreign material, discoloration, or other anomalies with the retaining pin material.

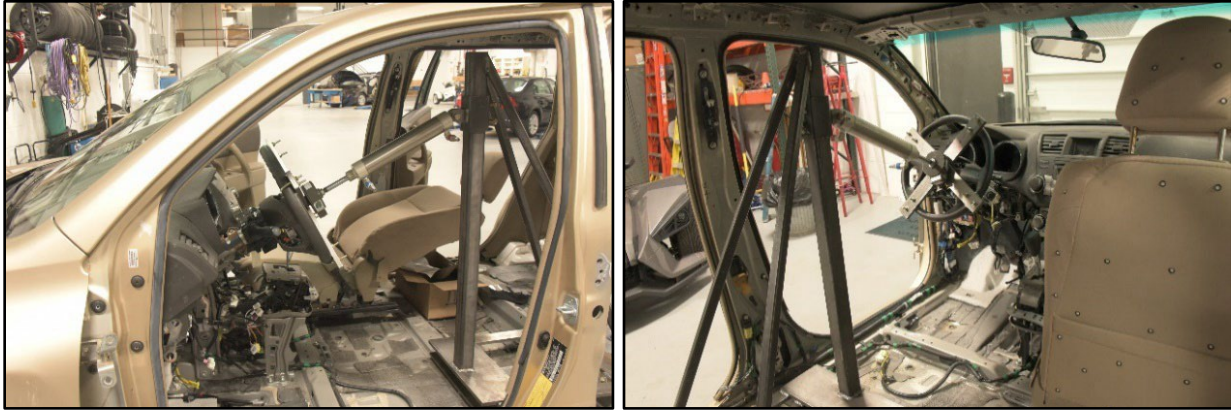
**Figure 5. Vehicle Test Fixture**

VRTC conducted testing to gather data on the force needed to cause the shear capsule to break. A 2010 Toyota Highlander, previously used in NHTSA testing, was built into a test buck/fixture (Figure 5). The driver's seat was removed and replaced with a reinforced bracket. A pneumatic cylinder and load cell were attached between the bracket and steering wheel. The telescoping upper column was set to mid position and locked, the cylinder was activated, force and pressure information were collected. Five upper steering column assemblies were purchased through an automotive used parts facility. The VINs were provided for each steering column assembly and the donor vehicles listed no prior frontal collisions on a vehicle history report. Five steering column assemblies were tested in the fixture: four containing 3-pin shear capsules and one containing 4-pin shear capsules. The test fixture was inspected for damage after each test. After the fifth test, deformation of the floor pan was observed. Data from that test was found to be compromised by the deformation. Testing on this fixture was suspended.

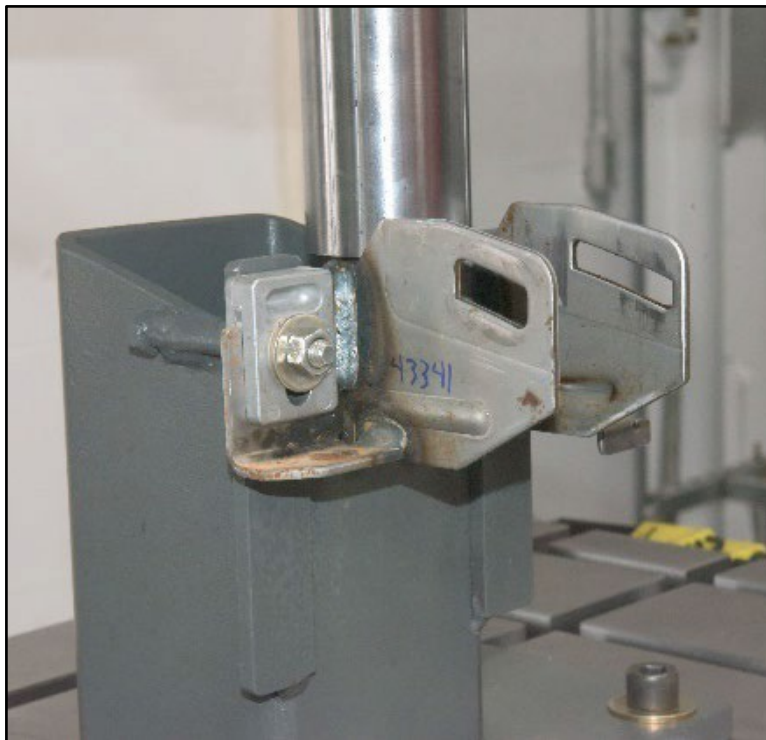
**Figure 6. VRTC Test Fixture**

Further component-level testing of the shear capsules was performed on an MTS Multiple Actuator Test System. The MTS test setup was configured to match Toyota's pre-production component testing (Figure 6). Shear capsules removed from steering column assemblies were purchased through an automotive used parts facility. Ten 3-pin capsules and seven 4-pin capsules were tested (see Tables 2 and 3). The average separation force for the 3-pin shear capsule was 404.1 lbf (1.79 kN), approximately 20 % higher result than the preproduction testing conducted by Toyota in 2008. Thus, testing demonstrated that there was no degradation in strength of the shear capsules assessed and the preproduction testing conducted by Toyota.
