# ODI RESUME

**Investigation:** EA 18-004  
**Prompted by:** NHTSA - Office of Defects Investigation  
**Date Opened:** 07/02/2018  
**Investigator:** Frederick Lamance      **Reviewer:** Jeff Quandt  
**Approver:** Stephen Ridella  
**Subject:** Door Latch Open While Driving

**Manufacturer:** LAND ROVER  
**Products:** 2013-2016 Range Rover and Range Rover Sport  
**Population:** 119,183 (Estimated)  
**Problem Description:** Consumers report incidents of doors opening while driving or failure to latch.

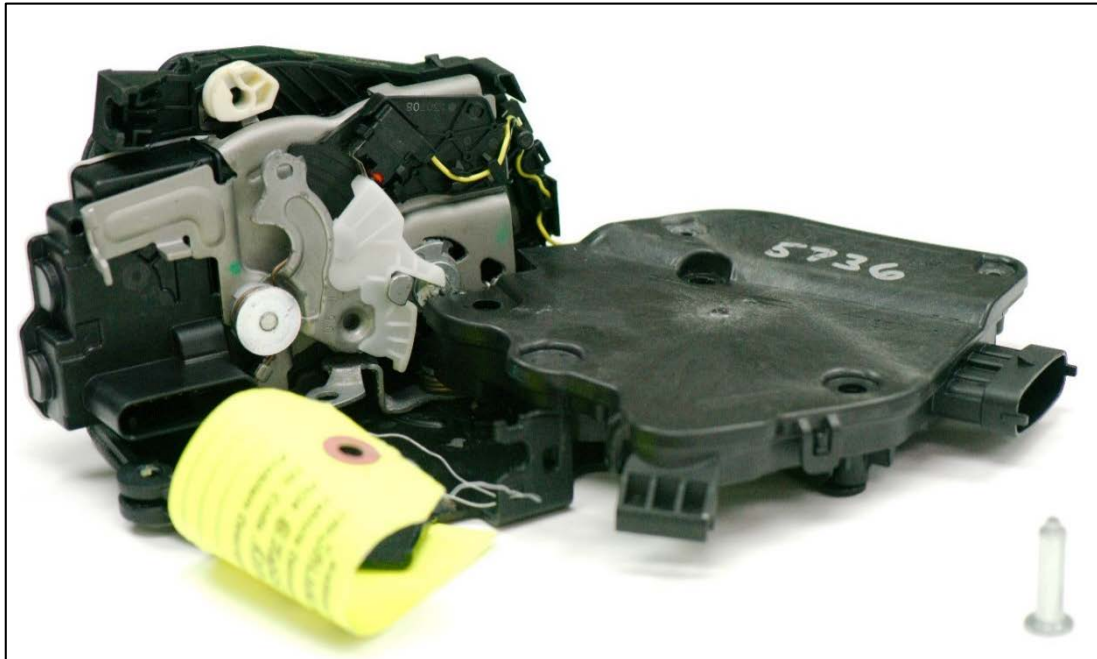
Figure 3. KV latch assembly, drive unit cover rivets removed (VOQ 10983285).

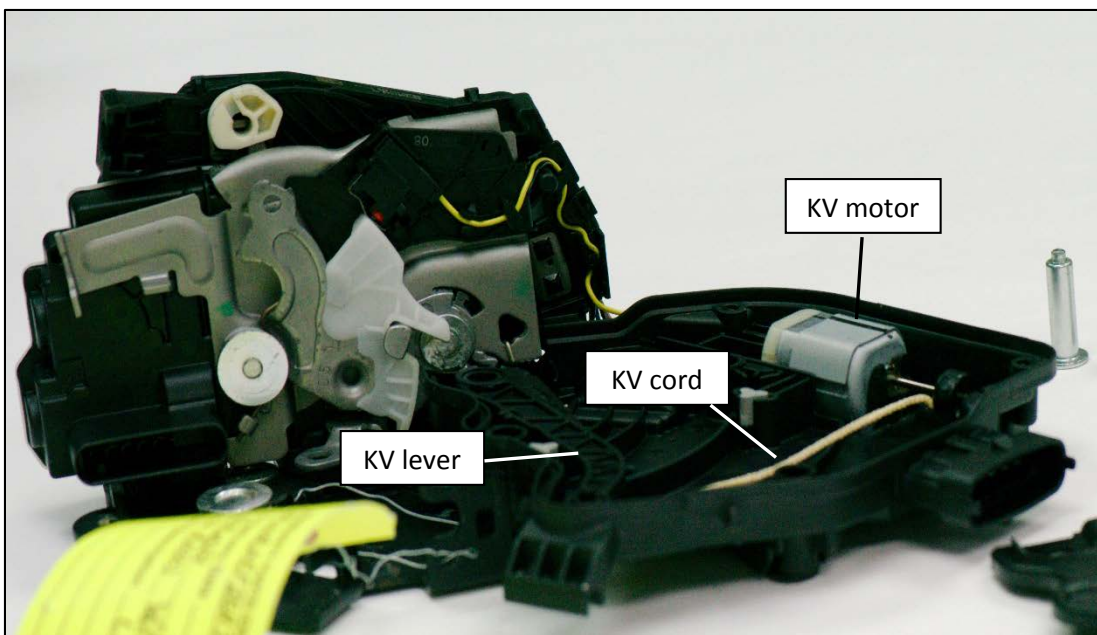
Figure 4. KV drive unit components, cover removed (VOQ 10983285).
