ODI RESUME

Investigation: EA 18-005
Prompted by: Seat belt webbing separation during NCAP frontal crash test
Date Opened: 07/03/2018
Investigator: Sharon Yukevich **Reviewer:** Gregory Magno
Approver: Stephen Ridella
Subject: Seat Belt Webbing Failure

Manufacturer: Volkswagen Group of America, Inc.
Products: 2018 MY Tiguan
Population: 110,000 (Estimated)

Problem Description: Seat belt webbing separation during crash test.

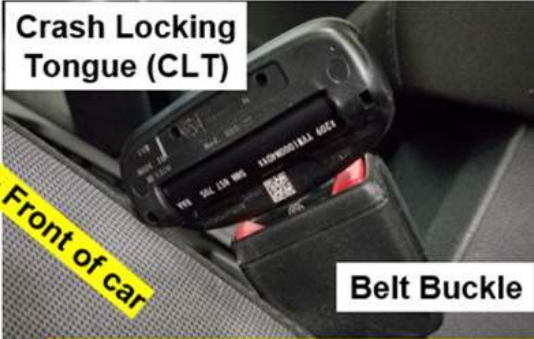
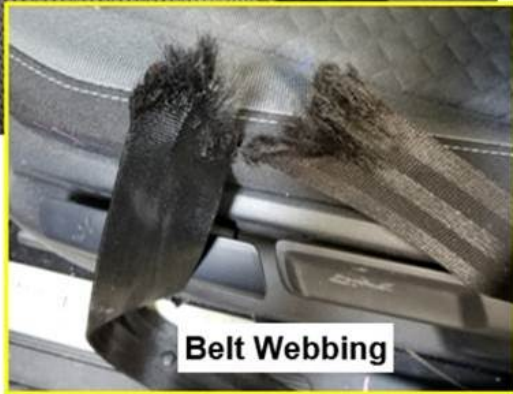
TRC

During both crash tests, the driver seat belt webbing completely separated in tension where it looped through the seat belt latch tongue (see attached photos). Based on its analysis of the NCAP test results, VW asserted that the test dummy umbilical cord exerted additional forces on the seat belt system causing the separation. To support this theory, VW conducted several sled tests.

The Office of Defects Investigation (ODI) opened a Preliminary Evaluation (PE18-001) on 01/10/2018 to evaluate the two (2) incidents of seat belt separation. ODI and NCAP reviewed the sled test data submitted by VW in support of their theory. Micro analysis, conducted by the Materials Laboratory at the National Transportation Safety Board (NTSB), verified the seat belts failed in tension and not due to cuts or abrasion.

Separated Seatbelt Webbing
