| | GROUP<br><b>Safety Recall Campaign</b> | MODEL<br><b>2010MY Soul (AM)<br/>2011MY Sorento (XM)</b> |
| | NUMBER<br><b>SC083</b> | DATE<br><b>September 2010</b> |
| <b>VOLUNTARY SAFETY RECALL CAMPAIGN</b> | | |
| <b>SUBJECT:</b> SOUL (AM) / SORENTO (XM) DOOR TRIM ACCENT<br>LIGHTING WIRING REPLACEMENT (SC083) | | |

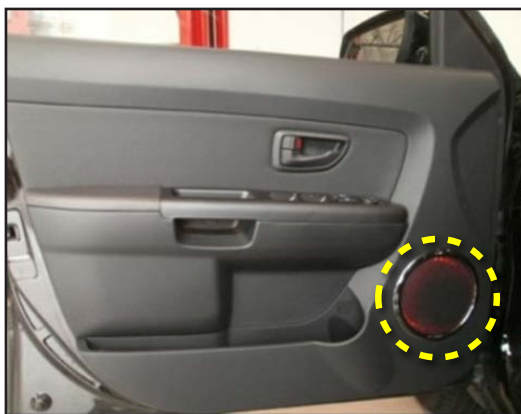
*Soul*

This bulletin provides information relating to the replacement of the door trim panel wiring harnesses used for the lighting in the “Advanced Lighting Speakers” in some 2010MY Soul (AM) vehicles produced from September 7, 2009 to June 08, 2010 and the “Interior Accent Illumination” in some 2011MY Sorento (XM) vehicles produced from October 23, 2009 to July 30, 2010. These wiring harnesses may have been improperly soldered. As a result, when the lights are illuminated under certain conditions, an electrical short may ensue, and can result in a fire.

Use the following repair procedure to install the new harnesses and to correct the condition.
