# Safety Recall

## Code: 69L2

| <b>Subject</b> | <b>Steering Wheel Clock Spring</b> |
| <b>Release Date</b> | December 10, 2015 |

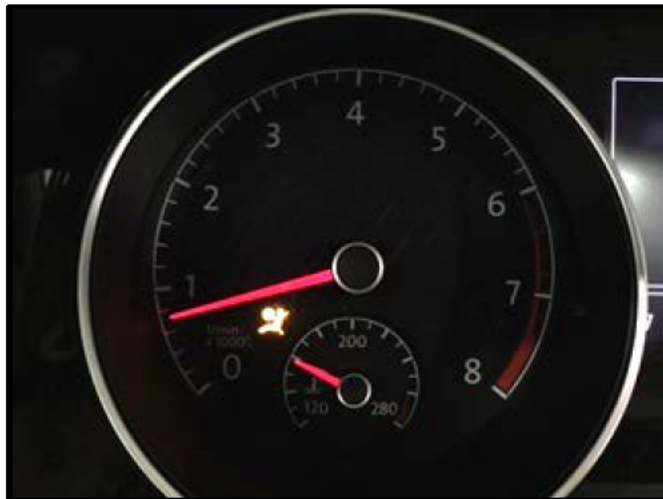
- If the airbag system faults include “Driver airbag igniter Resistance too high (B10001B)” or “Driver side airbag igniter (VAG00588) Upper limit exceeded” <as shown>, the clock spring **MUST** be replaced. Leave the VAS tester connected to the vehicle and **Proceed to Section D – Clock Spring Replacement**

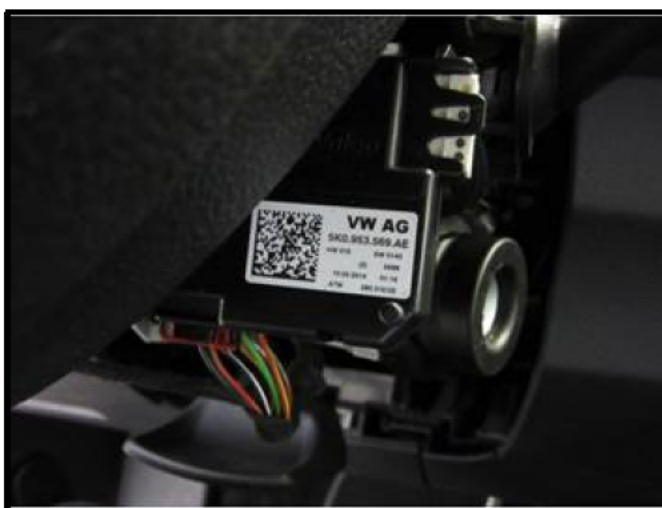
- <Position A> indicates the 8 o'clock position.
- <Position B> indicates the 4 o'clock position.
- Inspect the part number on the clock spring label <as shown>.
- If the part number suffix is "AL, AK, AS, or AR", the clock spring cover MUST NOT be installed. Reassemble the steering column trim and **Proceed to Section E**
- If the part number suffix is **NOT** "AL, AK, AS, or AR" – **proceed to the next step**.
