Jaguar Land Rover  
Limited  
Suspension Order

**Number:** 2019-004

**Title:** US NHTSA Engineering Analysis EA18-004 - Doors Opening whilst driving

**Model:** Range Rover (L405) and Range Rover Sport (L494)

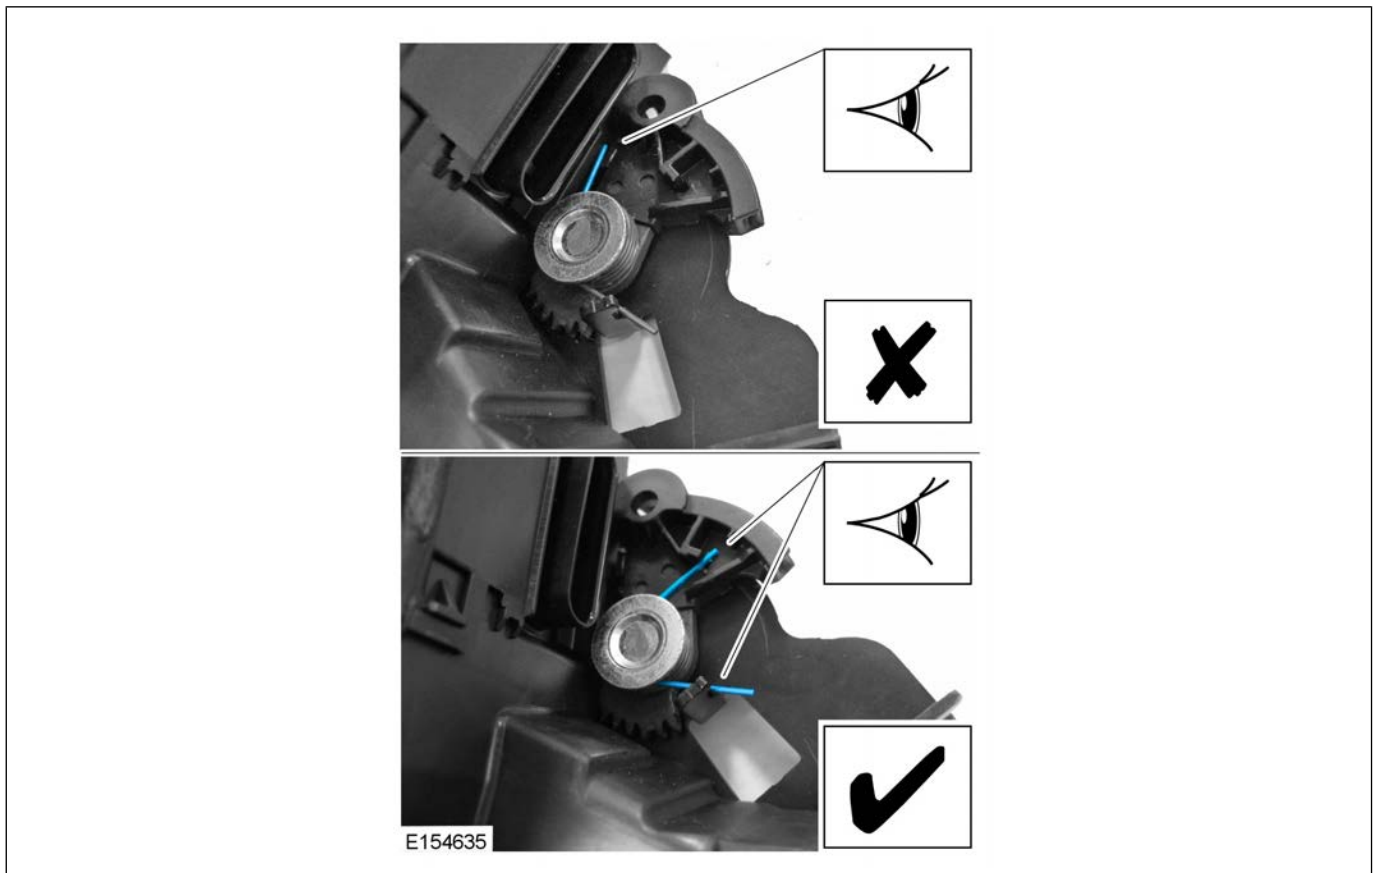
This may be caused by the soft door close mechanism spring becoming dislocated.

Using a suitable tool, relocate the spring in to the recess as shown.

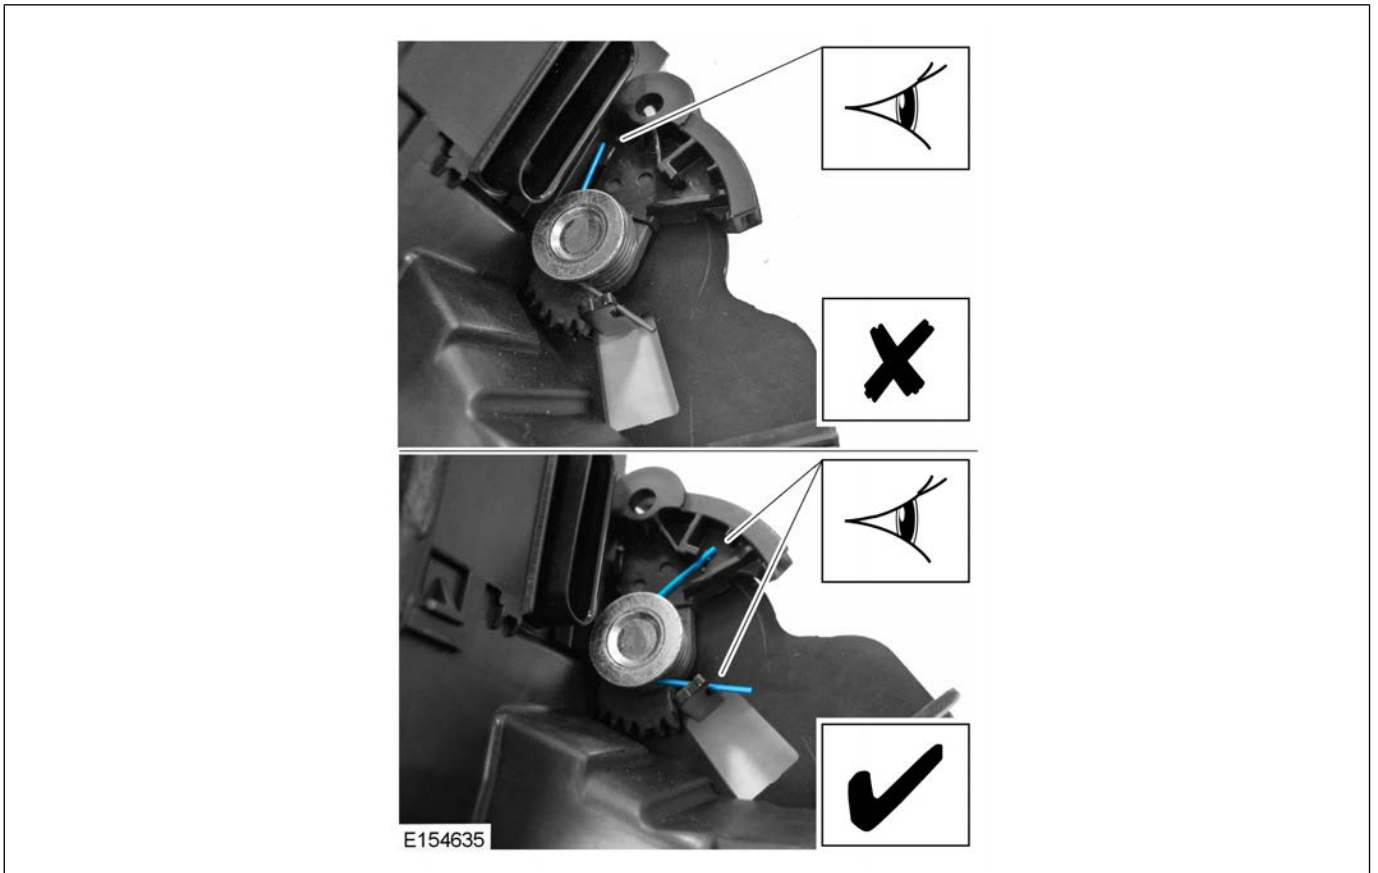
This may be caused by the soft door close mechanism spring becoming dislocated.

Using a suitable tool, relocate the spring in to the recess as shown.

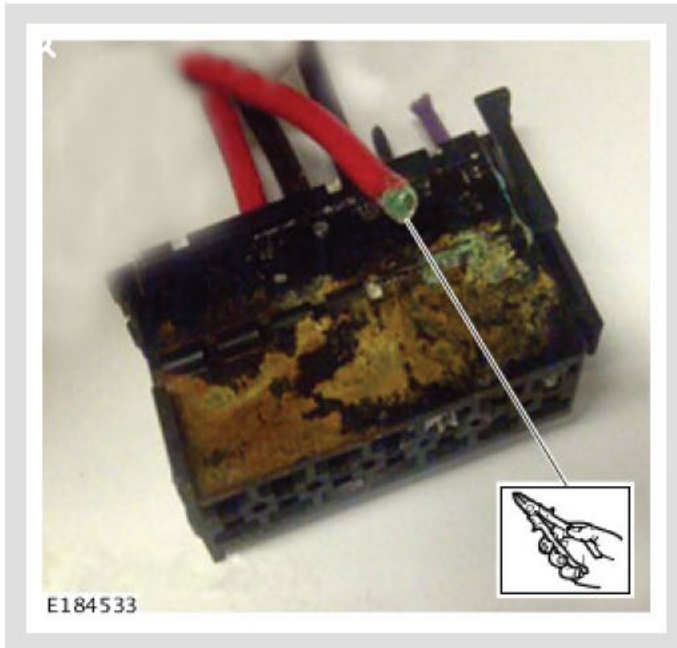
Check the following terminals for signs of corrosion:

Remove the connector block and cut back the corroded wires to a suitable length until corrosion is no longer visible.

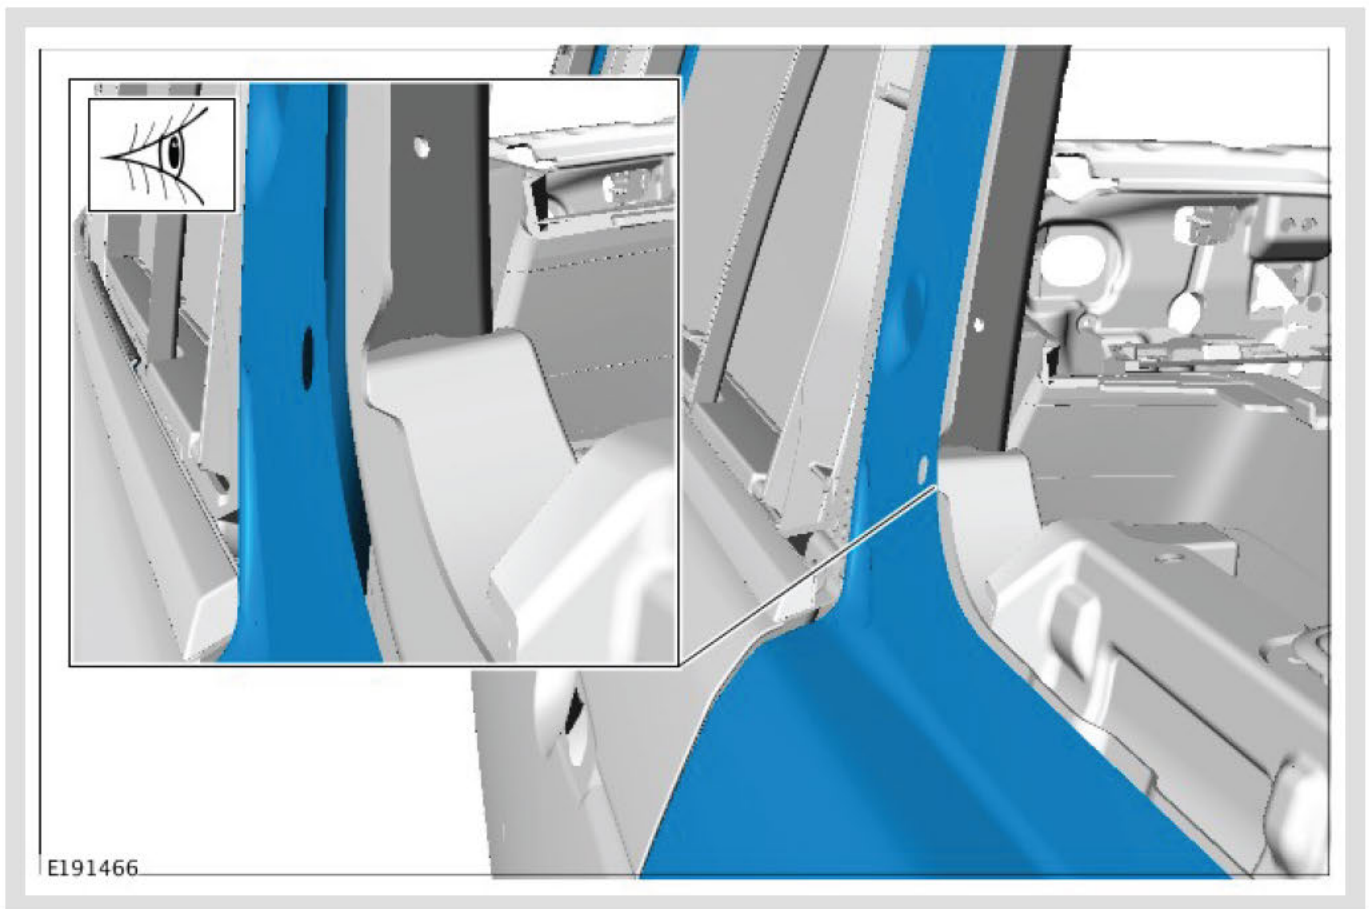
Visually check the body panel.

Using a suitable tool, dress the body panel until the gap between the body panel and reinforcement panel has been closed.
