Jaguar Land Rover
Limited
Suspension Order

Number: 2019-004

Title: US NHTSA Engineering Analysis EA18-004 - Doors Opening whilst driving

Model: Range Rover (L405) and Range Rover Sport (L494)

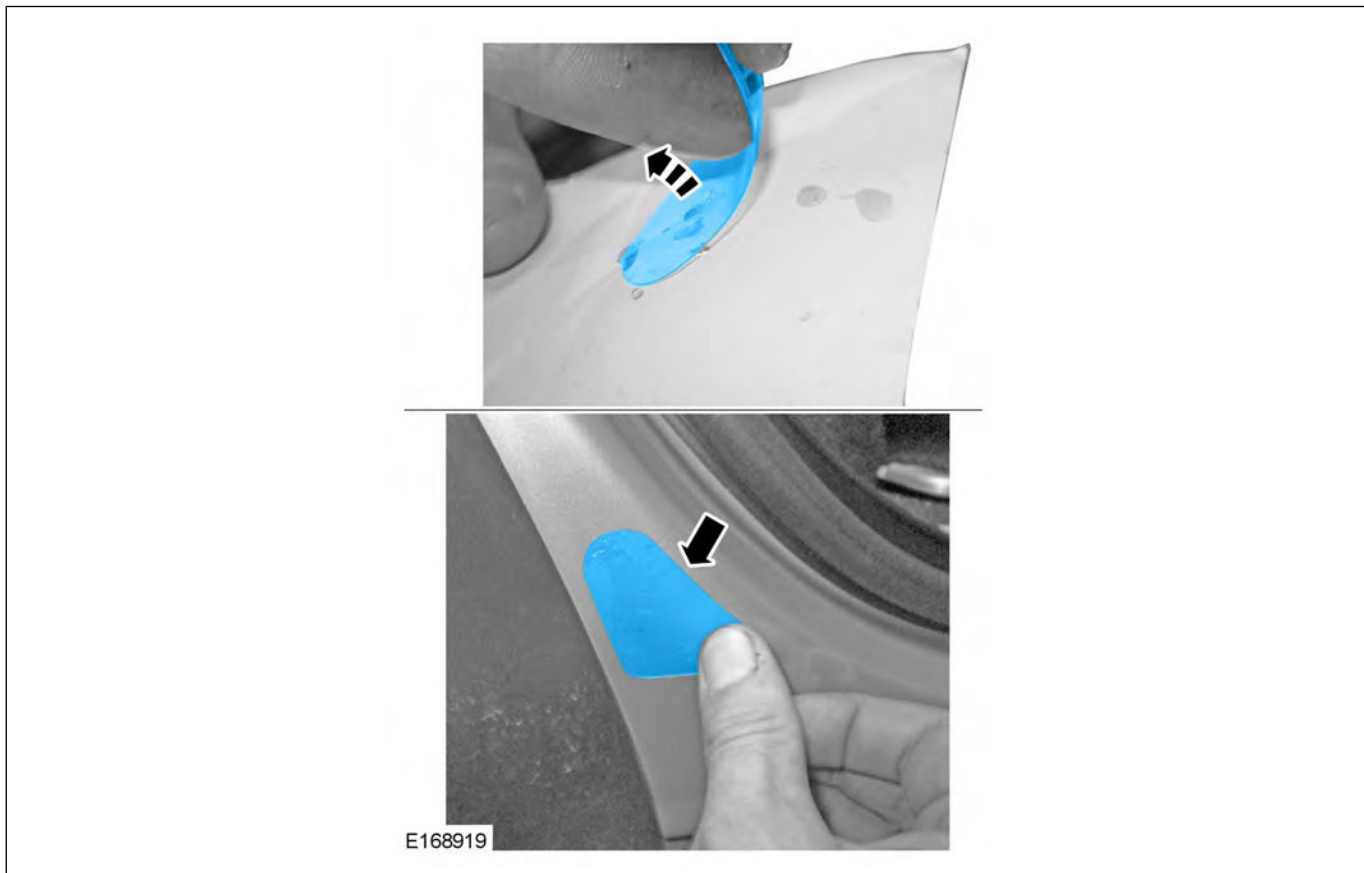
Cause: This may be caused by insufficient back pressure from door sealing system.

- Install the clear patch directly over the water witness mark.

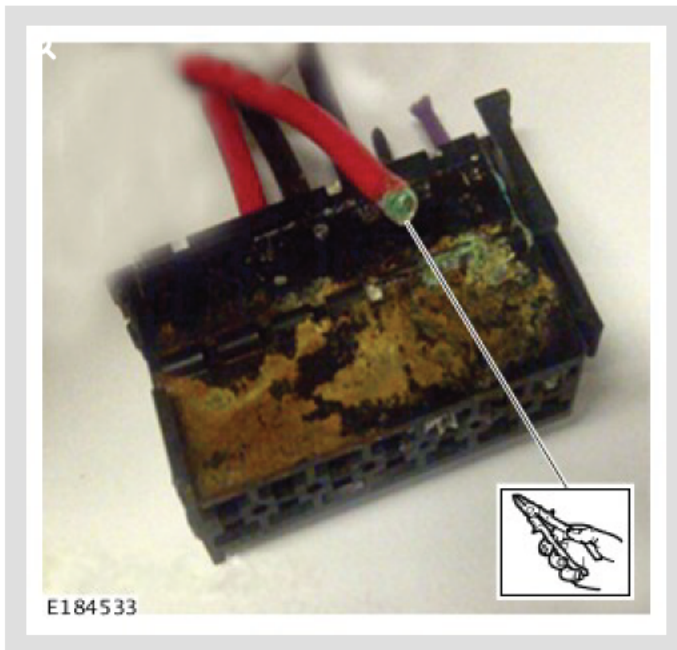
Check the following terminals for signs of corrosion:

Remove the connector block and cut back the corroded wires to a suitable length until corrosion is no longer visible.

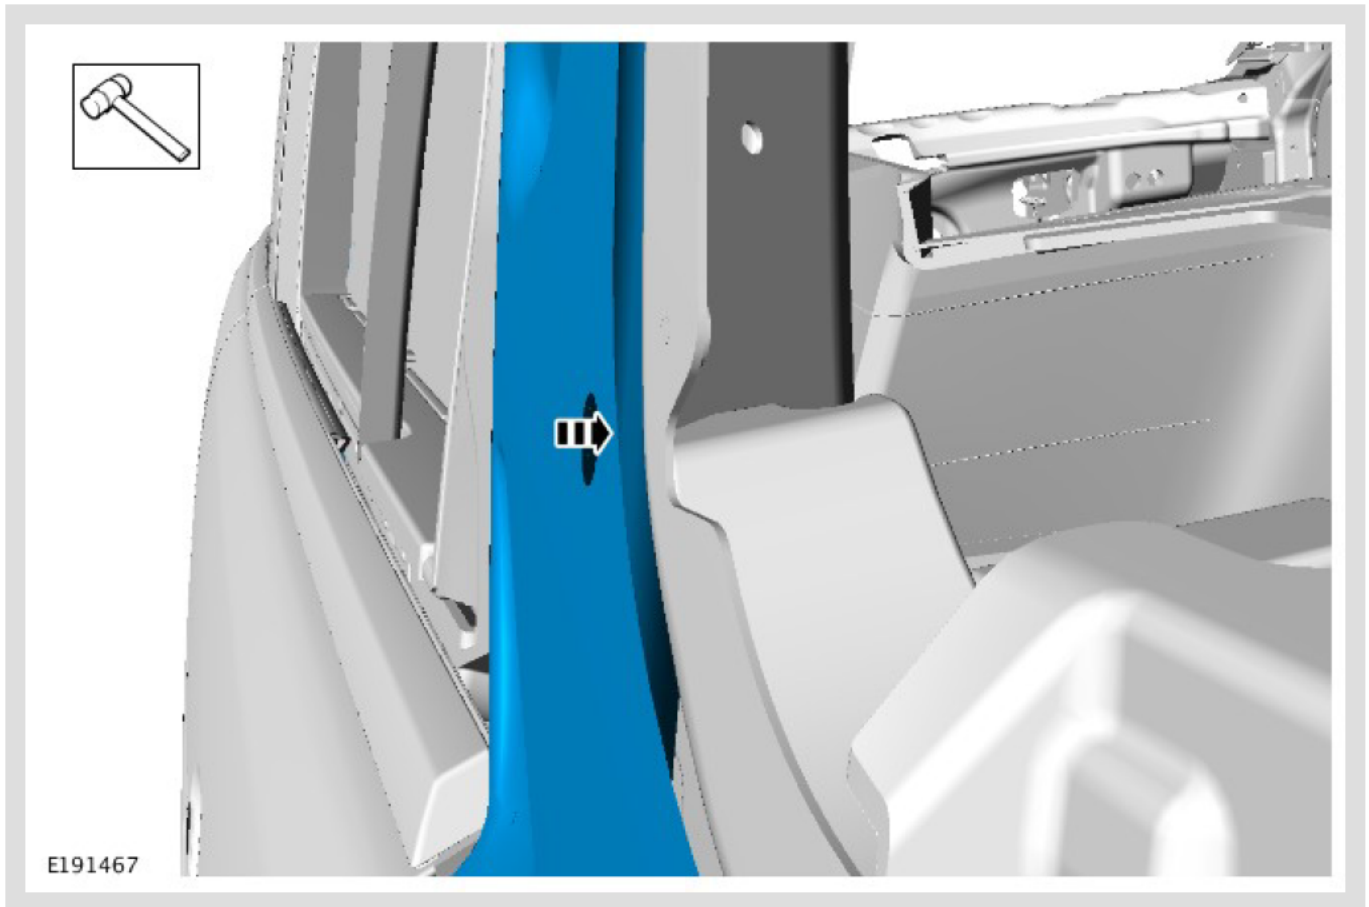
Visually check the body panel.

Using a suitable tool, dress the body panel until the gap between the body panel and reinforcement panel has been closed.
