Scope and Prioritise Potential Causes

Intermediate result of KV actuator analysis

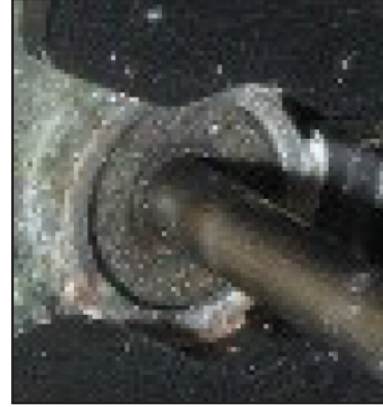
JLR corrosion test sample A3 after 480h

OK without short circuit

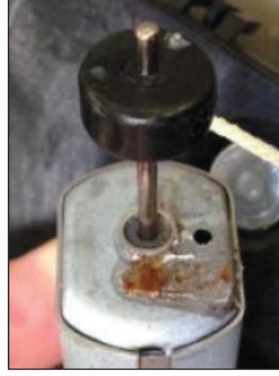
After KV operation at test box with open circuit cord fully unwound
→ OK

Corrosion visible at motor housing, sinter bearing grey

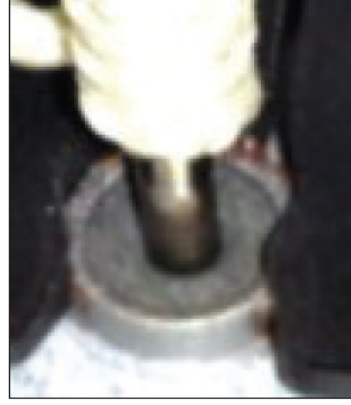
Latch received with 6 windings left on motor shaft

Sinter bearing grey, corrosion at the motor housing
Failure prior to P068 update, P068 didn't resolve issue, latch replaced

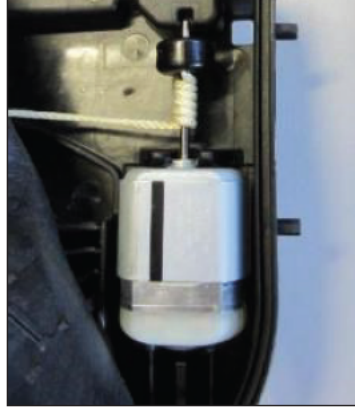
FT RH CL KV
23.08.2013

Latch received with 6 windings left on motor shaft

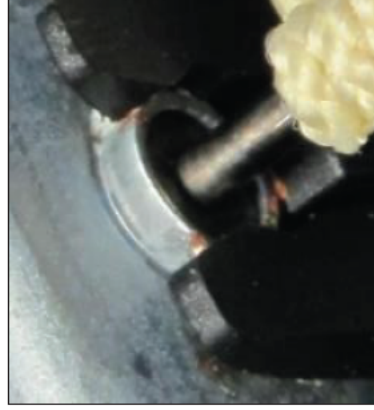
Sinter bearing grey, corrosion on motor housing visible

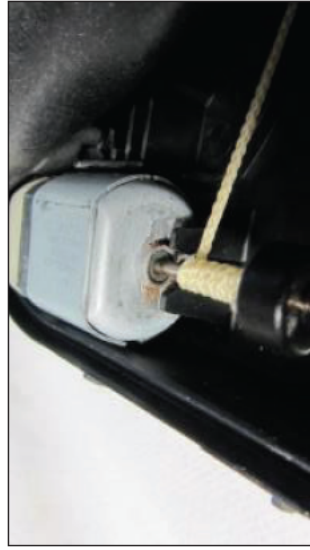
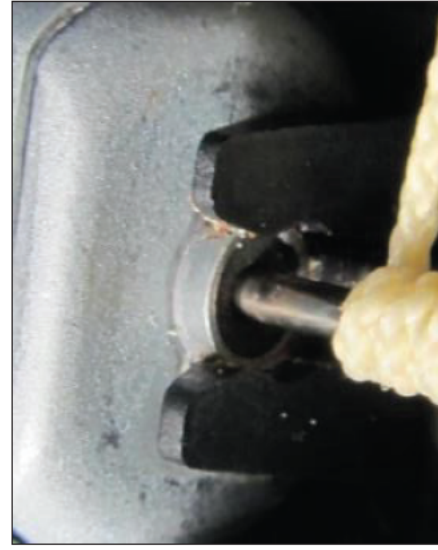
FT RH CL PC KV
27.10.2014

Latch received with 6 windings left on motor shaft
Sinter bearing grey, corrosion on motor housing visible

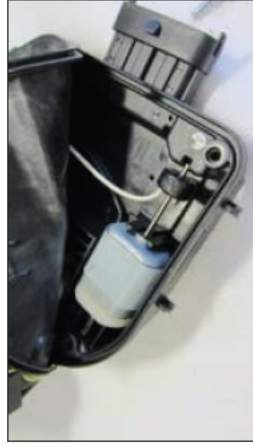
RR RH CL KV ECS
05.11.2014

Latch received completely unwound

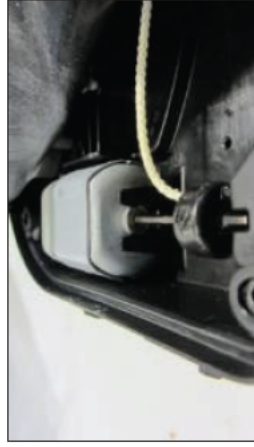
Sinter bearing shiny, no corrosion on motor housing visible

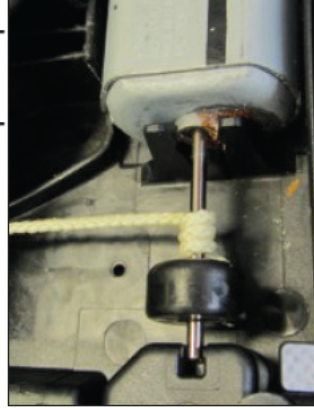
Latch received with 3 windings left on the motor shaft

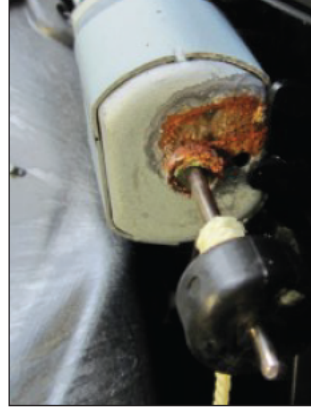
Sinter bearing and motor housing corroded

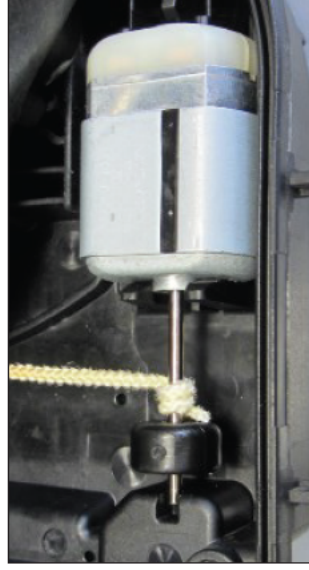
Latch received with two windings left on the motor shaft

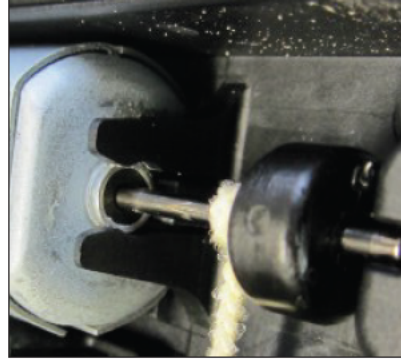
Sinter bearing grey, slight corrosion on motor housing visible

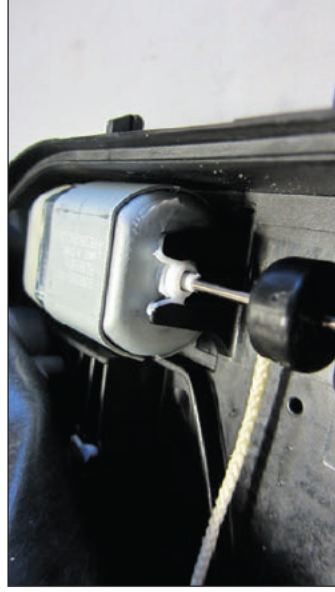
Latch completely unwound

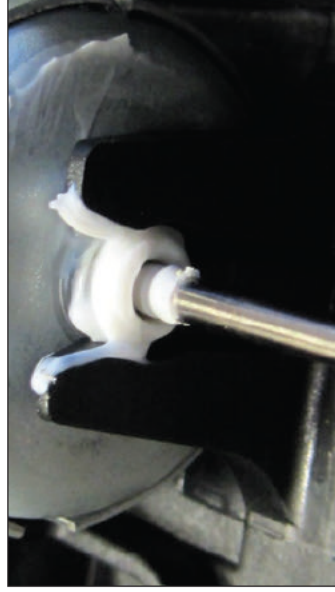
Sinter bearing greased, no corrosion on housing visible

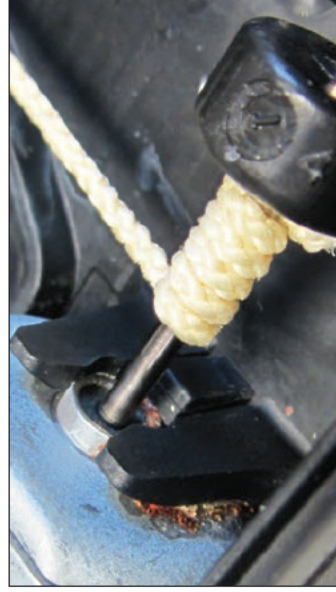
Sinter bearing grey, corrosion on housing visible

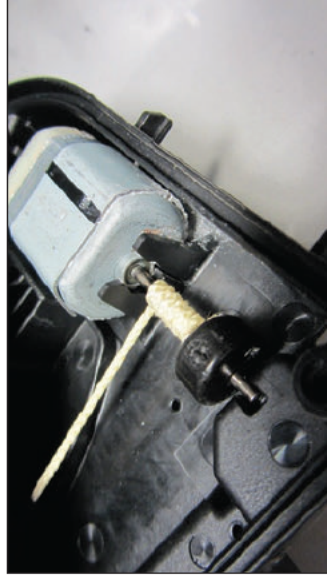
Latch received with 6 windings left on the motor shaft.

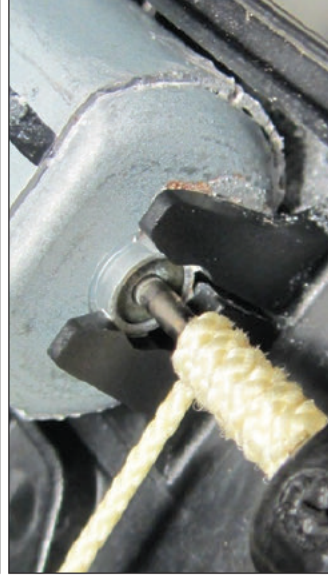
Sinter bearing grey, corrosion on housing visible

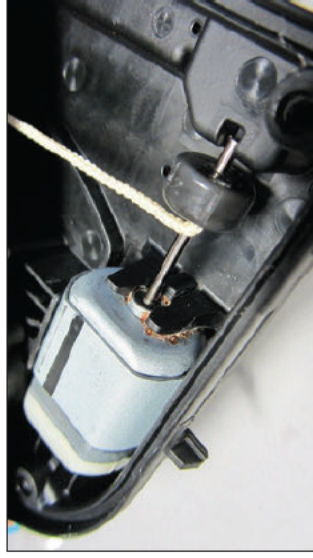
Latch received completely unwound

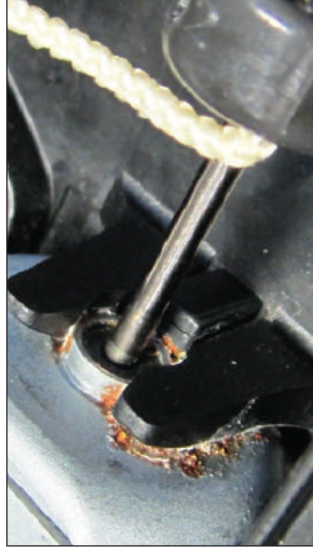
Sinter bearing grey, corrosion on housing visible

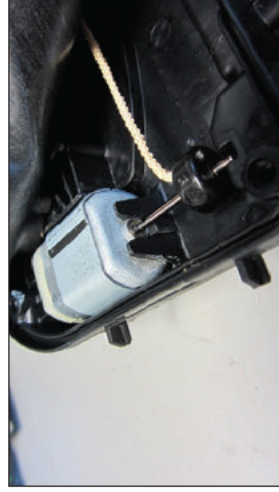
Sinter bearing shiny, slightly corrosion on motor housing visible

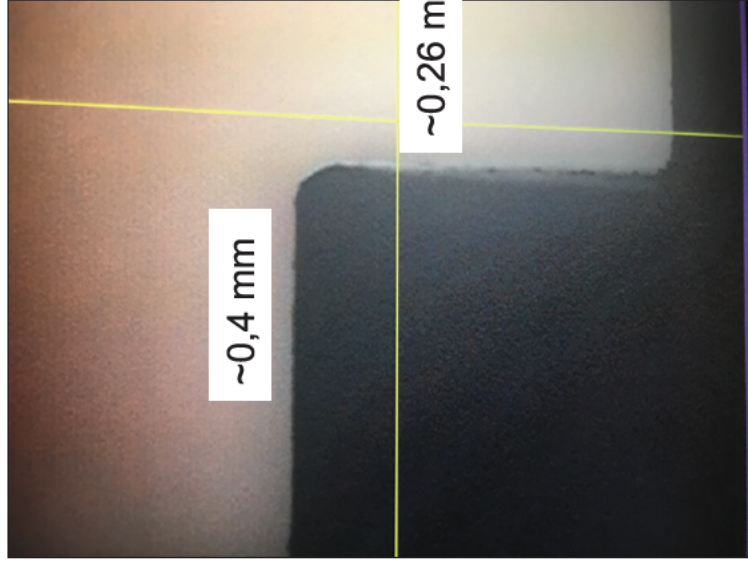
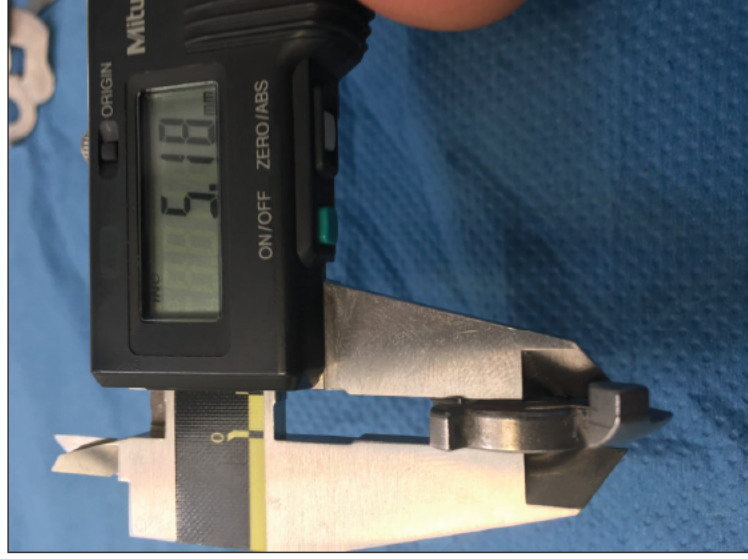
Ft RH CL PC KV
02.04.2013

→ Chamfer from bushing and height of KV transmission lever ok

Investigation completed. Root cause for failure mode can not be detected. Latch passed all tests.

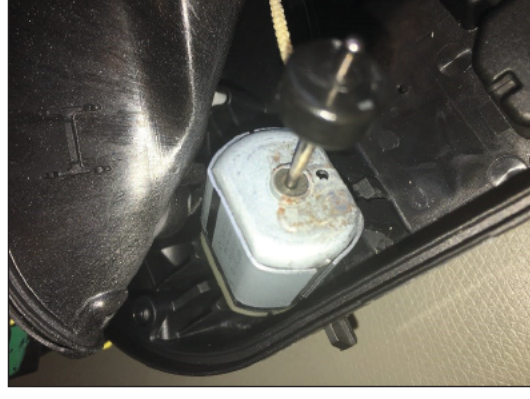
Sinter bearing grey, corrosion on housing visible

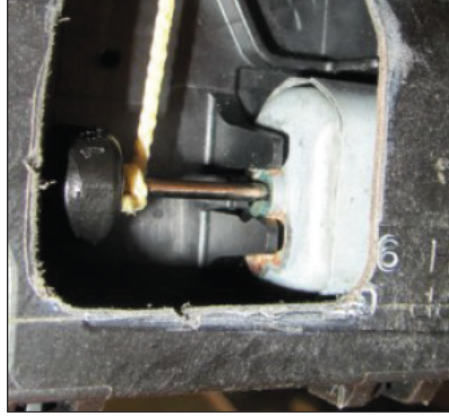
Bearing after 1. short circuit operation: 1 winding left

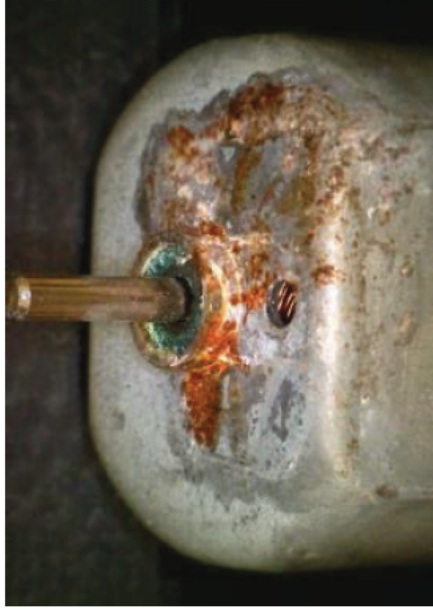
Corroded bearing and housing

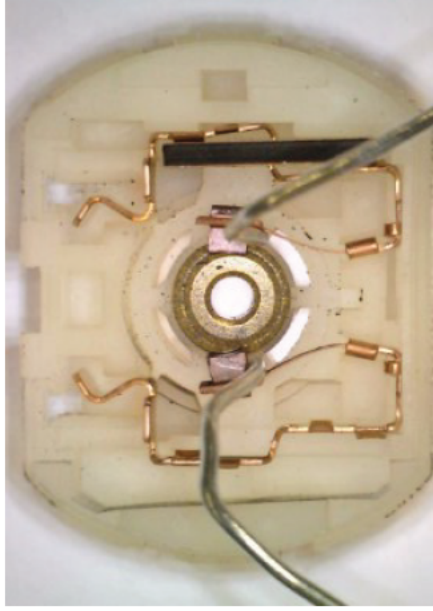
Bearing Commutator side ok

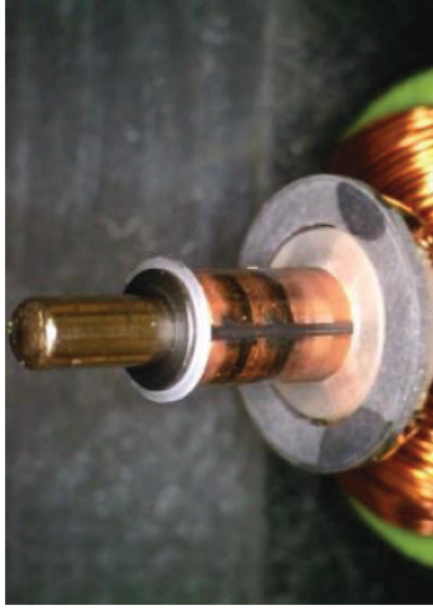
Washer Commutator side ok

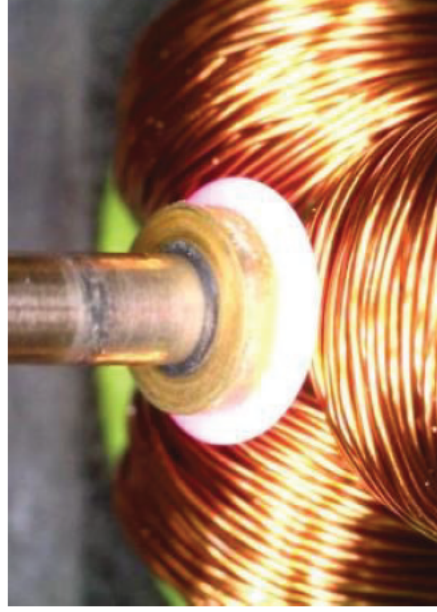
Corroded axis and residues at washer (360°),

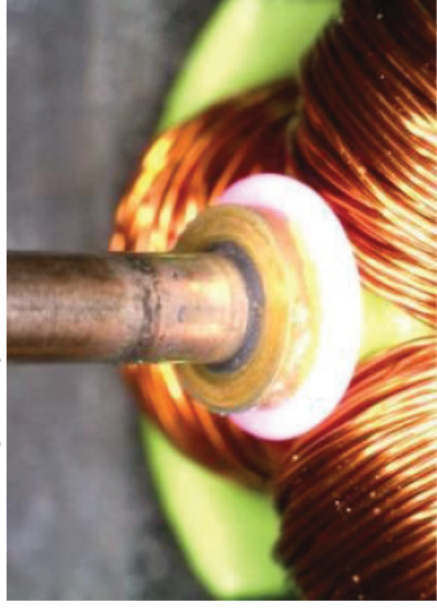
Corroded axis and residues at washer (360°)

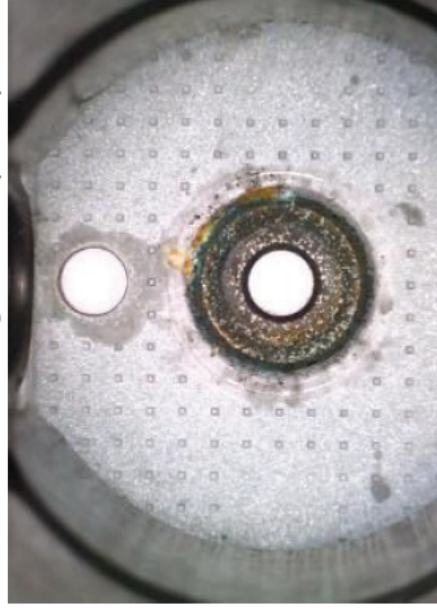
Corroded bearing inside (360°)
