Separation of 6-panel document on the 15th of September 2017 in two parts for better handling:

Scope and Prioritise Potential Causes

Intermediate result of KV actuator analysis

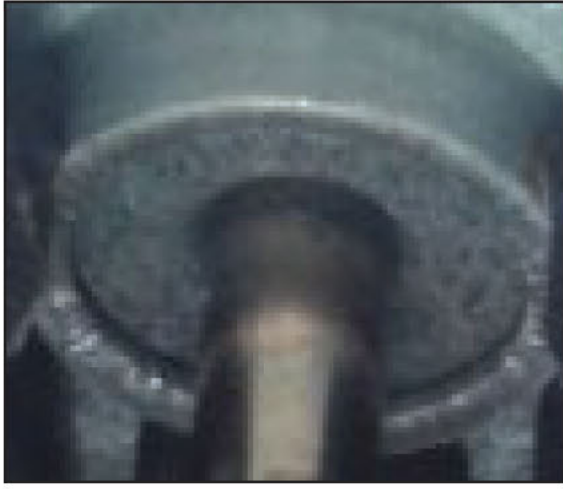
Colour comparison of KV sinter bearing

JLR corrosion test sample A3 after 480h

sample A5 after 600h

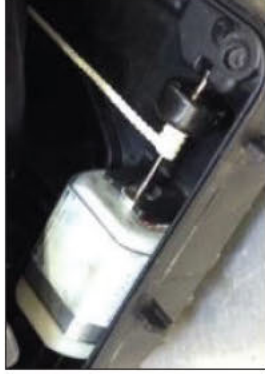
Latch from Critical Concern List / [REDACTED] UNITED STATES(USA)
 “Inadvertent Door Open Post P068 27/07/2015 dbromage”

Latch received with 3 windings left on motor shaft

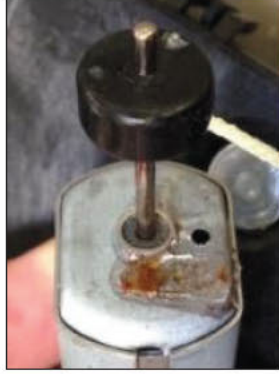
After KV operation at test box with open circuit cord fully unwound
 → OK

Corrosion visible at motor housing, sinter bearing grey

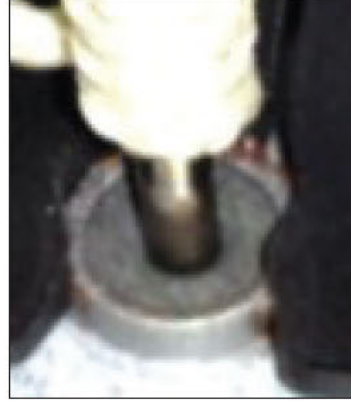
Latch received with 6 windings left on motor shaft

Sinter bearing grey, corrosion at the motor housing
Failure prior to P068 update, P068 didn't resolve issue, latch replaced

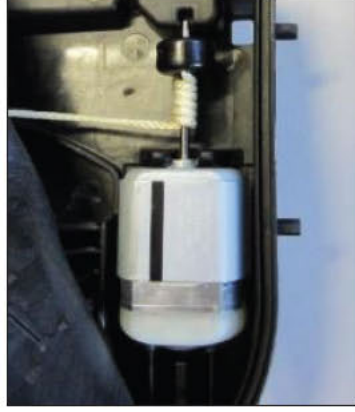
FT RH CL KV
23.08.2013

Latch received with 6 windings left on motor shaft

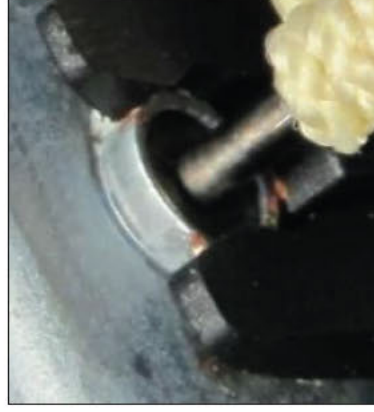
Sinter bearing grey, corrosion on motor housing visible

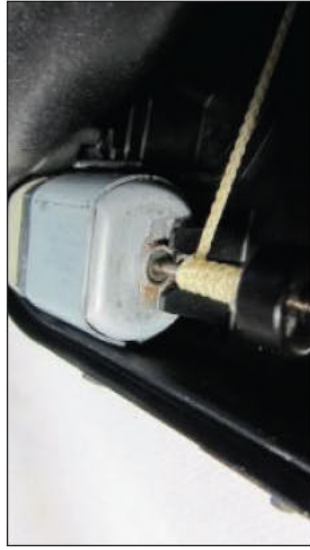
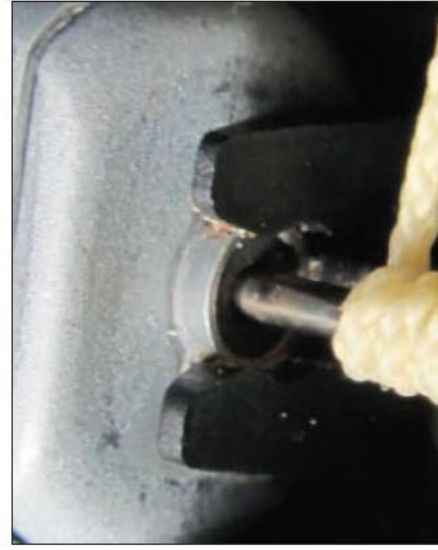
FT RH CL PC KV
27.10.2014

Latch received with 6 windings left on motor shaft
Sinter bearing grey, corrosion on motor housing visible

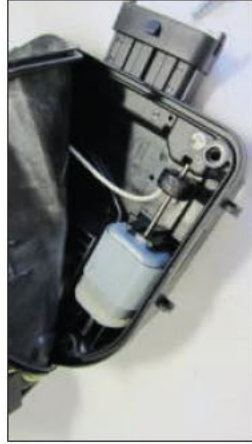
RR RH CL KV ECS
05.11.2014

Latch received completely unwound

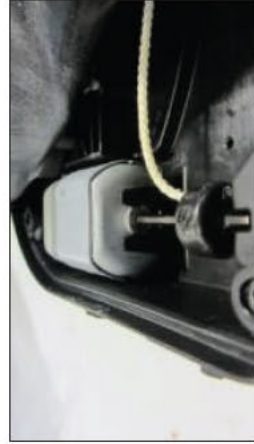
Sinter bearing shiny, no corrosion on motor housing visible

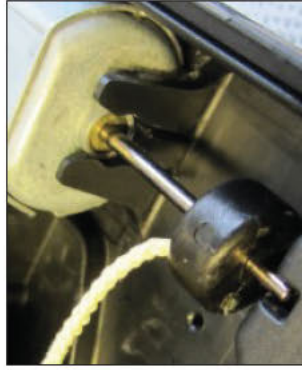
FT LH CL PC KV LB
12.05.2014

Latch received completely unwound

Sinter bearing shiny, no corrosion on motor housing visible

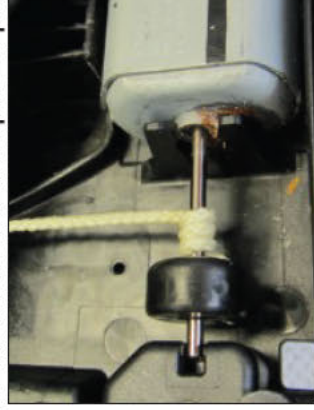
Latch received with 3 windings left on the motor shaft

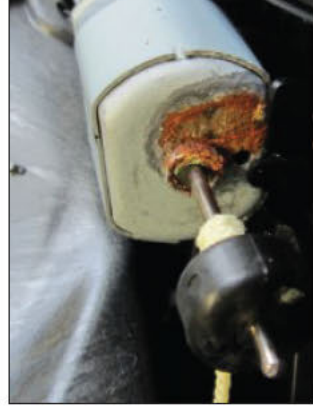
Sinter bearing and motor housing corroded

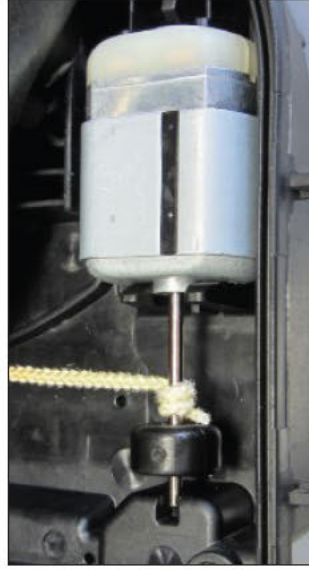
Latch received with two windings
left on the motor shaft

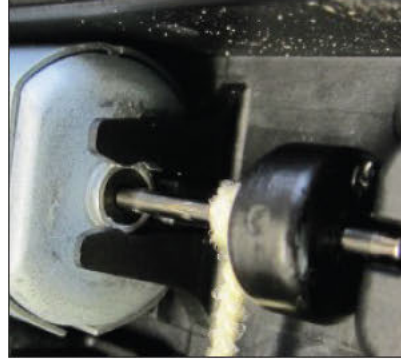
Sinter bearing grey, slight
corrosion on motor housing
visible

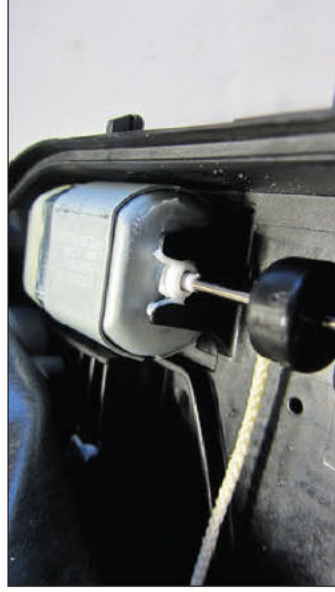
Latch completely unwound

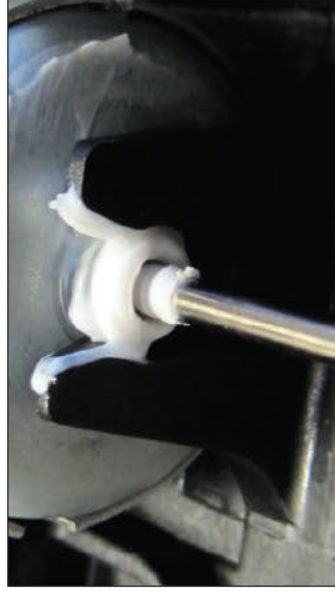
Sinter bearing greased, no corrosion on housing visible

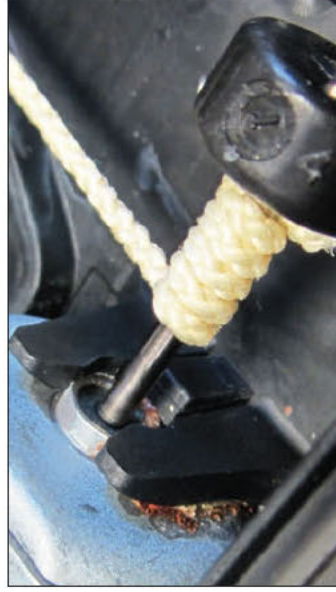
Sinter bearing grey, corrosion on housing visible

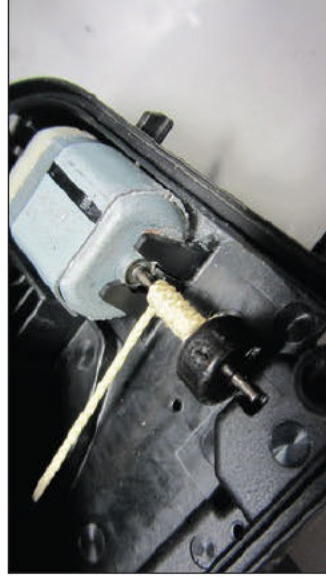
Latch received with 6 windings left on the motor shaft.

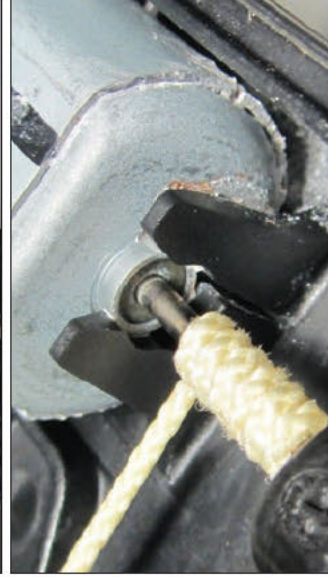
Sinter bearing grey, corrosion on housing visible

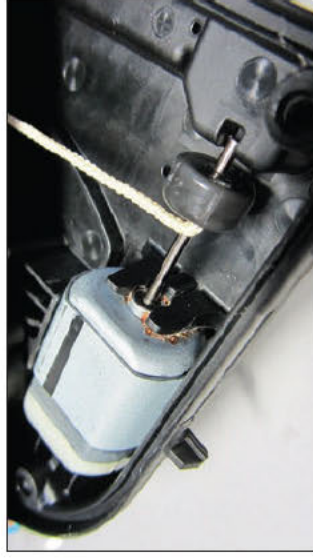
Latch received completely unwound

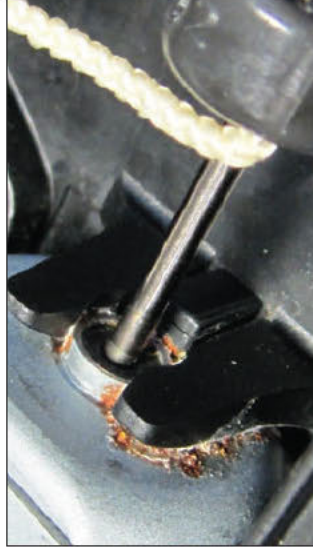
Sinter bearing grey, corrosion on housing visible

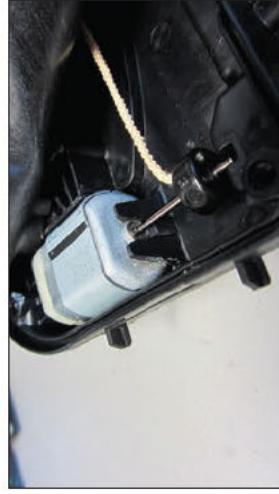
Sinter bearing shiny, slightly
corrosion on motor housing
visible

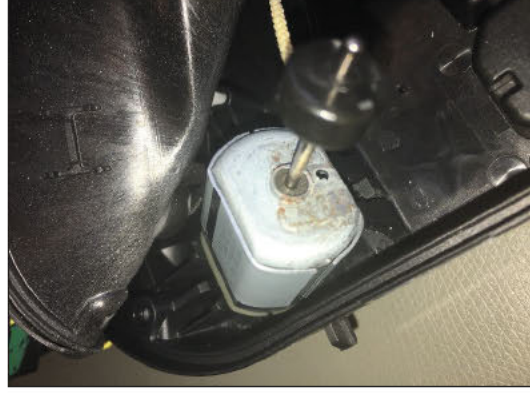
Sinter bearing grey, corrosion on housing visible

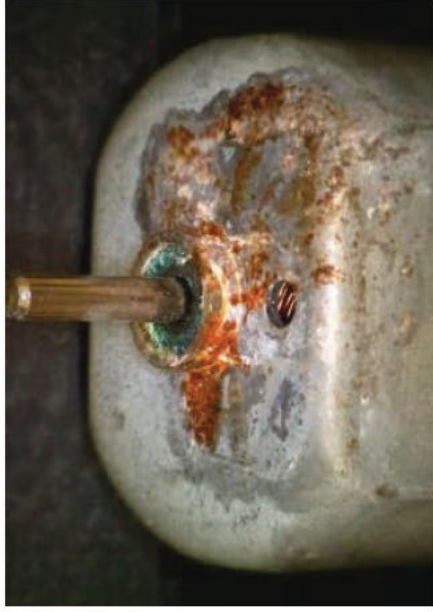
Corroded bearing and housing

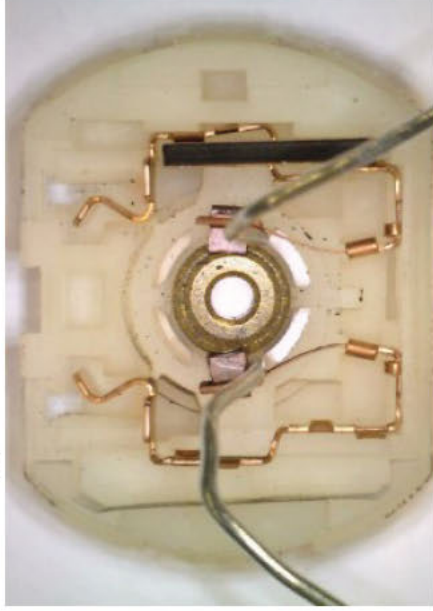
Bearing Commutator side ok

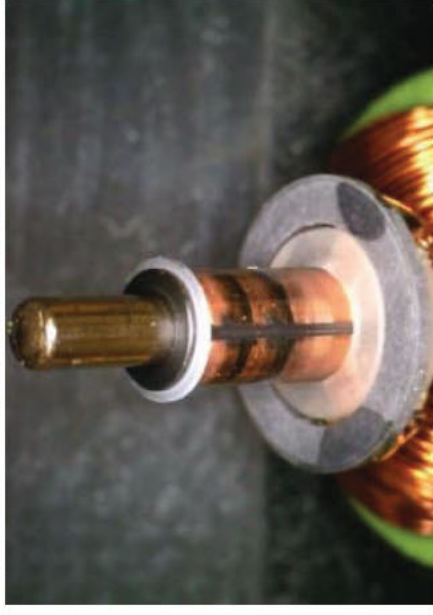
Washer Commutator side ok

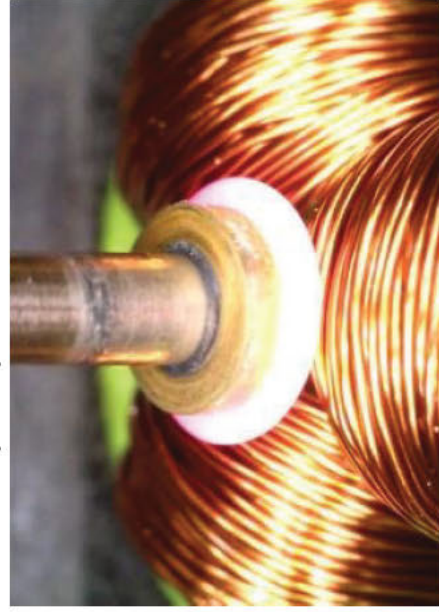
Corroded axis and residues at washer (360°),

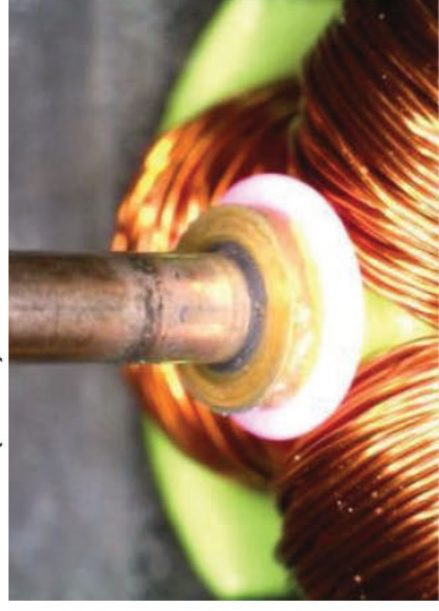
Corroded axis and residues at washer (360°)

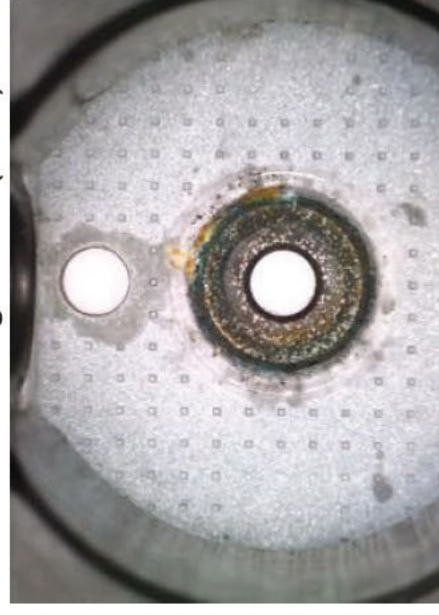
Corroded bearing inside (360°)
