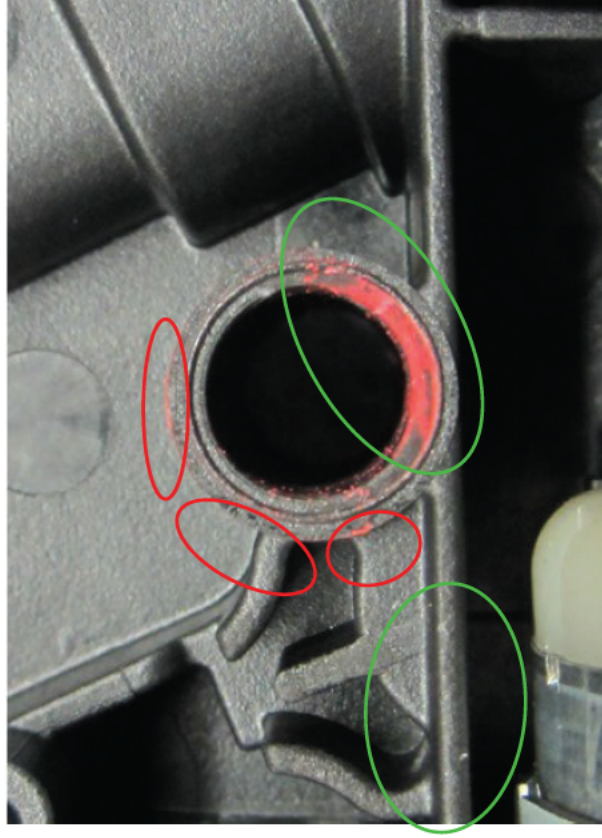
Samples with sealing contour (height 0,3 mm) in KV housing and 3 tolerance spots

Slight water traces found inside of the sealing contour ✗

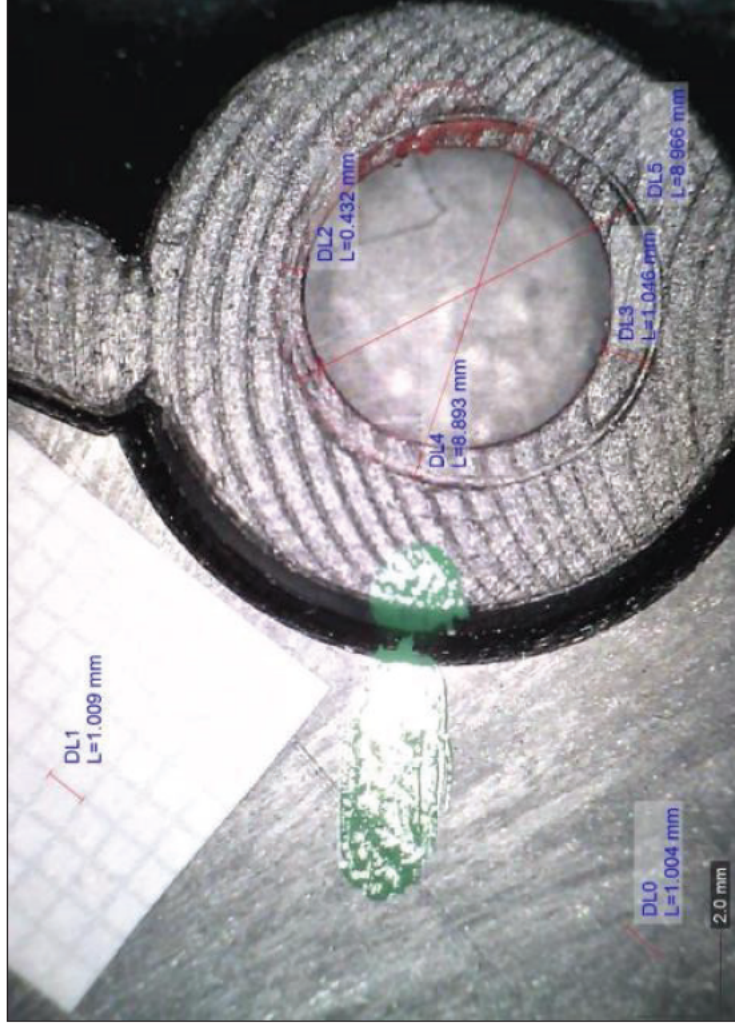
Due to tolerances the sealing contour is not central. Depth of indentation not sufficient to seal complete area.

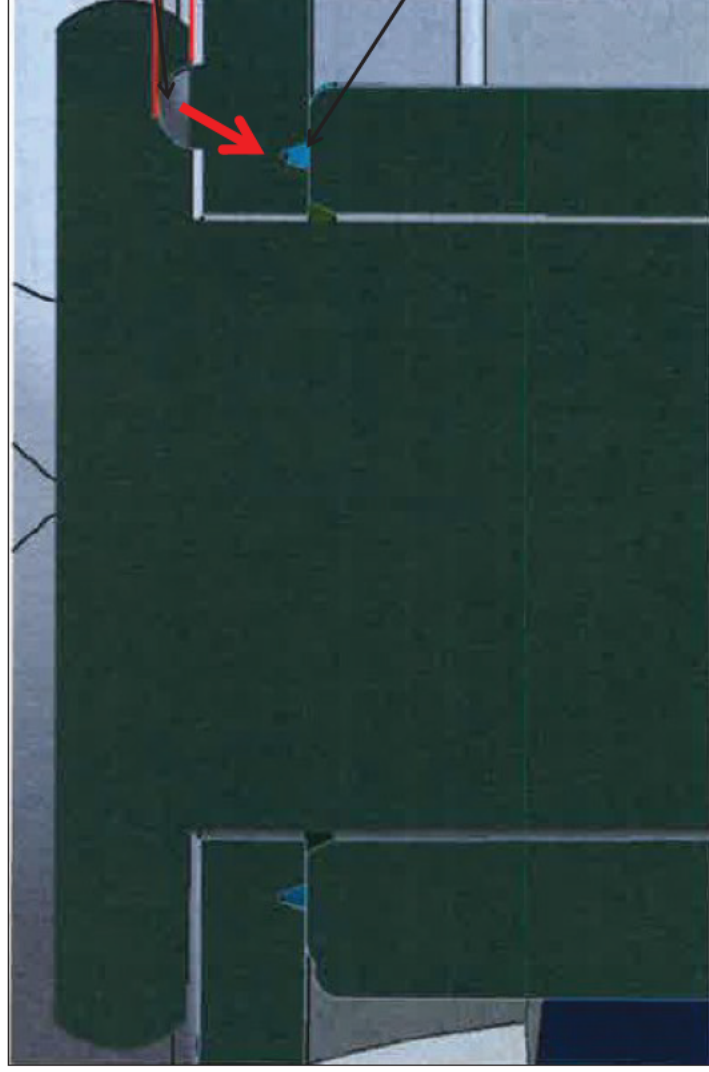
Tolerance spots of the KV lid not perpendicular to the sealing contour at the KV housing. Force transmission during riveting process not optimal (transverse) to press the sealing contour into the lid

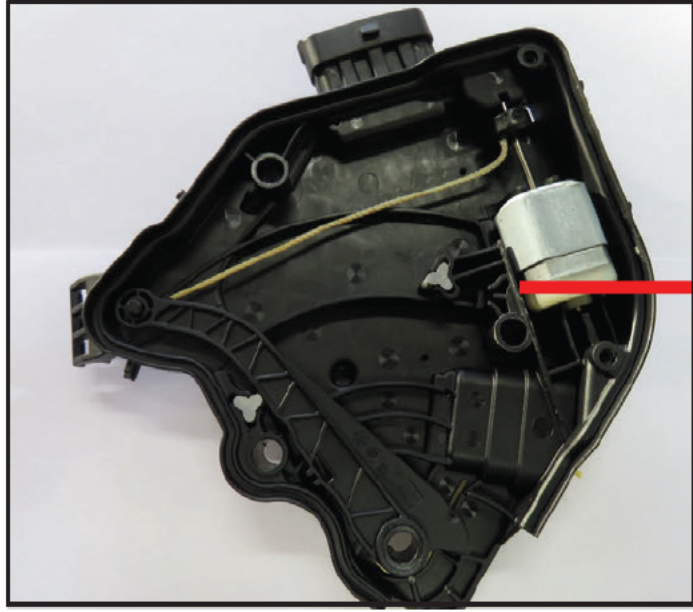
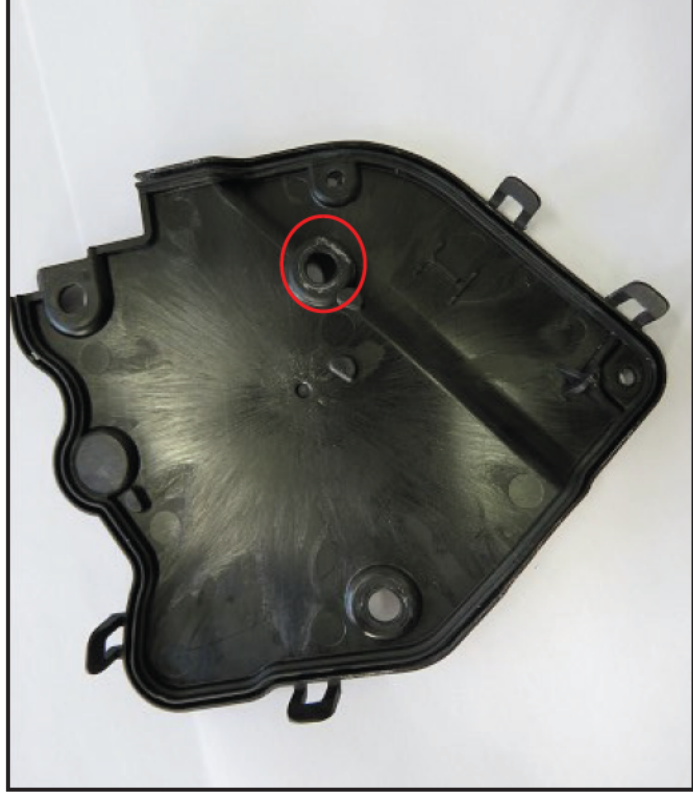
Conclusion: leak path via KV rivet hole found, part prior grey sticker introduction.

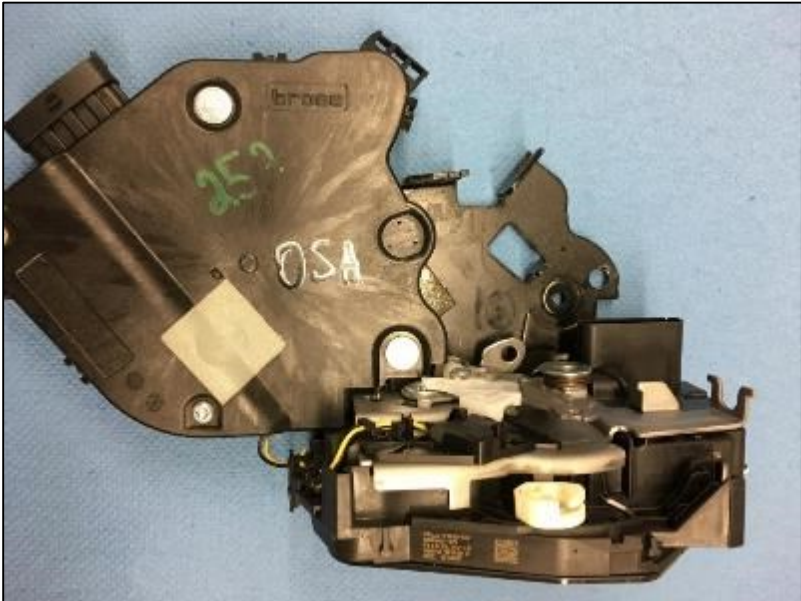
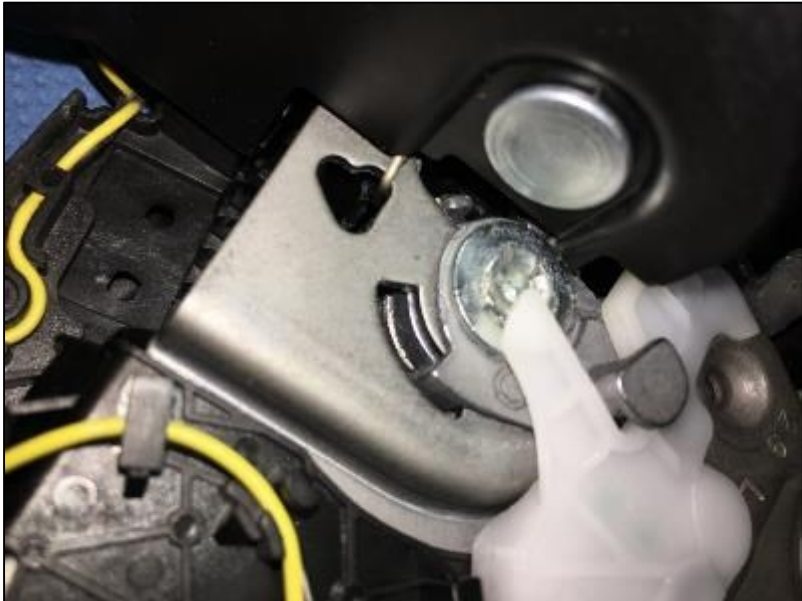
- Latch received in jammed condition (not possible to latch)
- KV Transmission lever (zamak) jammed / KV plastic lever in home position

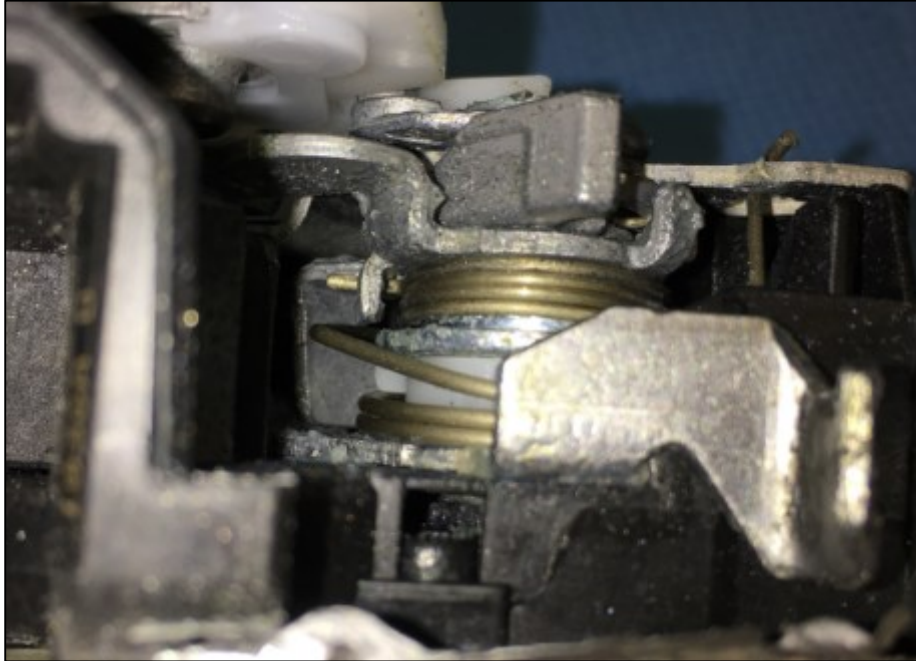
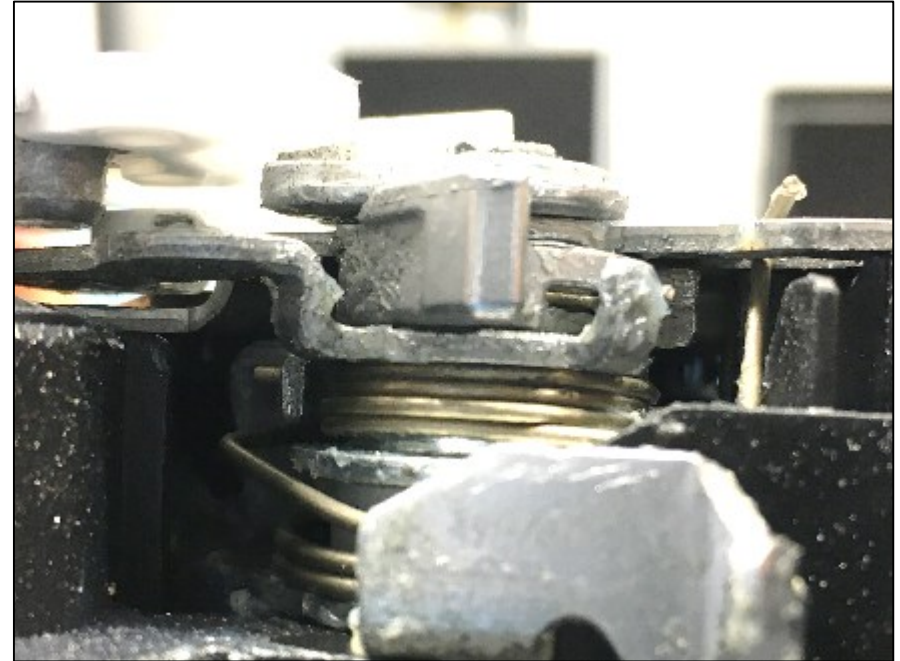
- after cutting off retention plate the failed condition is still present
- spring between O/S transmission lever and bushing

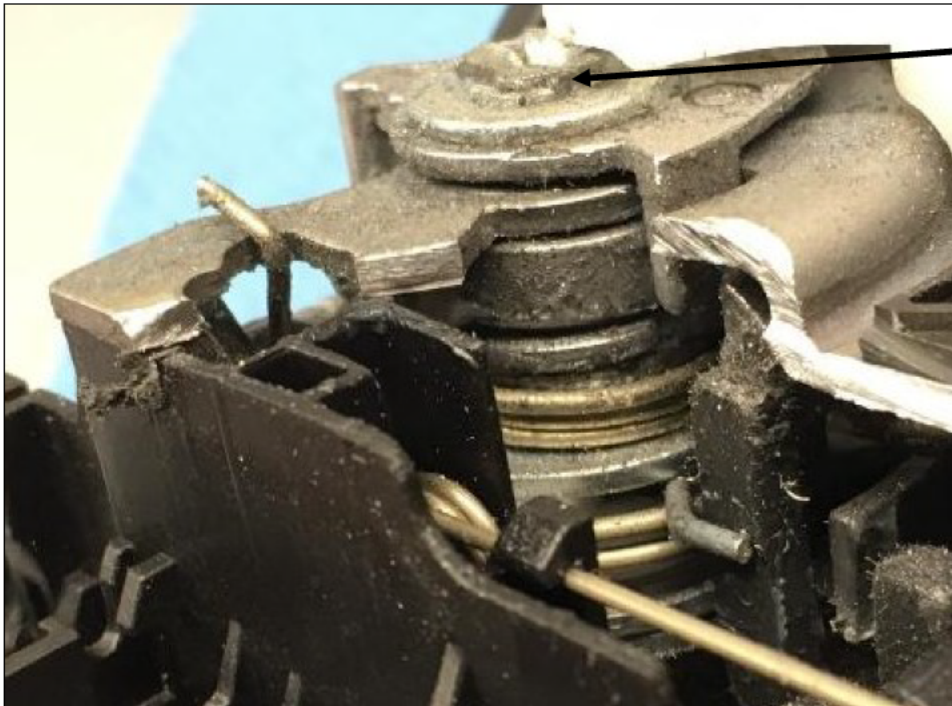
During disconnecting the pawl pin from the backplate sub-assy the jammed condition dissolved

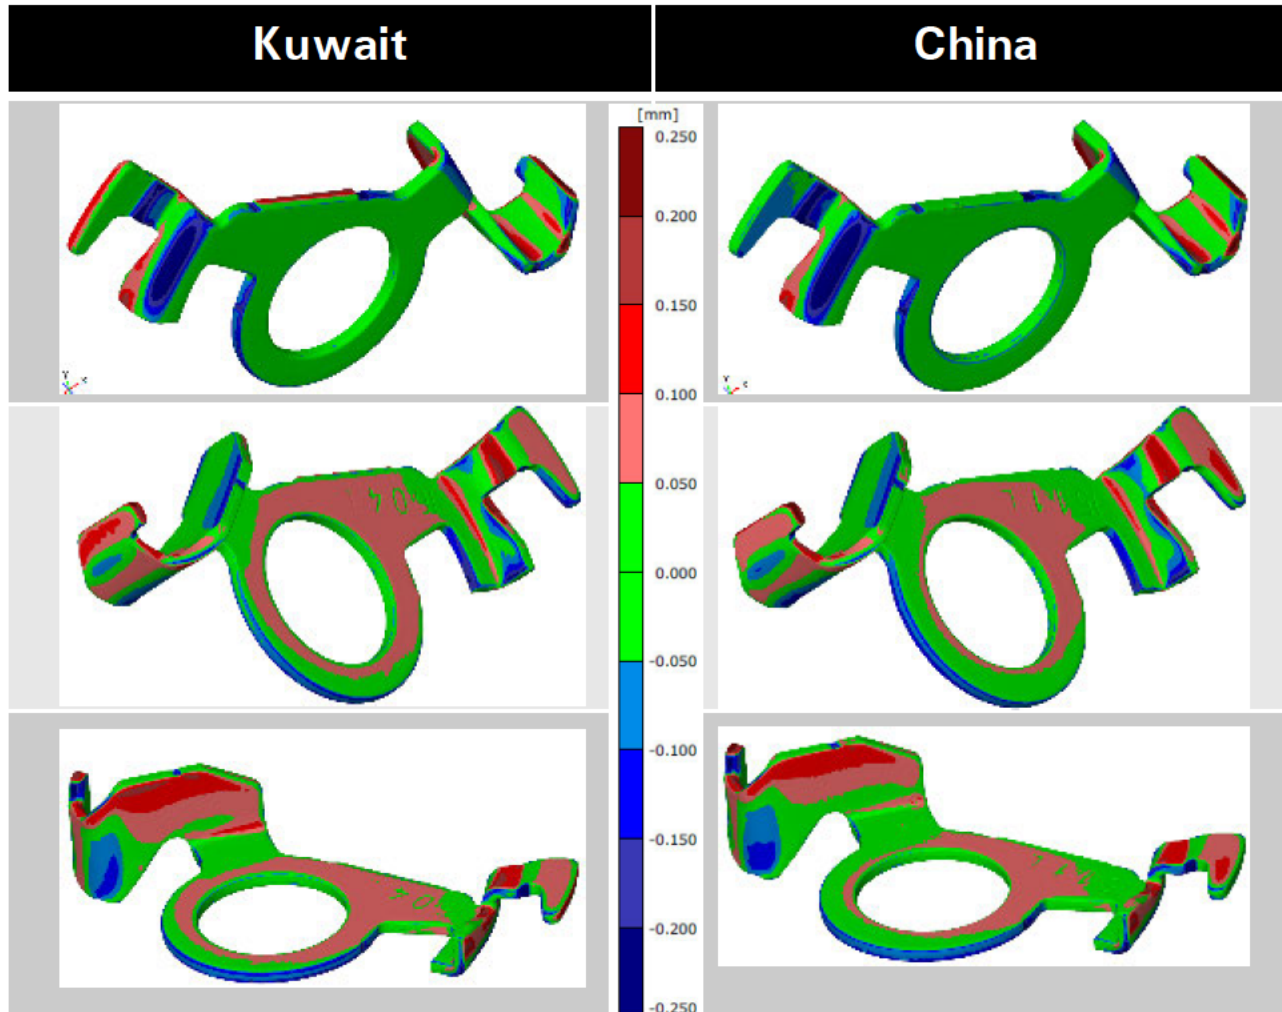
- Thickness of the lever **ok**
- Scratch marks on lever not visible in scan comparison – nothing on this lever indicates why it was in contact with o/s transmission lever

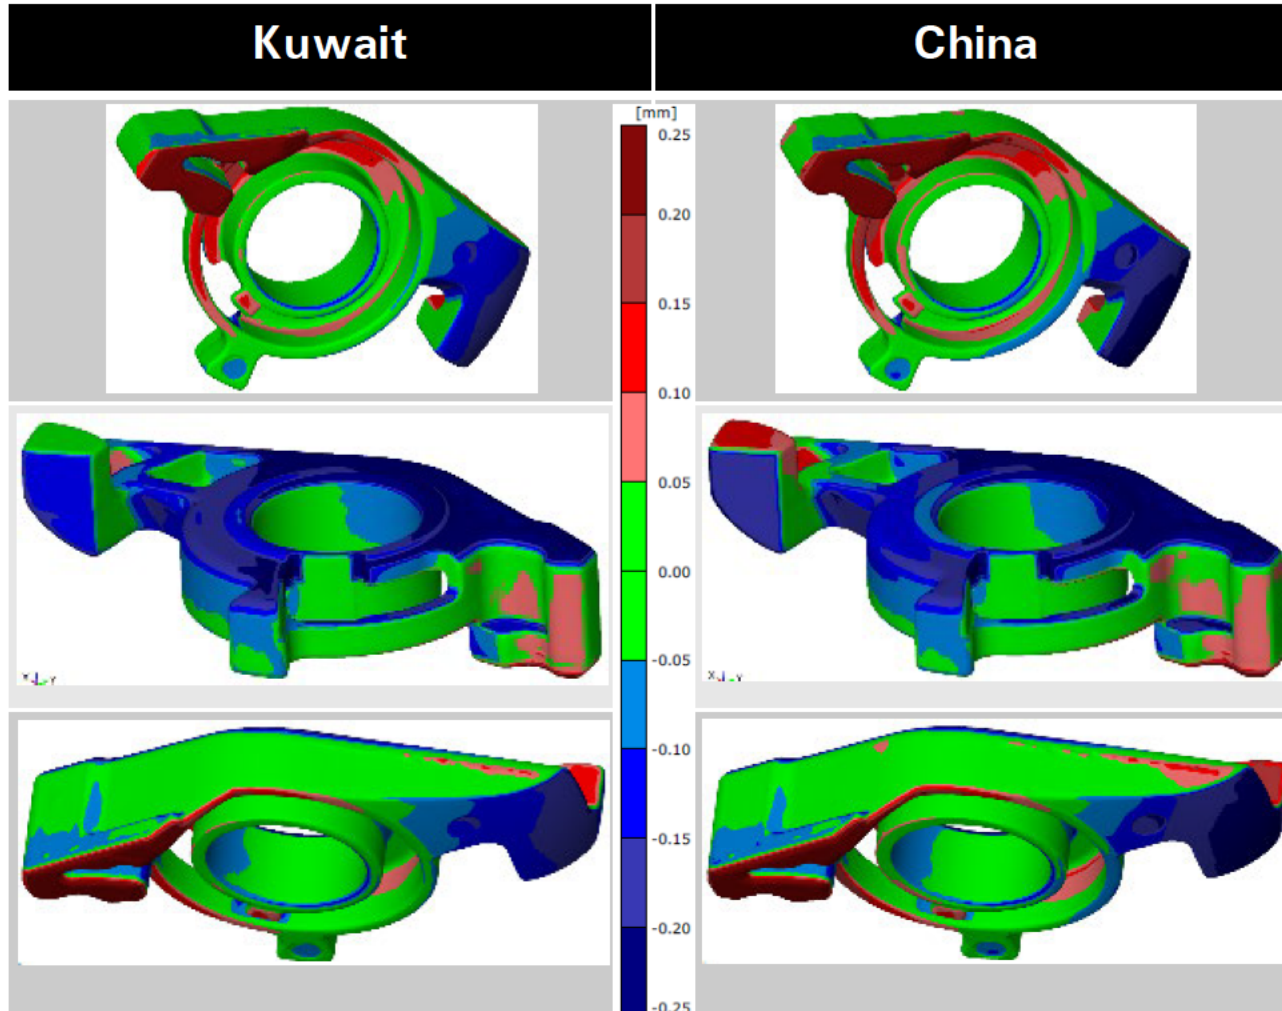
- Wear out area of the lever too thin – 4,92 **nok**
- Other area of the lever too thin – 5,06 **nok**
- Supplier involvement to clarify quality situation

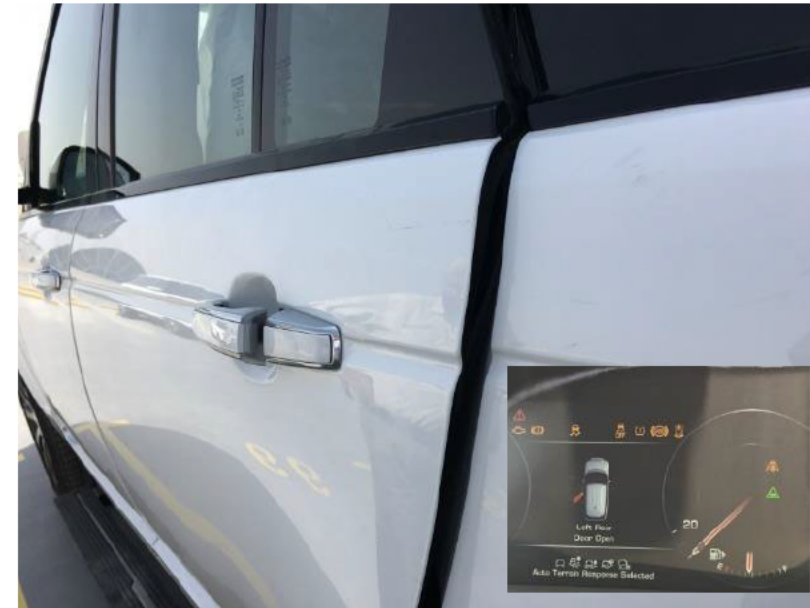
Problem Investigation/Verification: Visit to vehicle in Dubai August 2016. Customer reported a door opening post P068, vehicle held for investigation. Vehicle tested by JLR UK Engineer in market and unable to fault the latch. Open circuit condition evident on the vehicle, therefore P068 flash was a success. Vehicle in workshop, ambient temp circa 25°C. Unable to jam the handle in the workshop. Placed vehicle onto roof, high solar load, ambient temp 48°C. Soaked vehicle for two hours, and then able to jam three of the four handles on the vehicle on the first attempt.

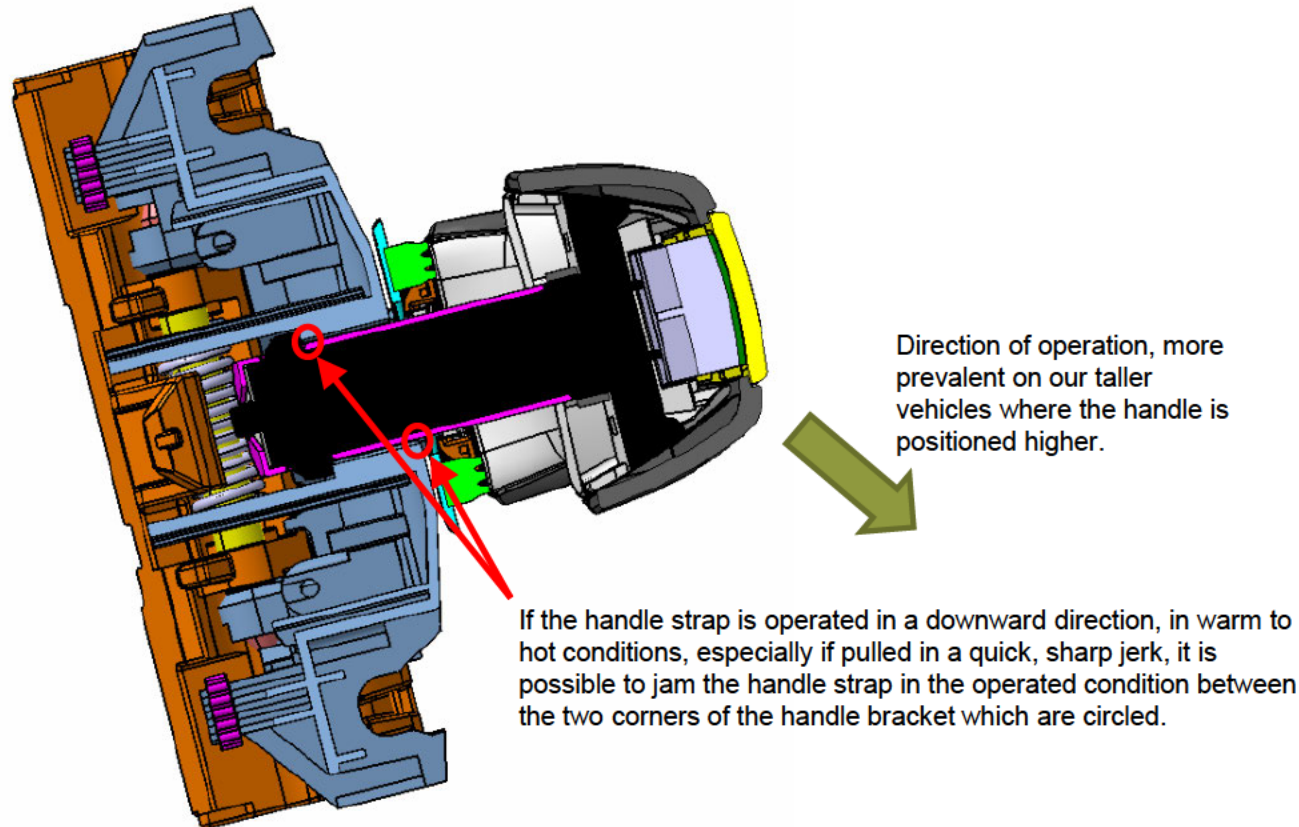
Exterior release handle jammed in the actuated position due to diametrically opposing contact points, increasing friction to the point where the counter balance spring cannot return the handle to rest position.

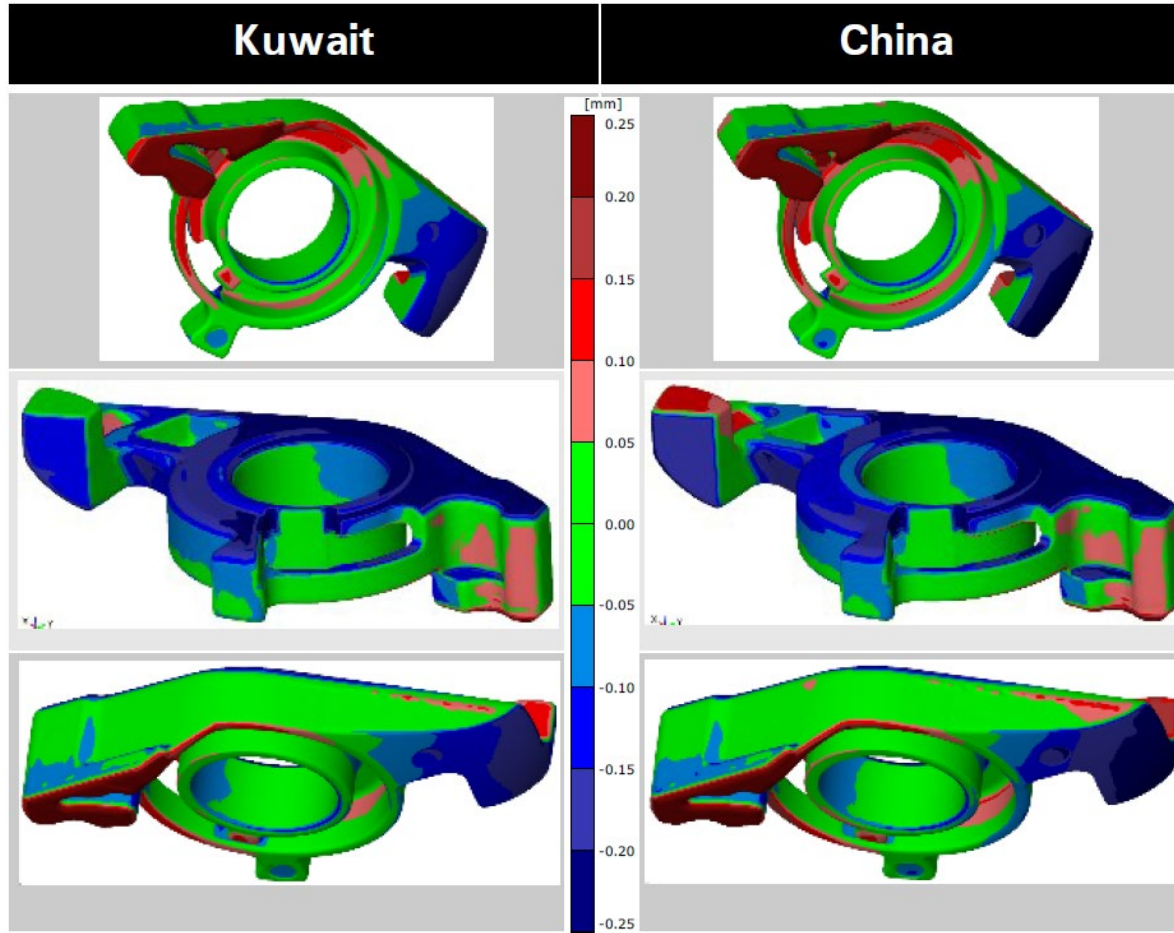
Abraded, worn area of the lever is out of spec at 4.92mm

Supplier is engaged to resolve OOS conditions
