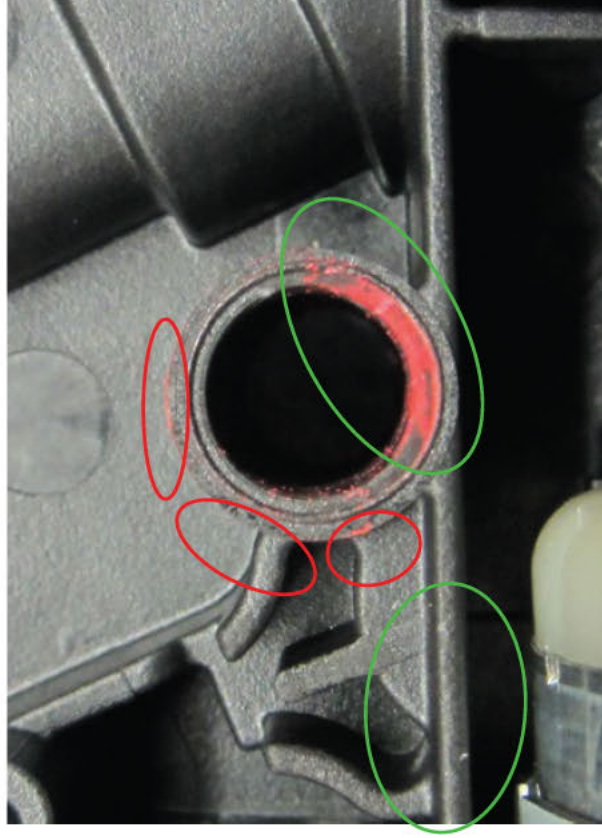
Samples with sealing contour (height 0,3 mm) in KV housing and 3 tolerance spots

Slight water traces found inside of the sealing contour ✗

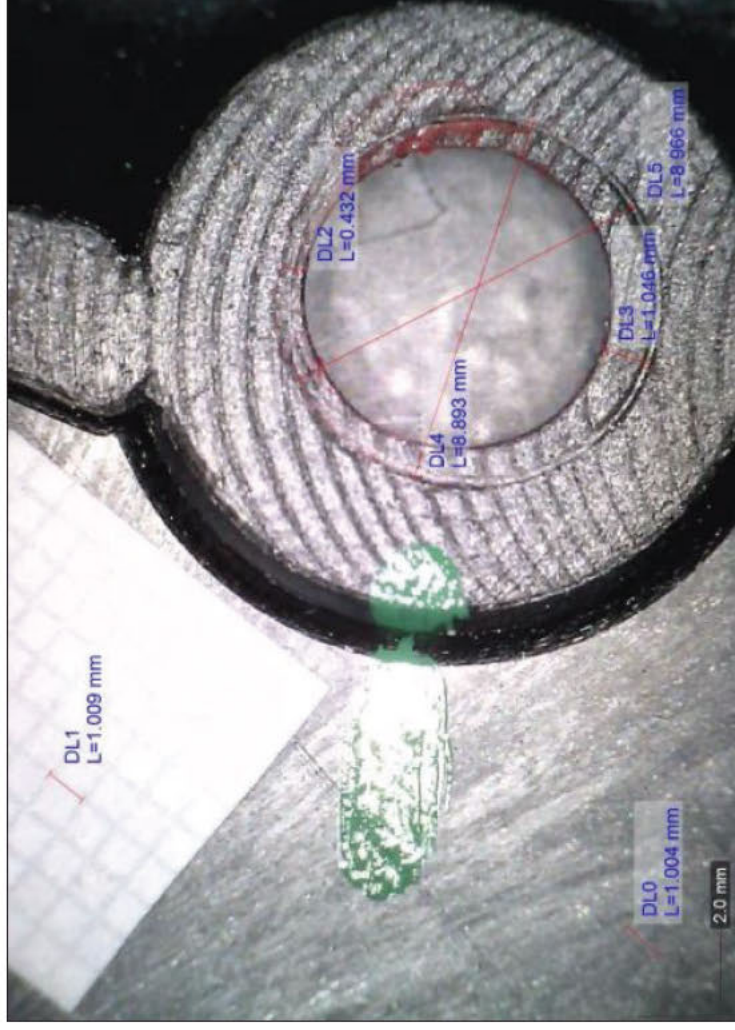
Due to tolerances the sealing contour is not central. Depth of indentation not sufficient to seal complete area.

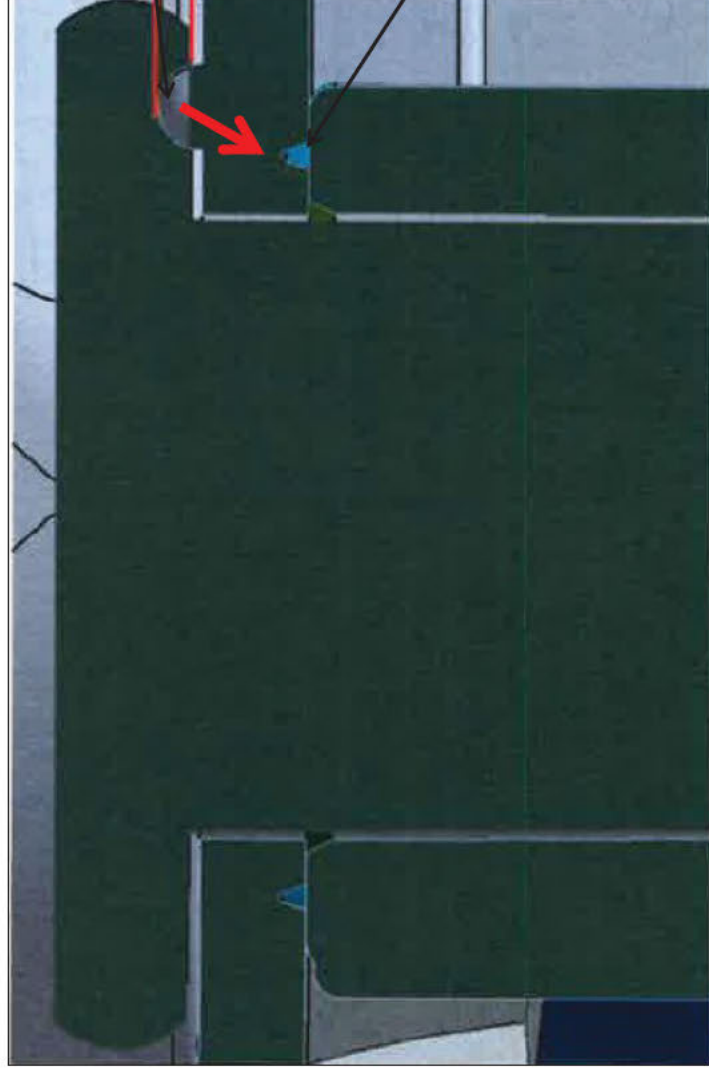
Tolerance spots of the KV lid not perpendicular to the sealing contour at the KV housing. Force transmission during riveting process not optimal (transverse) to press the sealing contour into the lid

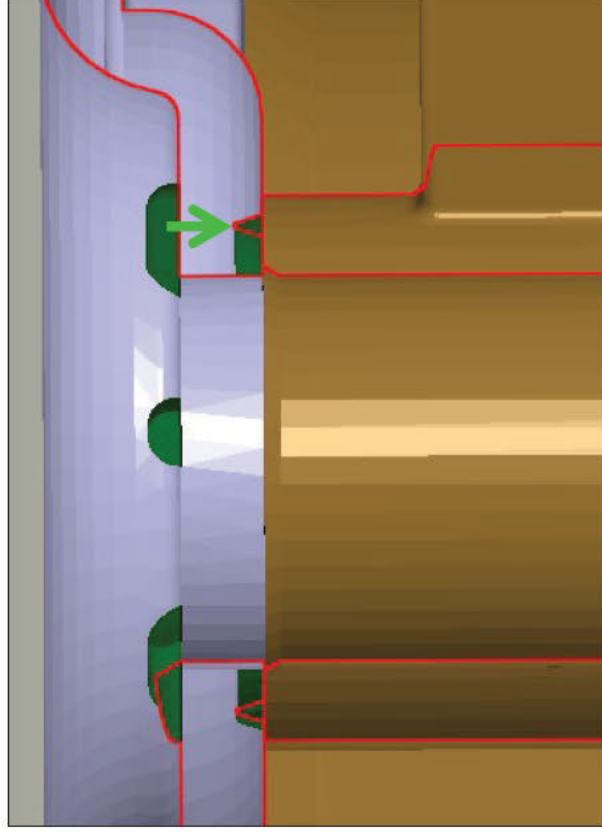
Optimized design of tolerance spots

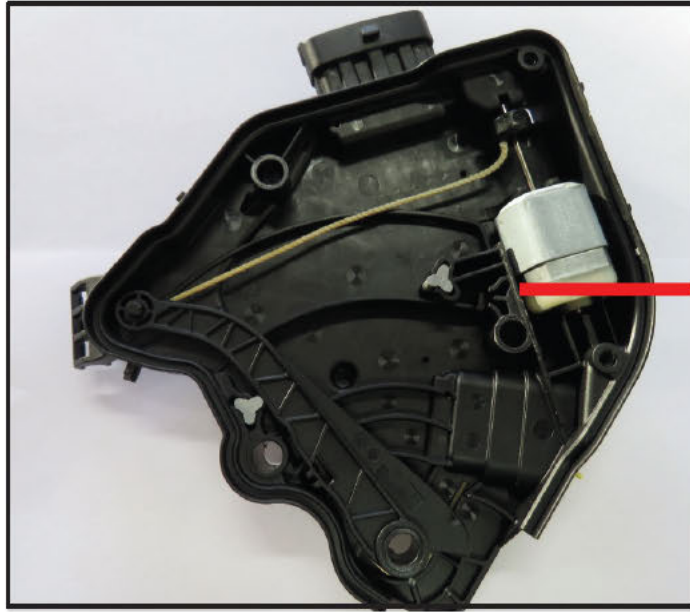
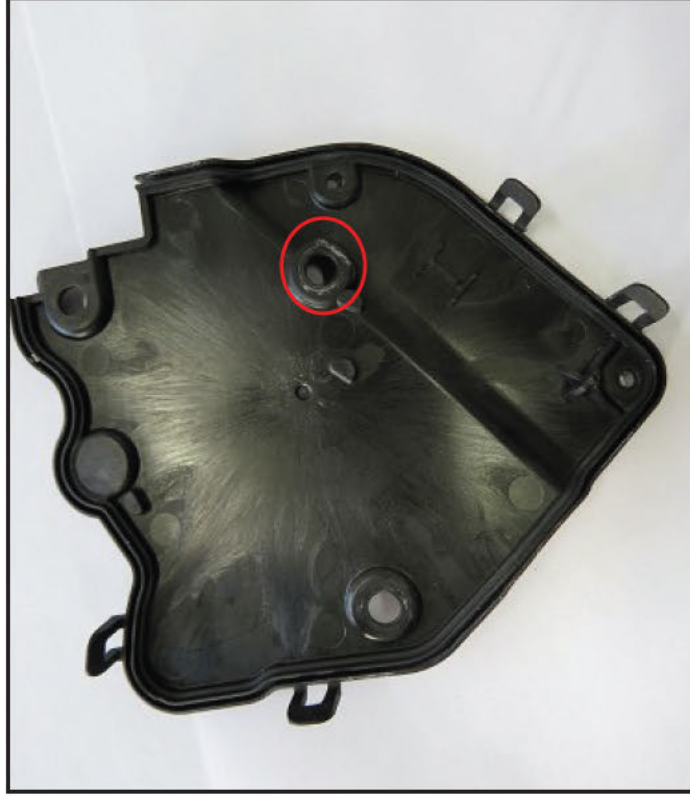
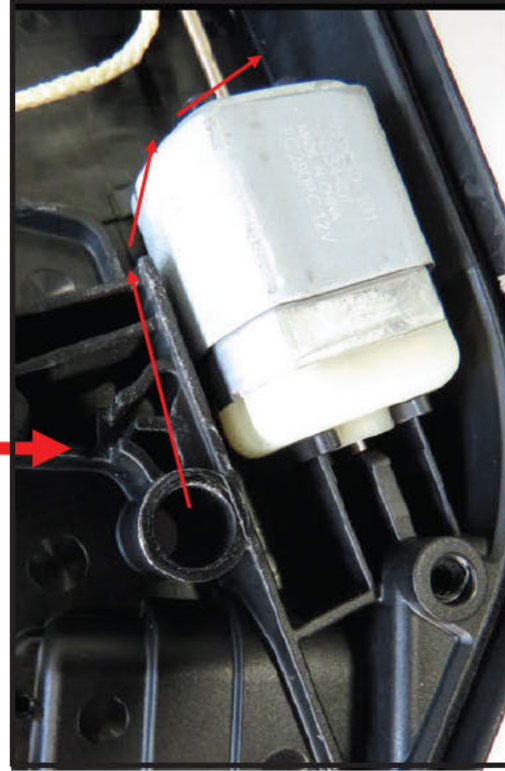
**FT LH CL KV LB
18.9.2017**

Conclusion: leak path via KV rivet hole found, part prior grey sticker introduction.

No corrosion on the KV motor visible
KV motor operation open circuit → OK KV function, 0 windings left, cord will fully unwound

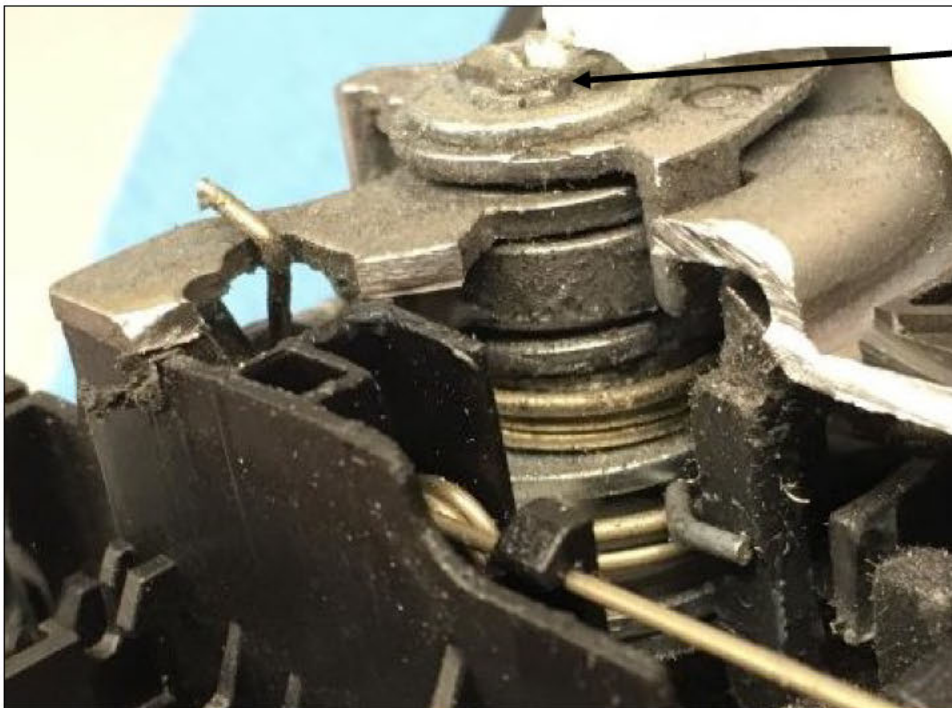
During disconnecting the pawl pin from the backplate sub-assy the jammed condition dissolved

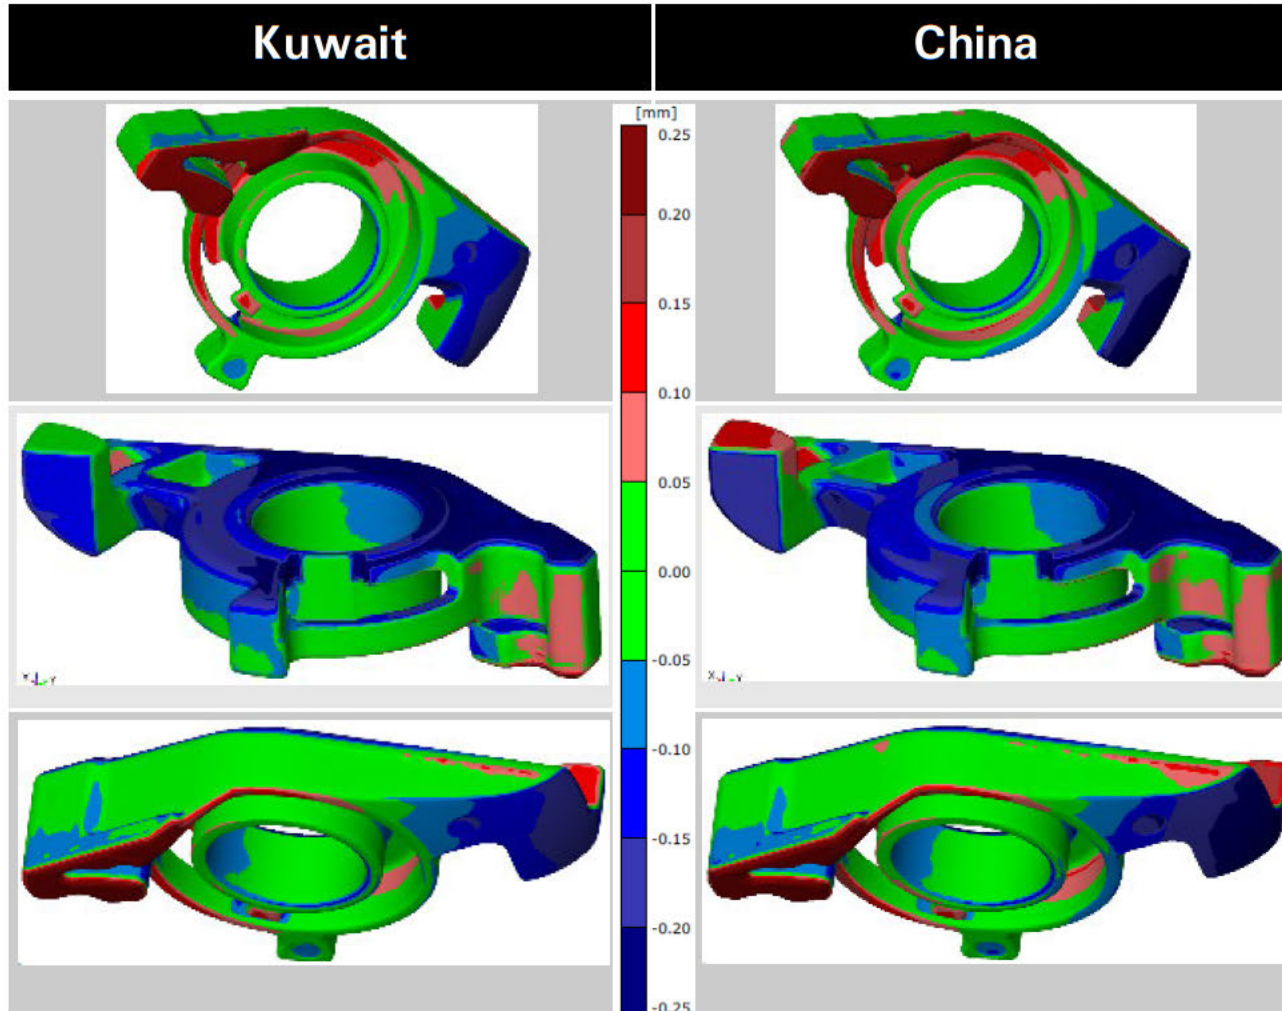
- Wear out area of the lever too thin – 4,92 **nok**
- Other area of the lever too thin – 5,06 **nok**
- Supplier involvement to clarify quality situation

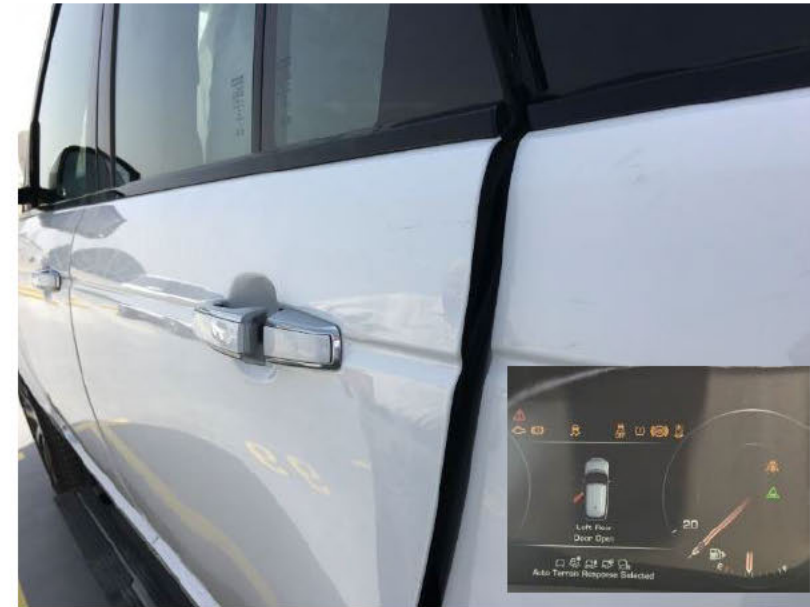
Problem Investigation/Verification: Visit to vehicle in Dubai August 2016. Customer reported a door opening post P068, vehicle held for investigation. Vehicle tested by JLR UK Engineer in market and unable to fault the latch. Open circuit condition evident on the vehicle, therefore P068 flash was a success. Vehicle in workshop, ambient temp circa 25°C. Unable to jam the handle in the workshop. Placed vehicle onto roof, high solar load, ambient temp 48°C. Soaked vehicle for two hours, and then able to jam three of the four handles on the vehicle on the first attempt.

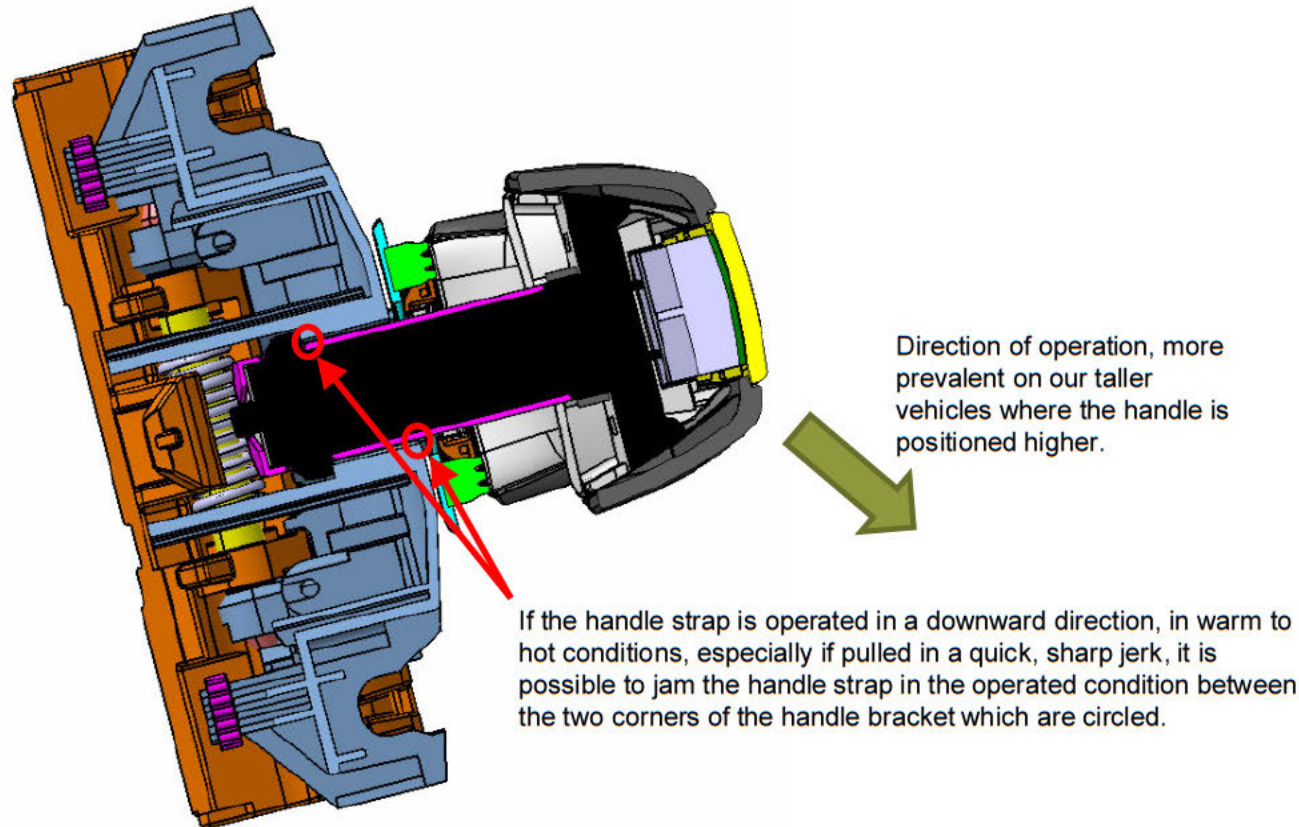
Exterior release handle jammed in the actuated position due to diametrically opposing contact points, increasing friction to the point where the counter balance spring cannot return the handle to rest position.

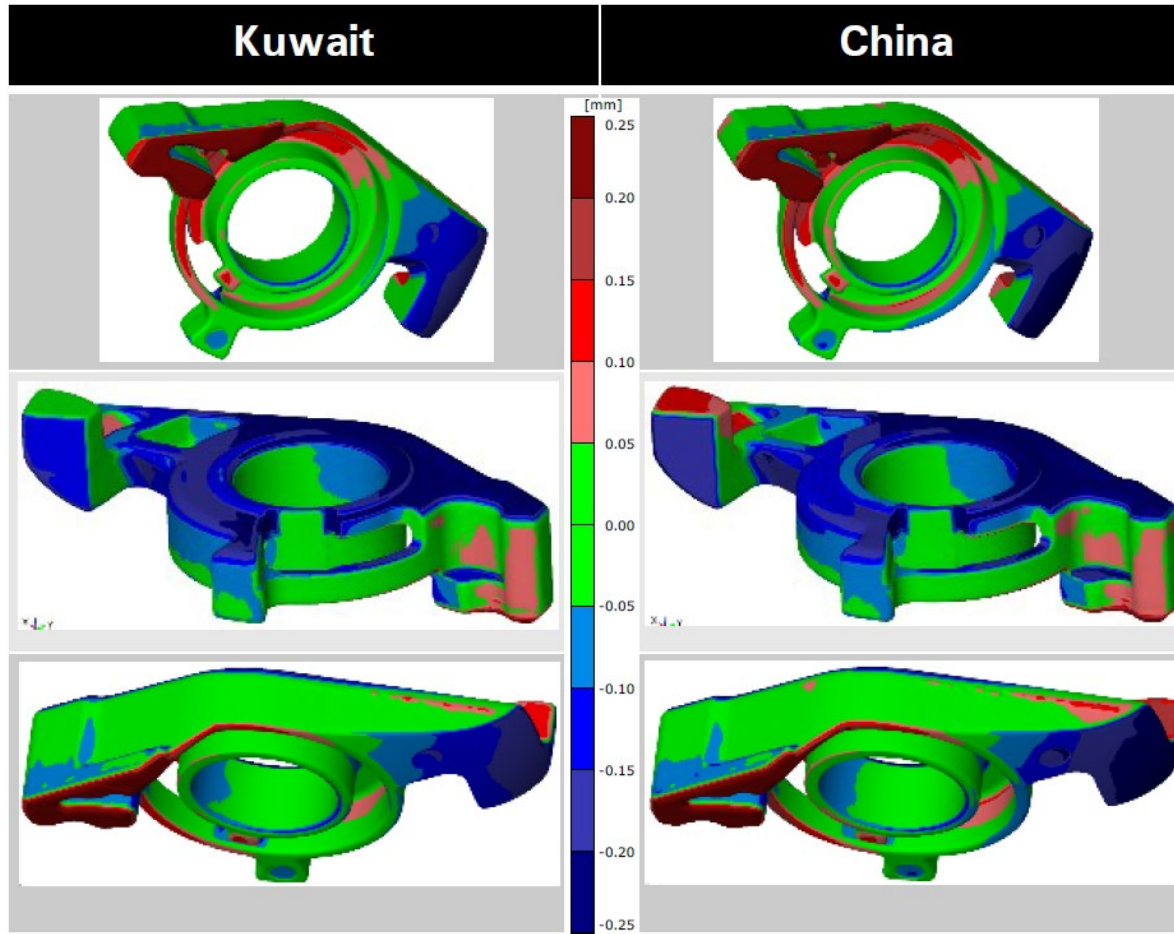
Abraded, worn area of the lever is out of spec at 4.92mm
