PE18-004

Material Request Number 8
Materials previously provided
to NHTSA

Field Service Reporting- Incident Report

CAC FS: Product Information Report

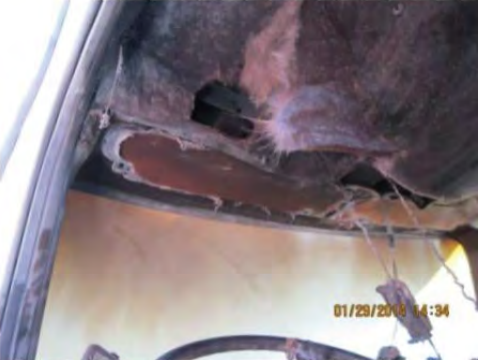
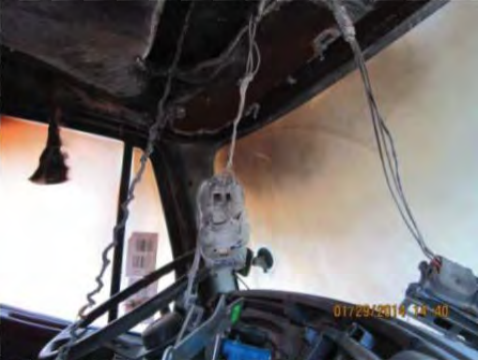
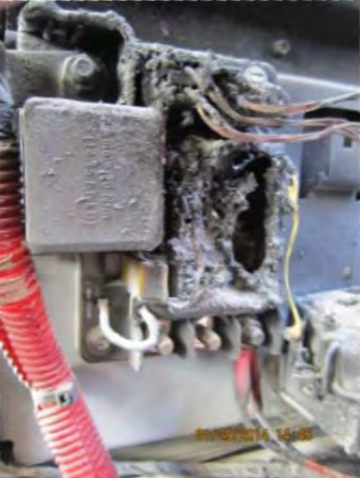
INTERIOR CAB FIRE SEEMS TO HAVE STARTED BEHIND DRIVERS AT POWER NET DISTRIBUTION BOX AND THEN WENT UP BACK WALL INTO HEADLINER AND THEN PROGRESSED FORWARD

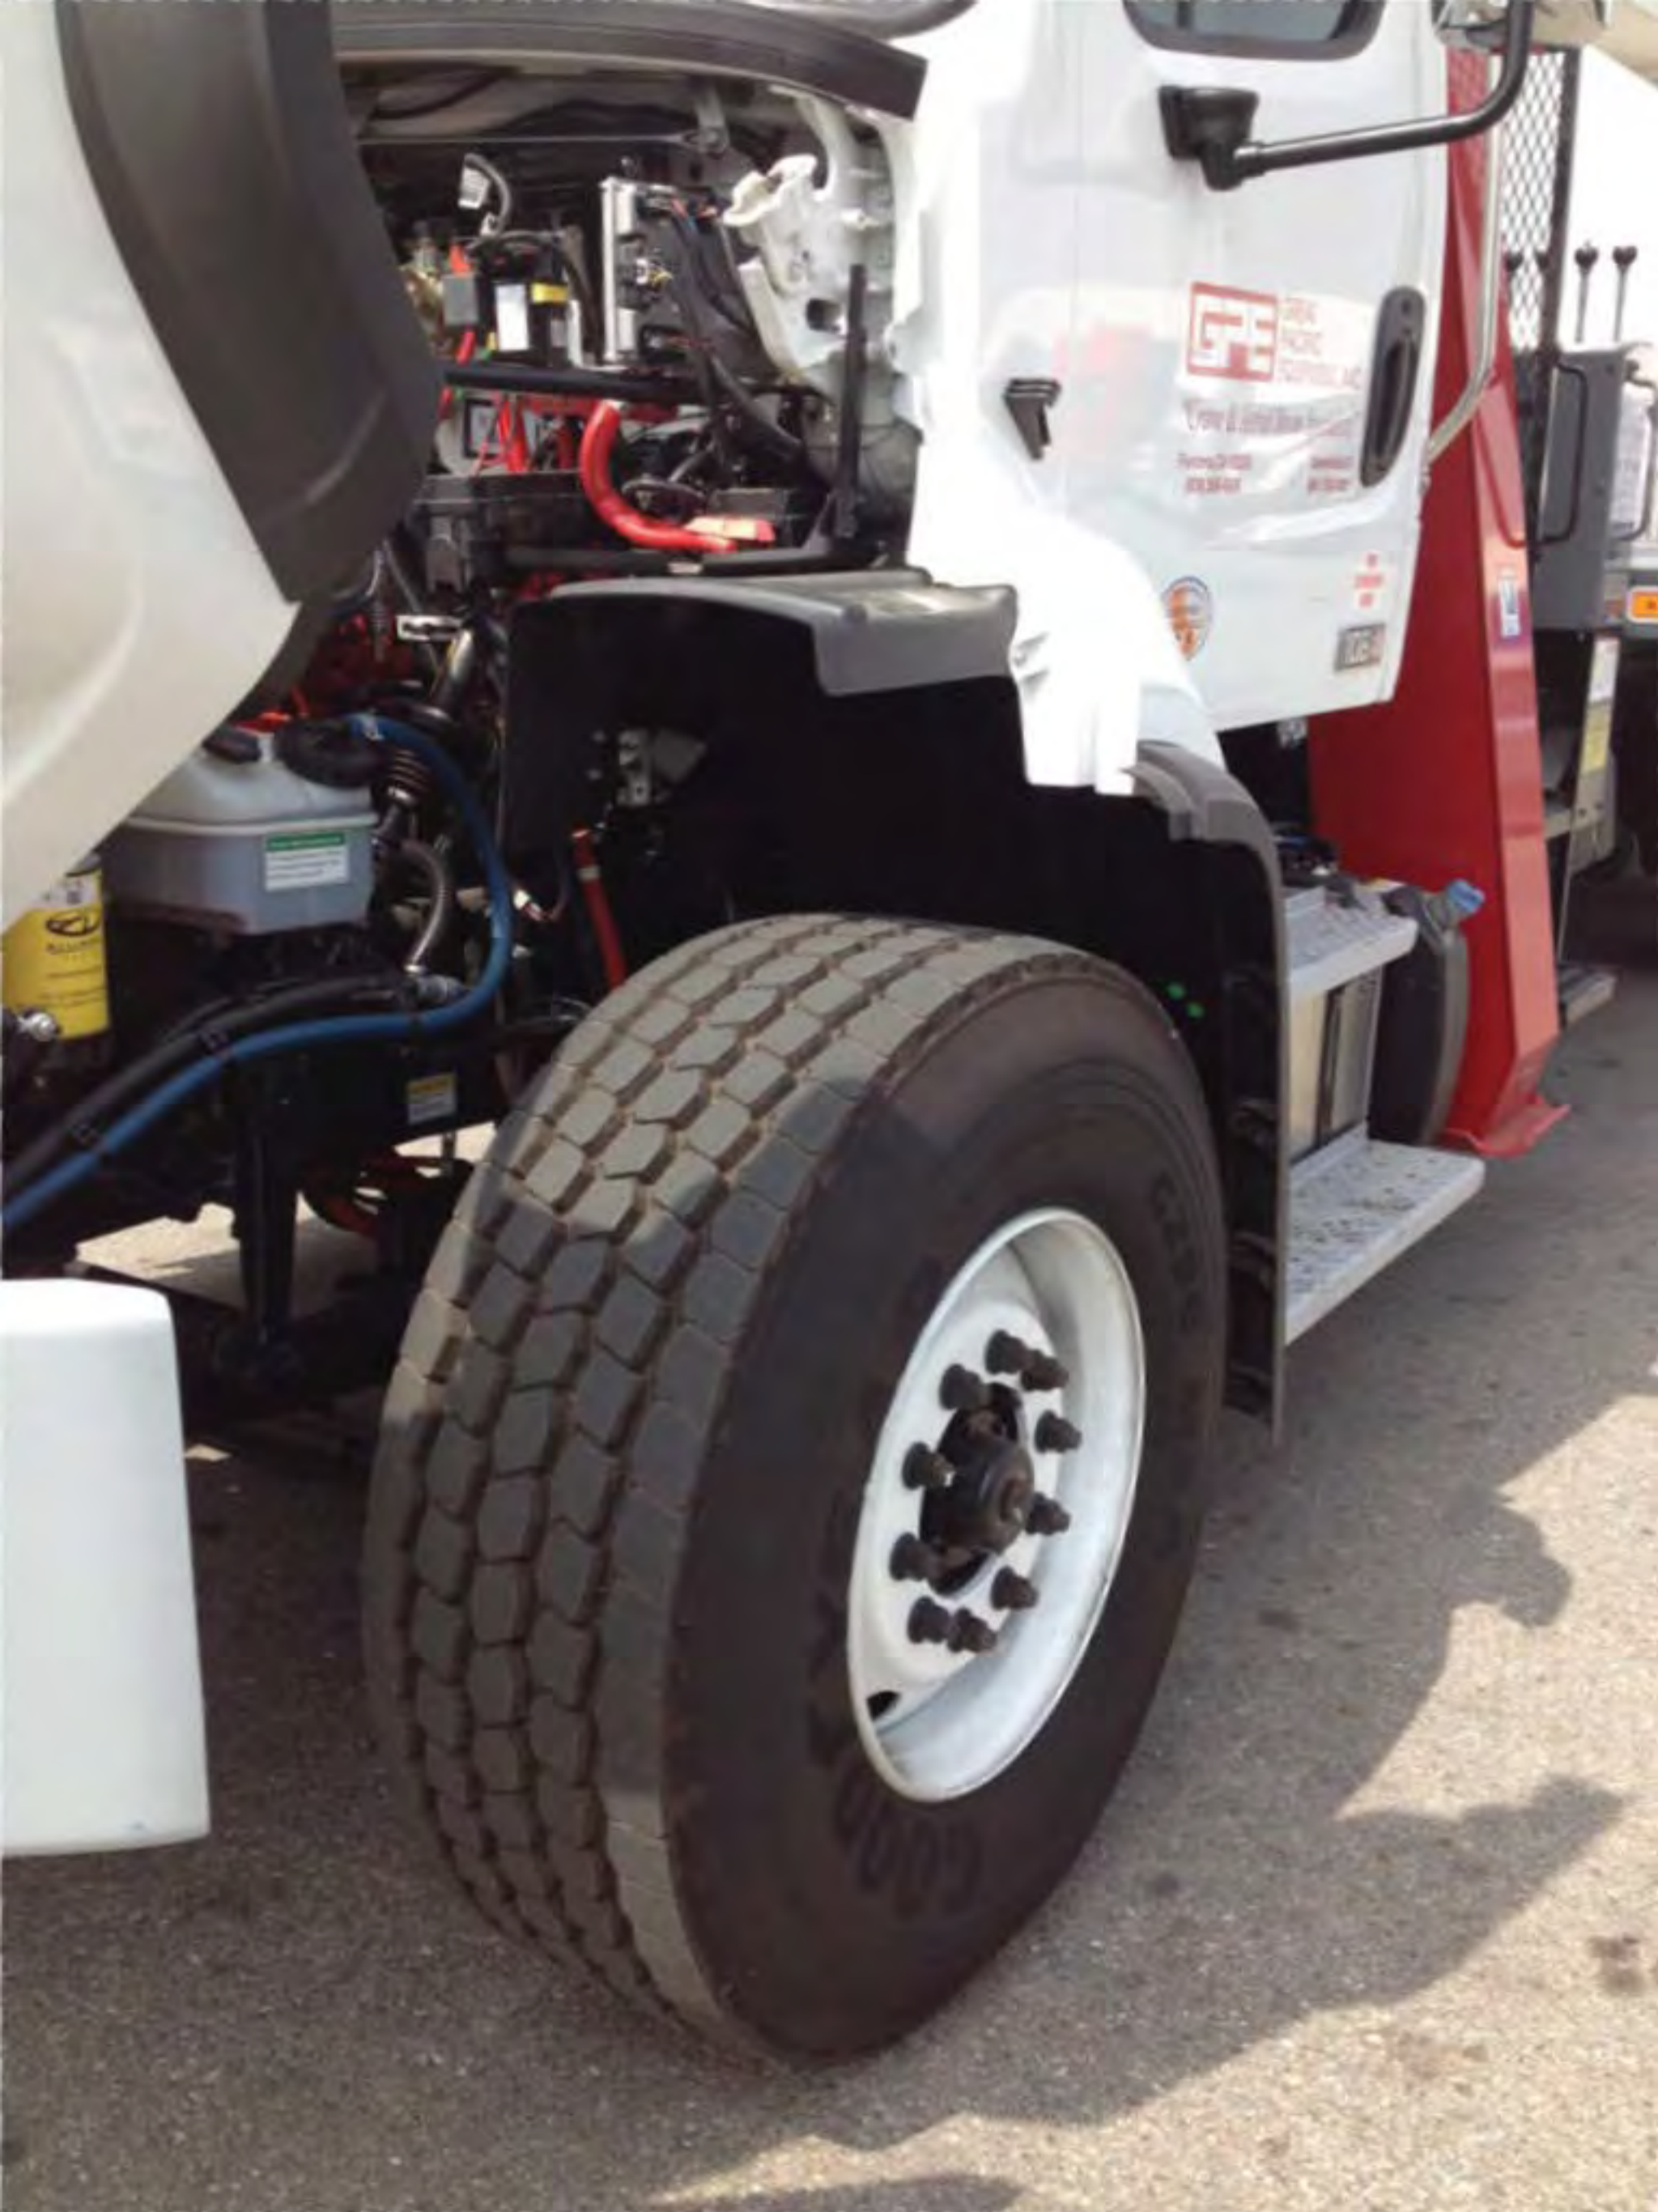
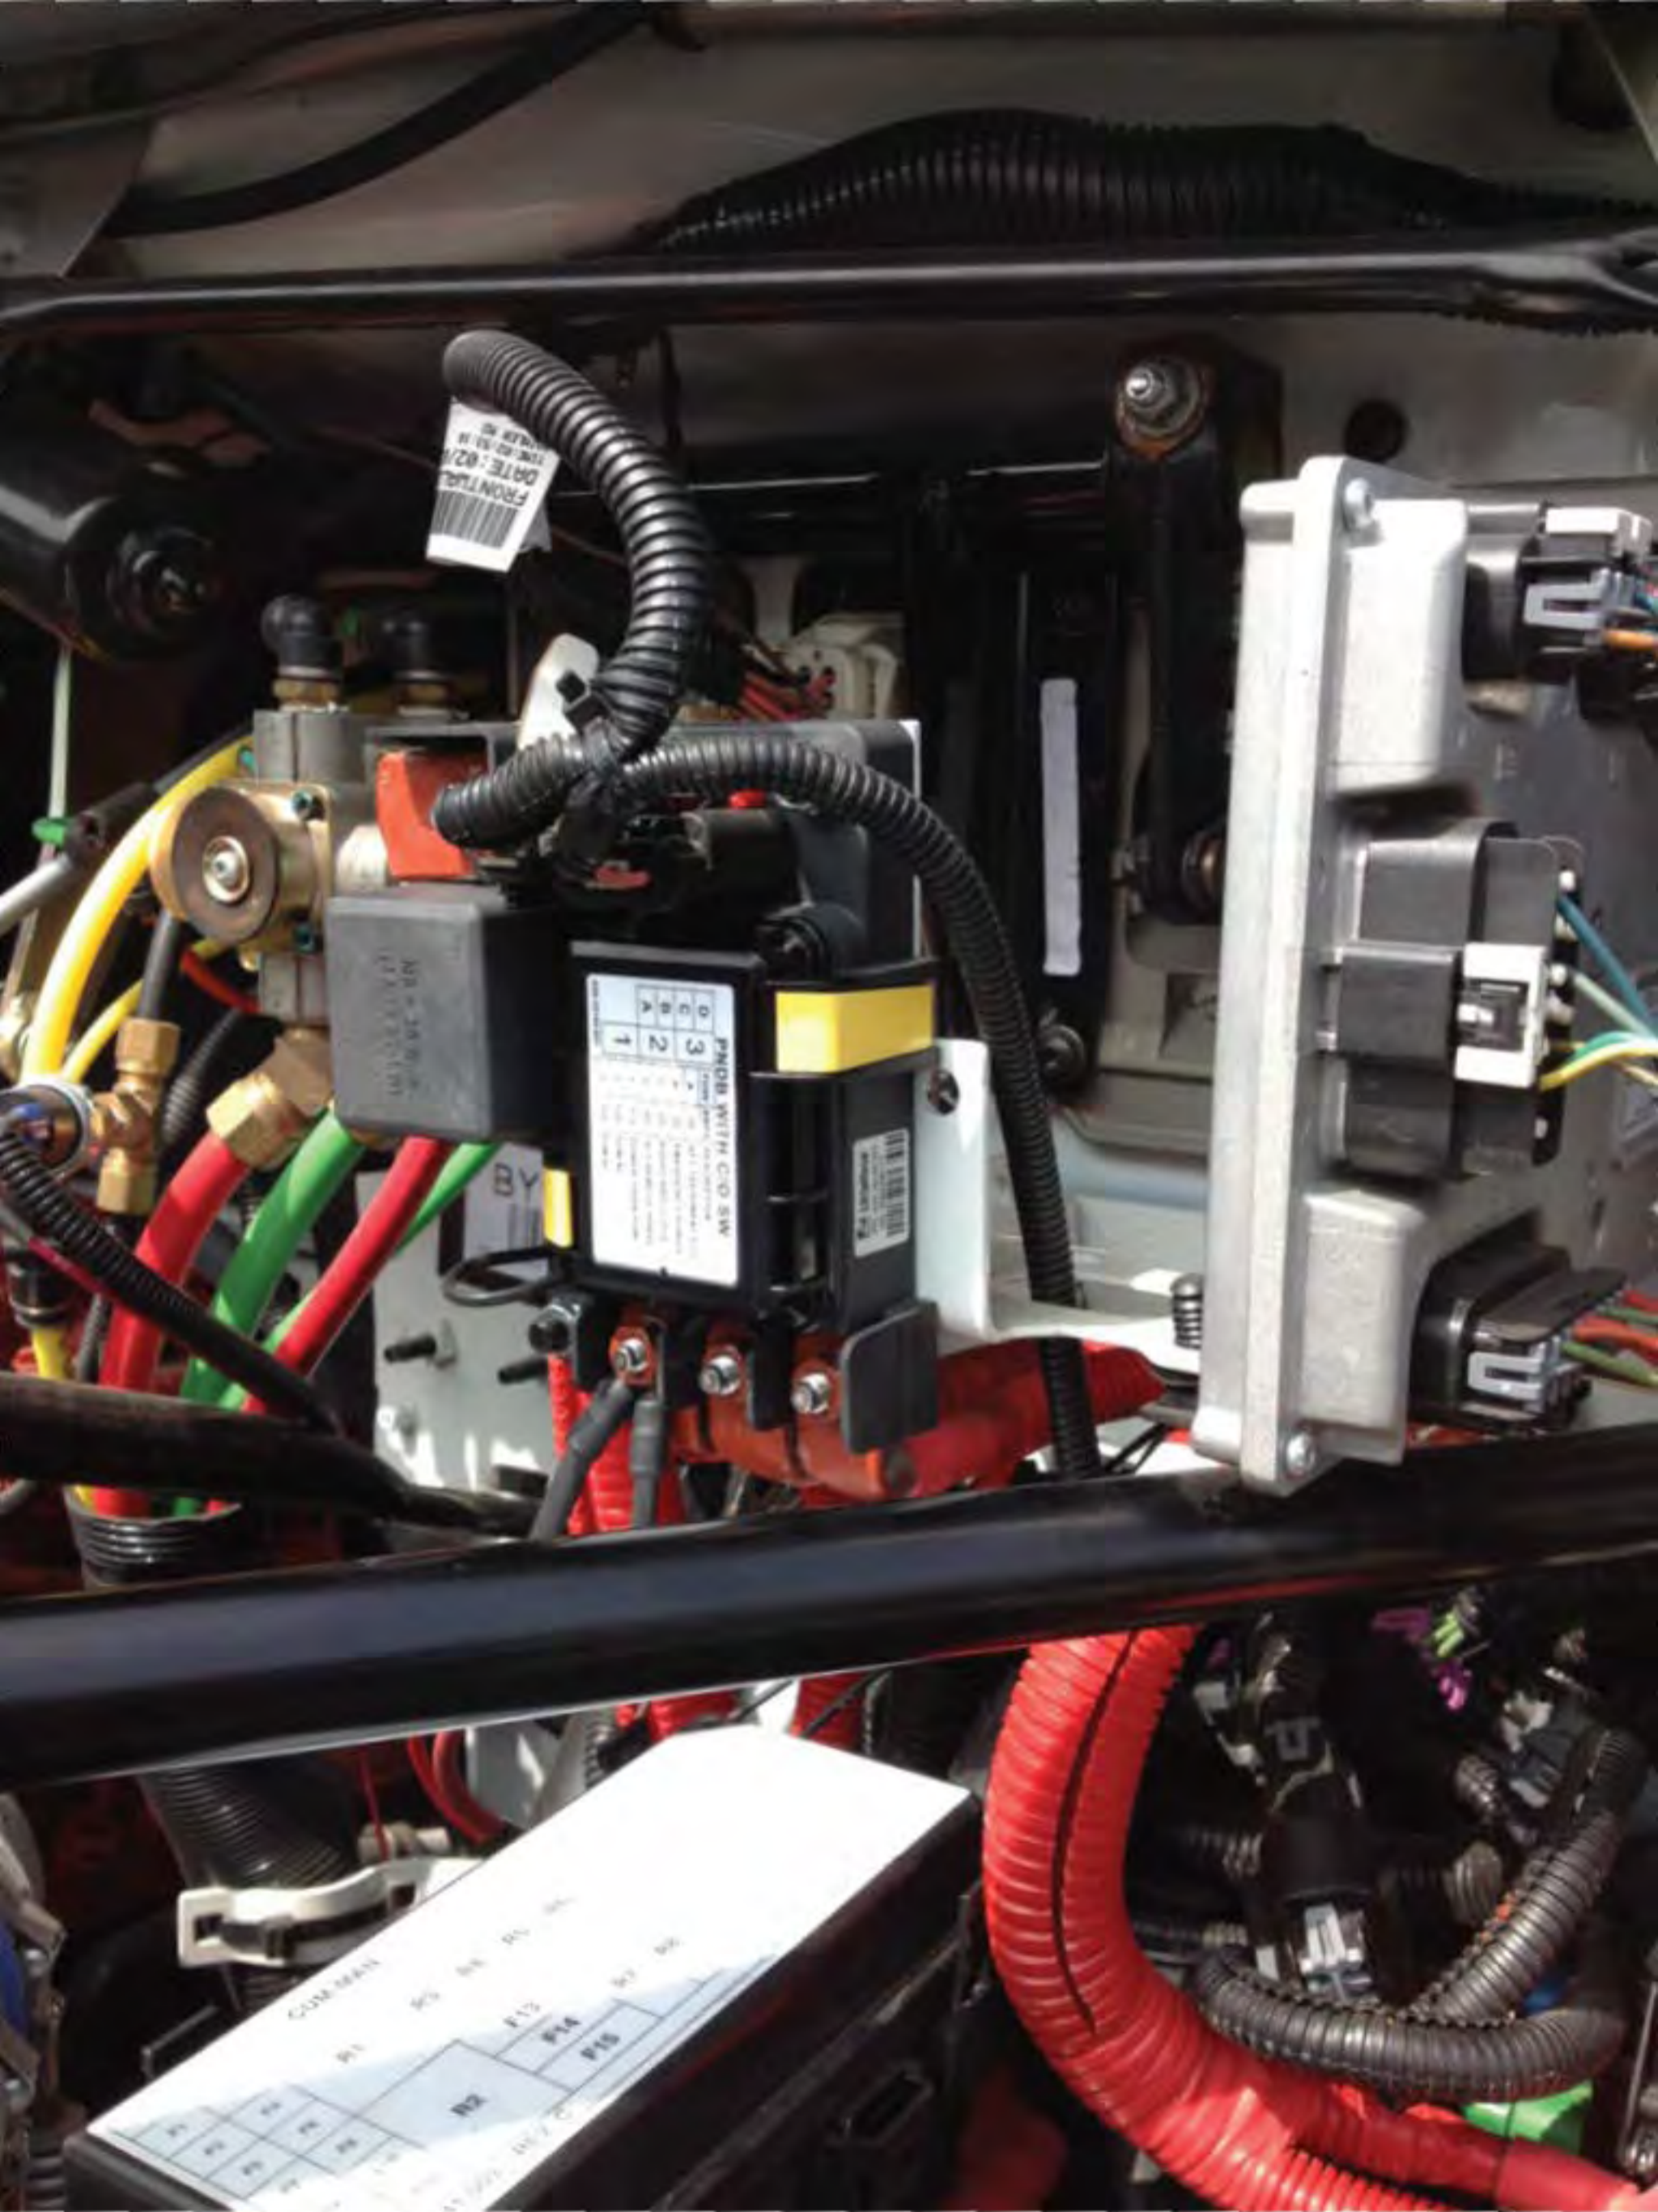
THE BLADE FUSES ARE FALLING OUT OF THE PNDB DUE TO A LACK OF ADEQUATE RETENTION. THE VEHICLES ARE TOWED INTO THE SHOP WITH VARIOUS FAULT CODES, AND WHEN THE COVER IS REMOVED FROM THE PNDB THE TECH DISCOVERS ALL FUSED ARE LOOSE AND OUT OF POSITION. BY9852 HAD THE PNDB REPLACED AT 2743 MILES. WE FOUND THE SAME ISSUE ON FH2171. NOTE IN THE 2 ATTACHED PHOTOS THAT THE PNDB IS MOUNTED ON A NON-RIGID BRACKET THAT ALLOWS SIGNIFICANT FORE-AFT MOVEMENT AND VIBRATION DURING VEHICLE OPERATION. THIS MOTION COULD BE DISPLACING THE FUSES, ESPECIALLY IN THE HEAVY DUTY VOCATION IT APPEARS THIS UNIT IS SPEC'D FOR. A SUGGESTED FIELD FIX ON UNITS THAT DO NOT HAVE FUSE RETENTION RIBS MOLDED INTO THE COVER WOULD BE TO FIND AN ADHESIVE BACKED RUBBER SQUARE OF THE APPROPRIATE THICKNESS THAT CAN BE BONDED ONTO THE COVER TO APPLY A COMPRESSIVE FORCE ON THE FUSES.
COMPLETE MODULES FOR BOTH VEHICLES ARE BEING RETURNED TO ALEX DEMOSS VIA FEDEX TRACKING # ██████████

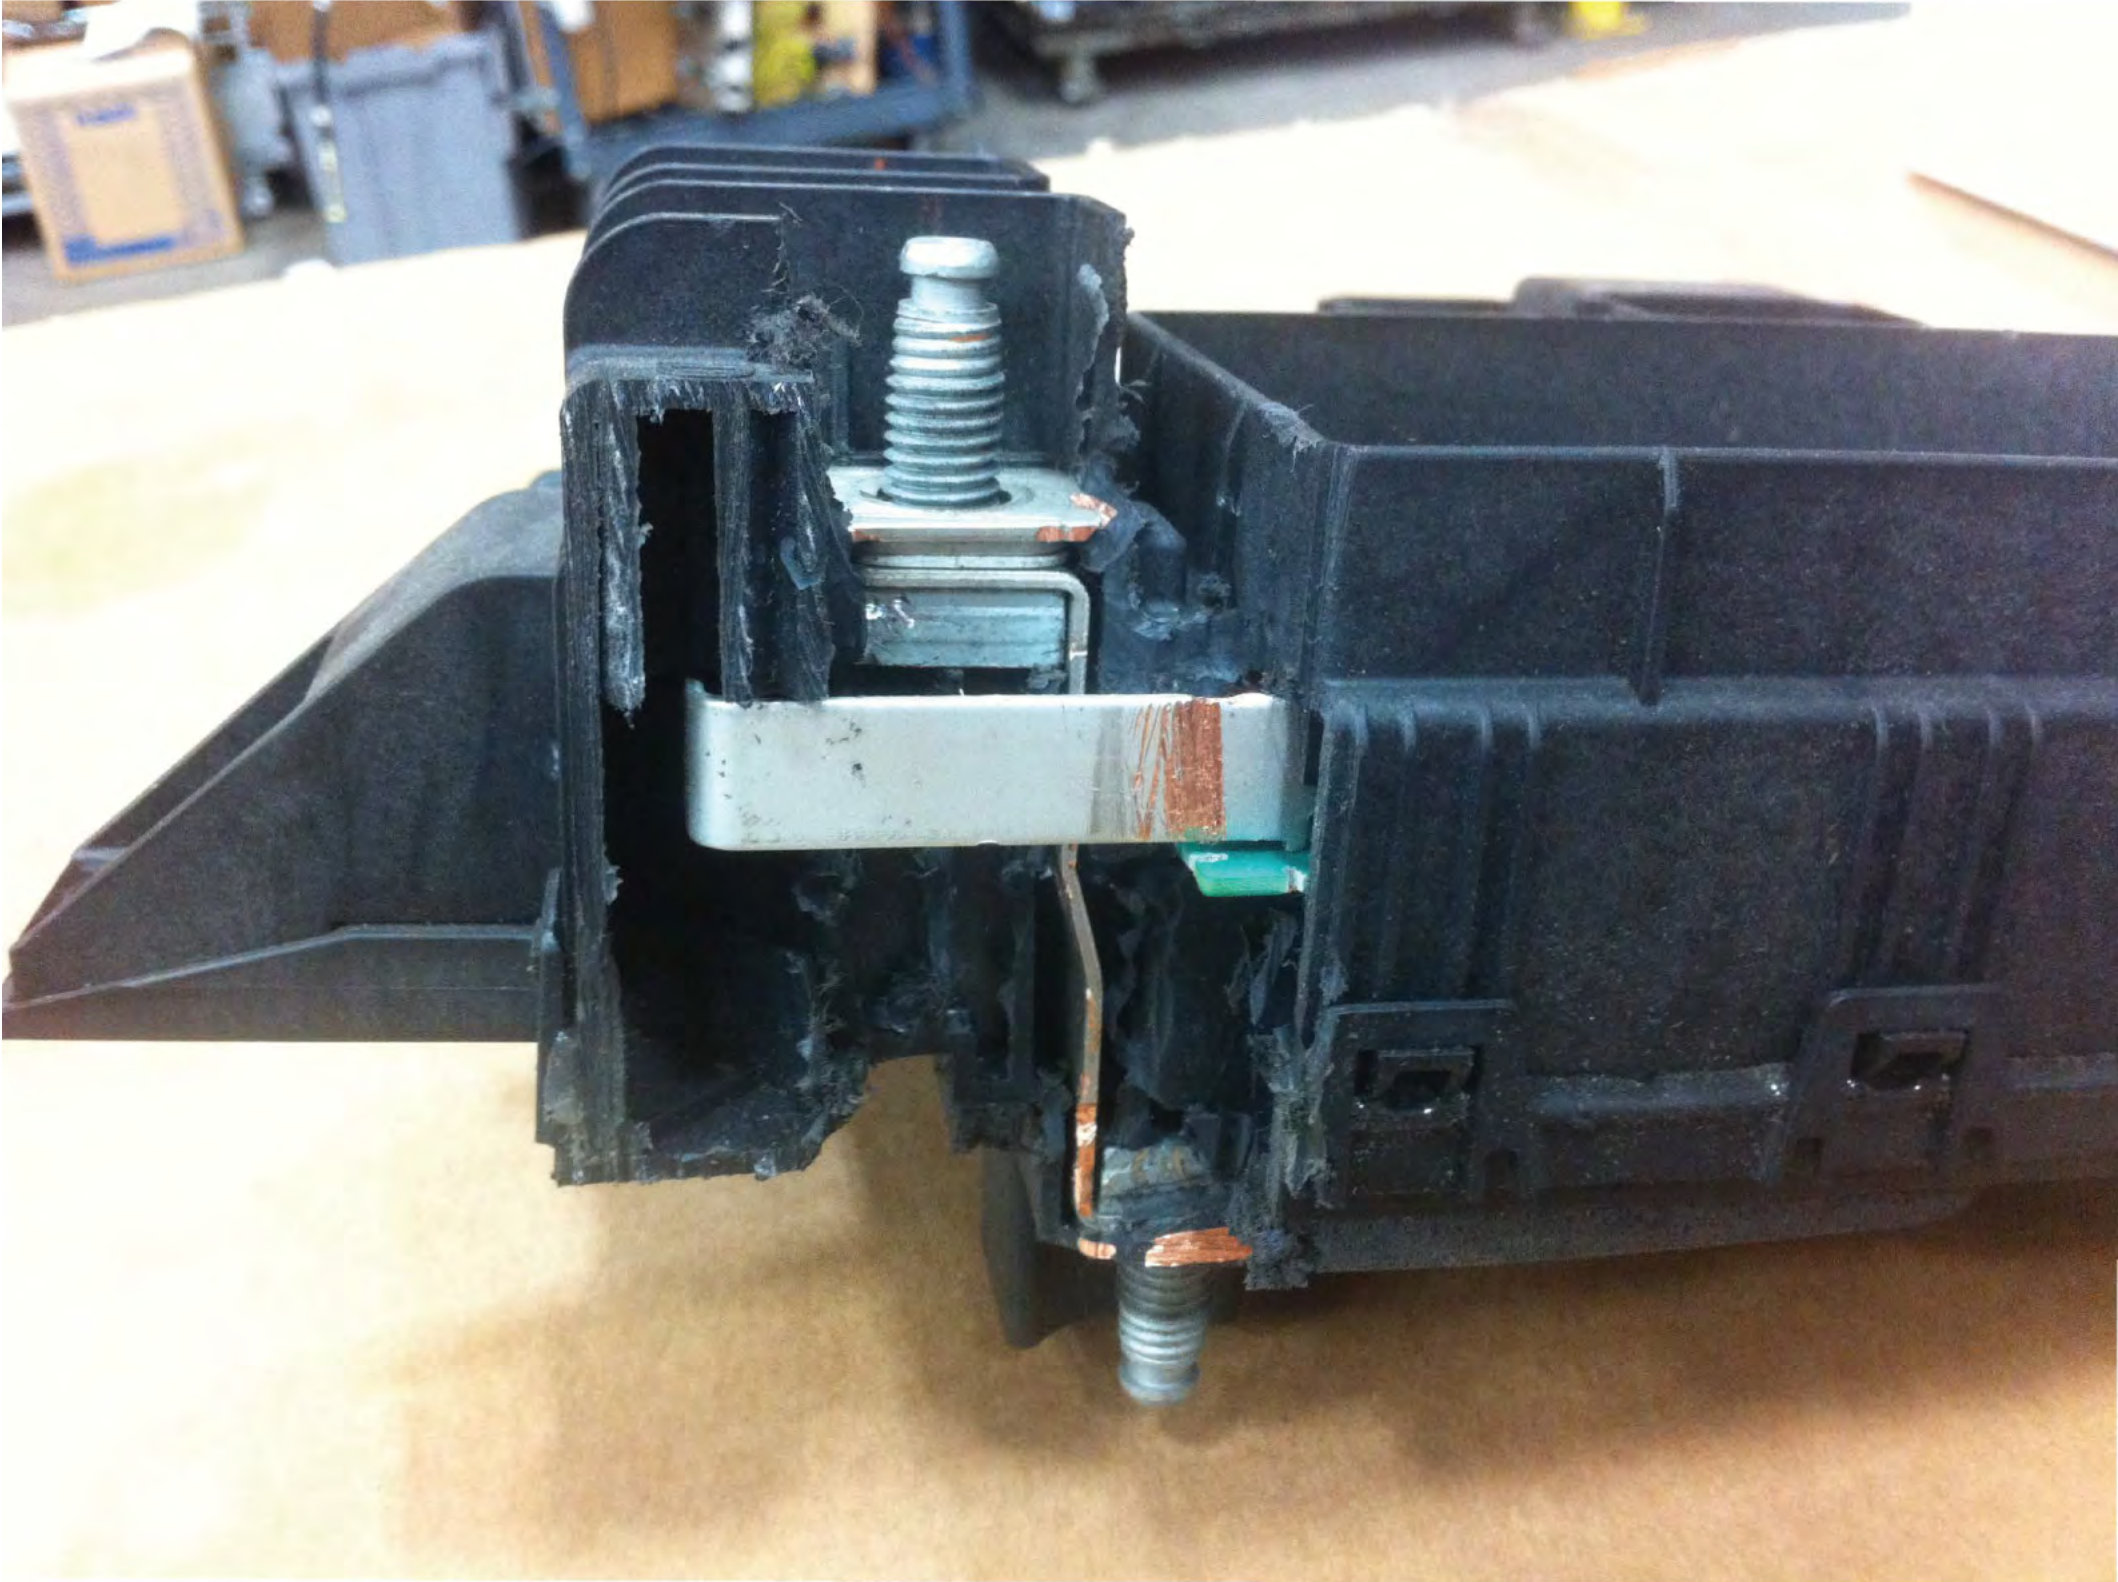
WHEN THE DEALER TIGHTENS THE POWER SUPPLY CABLE DOWN AS MUCH AS POSSIBLE IT IS STILL LOOSE, CAUSING AND INTERMITTENT CONNECTION ISSUES. IT APPEARS AS IF THERE IS AN INTERNAL ISSUE PREVENTING A PROPER TORQUE. PLEASE SEE THE ATTACHED MOVIE AND CUT AWAY PICTURE. THE MODULE IN THE VIDEO IS AVAILABLE FOR RETURN IF REQUESTED.

REPLACE PNDB

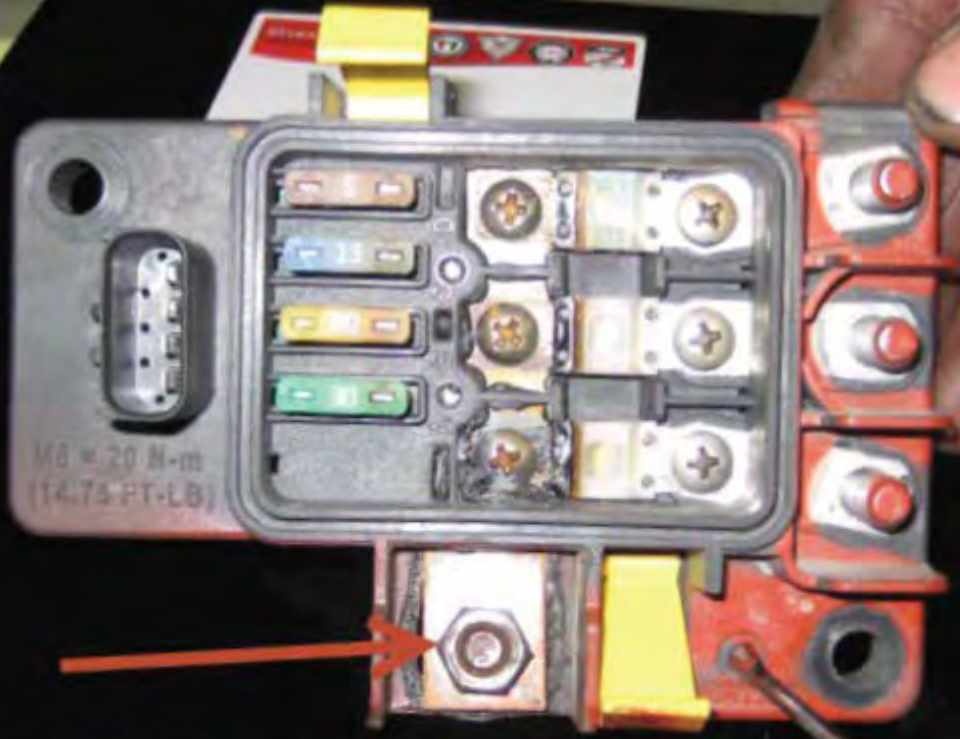
NUTS HOLDING CABLES TO PNDB LOOSE CAUSING HEAT AND DAMAGE TO PNDB. ISSUE REPORTED TO TMP. APPEARS THESE FAILURES ARE AFTER THE PREVIOUS FSPRS.

M8 x 20 N-m
(14.75-PT-LB)

1392836813ADEMOSSPOKE TO GLENN THORNTON, REQUESTED HE HAVE THEM CHECK 33P BOM AND ADVISE WHICH PNDB FAILED, THEN CHECK THE CABLE STRAIN RELIEF TO SEE IF IT MAY HAVE CONTRIBUTED TO THE FAILURE.

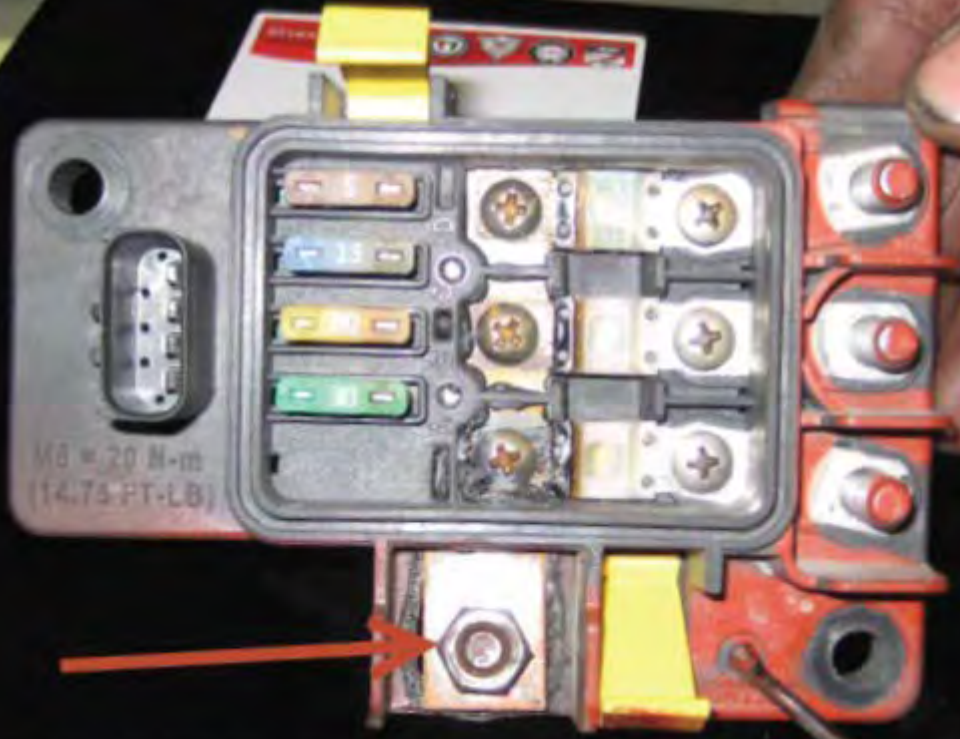
NUTS HOLDING CABLES TO PNDB LOOSE CAUSING HEAT AND DAMAGE TO PNDB

M8 x 20 N-m
(14.75-PT-LB)

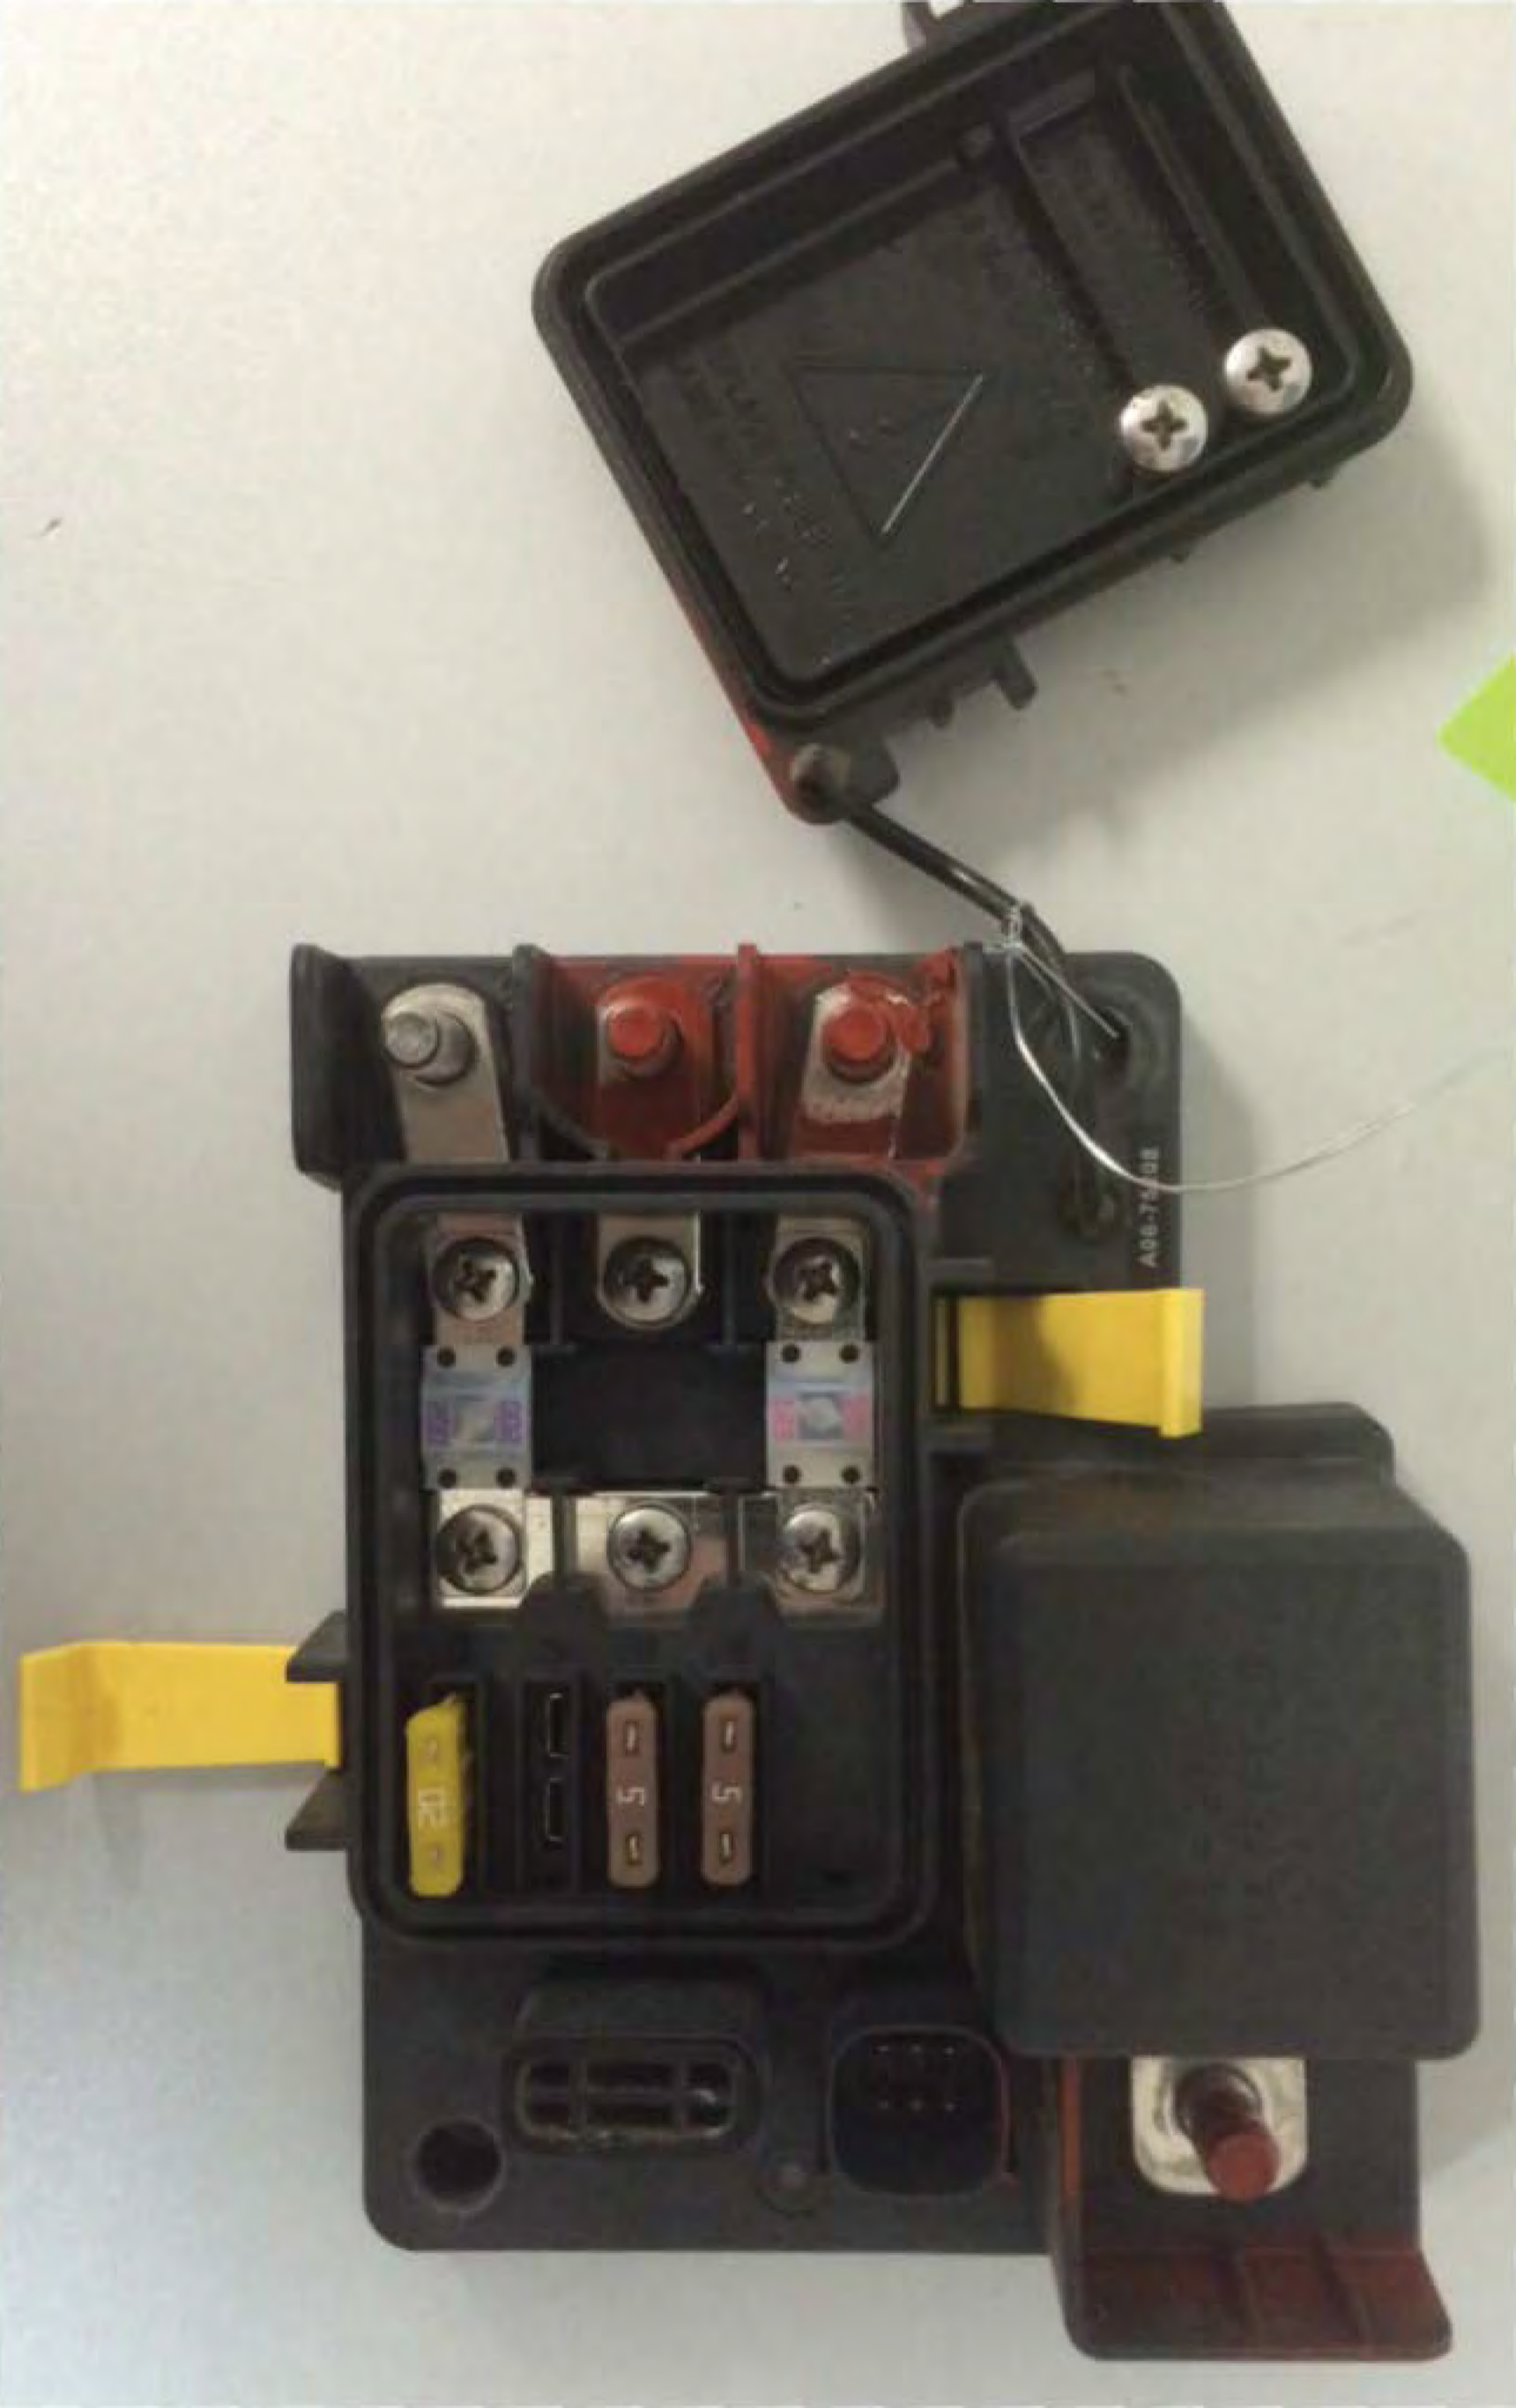
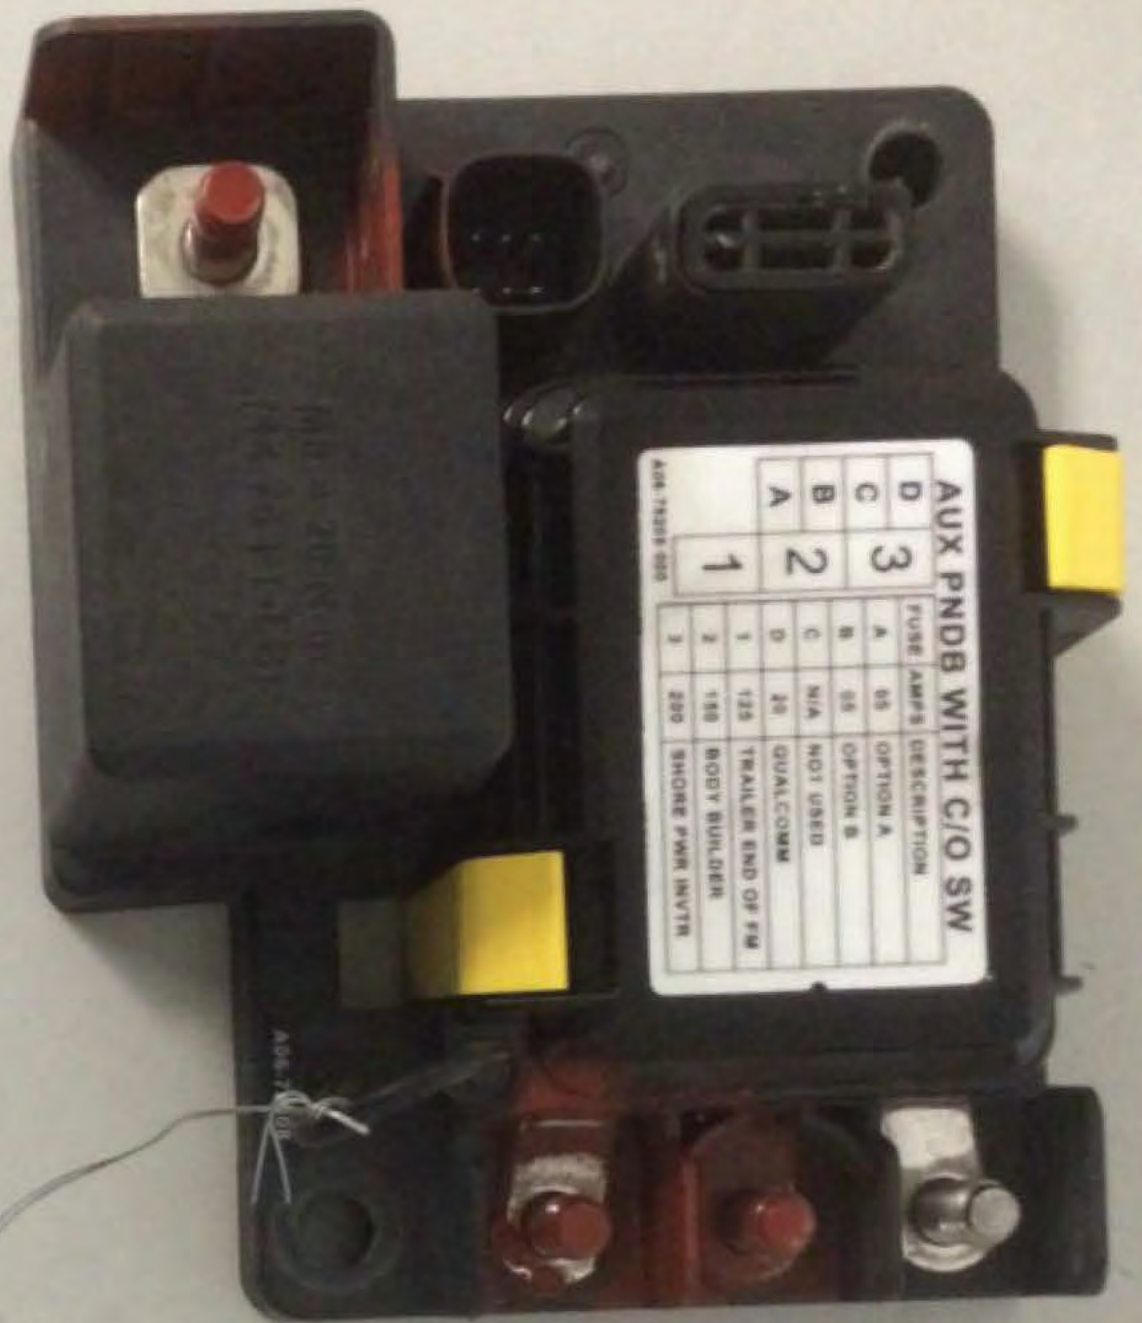
THE CUSTOMER COMPLAINT WAS THAT MULTIPLE DASH WARNING LIGHTS WOULD COME ON, THE BATTERY VOLTAGE WOULD REGISTER AROUND 17 VDC, AND THE VEHICLE WOULD NOT RUN PROPERLY. UPON INSPECTION OF THE VEHICLE THE DEALER FOUND THAT THE ALTERNATOR WAS NOT FUNCTIONING PROPERLY. THE CUSTOMER HAD BEEN INTO OTHER DEALERS PREVIOUSLY THAT COULD NOT FIND THIS PROBLEM. TOW BILLS AND RENTAL CHARGES HAVE ACCUMULATED FOR THIS CUSTOMER. THE CUSTOMER OPERATES OVER THE ROAD AND RUNS A ROUTE BETWEEN LA AND PHOENIX.

UPDATE 5/14/14: WHILE SEARCHING FOR ANOTHER ISSUE I FOUND FSPR 20985 FOR LOOSE FUSES IN THE PNDB. I HAD THE DEALER CHECK THIS UNIT AND THEY FOUND FUSES FALLING OUT OF THE PNDB UPON INSPECTION. THIS APPEARS TO BE THE ROOT CAUSE OF THE CHARGING ISSUE, AS A RESULT OF INCORRECT VOLTAGE VALUES AT THE POSITIVE ALTERNATOR POST.

UPDATE 5/16/14: FAILED PNDB WAS SHIPPED BACK TO ALEX DEMOSS, FEDEX TRACKING # [REDACTED] PHOTOS ADDED.

[REDACTED] ADEMOSSREQUESTED PAUL CAPTURE THE PNDB AND RETURN FOR ANALYSIS BY LITTELFUSE.

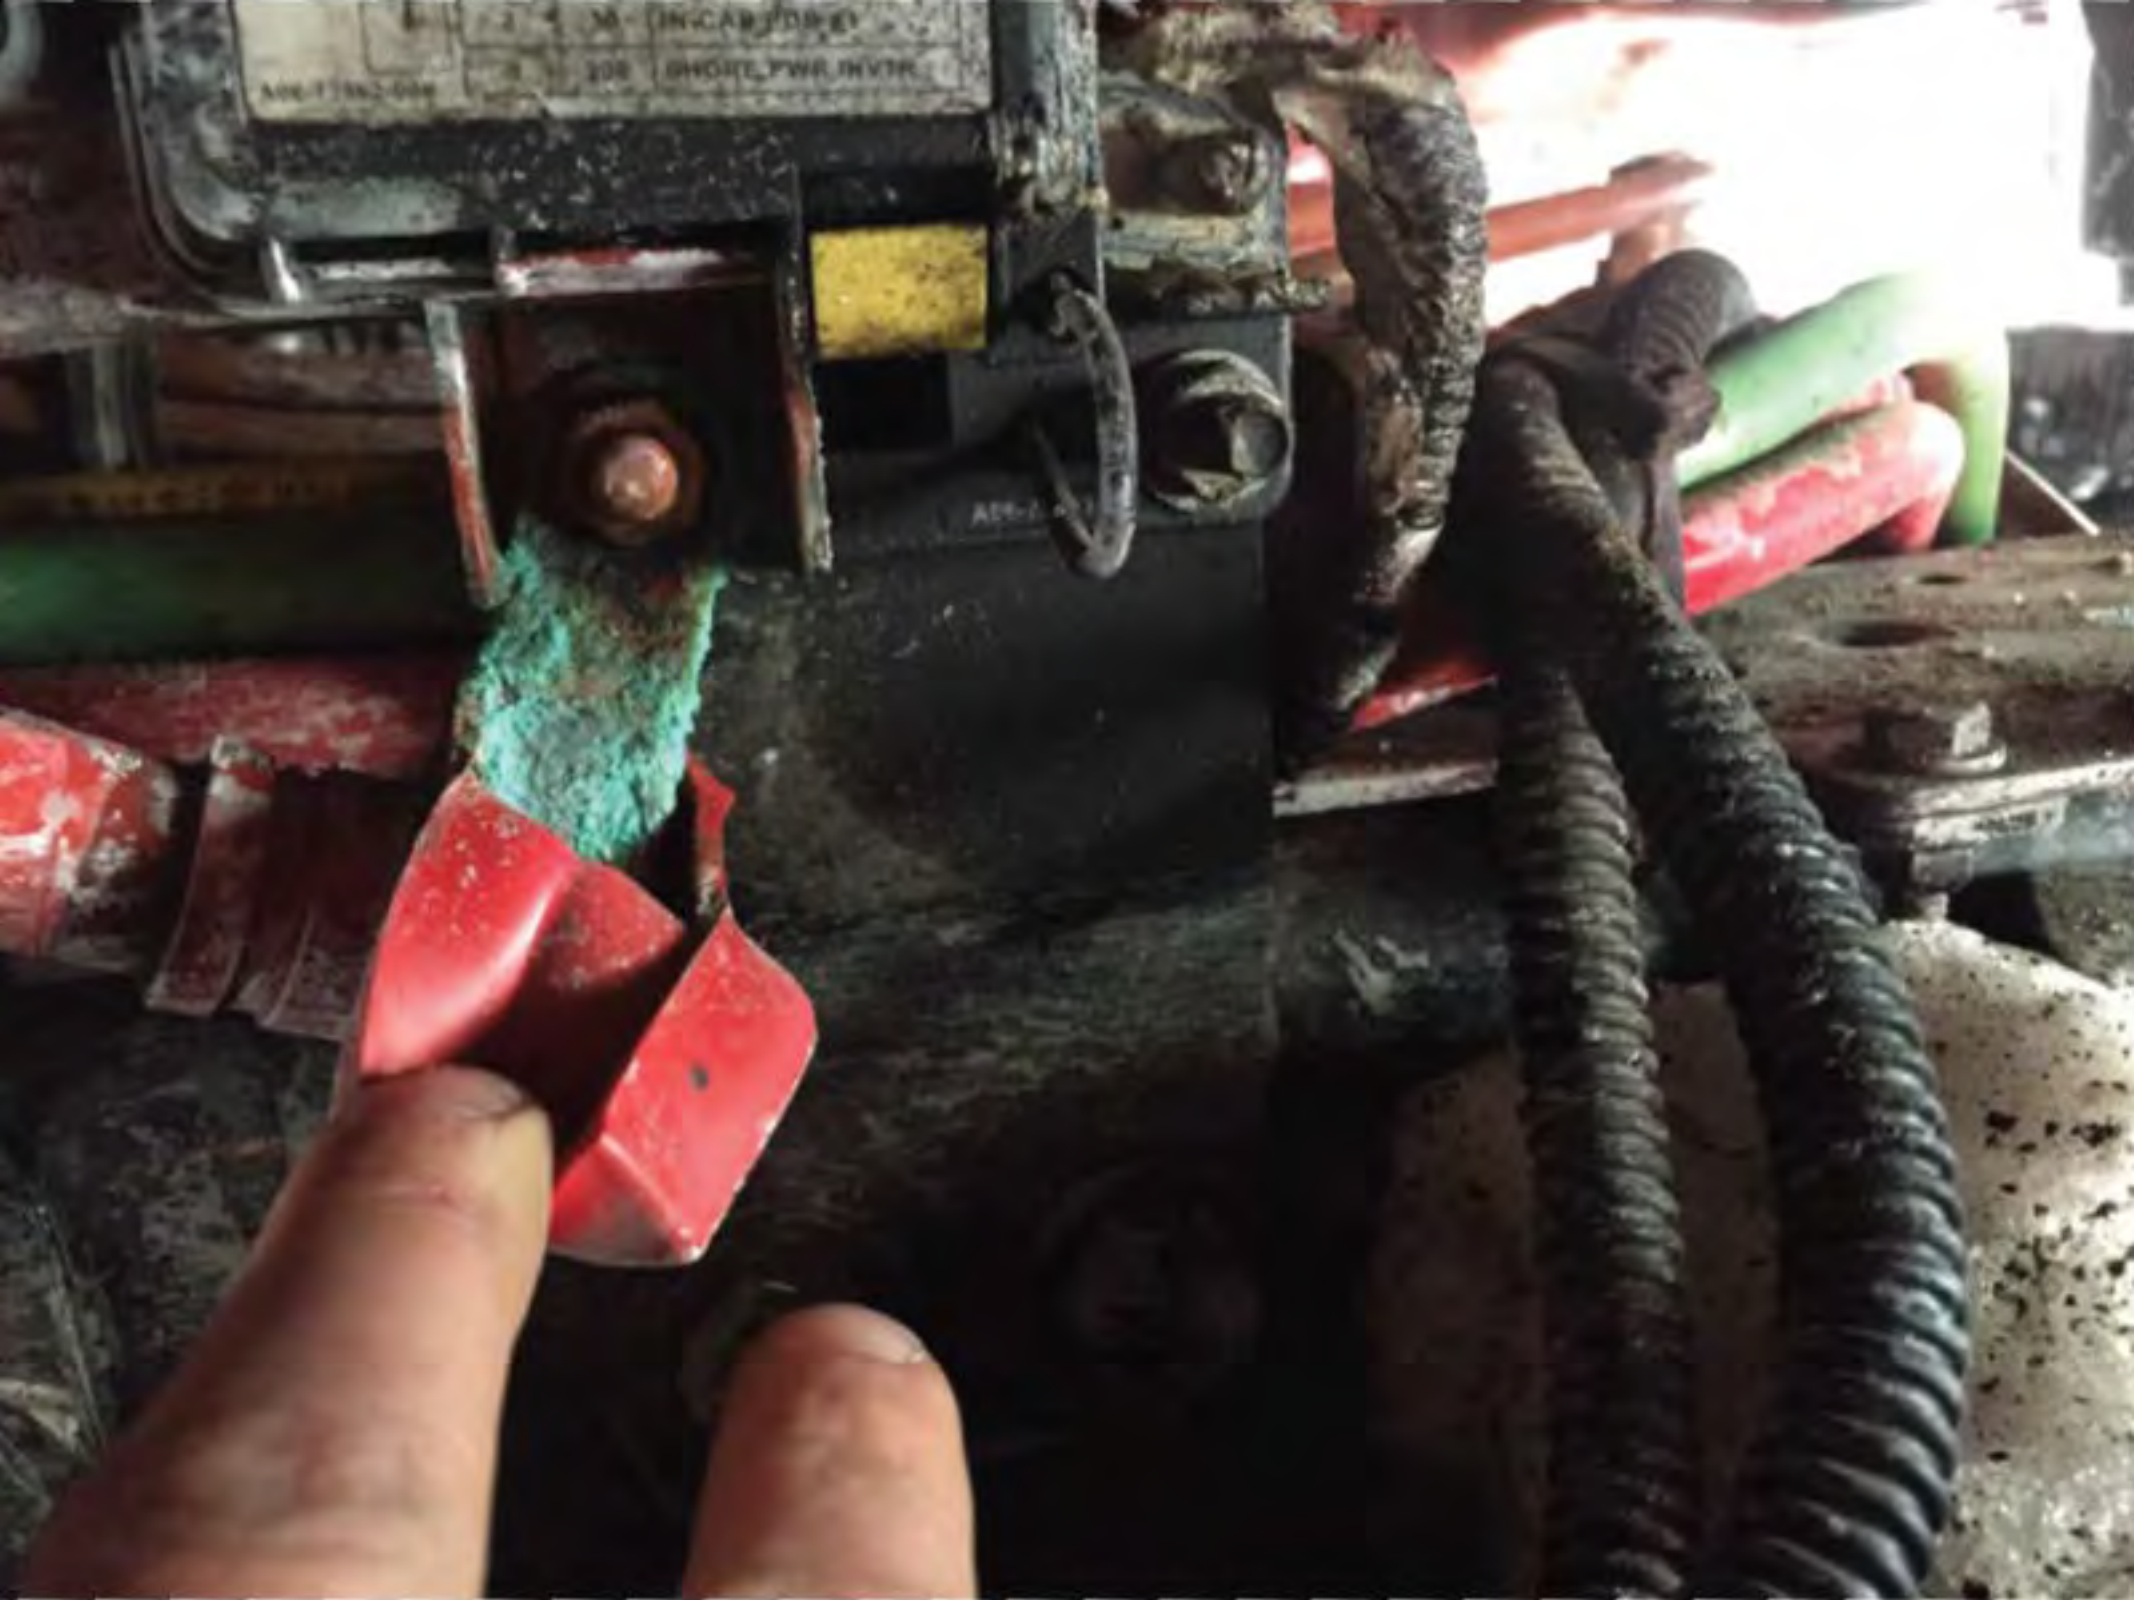
FRAME RAIL MOUNTED AUX PNDB POWER CABLE IS CORRODED AT LOW MILES, NOTIFIED THE TMP ASKING TO COAT WITH GLYPTAL. CAMPAIGNING GROUP OF TRUCKS TO CLEAN AND COAT WITH GLYPTAL. FLEET RUNS IN THE NE US.
