PE18-004

Material Request Number 8
Materials previously provided
to NHTSA

Field Service Reporting- Incident Report

CAC FS: Product Information Report

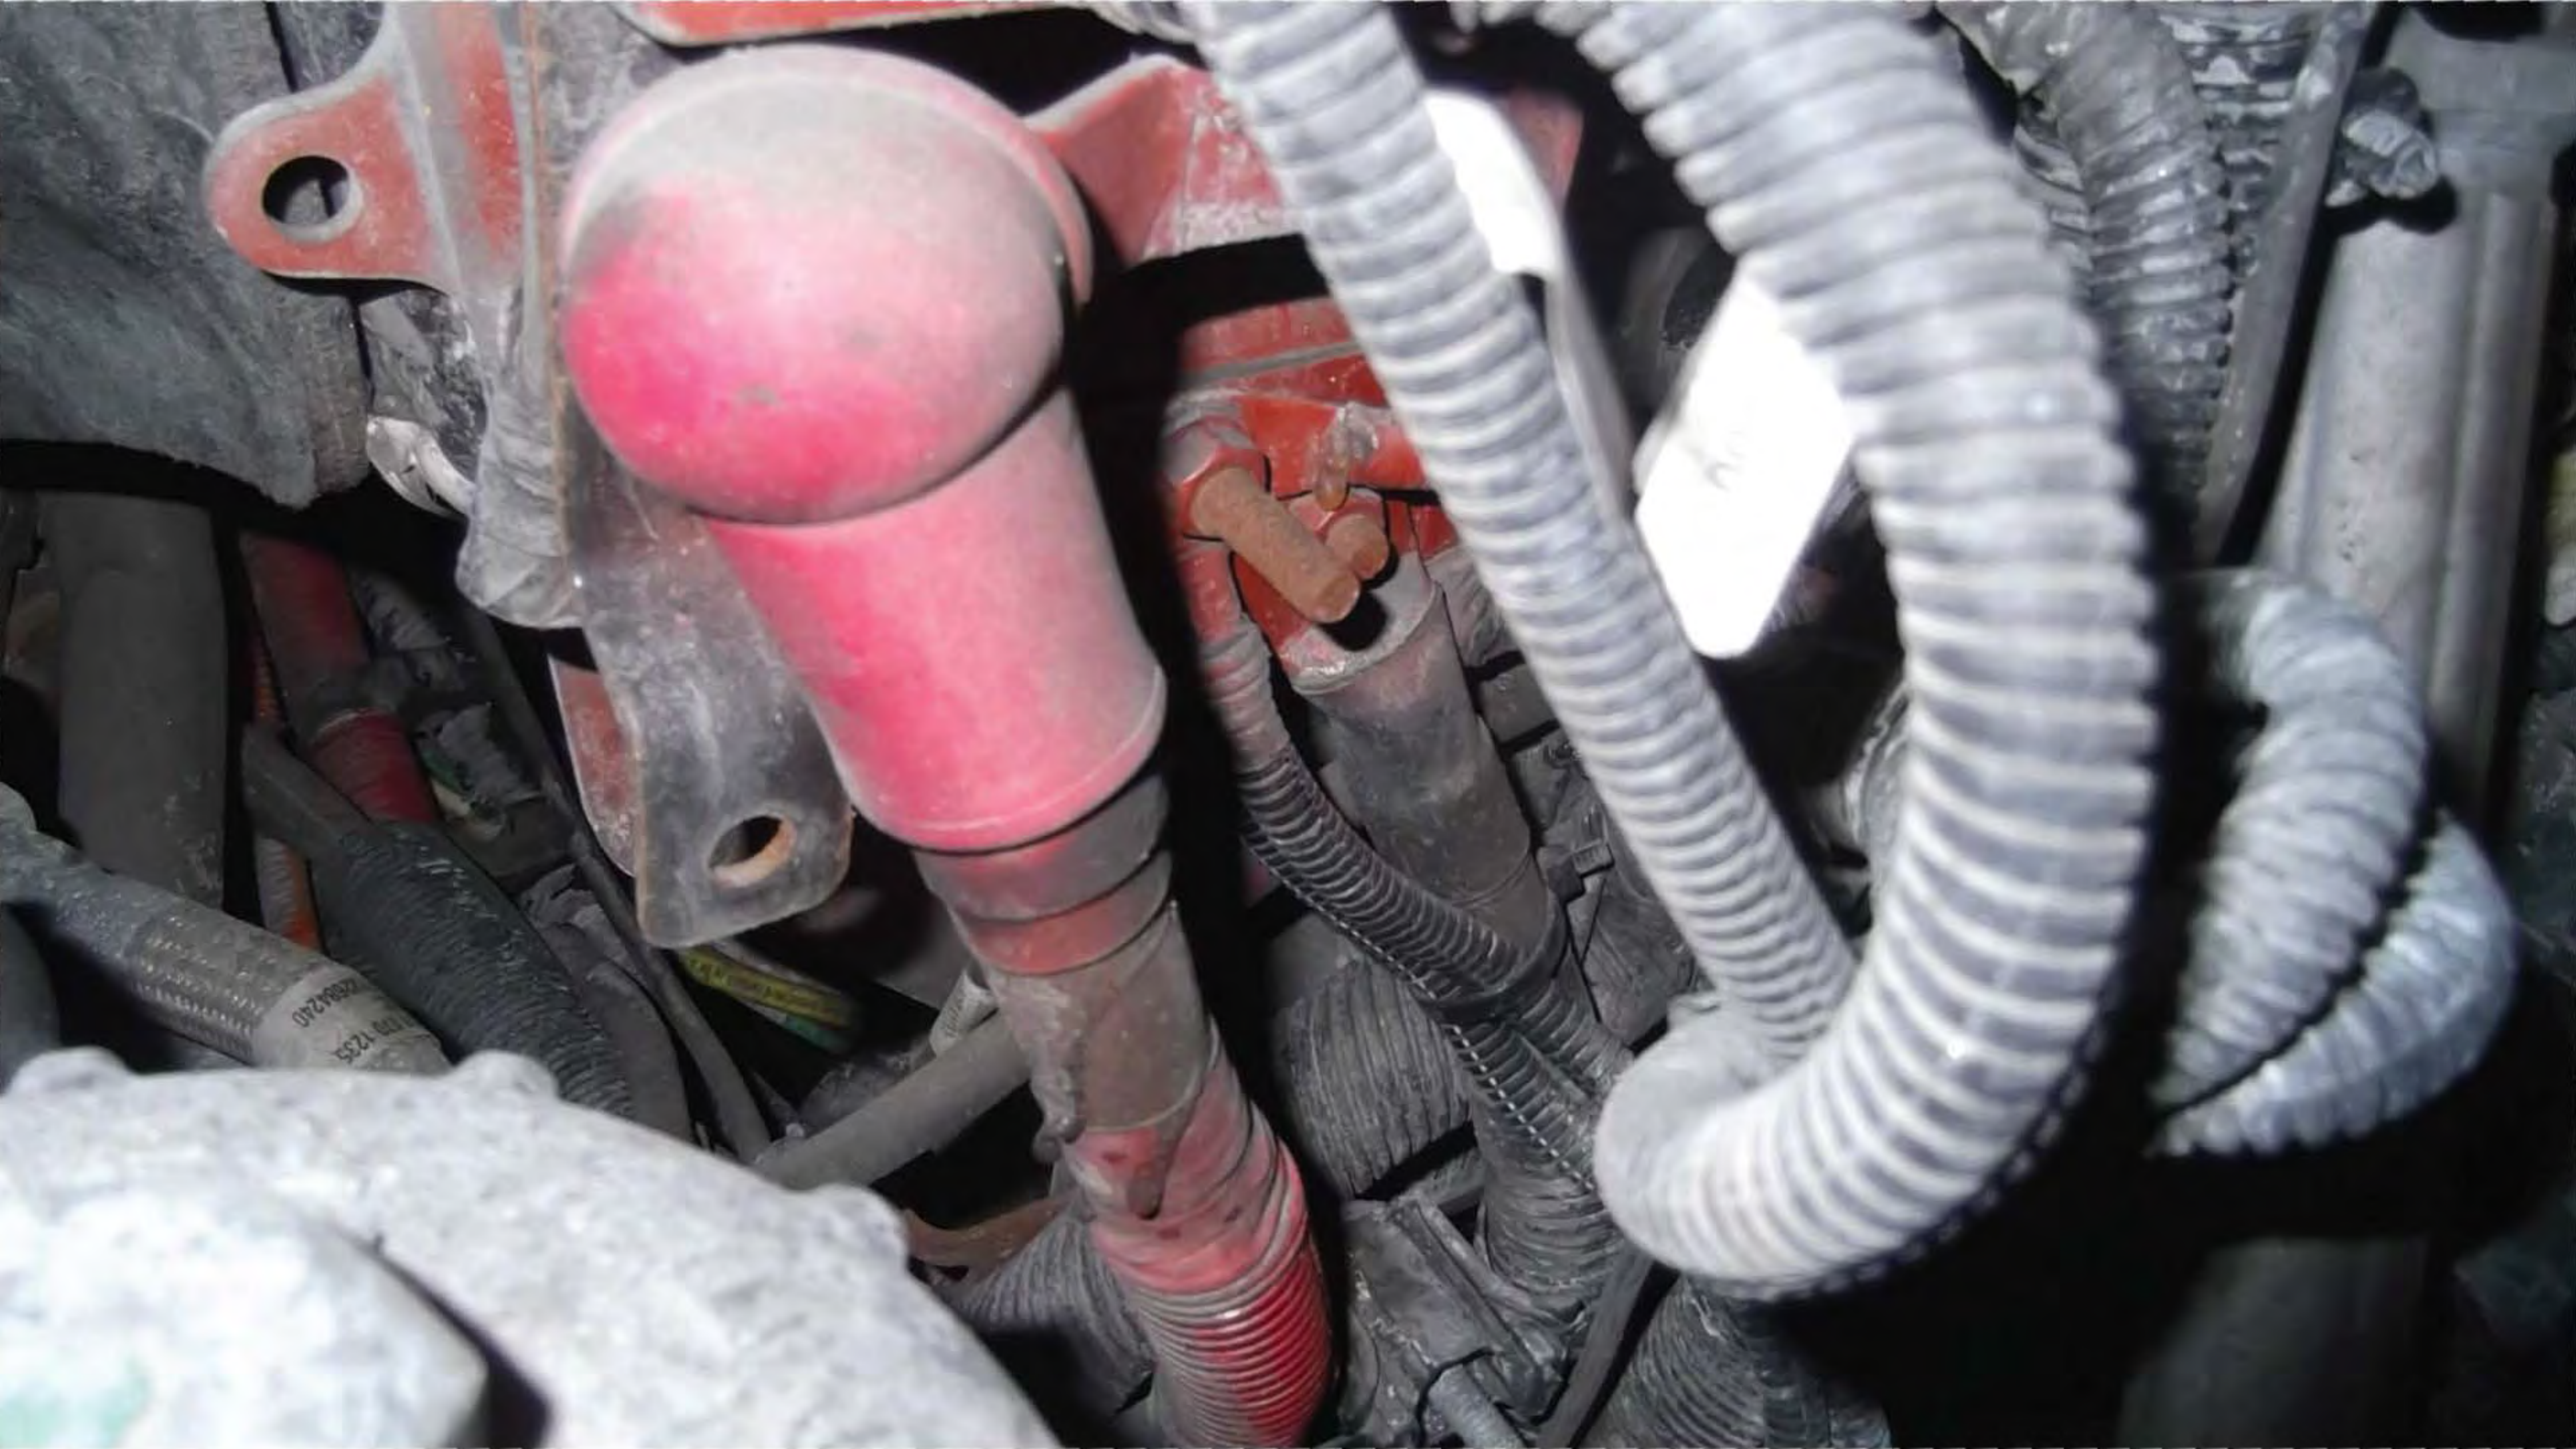
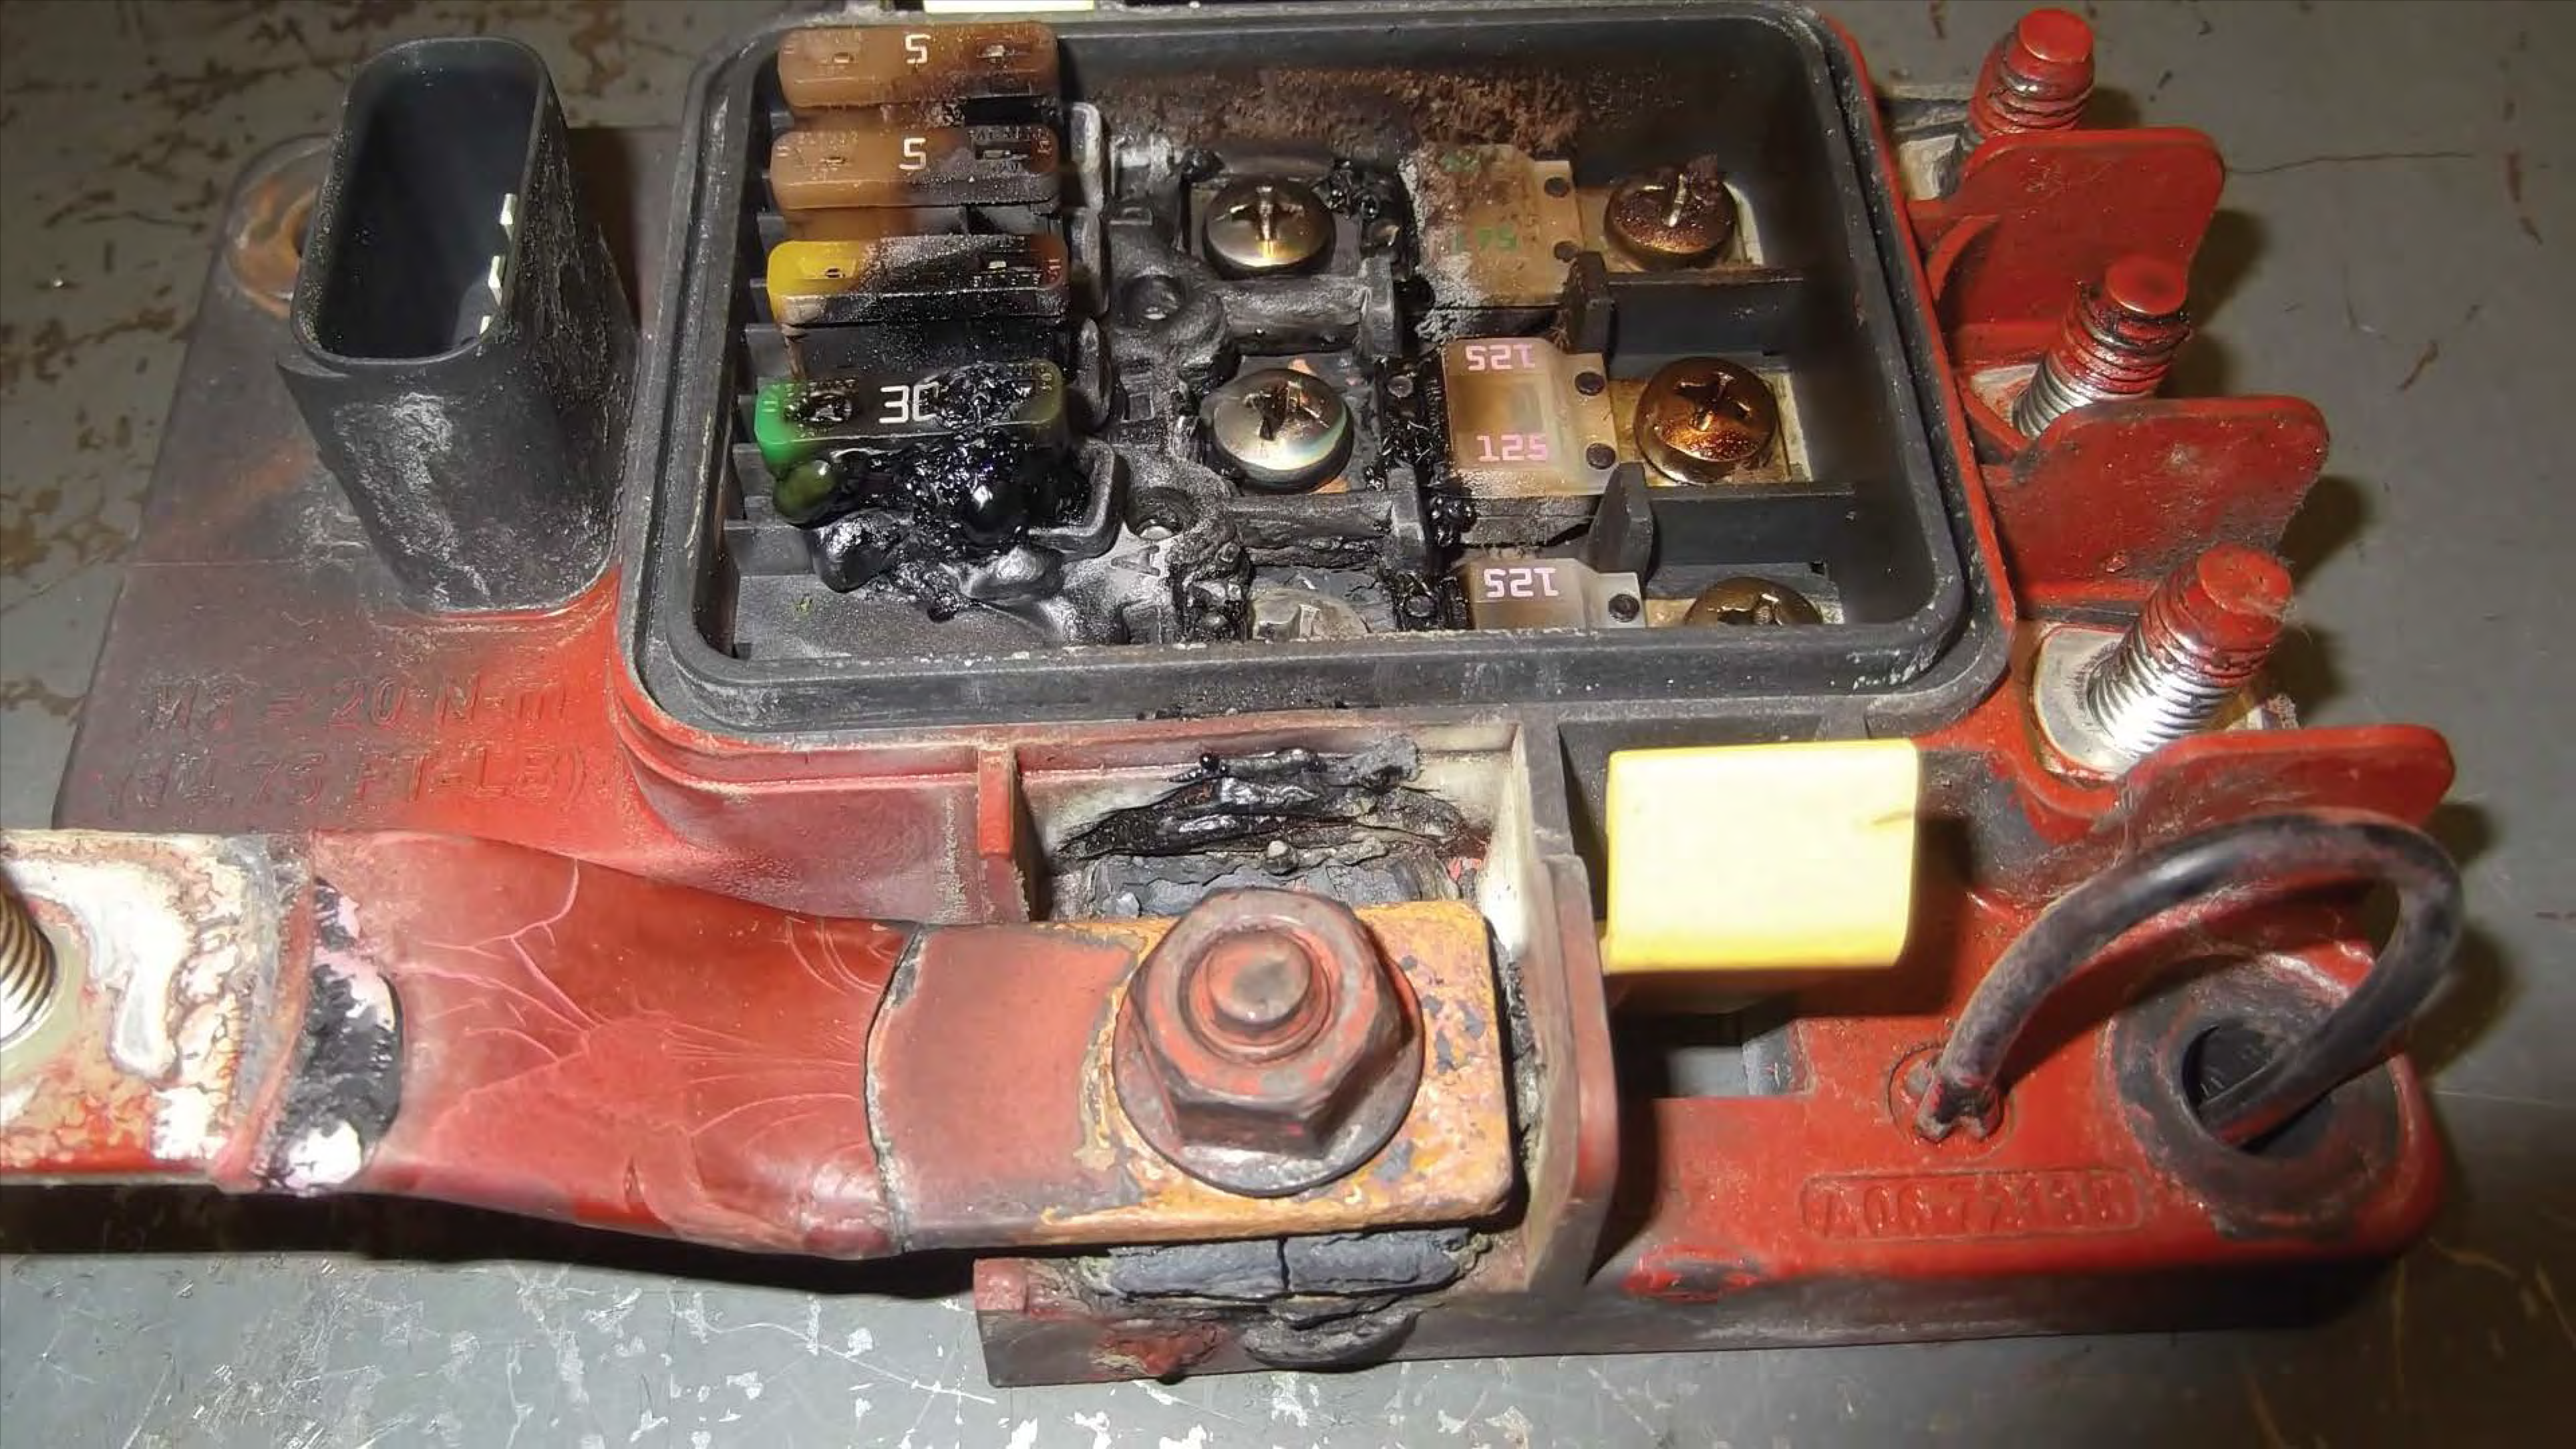
ATTACHED IS A PHOTO OF THE BURNT PNDB OFF SOUTH SHORE FK9247, 223311 MILES. IT APPEARS THE MAIN EXTERNAL BATTERY CONNECTION WAS LOOSE AND CAUSED THE ENTIRE BUSS BAR TO OVERHEAT.

I AM NOT SURE I UNDERSTAND WHY THE ADDED STRAP IS USED IN THIS APPLICATION (WITHOUT THE C/O SWITCH) VS. THE CUTOFF SWITCH APPLICATION THAT HAS THE CABLE CONNECTION DIRECTLY TO THE MAIN BUSS. THE ADDED LEVERAGE WOULD SEEM TO PULL ON THE STRAP ENOUGH AND EVENTUALLY LOOSEN THE CONNECTION?? IF THE CABLE WAS 2 INCHES LONGER THE STRAP WOULD NOT BE NEEDED.

UNITS WERE NOT MANUFACTURED PER DESIGN (STRAIN RELIEF NOT INSTALLED). DSM WILL HAVE THIS FLEET INSPECTED AND CORRECTED. TOO OLD TO SUBMIT DPR. CLOSING - AND

REPLACE PNDB. ENSURE THAT B+ CABLE STRAIN RELIEF IS INSTALLED, AS SHOWN IN D06-81443 (29A BOM).
