| General Service Bulletin (GSB): | PCM Ignition Coil Driver Test (2 Wire Coil) |

| General Service Bulletin (GSB): | Coolant Pump Inspection |
| GSB Overview: | This General Service Bulletin details warrantable/non warrantable condition of coolant pumps |

| General Service Bulletin (GSB): | Historical Powertrain Diagnostic Trouble Codes |

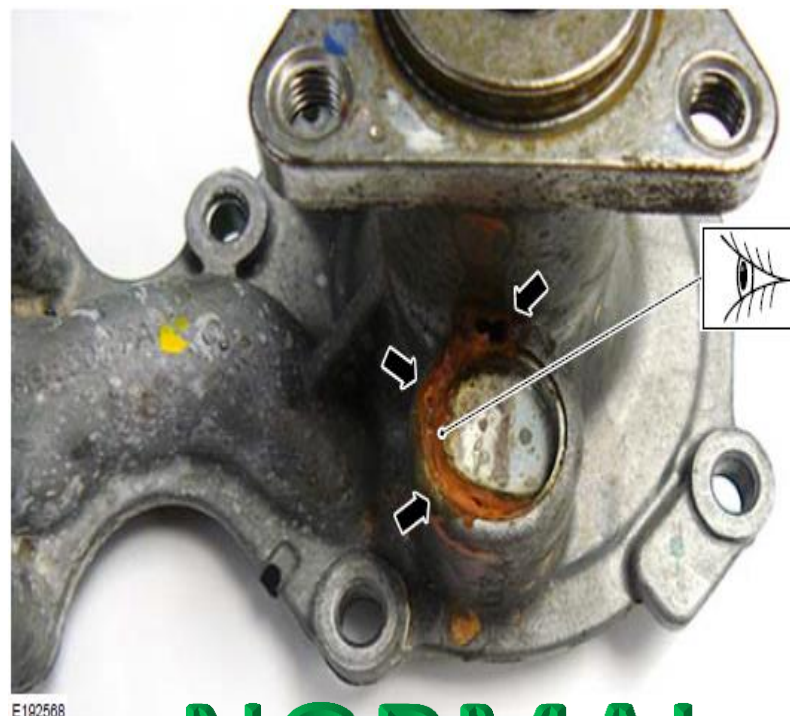
**NORMAL**

The coolant is used to lubricate the water pump seal. At this point it collects in the weep chamber, and later evaporates with normal usage.

This can sometimes result in the exterior cosmetic staining due to the vapor escaping past the vent hole and collecting on the pump housing instead of inside the weep chamber.

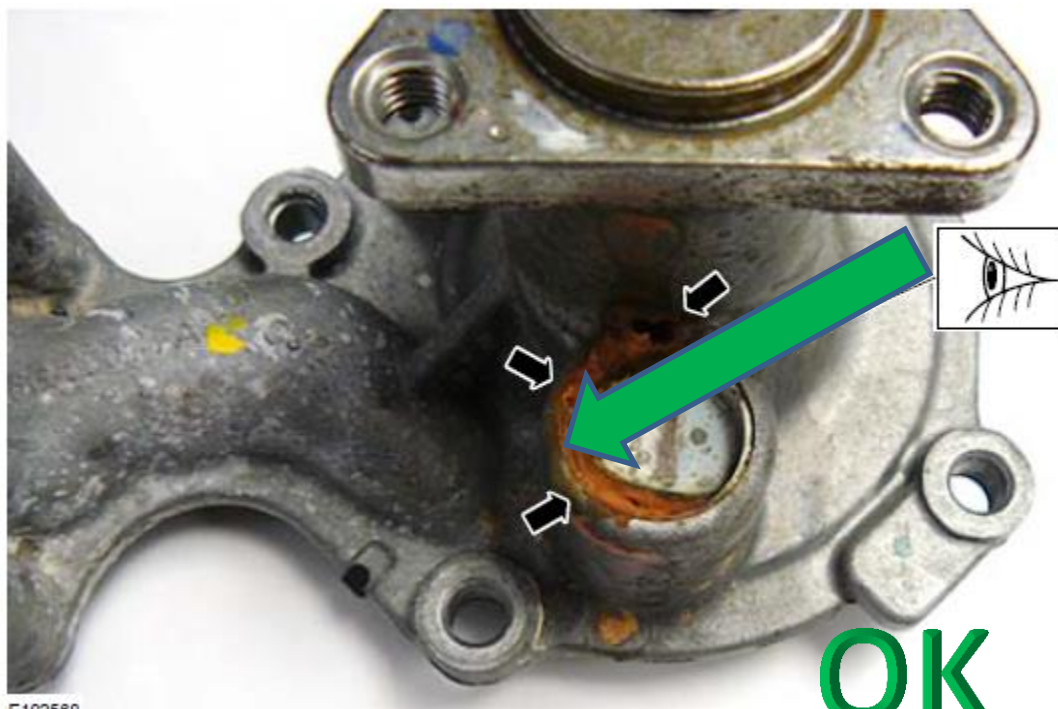
Signs of corrosion and or coolant staining water pump example

Staining on the pump indicates an earlier event or normal operation which does not constitute as a water pump failure. Slight staining and residual dried coolant build up around the weep chamber vent is considered normal

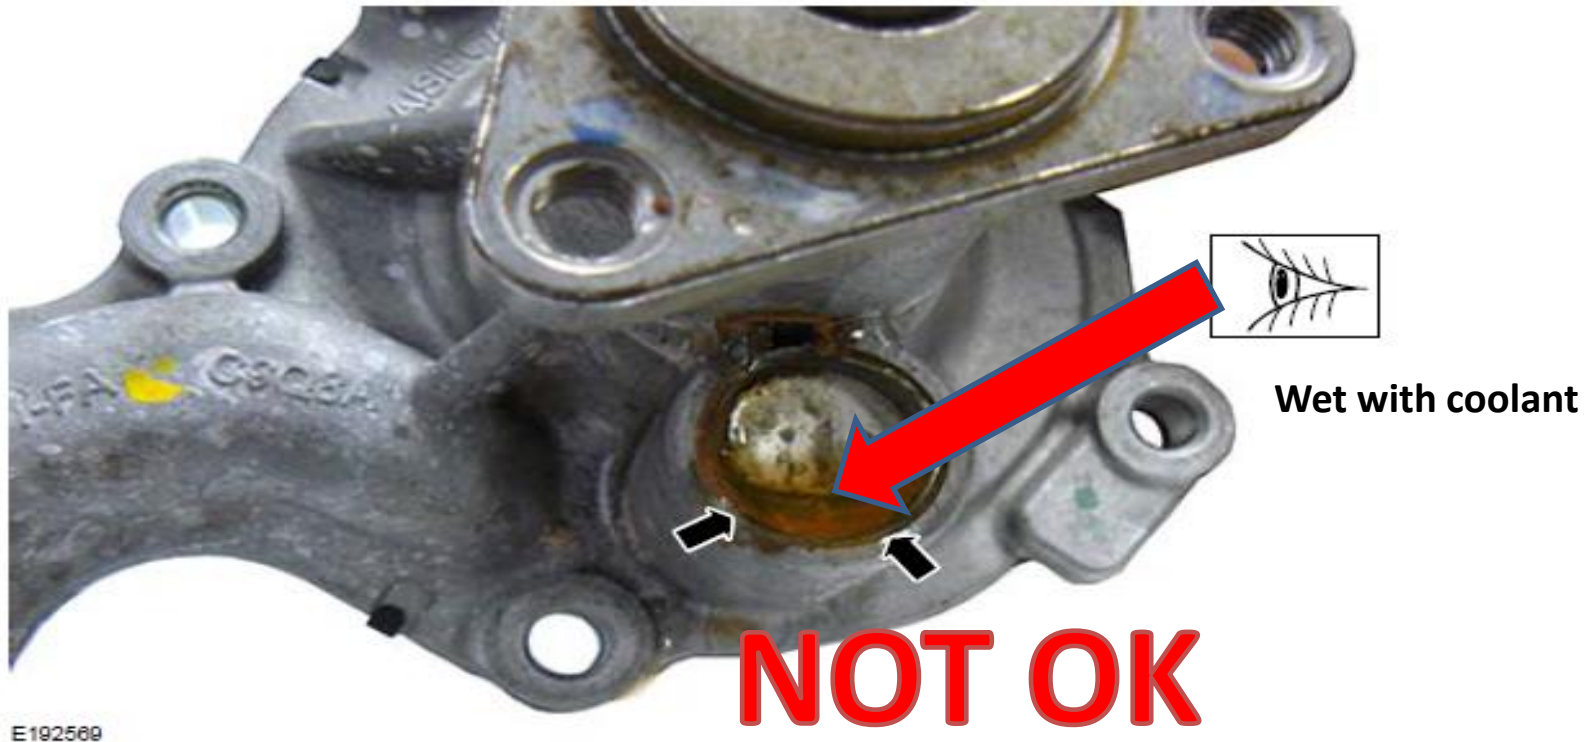
## Leaking water pump example

Coolant pump will have wet coolant residue with an evident puddle occurring on the pump weep chamber.

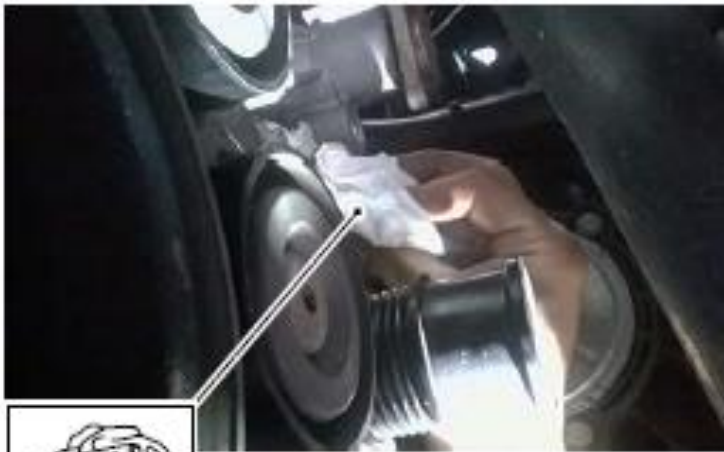
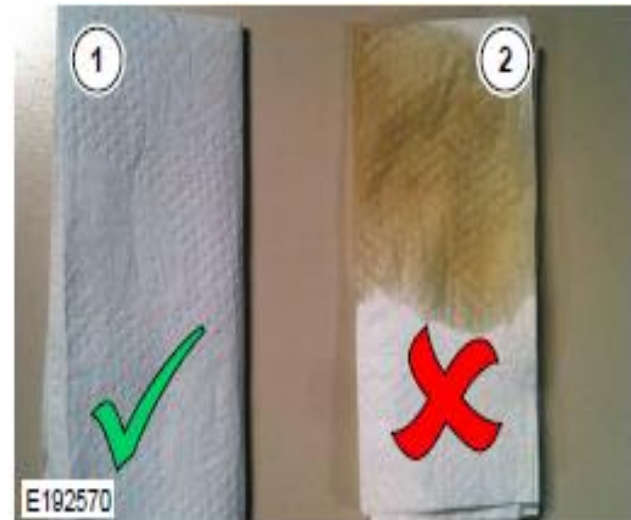
**Towel has only dry/waxy residue** - coolant pump seal is working properly-do not replace pump

**Towel is wet** - coolant pump is leaking - replace coolant pump

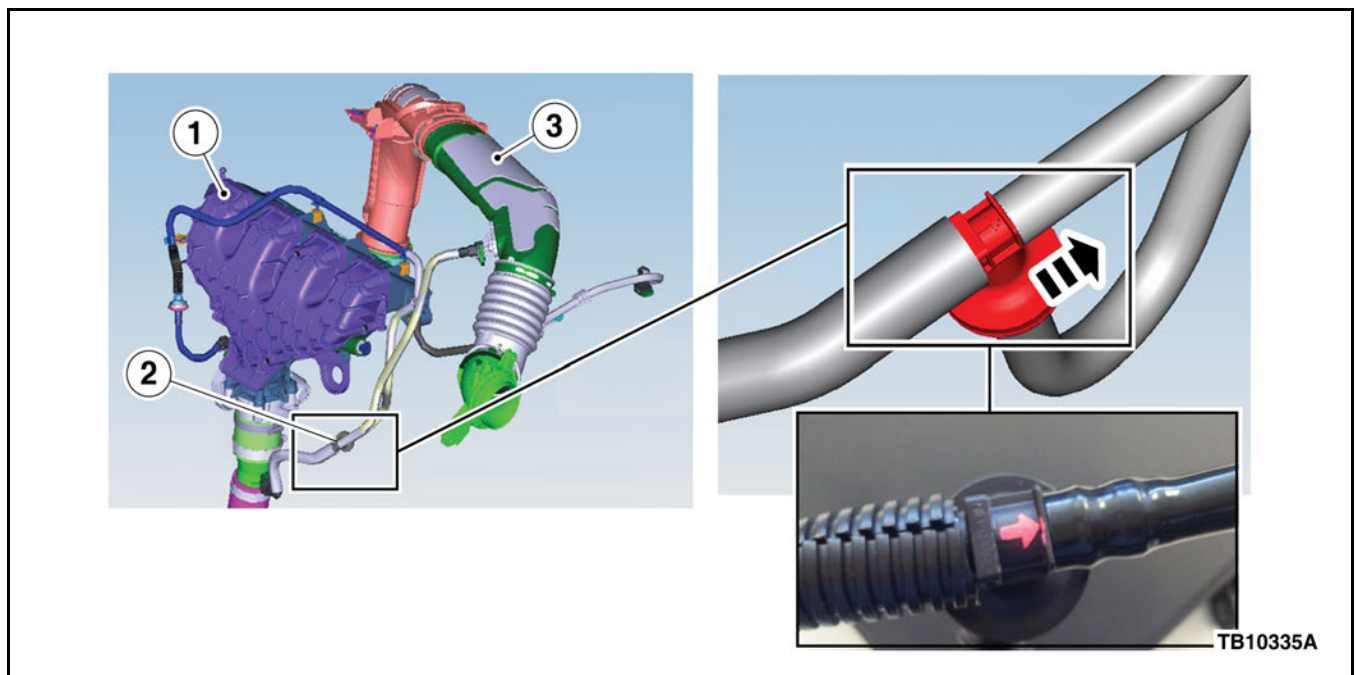
Figure 1 - Article 12-8-23

1. Remove engine cover for access, if necessary.
2. Disconnect battery ground cable. Refer to Workshop Manual (WSM), Section 414-01.
3. Inspect vapor ejector installation. Does arrow on vapor ejector indicate proper installation as shown? (Figure 1 or 2)

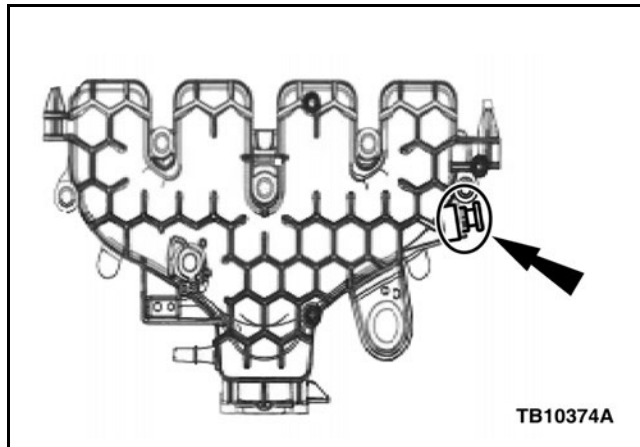
Figure 1 - Article 13-1-4

Some 2013 Escape and Fusion vehicles built on or before 9/28/2012 and equipped with the 2.0L gasoline turbo direct injection (GTDI) engine may exhibit a rolling/fast idle with DTCs P0507, P0171, and/or P0174. This may be due to a missing plug on the left hand side of the intake manifold.

1. Inspect the left hand side of the intake manifold for a missing plug. Is the plug missing from the intake manifold? (Figure 1)

2. Install the intake manifold plug using the instruction sheet provided in the kit.
  - a. The kit includes the locking ring which typically remains in the intake manifold. Discard the new locking ring in kit. Do not attempt to remove or replace the locking ring as intake manifold damage will occur.

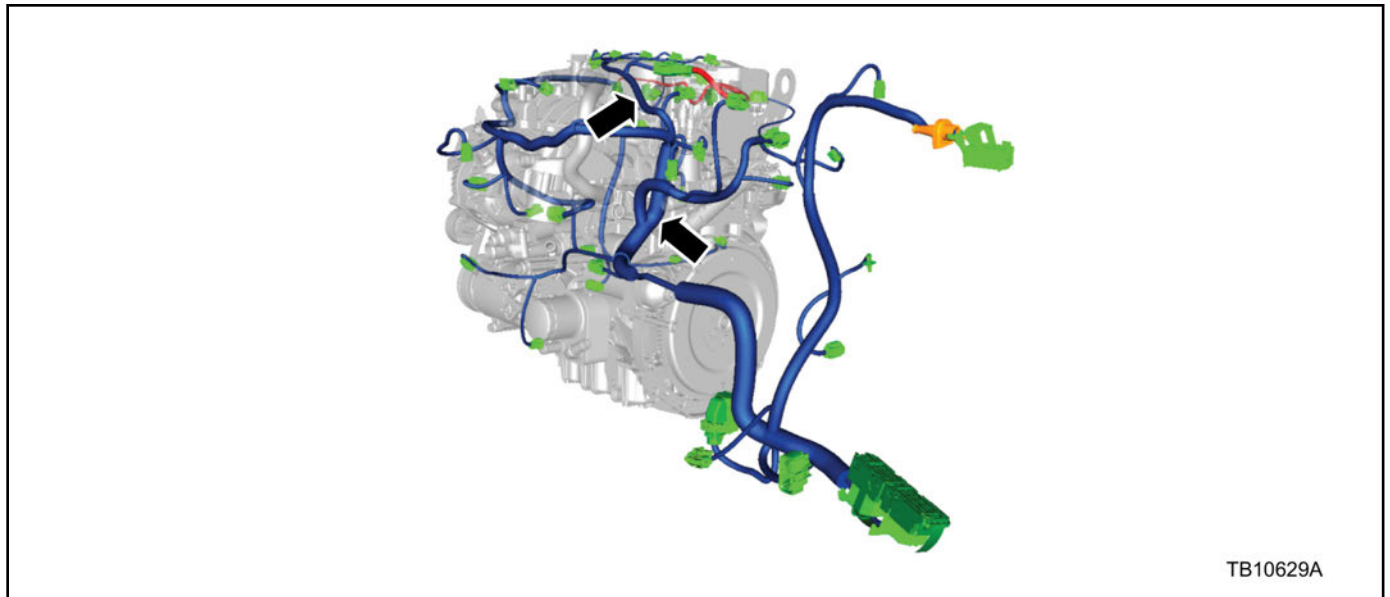
Figure 1 - Article 15-0005

Some 2013-2014 Escape vehicles equipped with 1.6L Gasoline Turbocharged Direct Injection (GTDI) engines and built on or before 10/24/2013 may exhibit difficult to start, runs rough, crank no-start, lack of power, loss of RPM or hesitation concerns with diagnostic trouble codes (DTCs) P0106, P0131, P0172, P061B, P2196 and P0236. An Engine Fault Service Engine Now message may also be displayed without any DTCs in self-test. These conditions may be caused by a wiring concern in the signal return splices.

- a. For 2013 vehicles, splice S123 can be in one of two locations. Splice S123 will have 5 circuits that are multi colored one green/violet (FRP), two white/brown (MAP and Sig Rtn to PCM), one brown/green (ECT) and one green/brown (TFT). (Figure 1)

- b. For 2014 vehicles, the splice S123 will have 6 circuits that are multi colored one green/violet (FRP), one white/brown (Sig Rtn to PCM) , one brown/green (ECT), one green/brown (TFT) and two blue/green (MAP and CHT). Refer to 2014 Wiring Diagram, Section 151-5. (Figure 1 Lower Arrow)
- (1) Remove enough harness wrap to locate and replace the splice.
  - (2) Solder before sealing the repair with heat shrink tube.

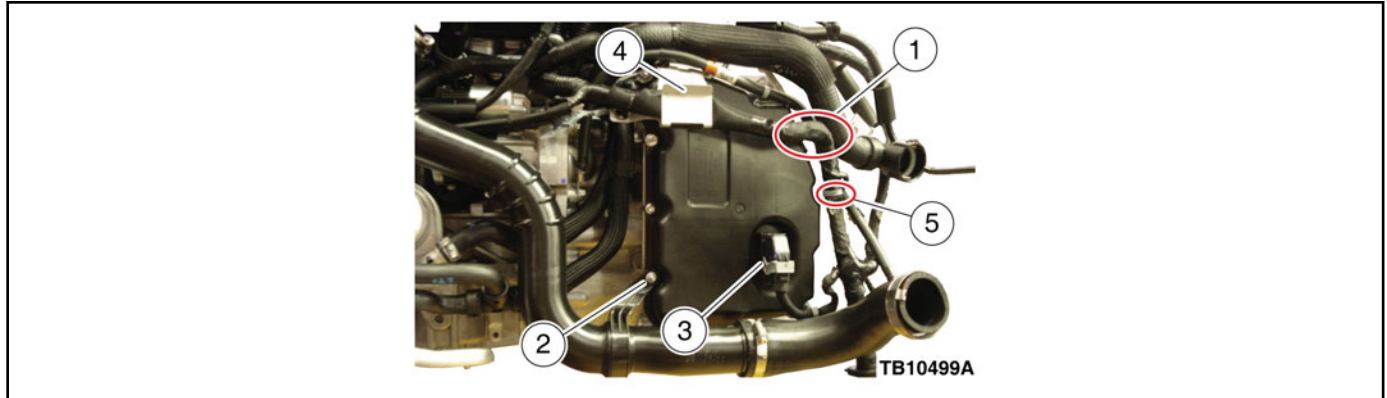
Figure 2 - Article 15-0005

- c. Splice S178 is located under the air box where the 12A581 harness turns downward near the transmission cover. It will have 3 circuits that are gray/blue. (Figure 2 Item 1)
