## **25300 01 - Safety Recall - Revised Warranty Information Section**

25300 01 - Safety Recall

Models: 2010-2017 Chevrolet Equinox

## 25300 Front Wiper Transmission Corrosion Failure (Canada Only)

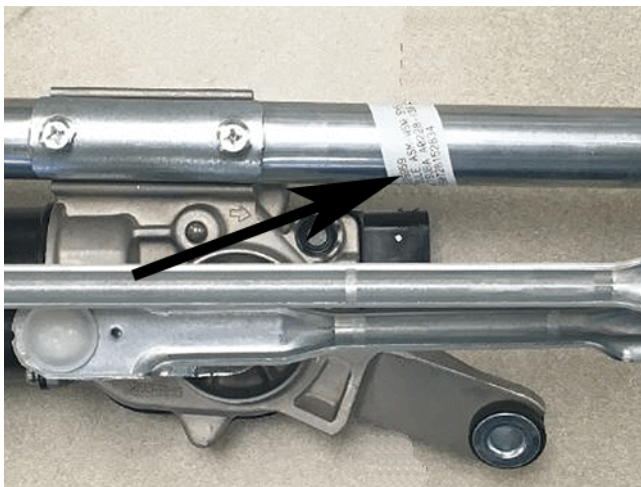
4627487

**Note:** Some interim repairs may have been completed under warranty or goodwill. With the wiper module assembly removed from the vehicle, inspect the part number tag located on the cross shaft. Determine if an interim repair was completed using PN 84126929. If so, check the vehicle repair history to determine if the repair was performed within the last 6 months. If the part has been in service for less than 6 months, this part does not have to be replaced again. Only the plug and deflector need to be installed, and add prior repair order number and date to warranty claim. If the interim repair was completed with the older part numbers (25948436 and 25942547) or if the interim repair was performed more than 6 months prior, the dealer must remove those parts and complete the entire recall using the new module assembly (PN 84126959) in addition to installing the plug and deflector.
