## ODI RESUME

| <b>Investigation:</b> | PE 19-005 | <b>Date Closed:</b> | 12/09/2021 |
| <b>Subject:</b> | Unintended Movement | | |

# PE19-005 Closing Report

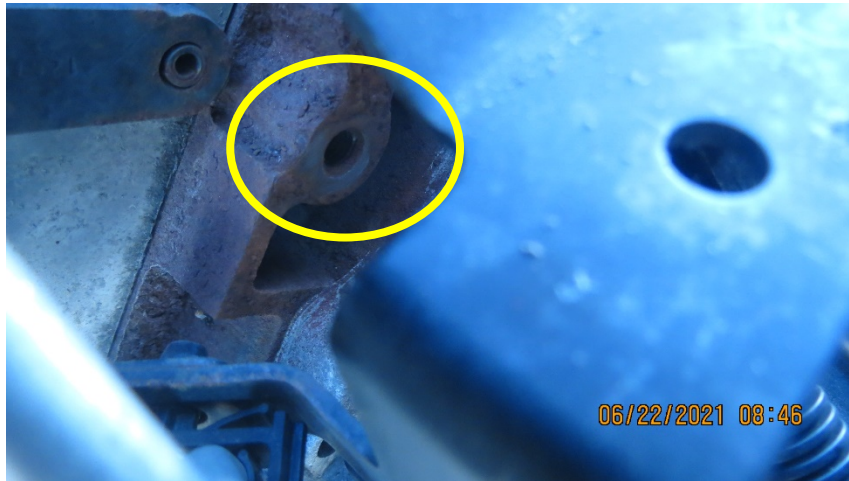
**Figure #2**

Shortly after this testing was completed at GM, Isuzu made ODI aware of another, and more probable, failure mechanism. While conducting their own internal investigation, Isuzu discovered that faulty continuity associated with the E-97 and E-98 ground wire fastener location could affect the ECM’s signal output. This failure mechanism was also detected within the 17 warranty reports submitted with Isuzu’s PE IR response. The E-97 and E-98 grounds are connected to the left rear of the engine (Figure #2) with eyelet connectors sharing a bolt (Figure #3).

*The location on the engine block for E-97 and E-98 ground ring terminals.*

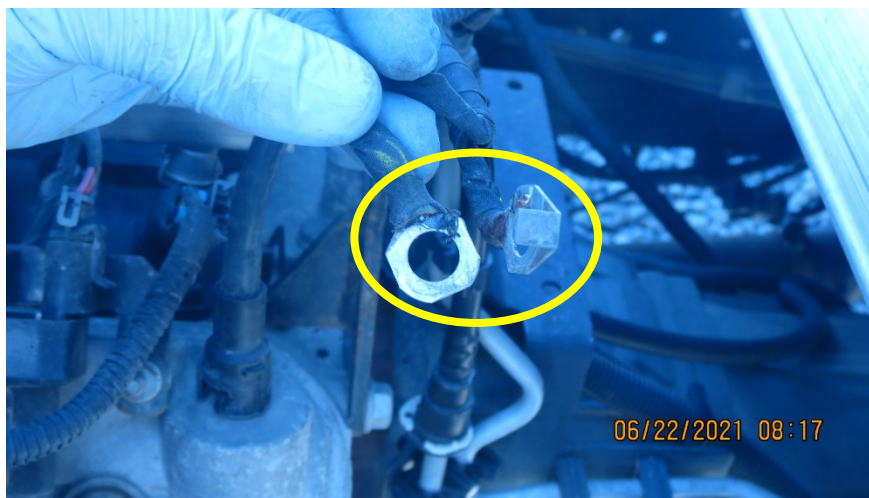
**Figure #3**

*The E-97 and E-98 ring terminals*

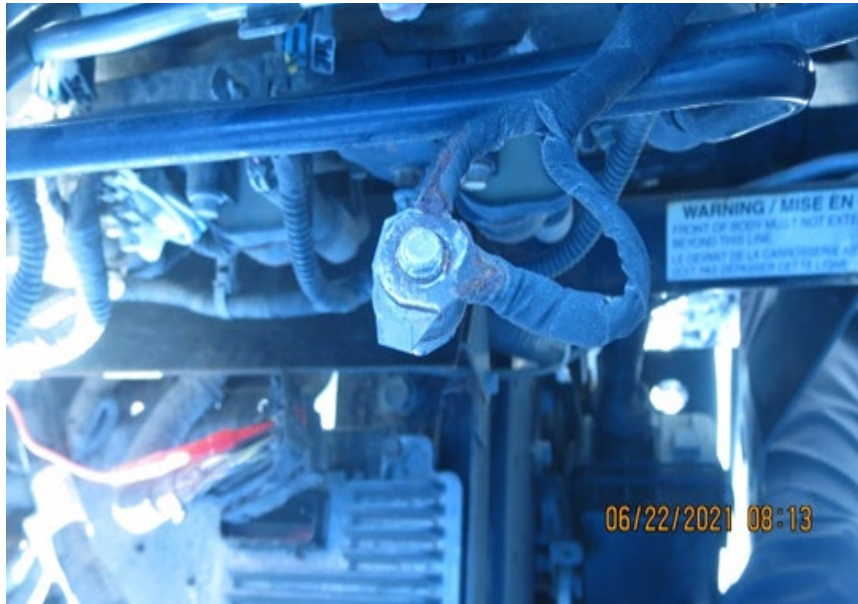
**Figure #4**

Upon inspection, both VRTC and Isuzu discovered loose ground connections, and the fasteners' (bolts) clamping load(s) were compromised. (Figure #4)

*Both ground ring eyelets and terminals show pitting and corrosion.*

In a report that Isuzu shared with ODI on February 3, 2021, Isuzu determined that during production of the engine harness, the E-97 and E-98 ground eyelets, pre-assembled onto the wiring harness, were faulty. Furthermore, Isuzu identified the crimped eyelet on the end of the harness ground wire was compromised due to a faulty heat shrinking process and a defective crimp interface to the ground wire. According to Isuzu, “when the non-conductive material is compressed within the joint, a clamping force reduction occurs due to material creep from heat and vibration. Once the clamping force lessens, the electrical resistance increases; that resistance may cease to increase at a point that does not cause an issue, or the bolt may continue to loosen and the resistance may continue to increase until high resistance, or an open circuit (loss of continuity) occurs”.

Although ODI believes, after the testing, that very lightly applied brake pressure is needed to keep the vehicle from lunging, discussions with Isuzu resulted in their initiation of a Customer Satisfaction Campaign to address the possible poor ground connection issue, including expanding the scope to incorporate MY 2012 through 2017 vehicles. Based on Isuzu's actions, including notifying owners of this potential problem, this investigation is closed. Further use of agency resources does not appear warranted; however, the closing of this investigation does not constitute a finding by NHTSA that a safety-related defect does not exist. The agency reserves the right to take further action if warranted by the circumstances.
