## ENGINEERING ANALYSIS (EA19-002) CLOSING REPORT

**SUBJECT VEHICLES:** Model Year (MY) 2013-2018 Nissan Altima

**SUBJECT:** Rear Suspension Control Arm Failure

**INVESTIGATION:** EA19-002 **DATE OPENED:** 07/29/2019 **DATE CLOSED:** 06/16/2025

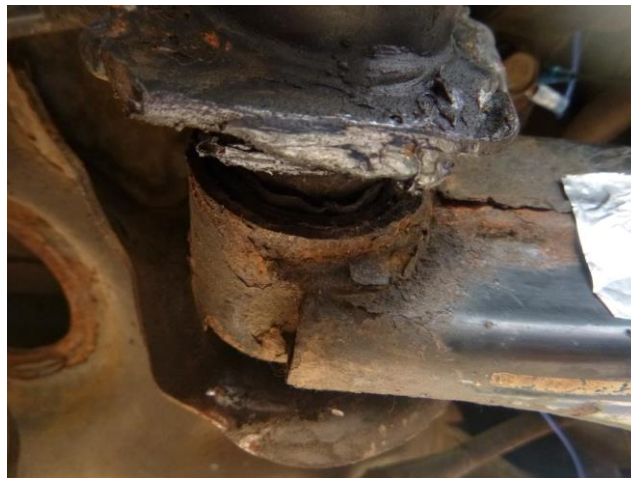
*Figure 3. 2013 Nissan Altima Pre-Test Inspection*

Initial base-line testing took place to have a reference point of performance on both vehicles. Both vehicles were located in and recovered from salt belt-like environments. At pre-test inspection, the 2013 MY vehicle had visible corrosion at the bushing and point of simulated pin separation (Figure 3). The 2018 MY vehicle had little to no visible corrosion at the bushing area, but some of the control arm collar appeared to have some discoloration that could be early signs of metal oxidation (Figure 4).

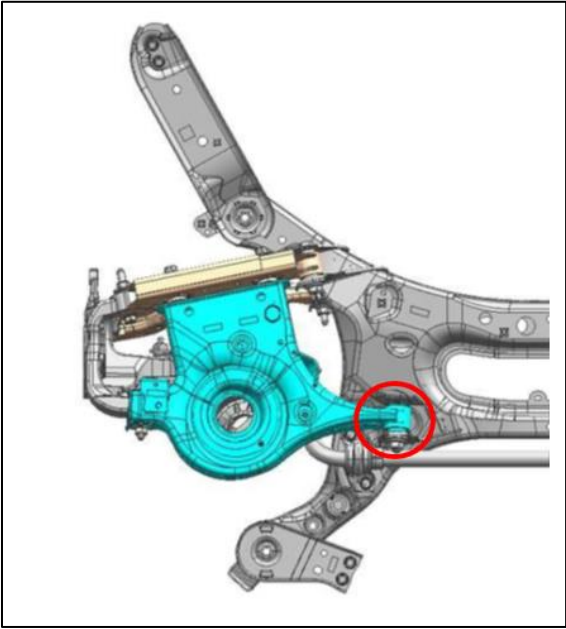
**FAILURE MECHANISM:** A small crack may propagate along the weld bead between the rear lower spring link collar and rear lower spring link arm (*Figure 7*). Certain conditions, such as the amount of suspension strokes and extensive use of road salt for snow and ice control, may contribute to crack propagation. Subsequently, corrosion is introduced within the bushing located inside of the rear lower control arm spring link collar. This corrosion within the bushing increases the twist reaction force of the bushing, thereby increasing stress in the rear lower spring

Figure 7. Point of Failure within Red Circle

**DESIGN, MATERIAL, AND PRODUCTION MODIFICATIONS:** Nissan implemented a design change on January 11, 2018, to improve the durability of the lower control arm and provided an analysis indicating that the design change resulted in significant improvement to its durability. A double bead weld was used at the location of the bushing at the end of the control arm collar. Nissan reported durability bench test improved by more than 5 times.

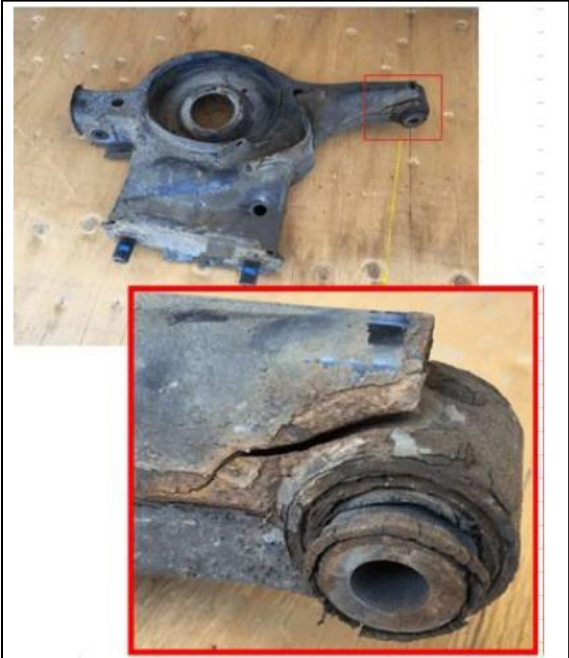
link collar-to-arm weld joint (Figure 8). Over time, with enough corrosion and with the increased stress applied to the joint, the crack in the collar-to-arm weld joint may propagate. In some instances, the rear lower spring link collar may separate from the rear lower spring link arm, leaving three of four connection points for the multi-3-link rear suspension.

Figure 8. Sample Part with Corrosion at Bushing and Bead Weld
