PE19-004  
KIA  
6/28/2019  
DEFECT B  
TECHLINES  
SORENTO

PE19-004\_Expanded Scope\_Alleged  
Defect B

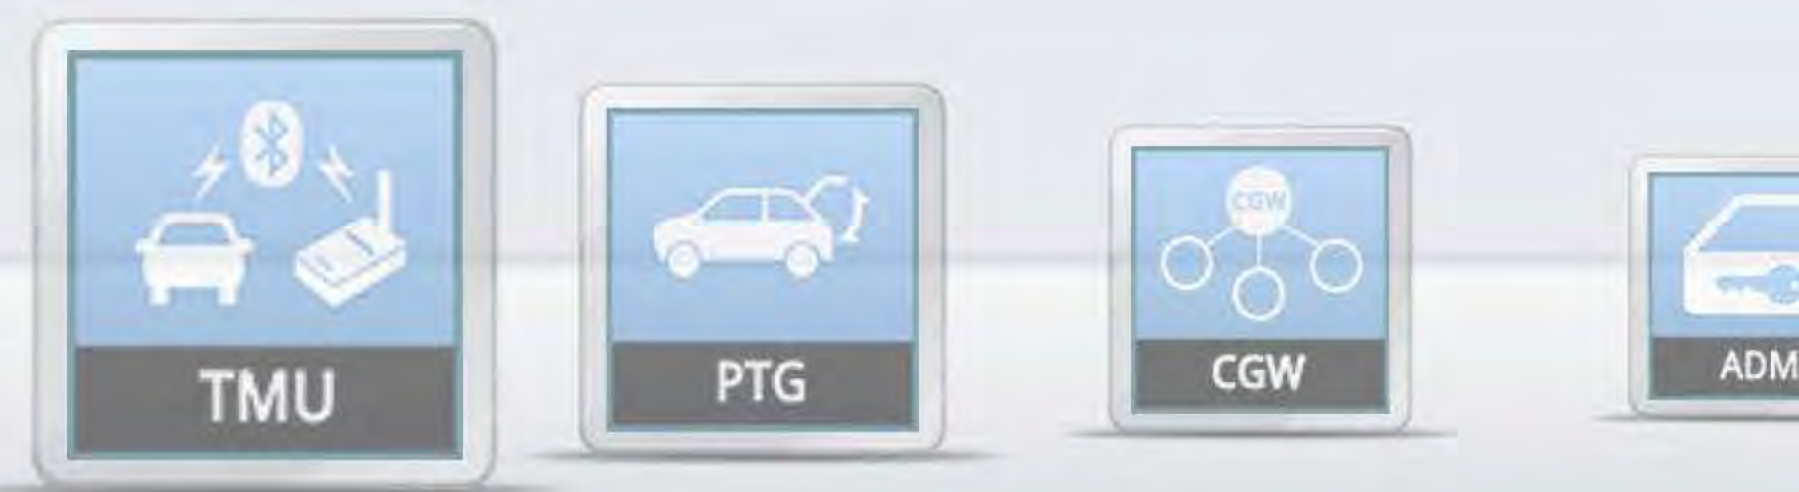
| System | Status | Result |
|---|---|---|
| ADM | Communication Fail / Check whether system is installed or not.<br>Check the IG key and DLC. | Failed |
| PTG | Communication Fail / Check whether system is installed or not.<br>Check the IG key and DLC. | Failed |

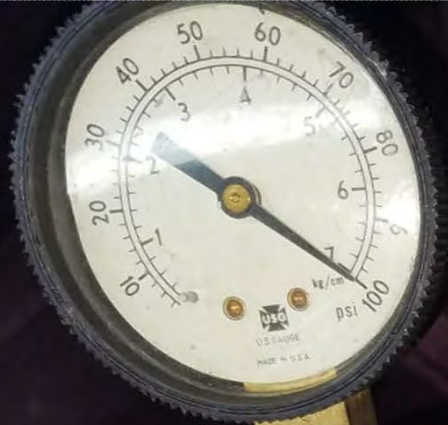
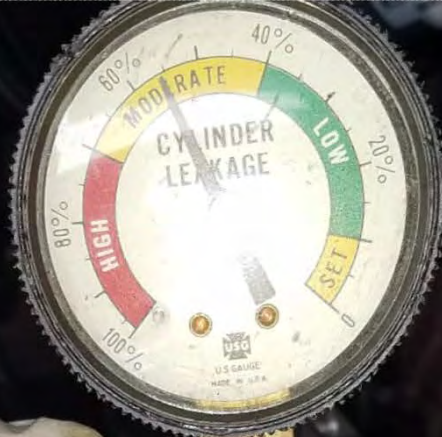
CL1006M  
CYLINDER  
LEAKAGE TESTER  
WATCO TOOLS  
4800 ALLEN RD. STEW. OHIO 44224
