PE19-004  
KIA  
6/28/2019  
DEFECT B  
TECHLINES  
SORENTO

PE19-004\_Expanded Scope\_Alleged  
Defect B

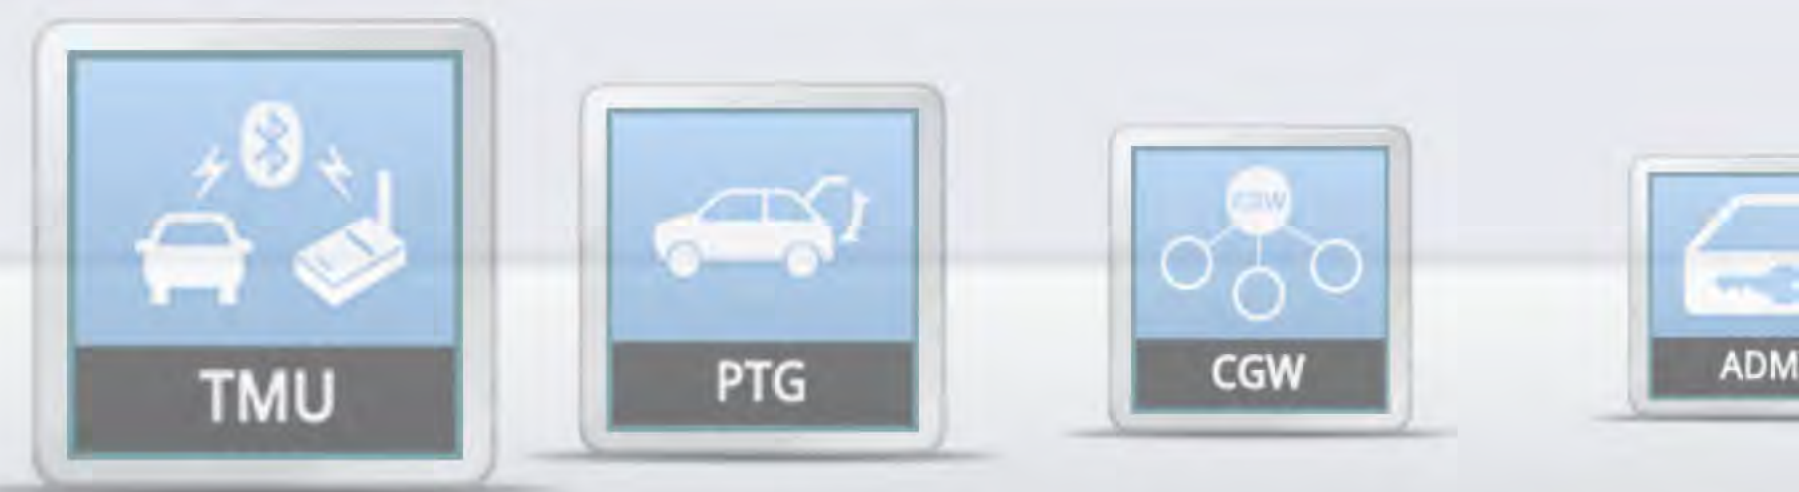
| System | Status | Result |
|---|---|---|
| ADM | Communication Fail / Check whether system is installed or not.<br>Check the IG key and DLC. | Failed |
| PTG | Communication Fail / Check whether system is installed or not.<br>Check the IG key and DLC. | Failed |
