PE19-004  
KIA  
6/28/2019  
DEFECT B  
TECHLINES  
STINGER

PE19-004\_Expanded  
Scope\_Stinger\_Alleged Defect B

# Kia Motors America Technical Assistance Center

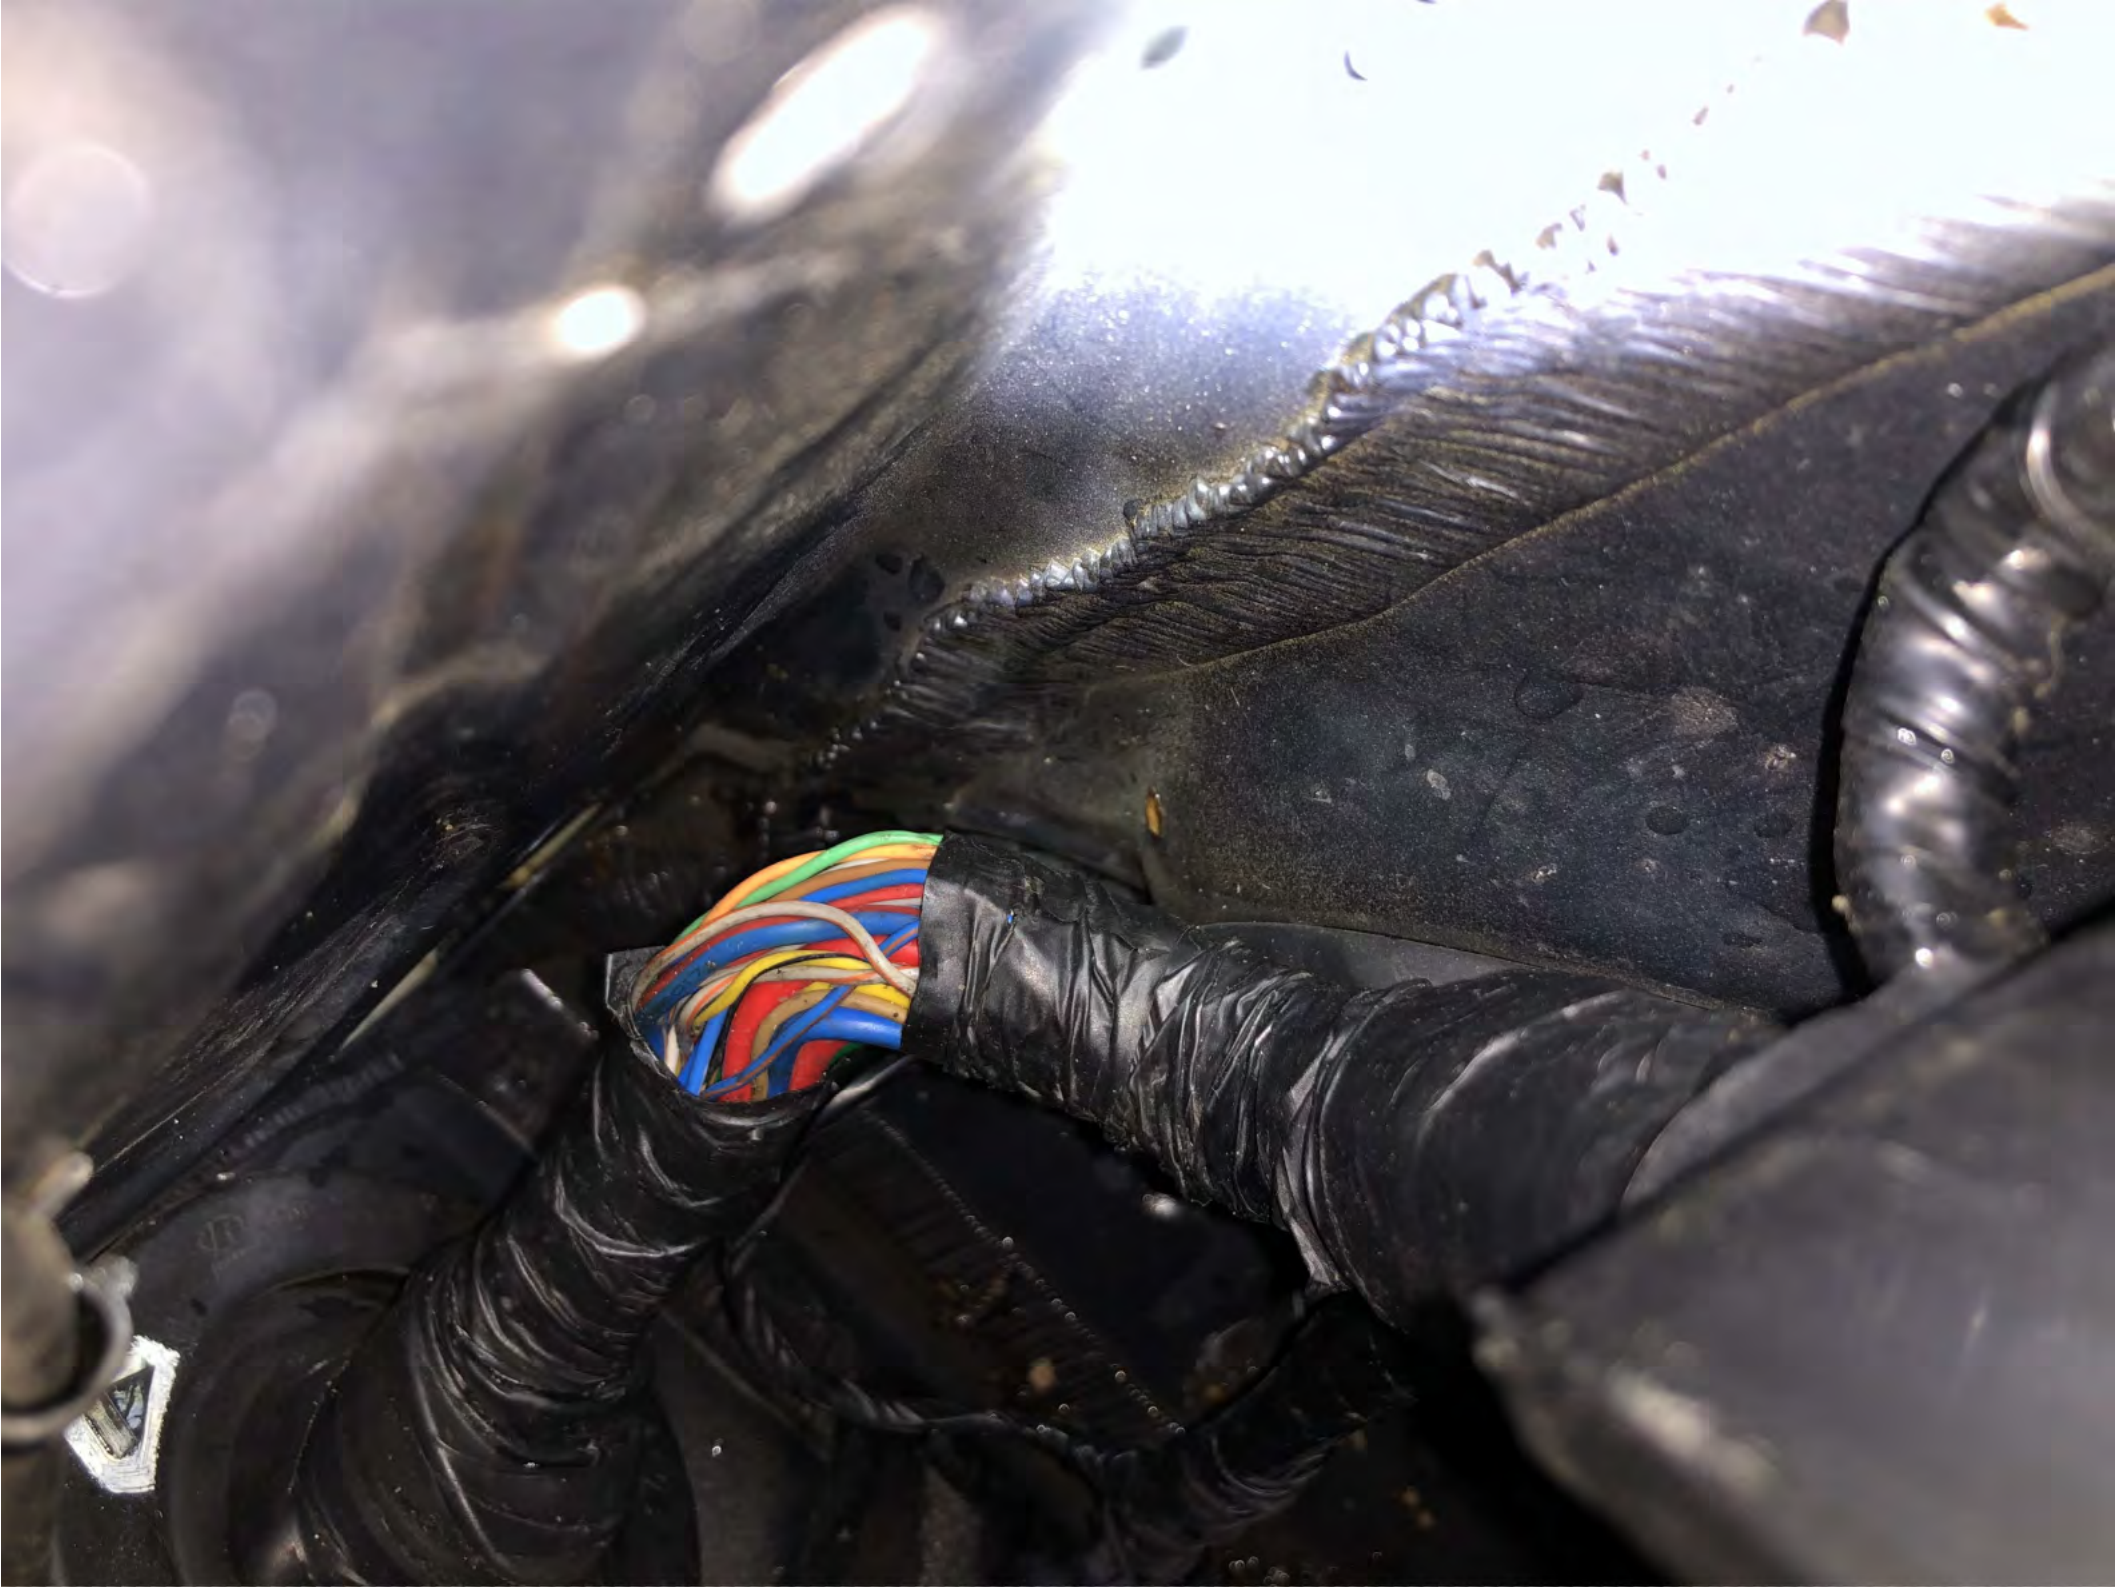
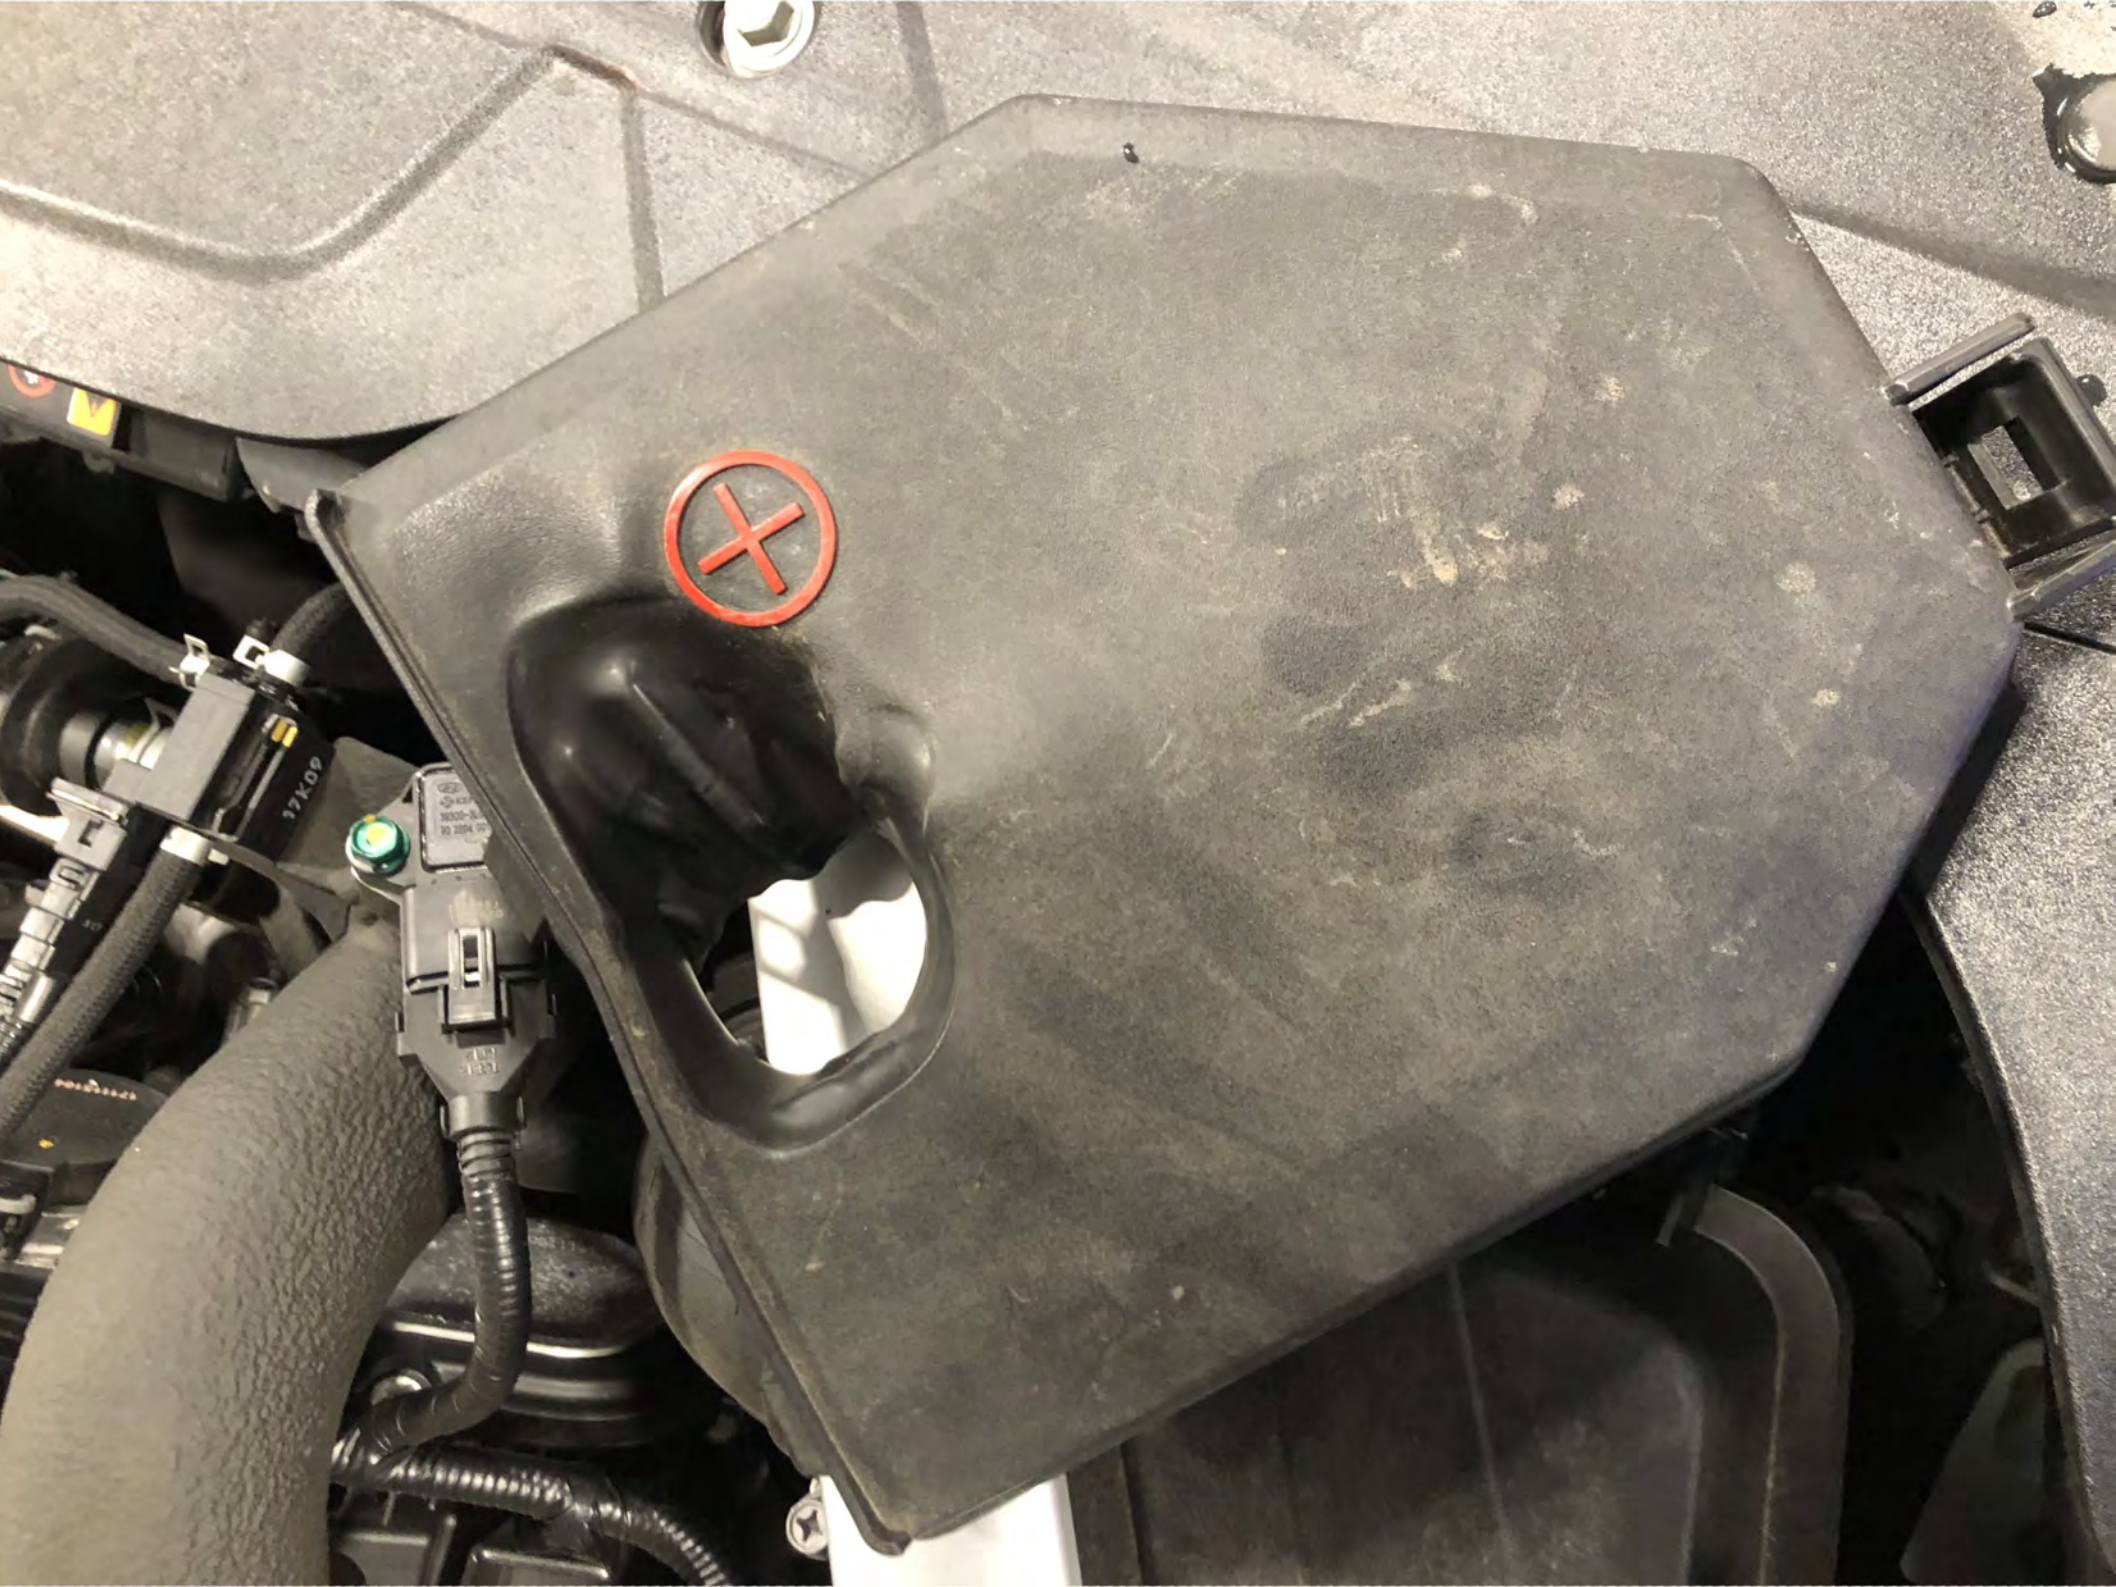
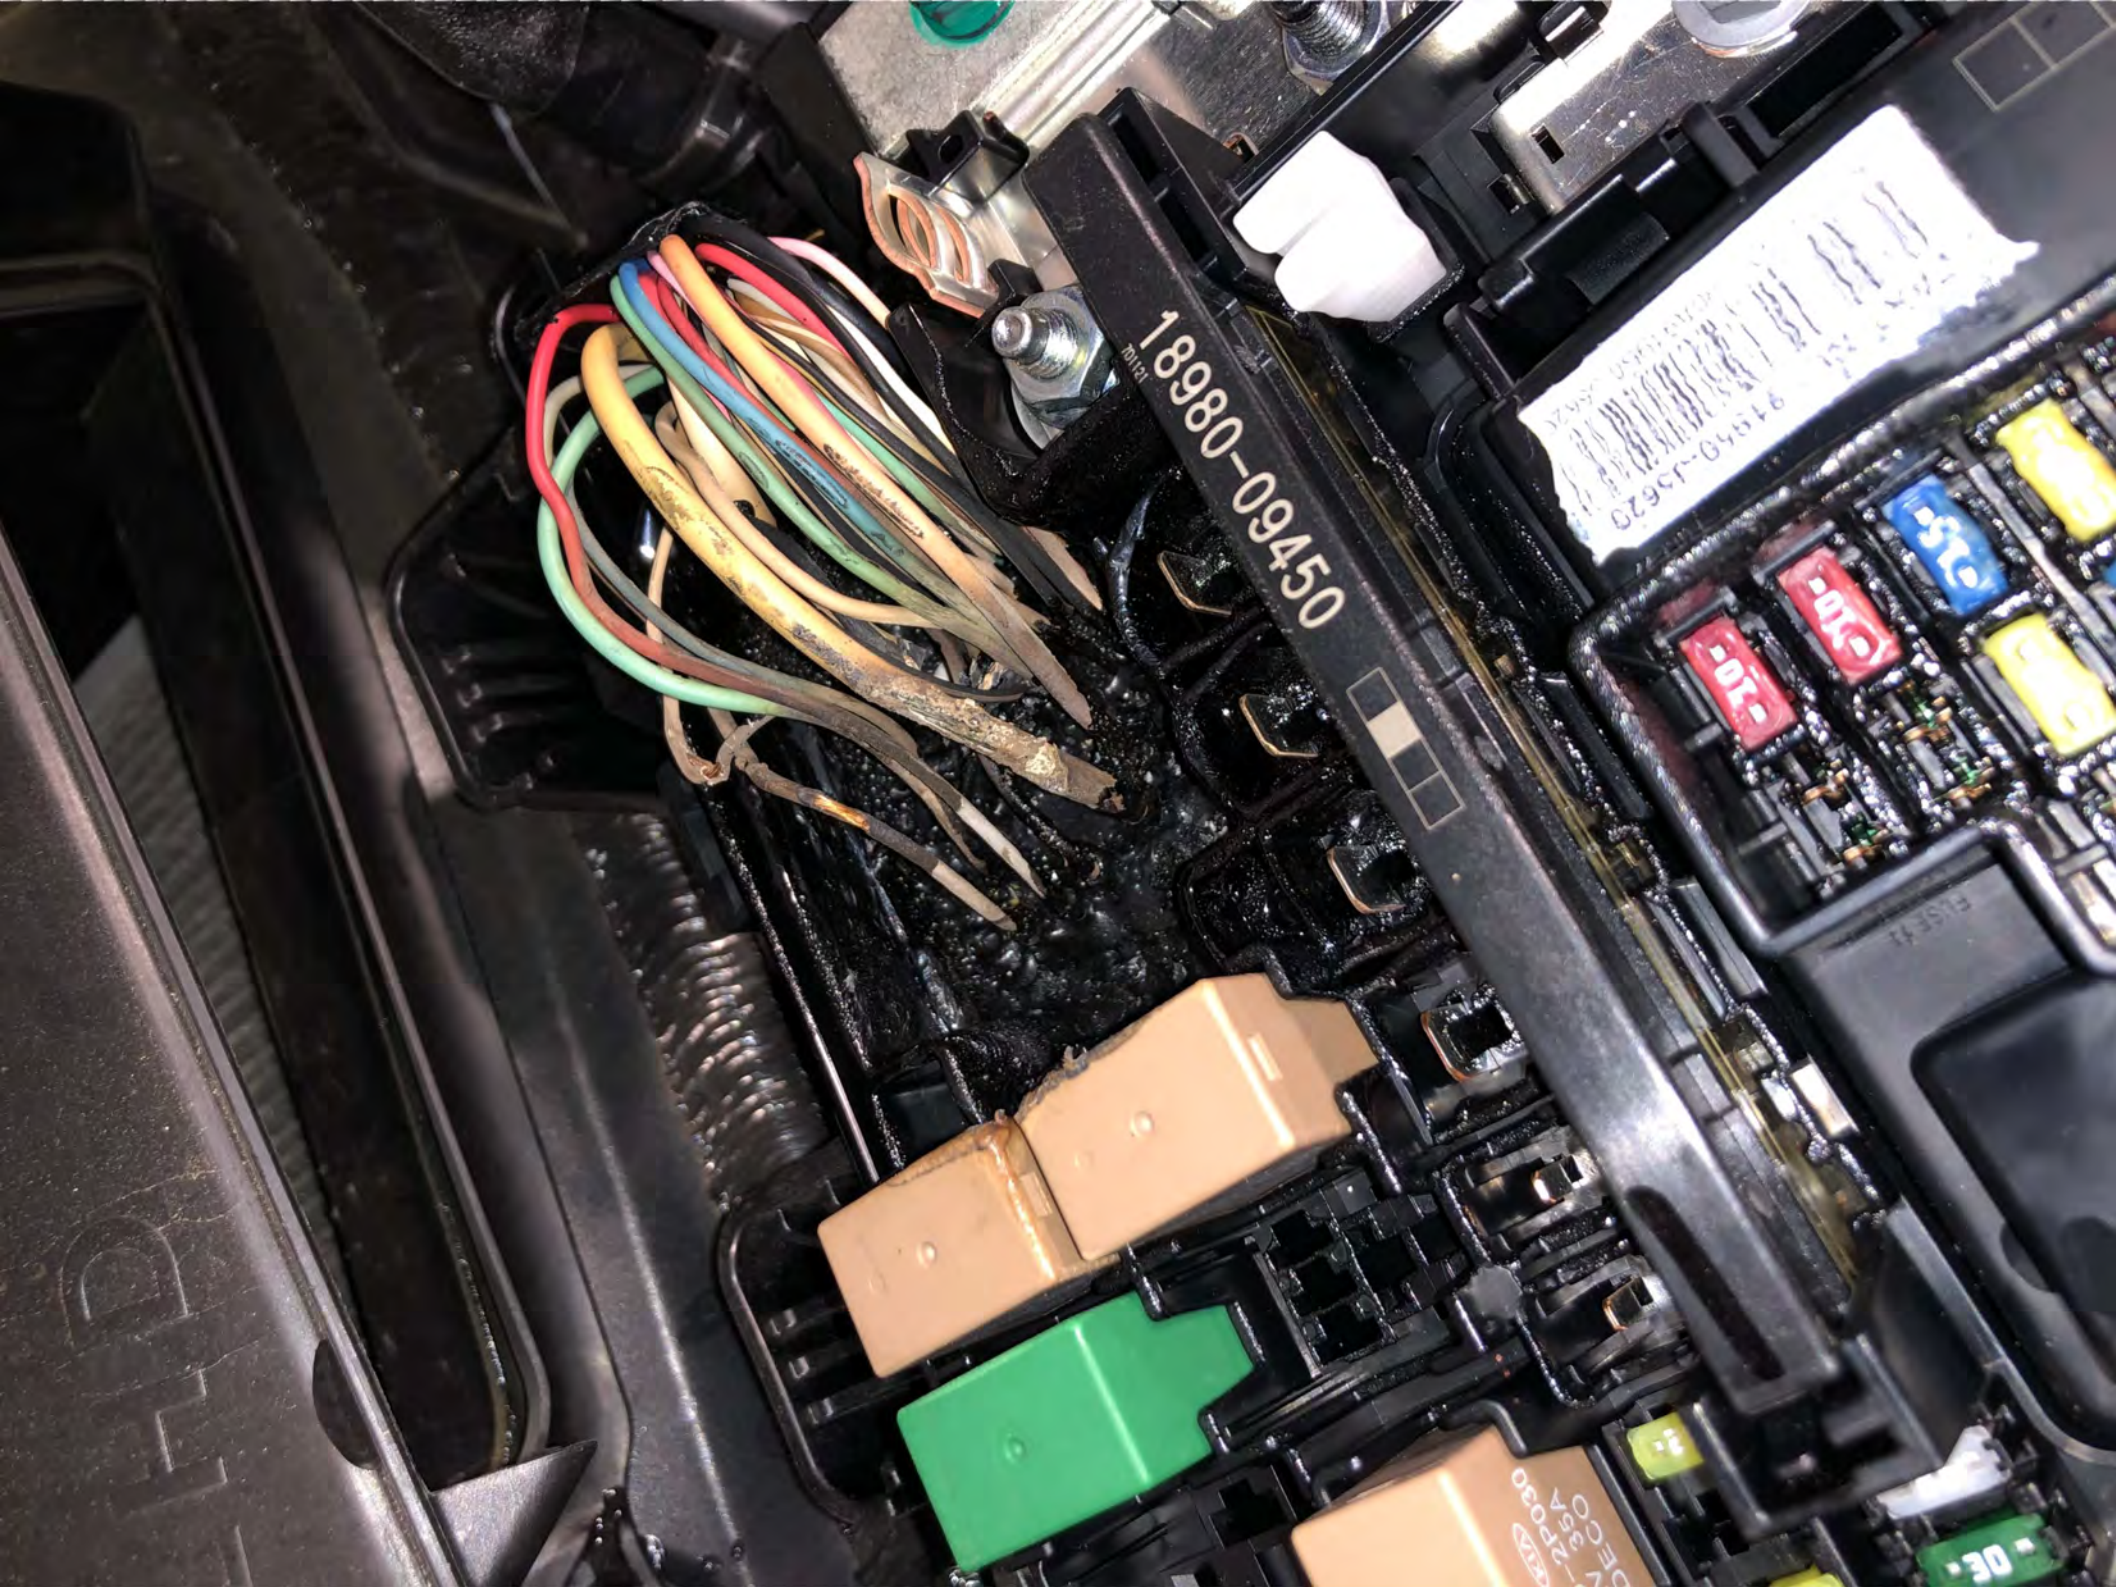
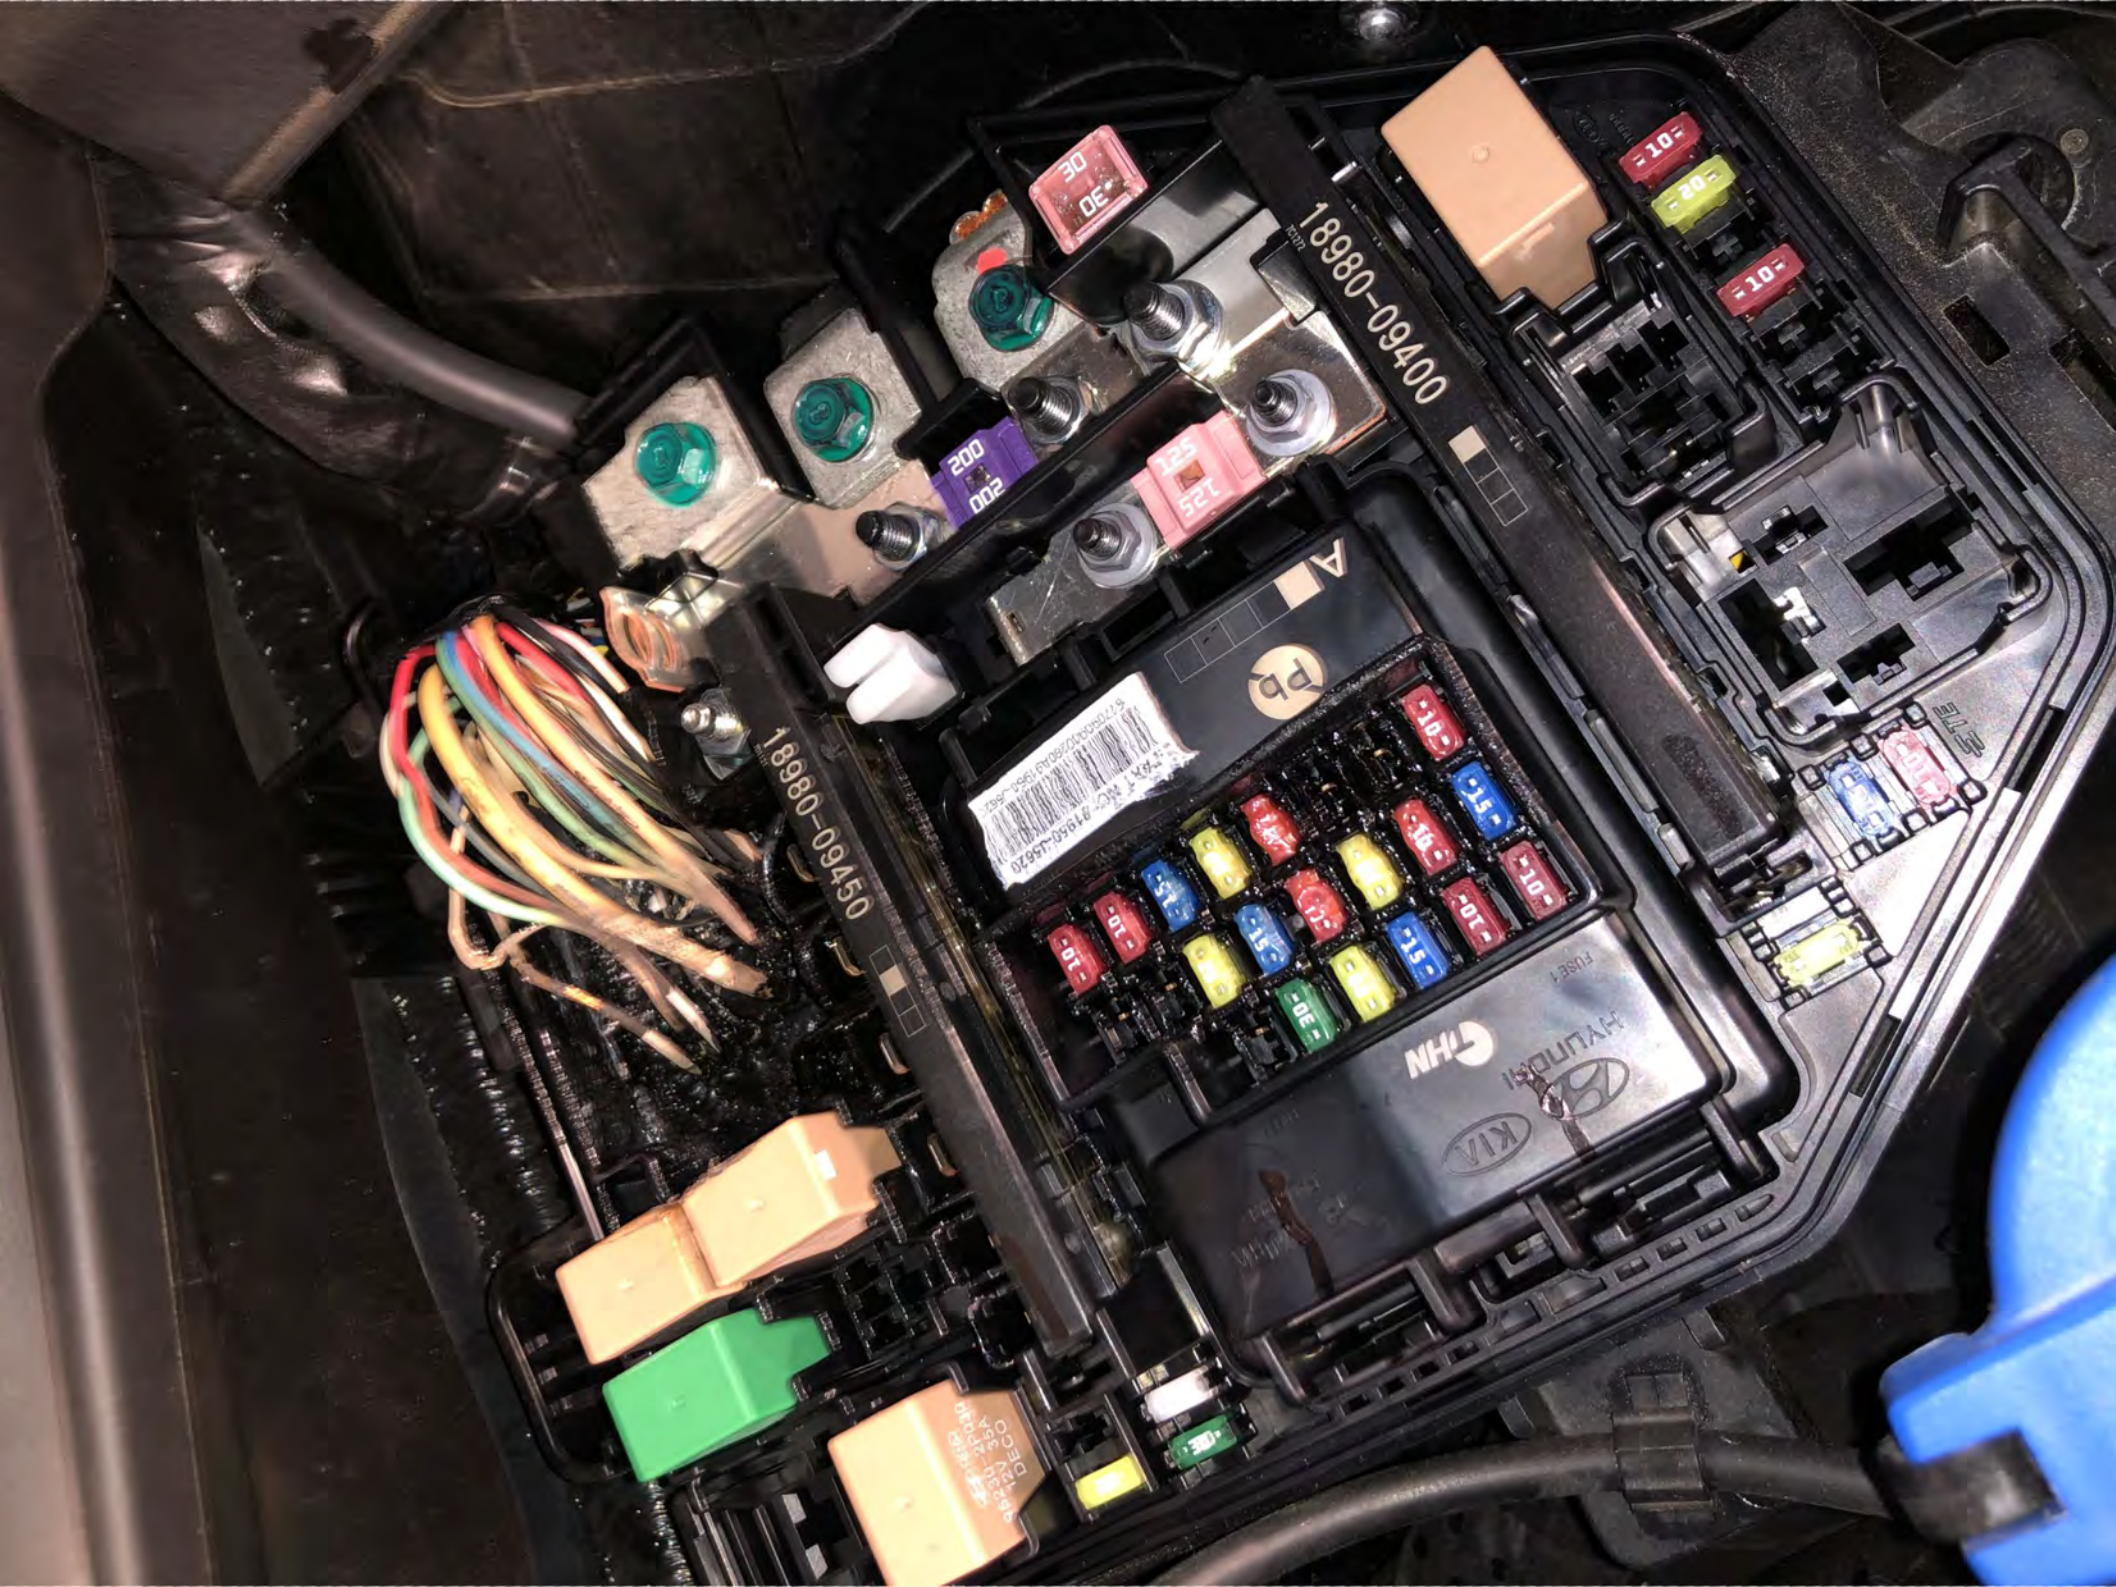
i followed your steps and checked pins tension on pins 4,83,21,17,20,19 of connector ec 11. then at components. i removed ecvvt cover to check contacts and found it to be melted and very worn and smells burnt.

1: Please replace the E-CVVT and cover. Reset the adaptive values and test for normal operation. Retain these parts, close the case and submit your warranty claim immediately after the repairs are completed.
