PE19-004  
KIA  
6/28/2019  
DEFECT B  
TECHLINES  
TELLURIDE

PE19-004\_Expanded  
Scope\_Telluride\_Alleged Defect B

## Kia Motors America Technical Assistance Center

**Case Title:** MIL - PCM # U012D00 - P250400

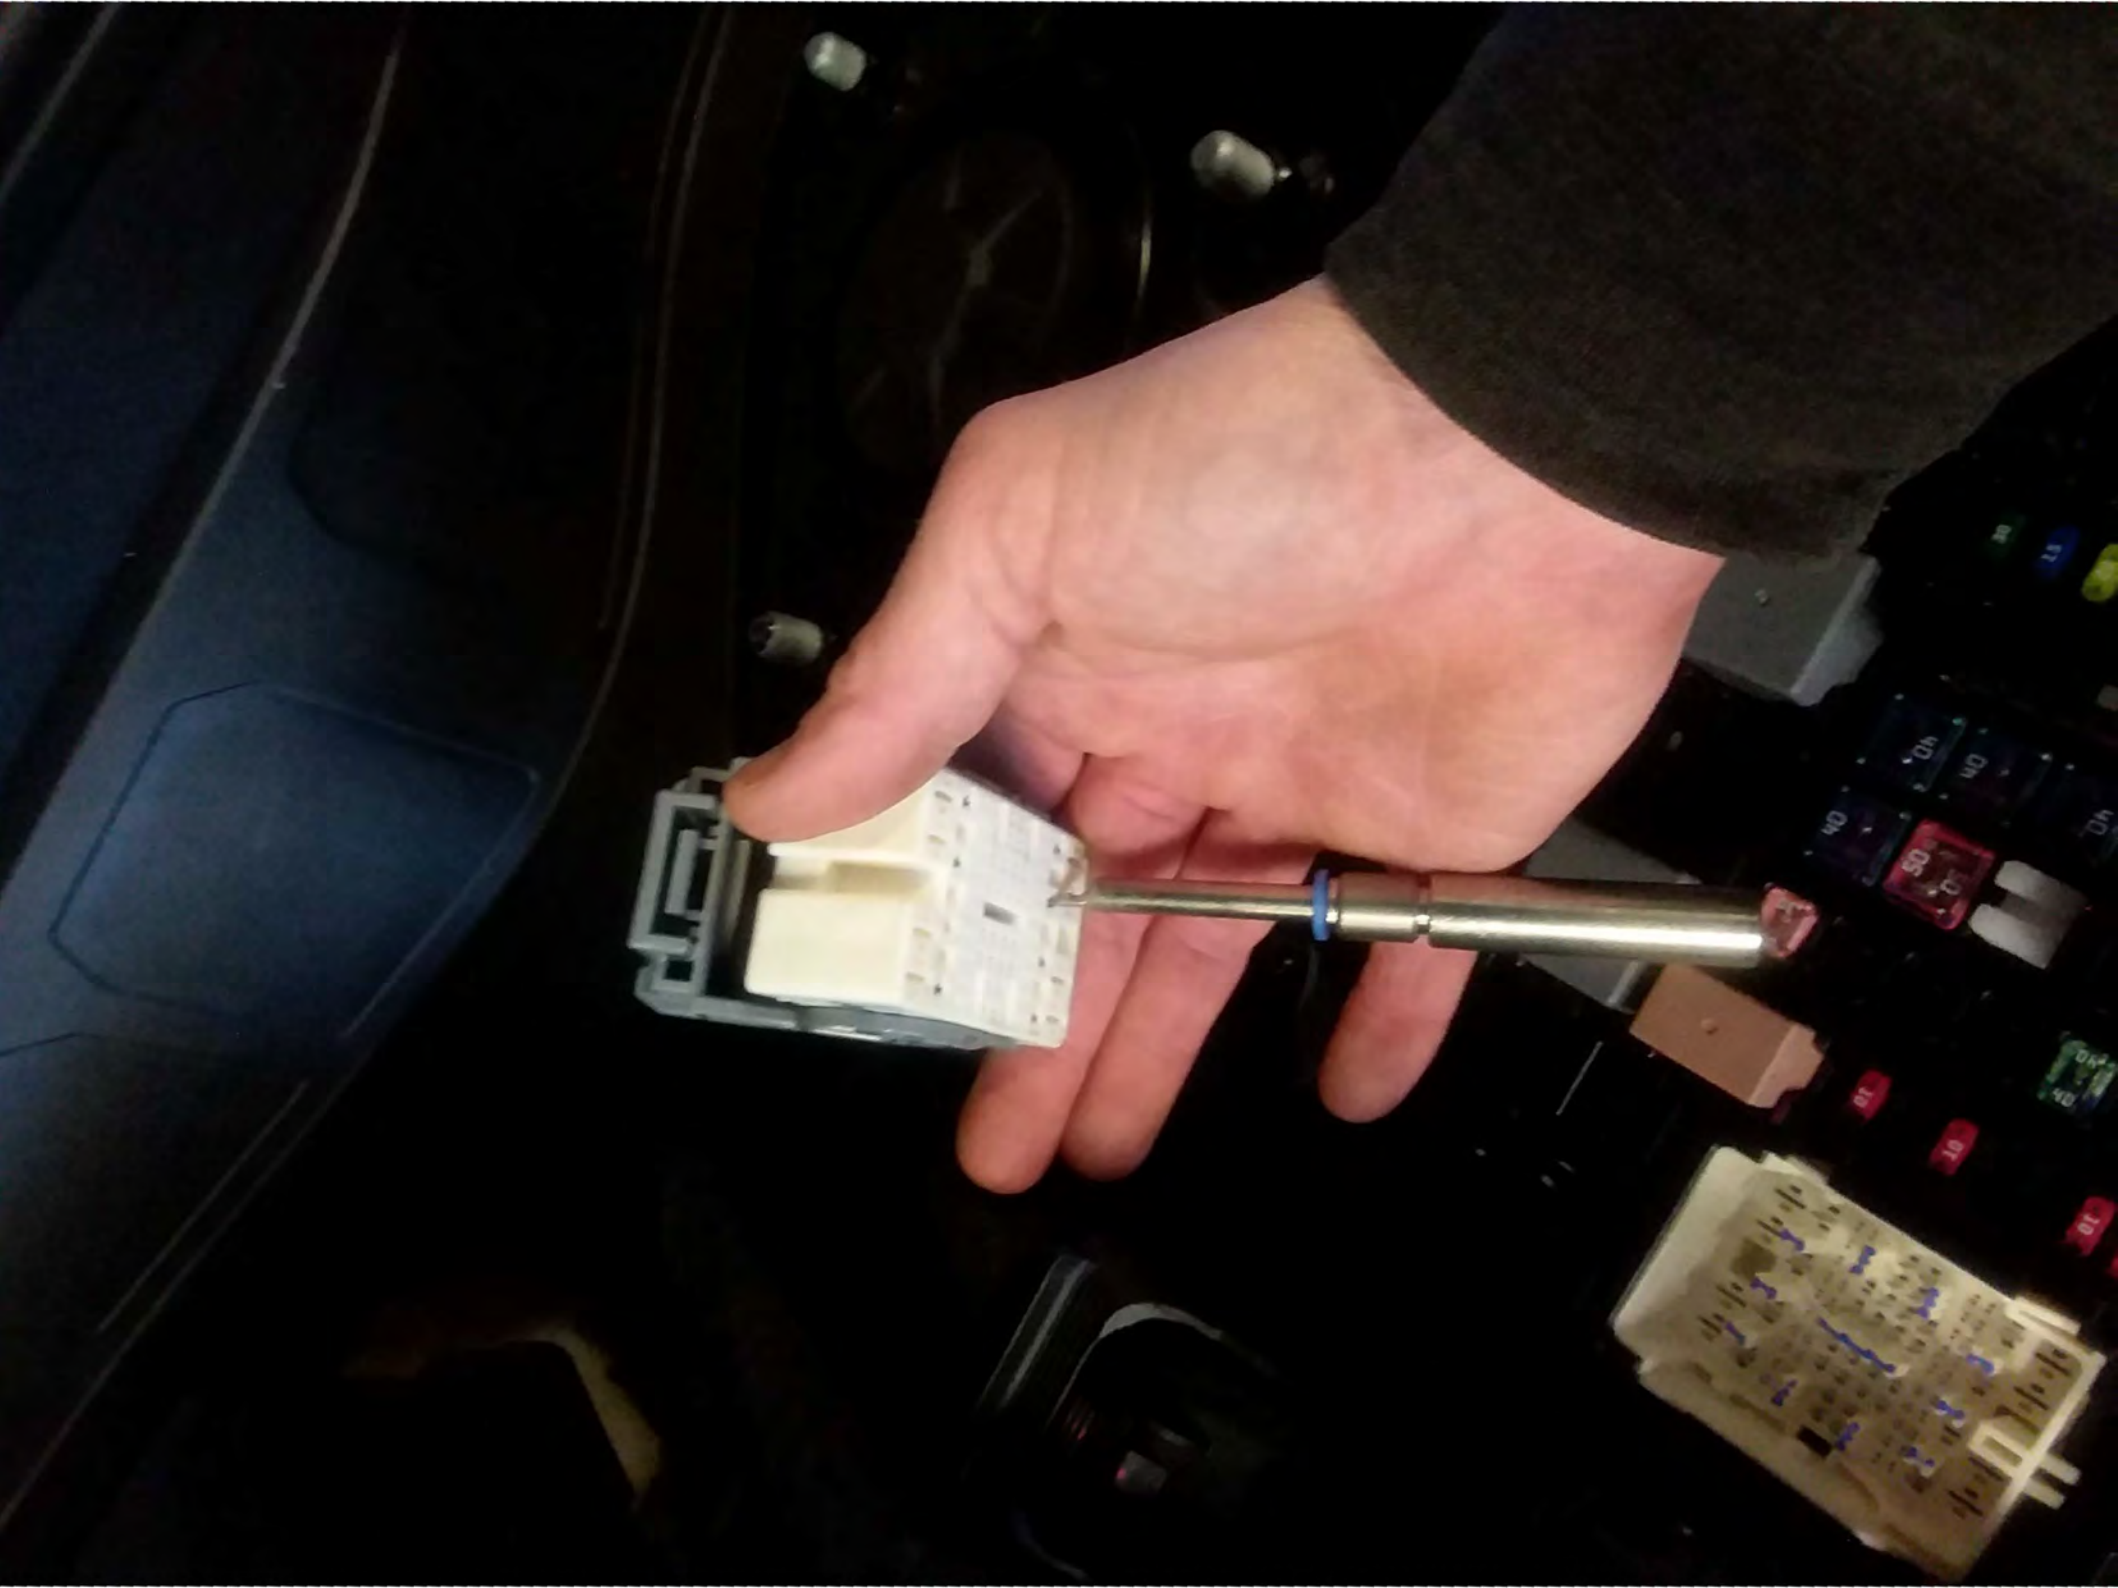
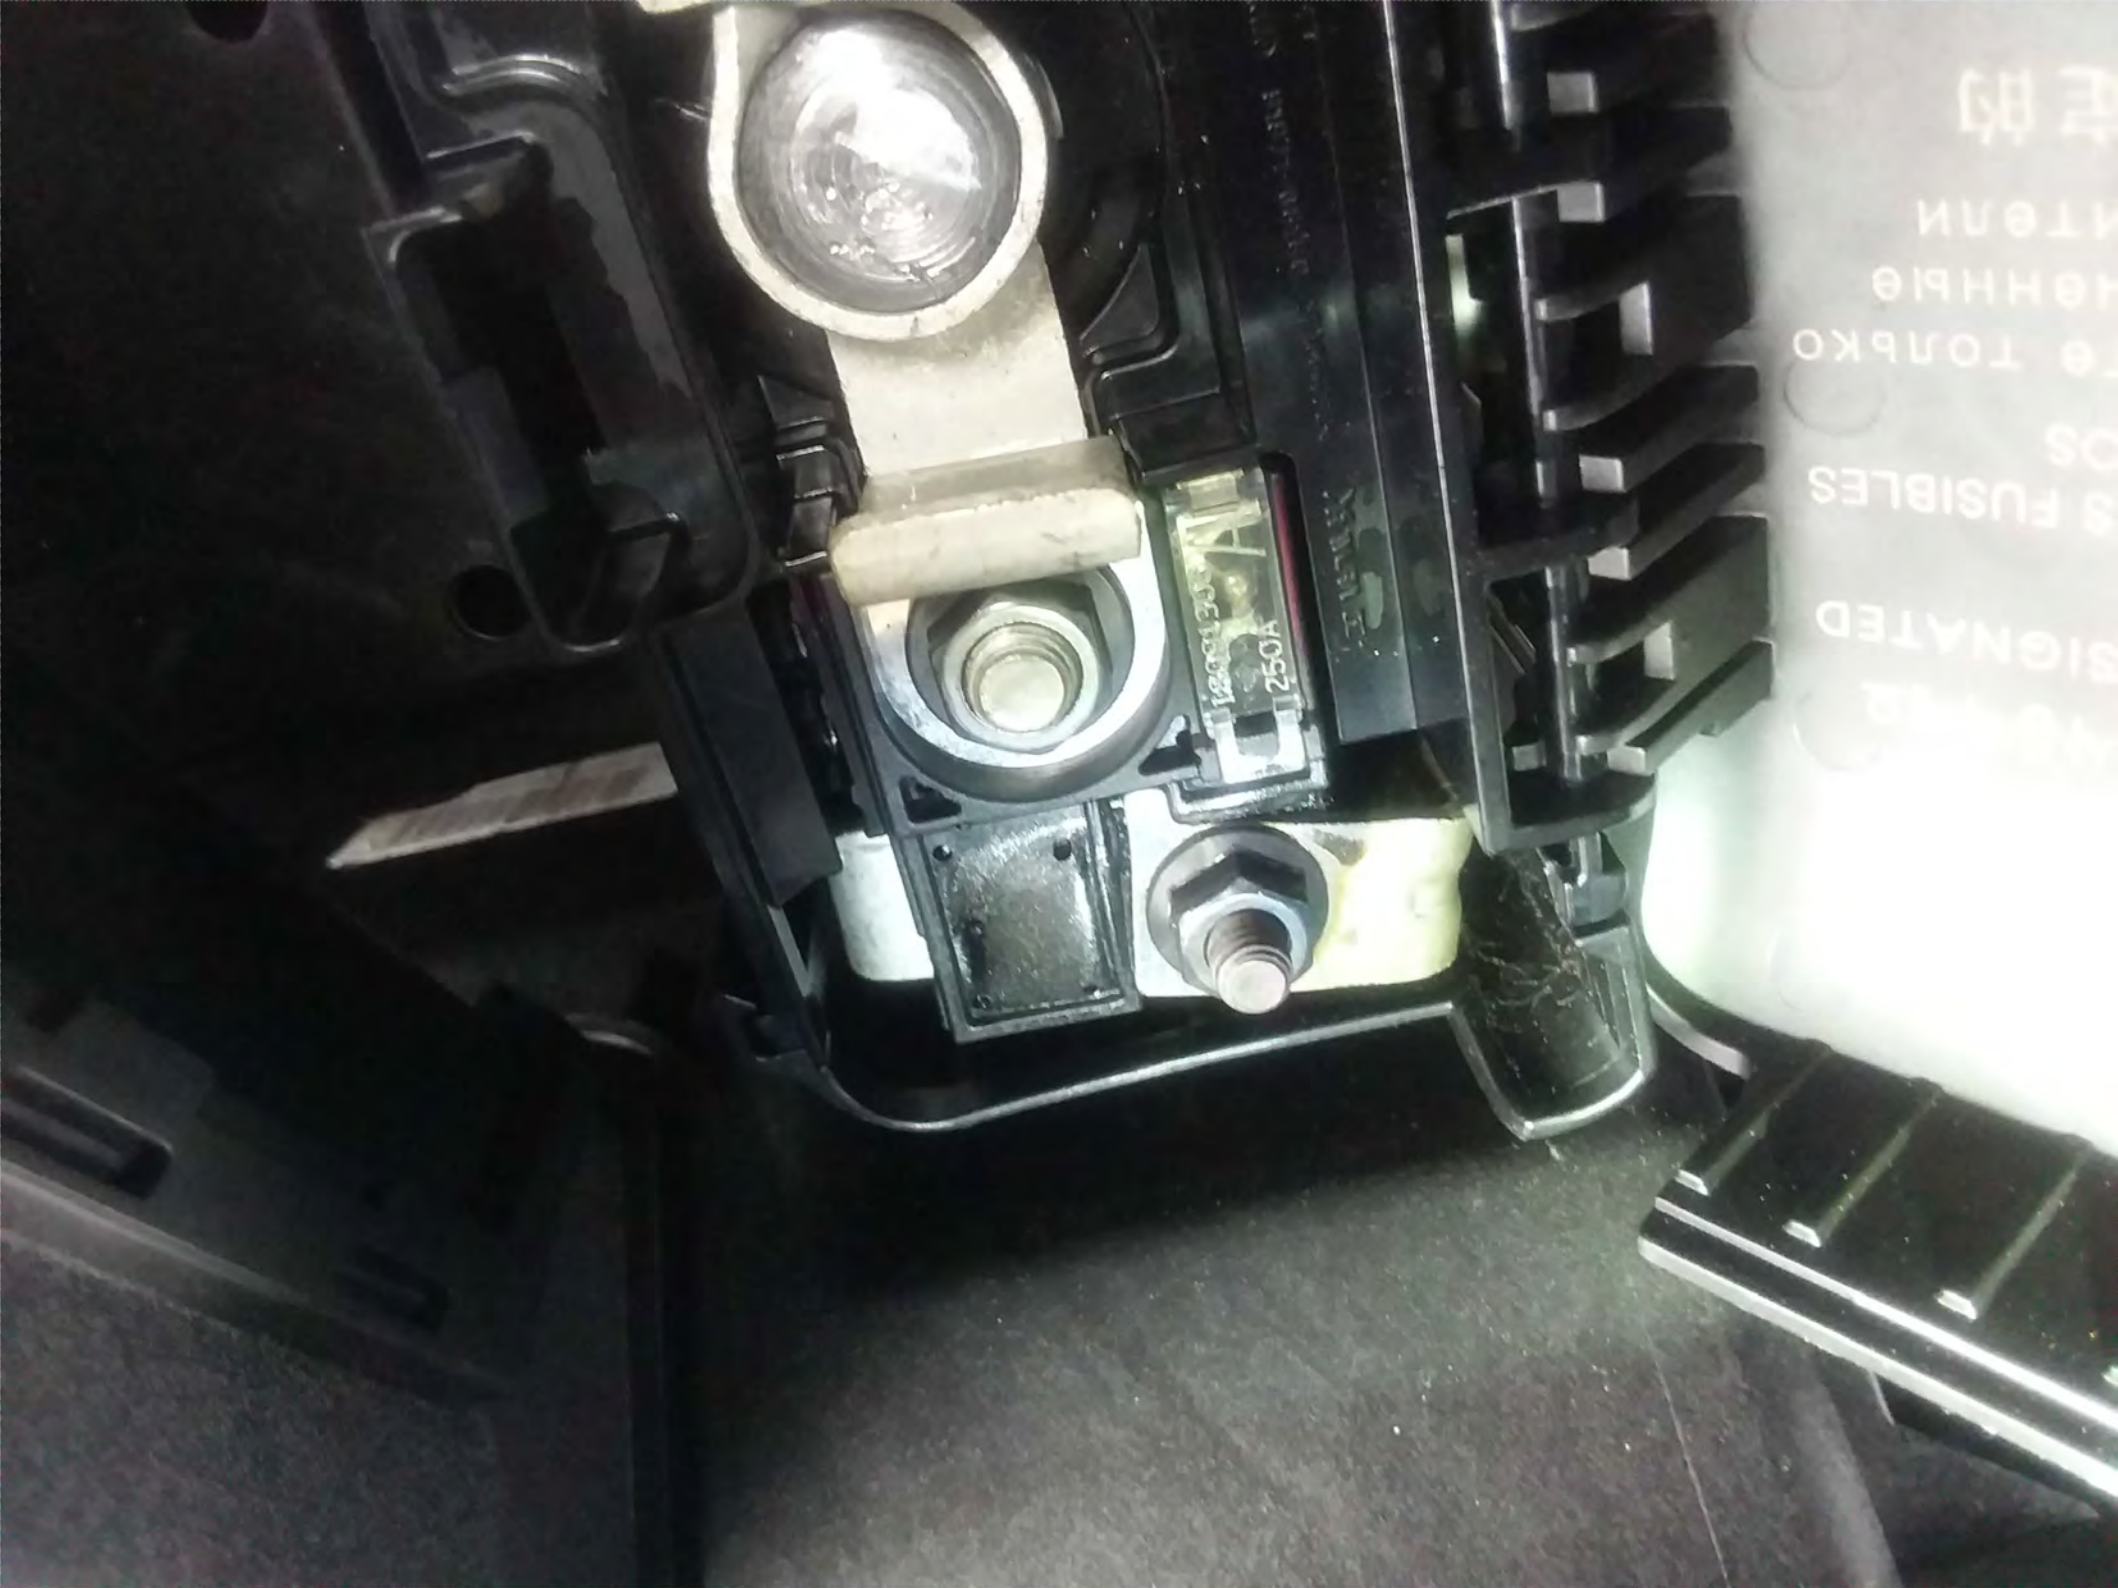
The harness and everything around there looked just fine, it isn't melted or burnt. The only damage was slight warp in the plastic on the positive terminal cover and a black spot on the metal of the terminal with the 10mm nut. Even though the fuse isn't blown or melted I was told to get an availability on it.

Resolution Summary: Replace fuse due to unsecure bolt

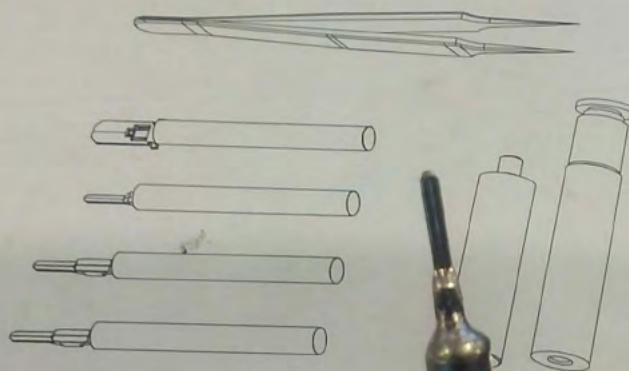
# TENSION GAUGE TOOL SET

The results of the full system test show no voltage coming from the alternator. And the tension gauge I used is the smallest gauge in the set, so I wouldn't damage anything, the tool set for the tension gauge says Box-8

All of the suspected connectors have good pin tension, they all have some drag and support the weight of the gauge.
