PE19-004  
KIA  
6/28/2019  
DEFECT C  
TECHLINES  
FORTE KOUP

PE19-004\_Expanded Scope\_Forte  
Koup\_Alleged Defect C

# Kia Motors America Technical Assistance Center

PE19-004\_Expanded  
Scope\_Sportage\_Alleged Defect C

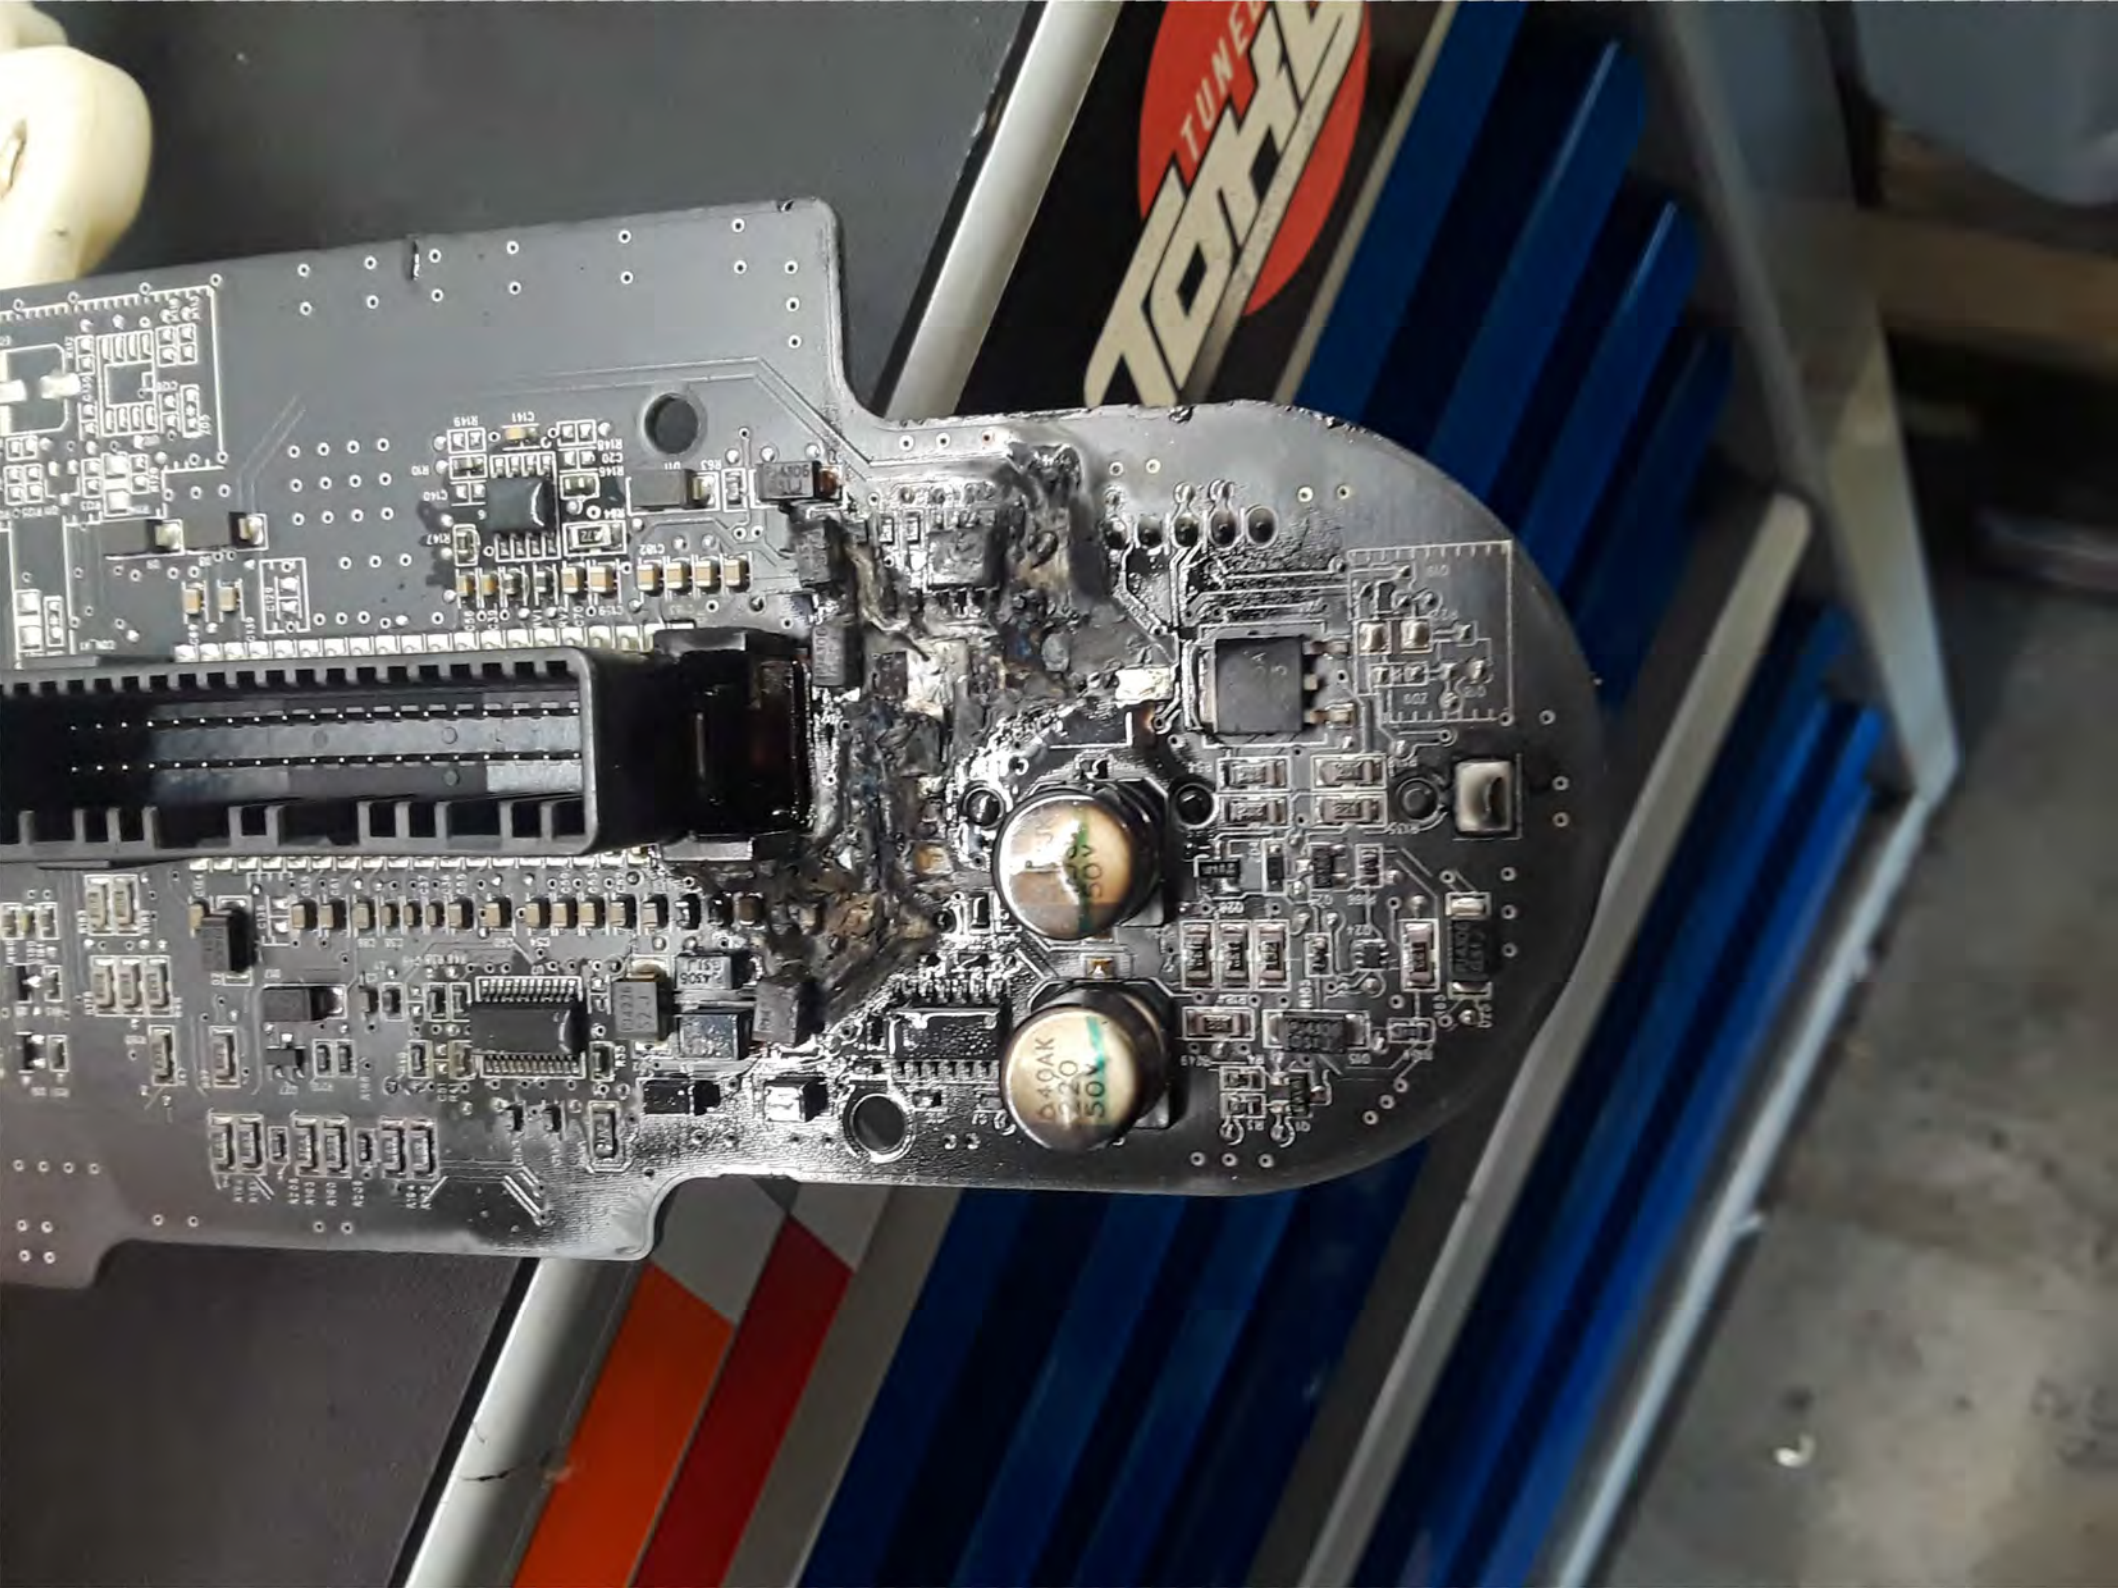
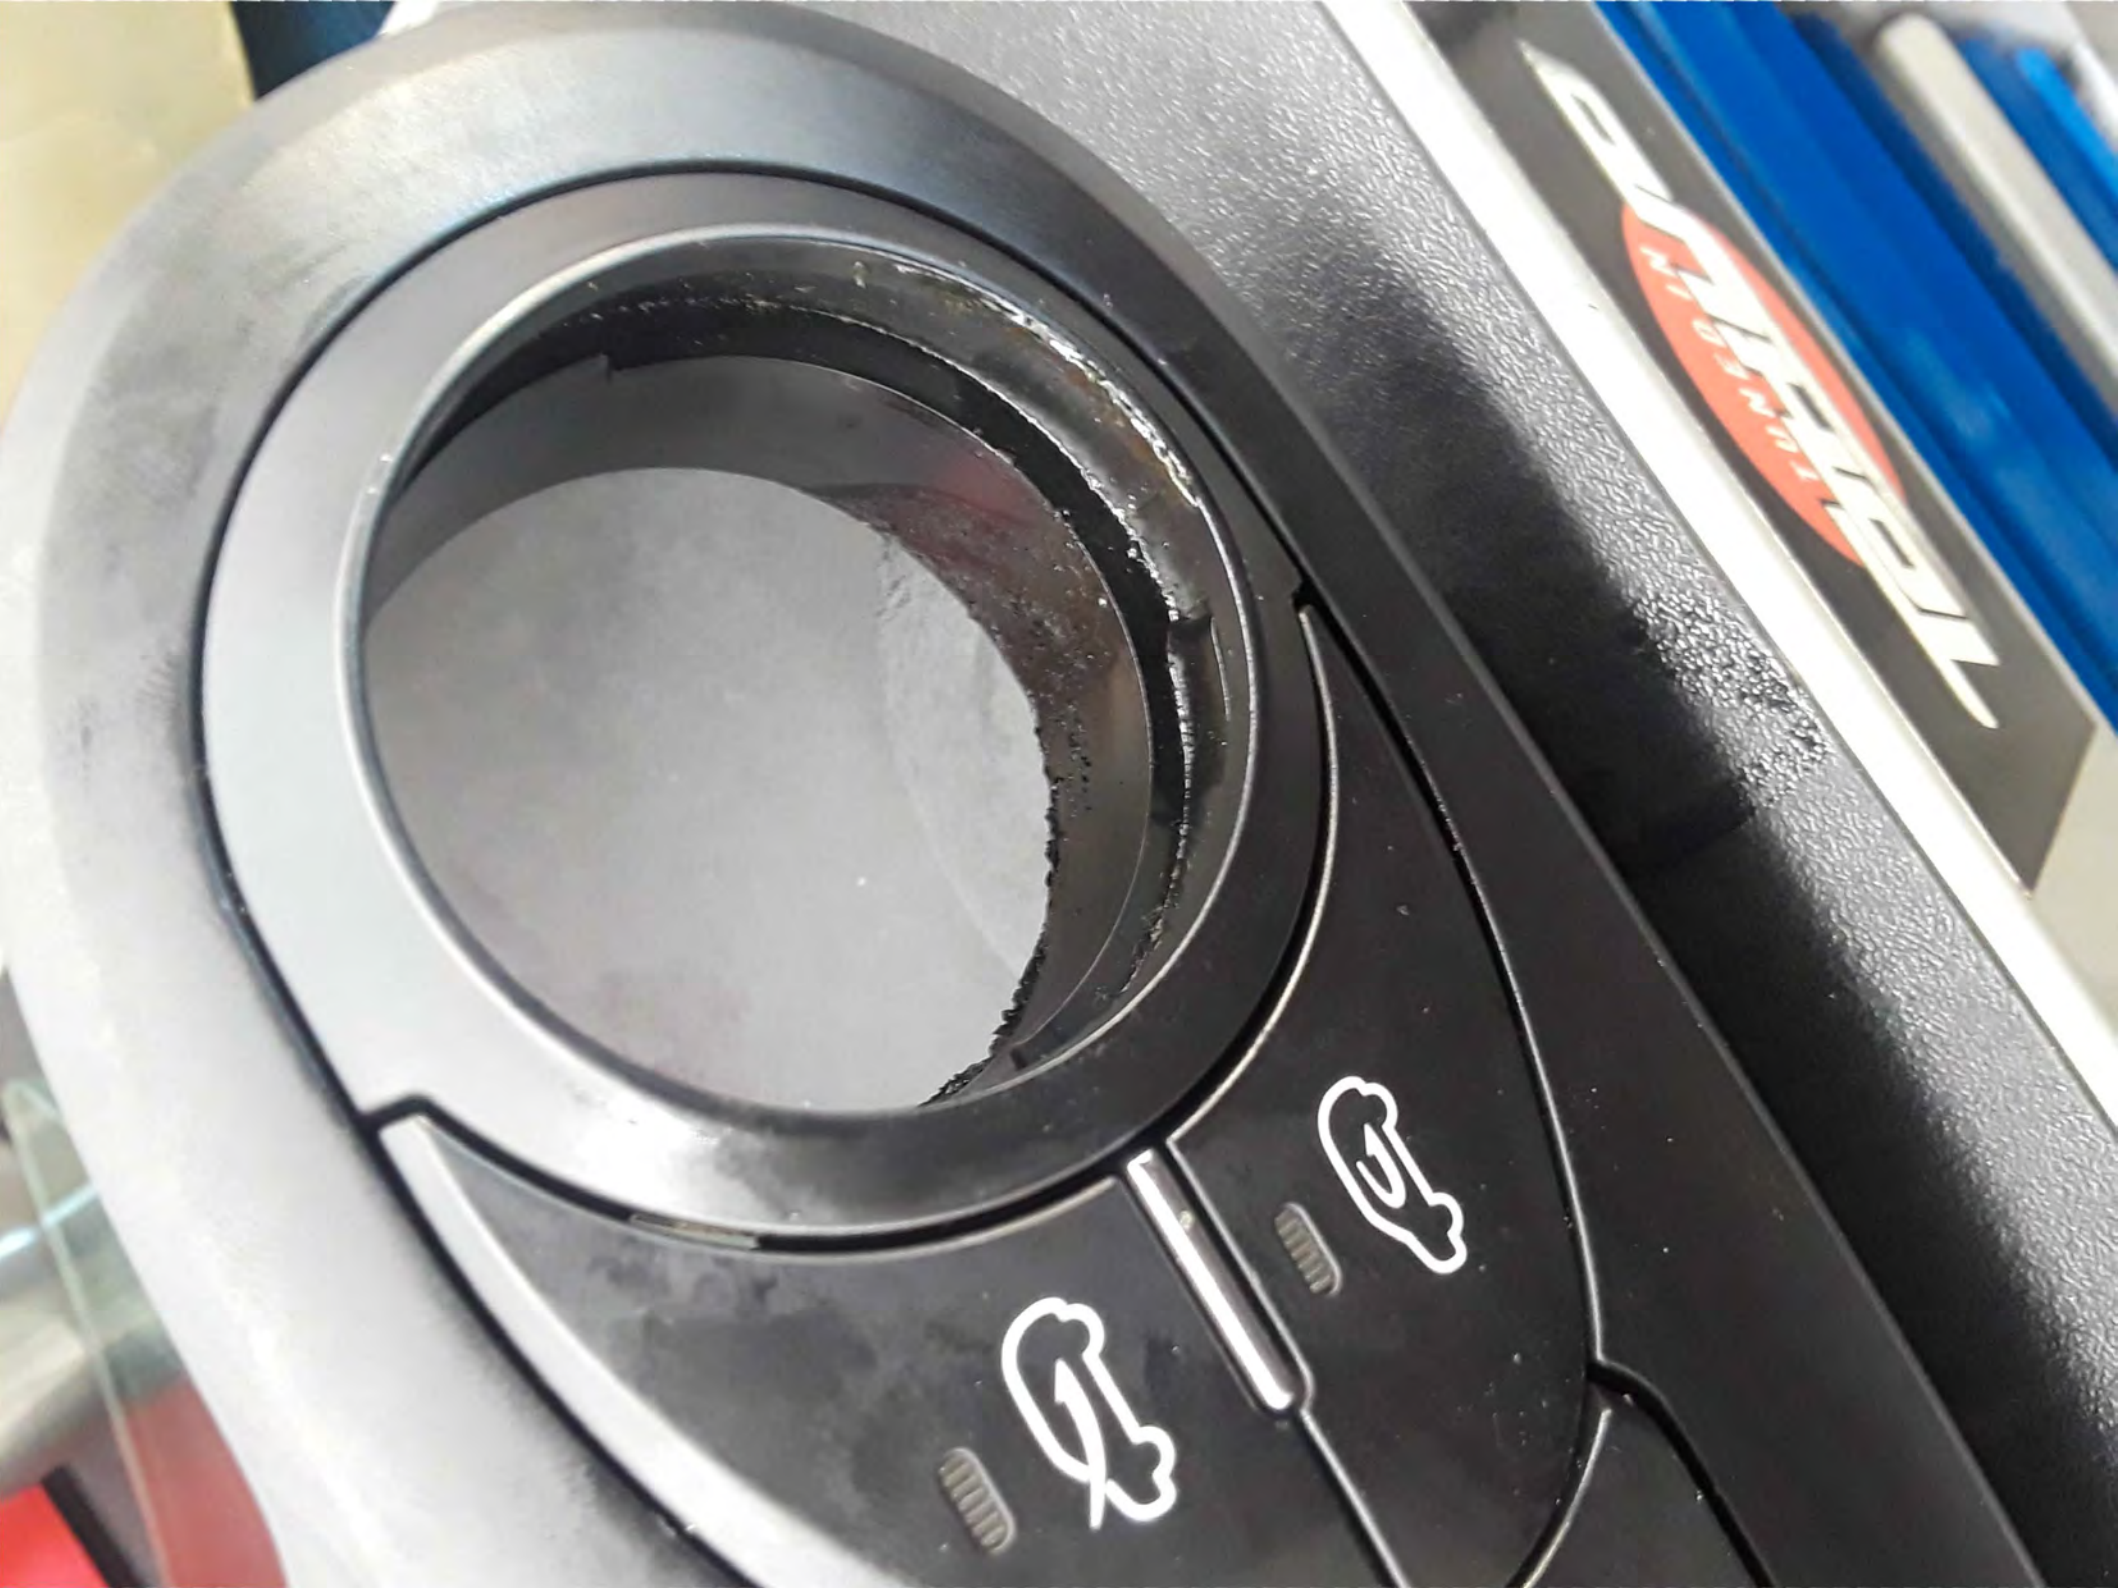
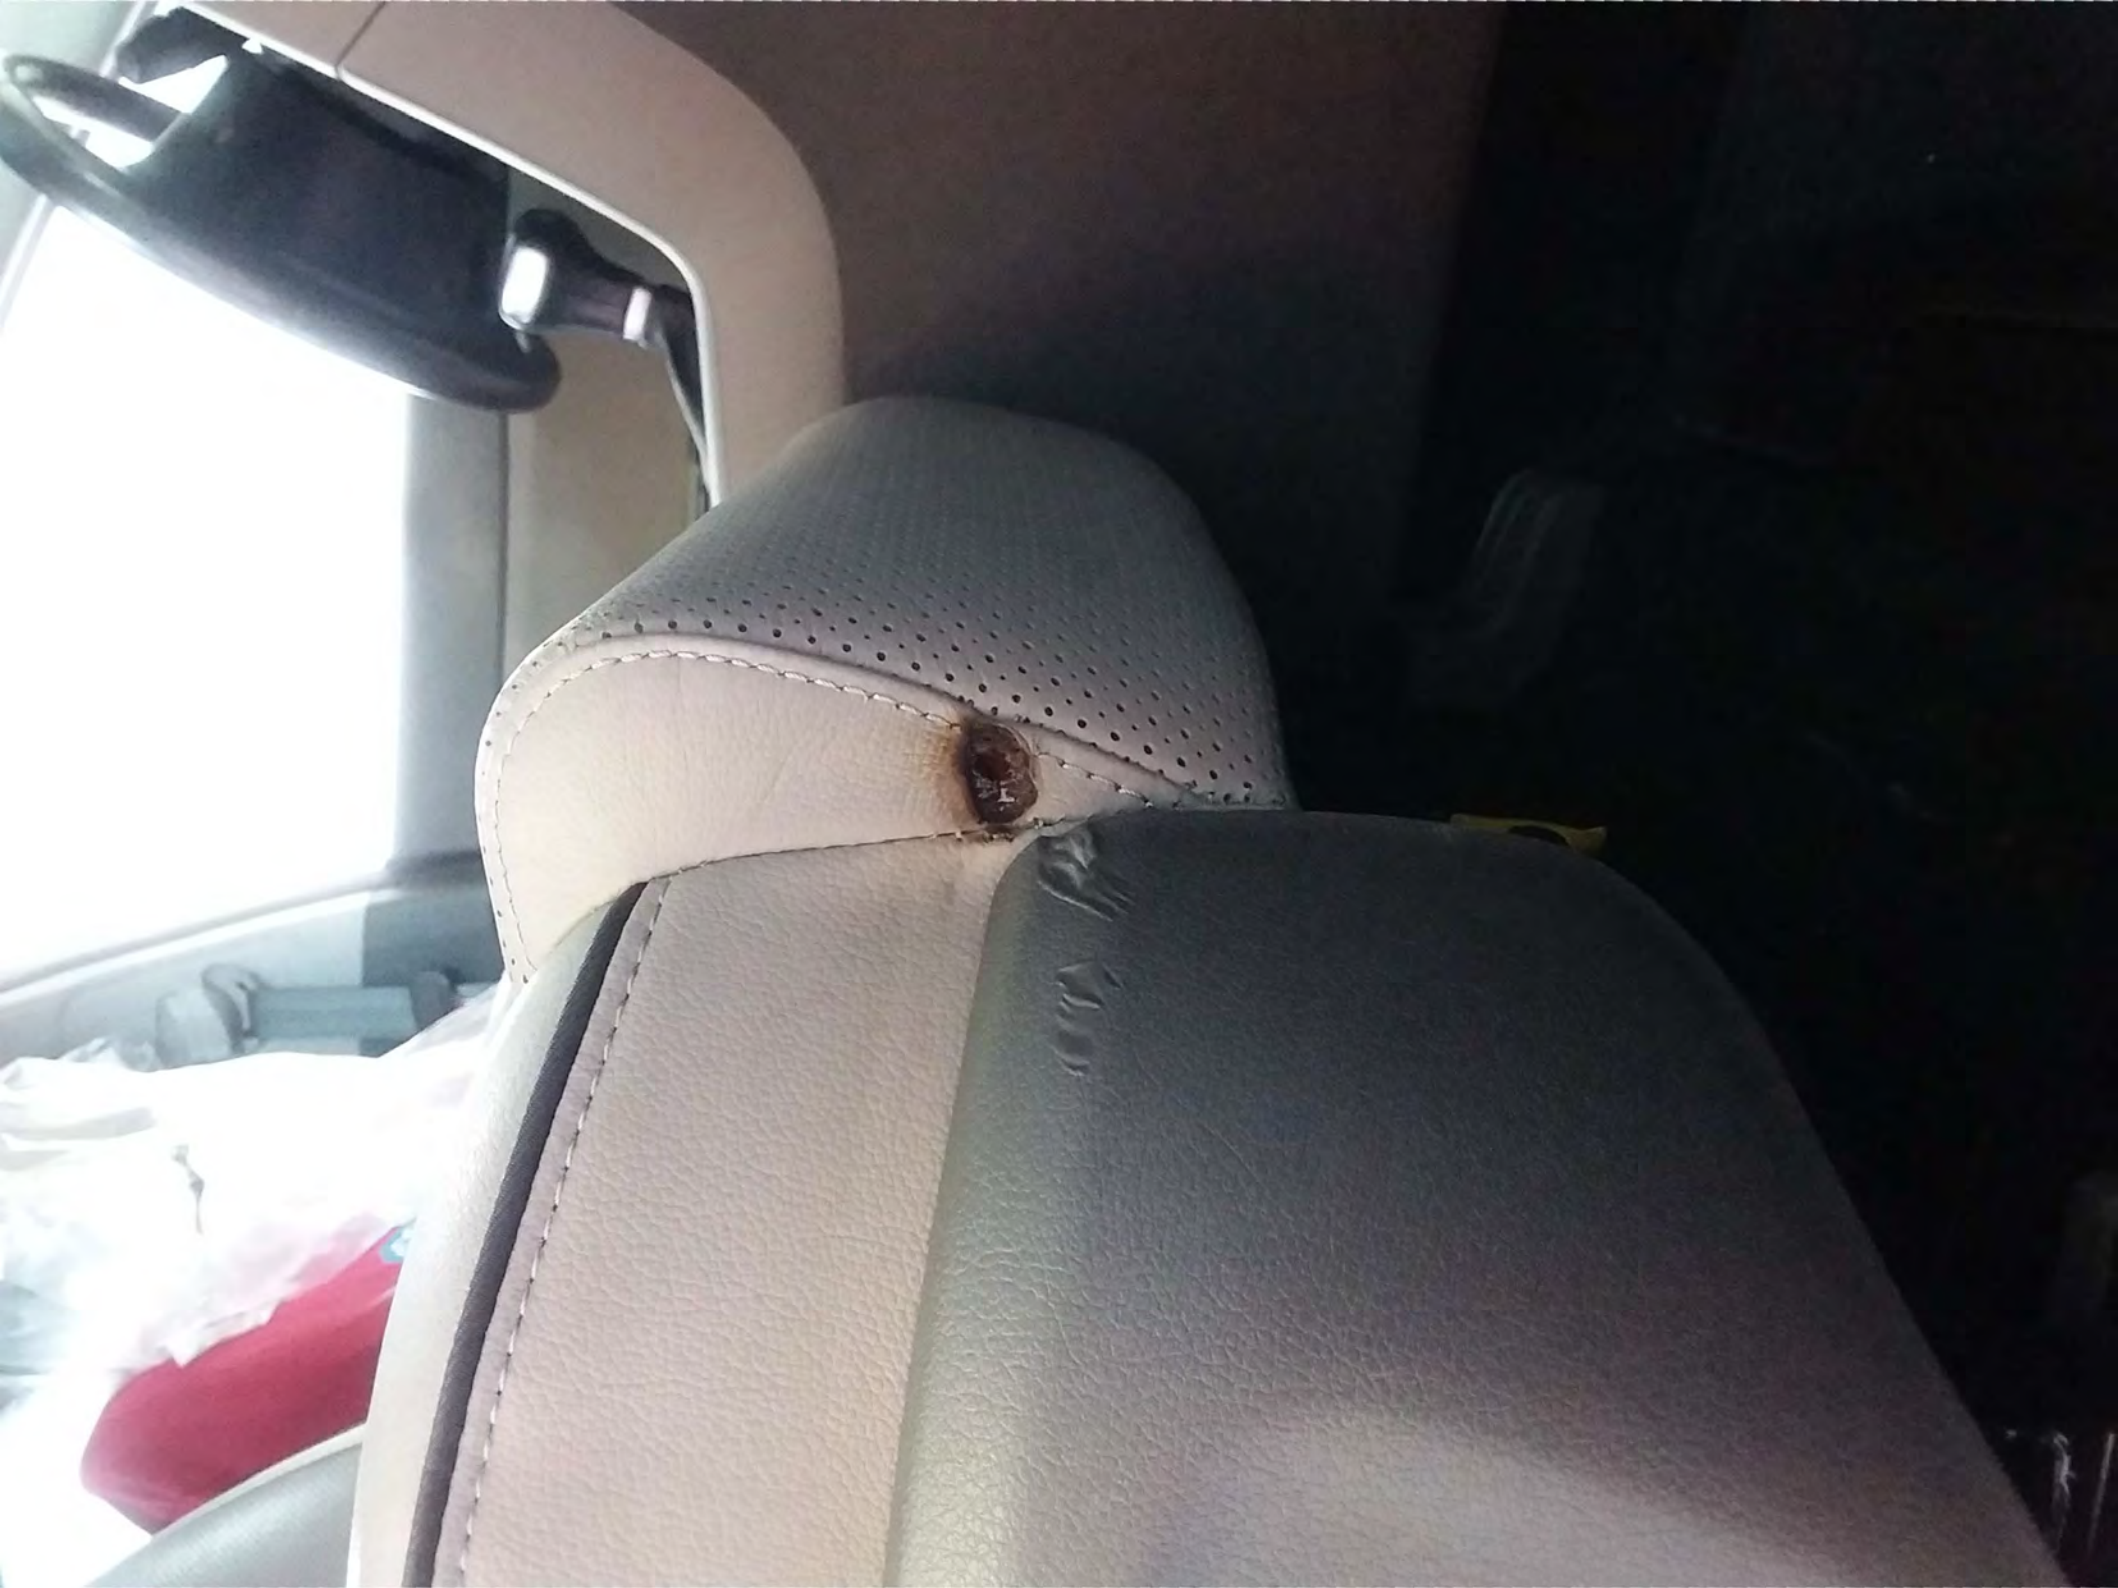
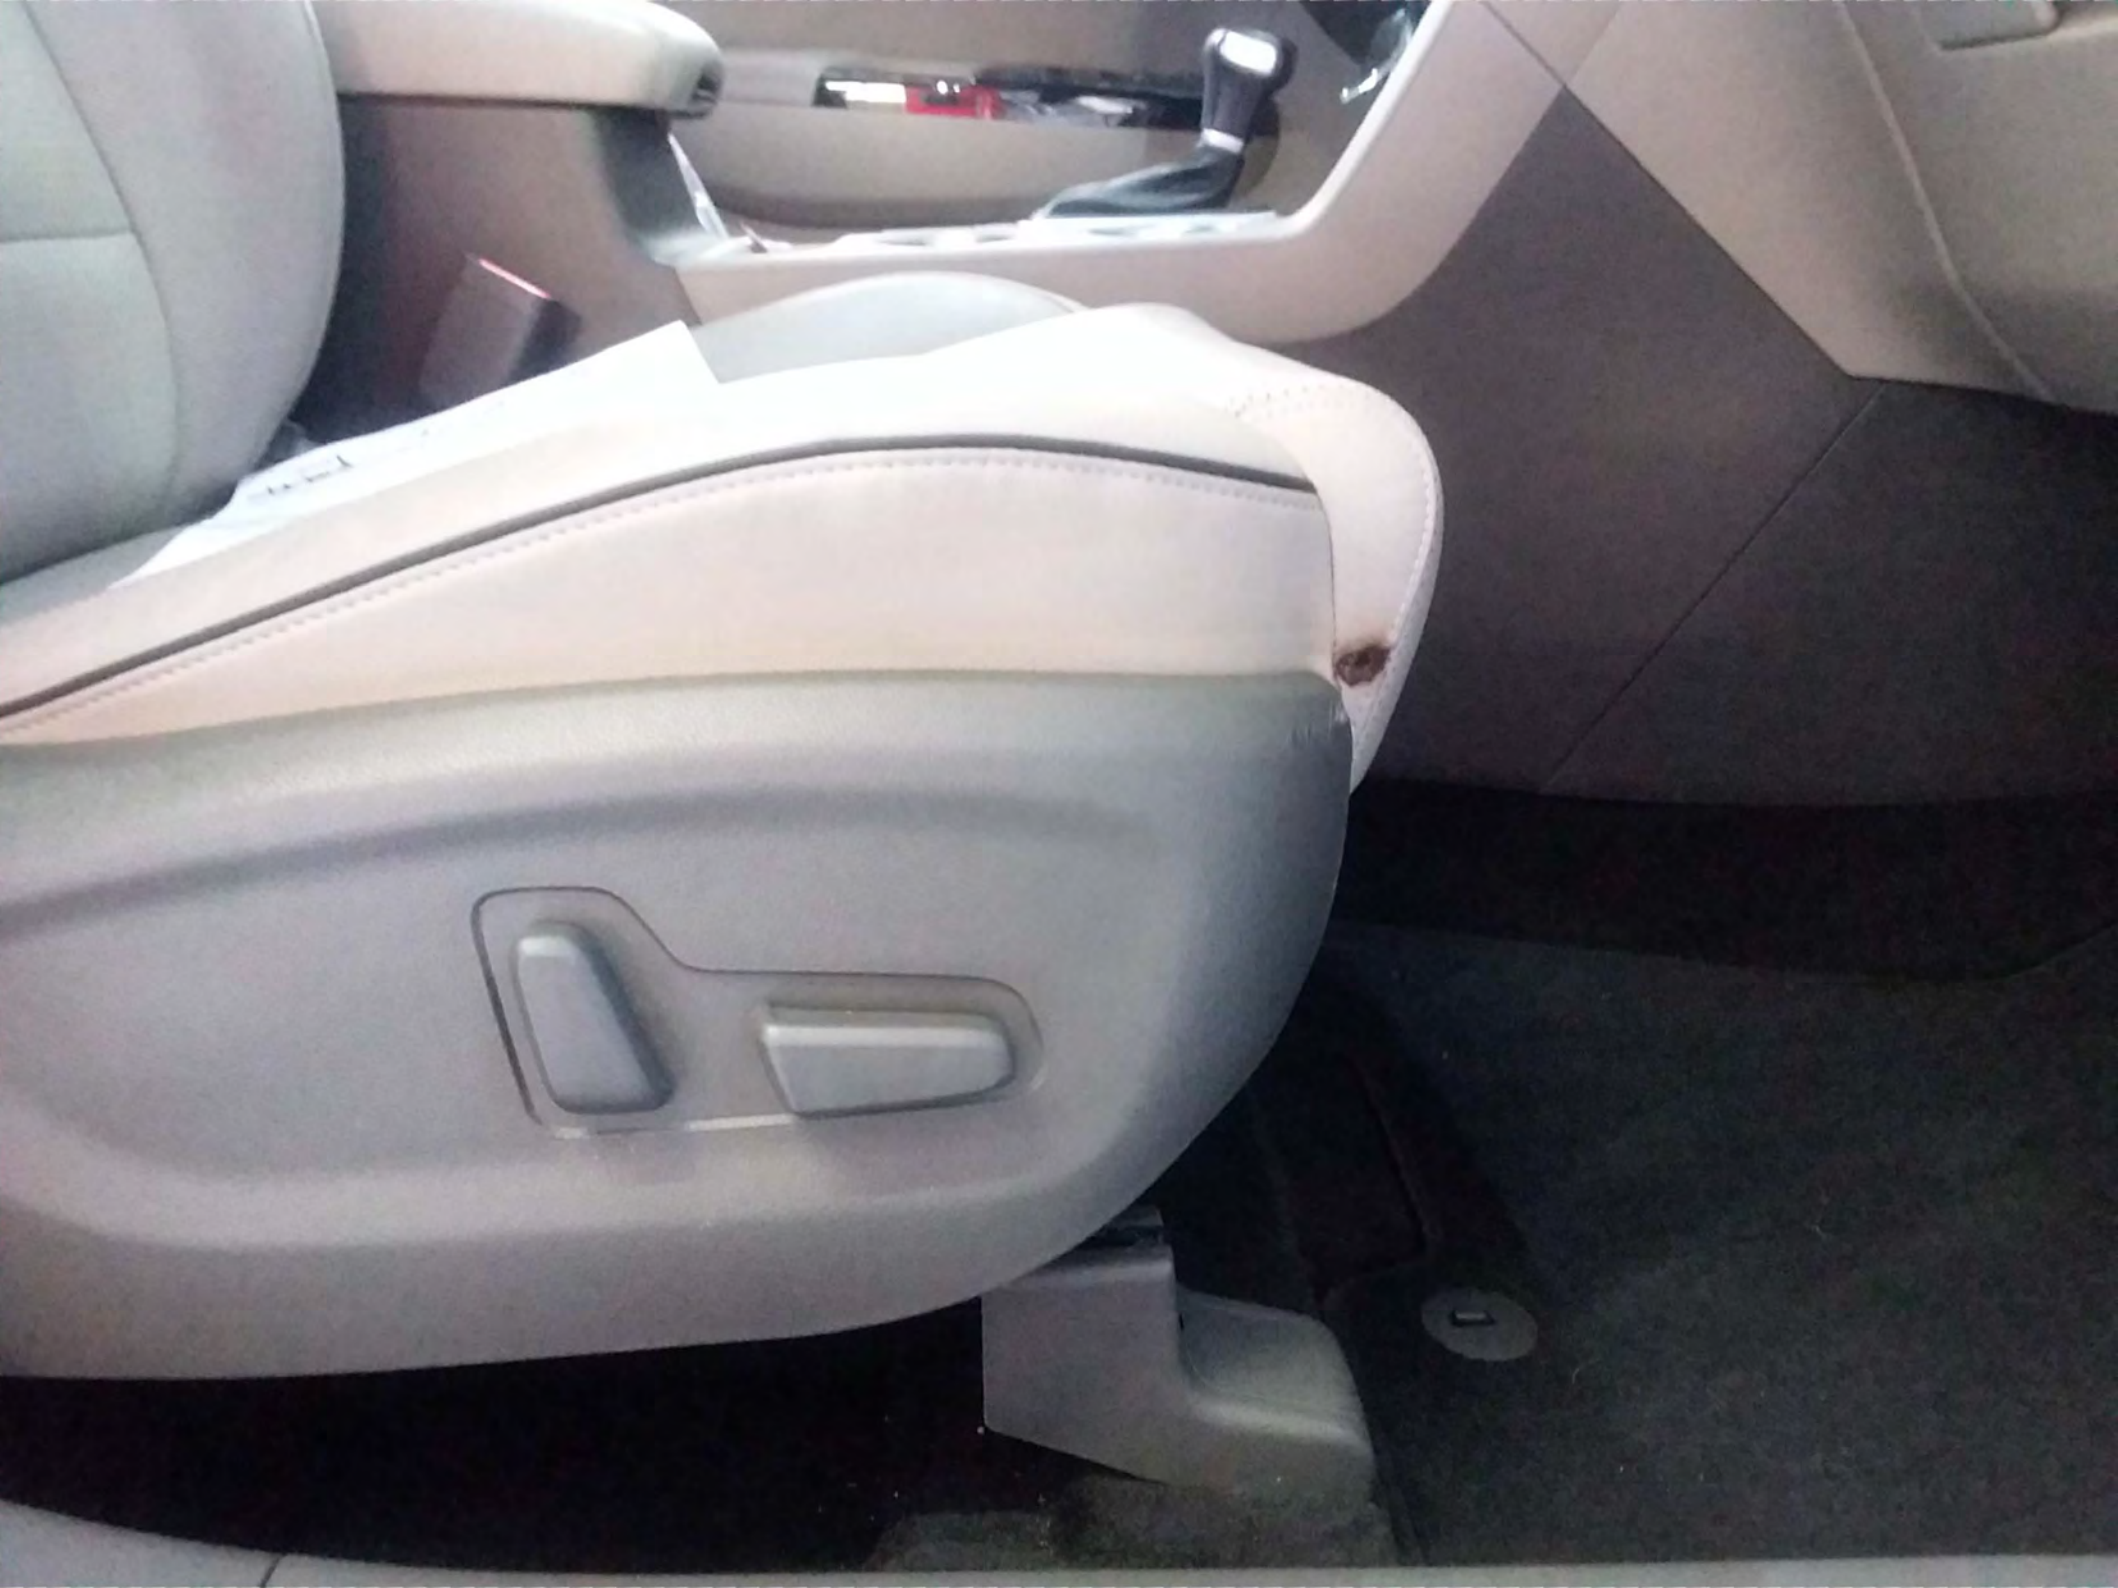
Web - Diagnostics created on 11/28/2018 13:03:47 and created by Gordon Key  
Confirmed that the fuses were good. Voltage to the blower motor was confirmed, however, when manipulating the fan speed at the control head it was noticed that resistance did not change. I replaced the MOSFET due to the lack of change in the resistance values. Fan remained inop. After removing the combination fuse it was noticed that one of the legs was burned with plastic having melted from the fuse box. No DTCs were/are present.

Web - Note created on 11/28/2018 13:13:55 and created by Gordon Key  
Added photos of multifuse and melted fuse block.

1: I have seen a few cases like this and the fix is to replace the fuse block and multi fuse. Thanks
