PE19-004  
KIA  
6/28/2019  
DEFECT C  
TECHLINES  
FORTE KOUP

PE19-004\_Expanded Scope\_Forte  
Koup\_Alleged Defect C

# Kia Motors America Technical Assistance Center

PE19-004\_Expanded  
Scope\_Sportage\_Alleged Defect C

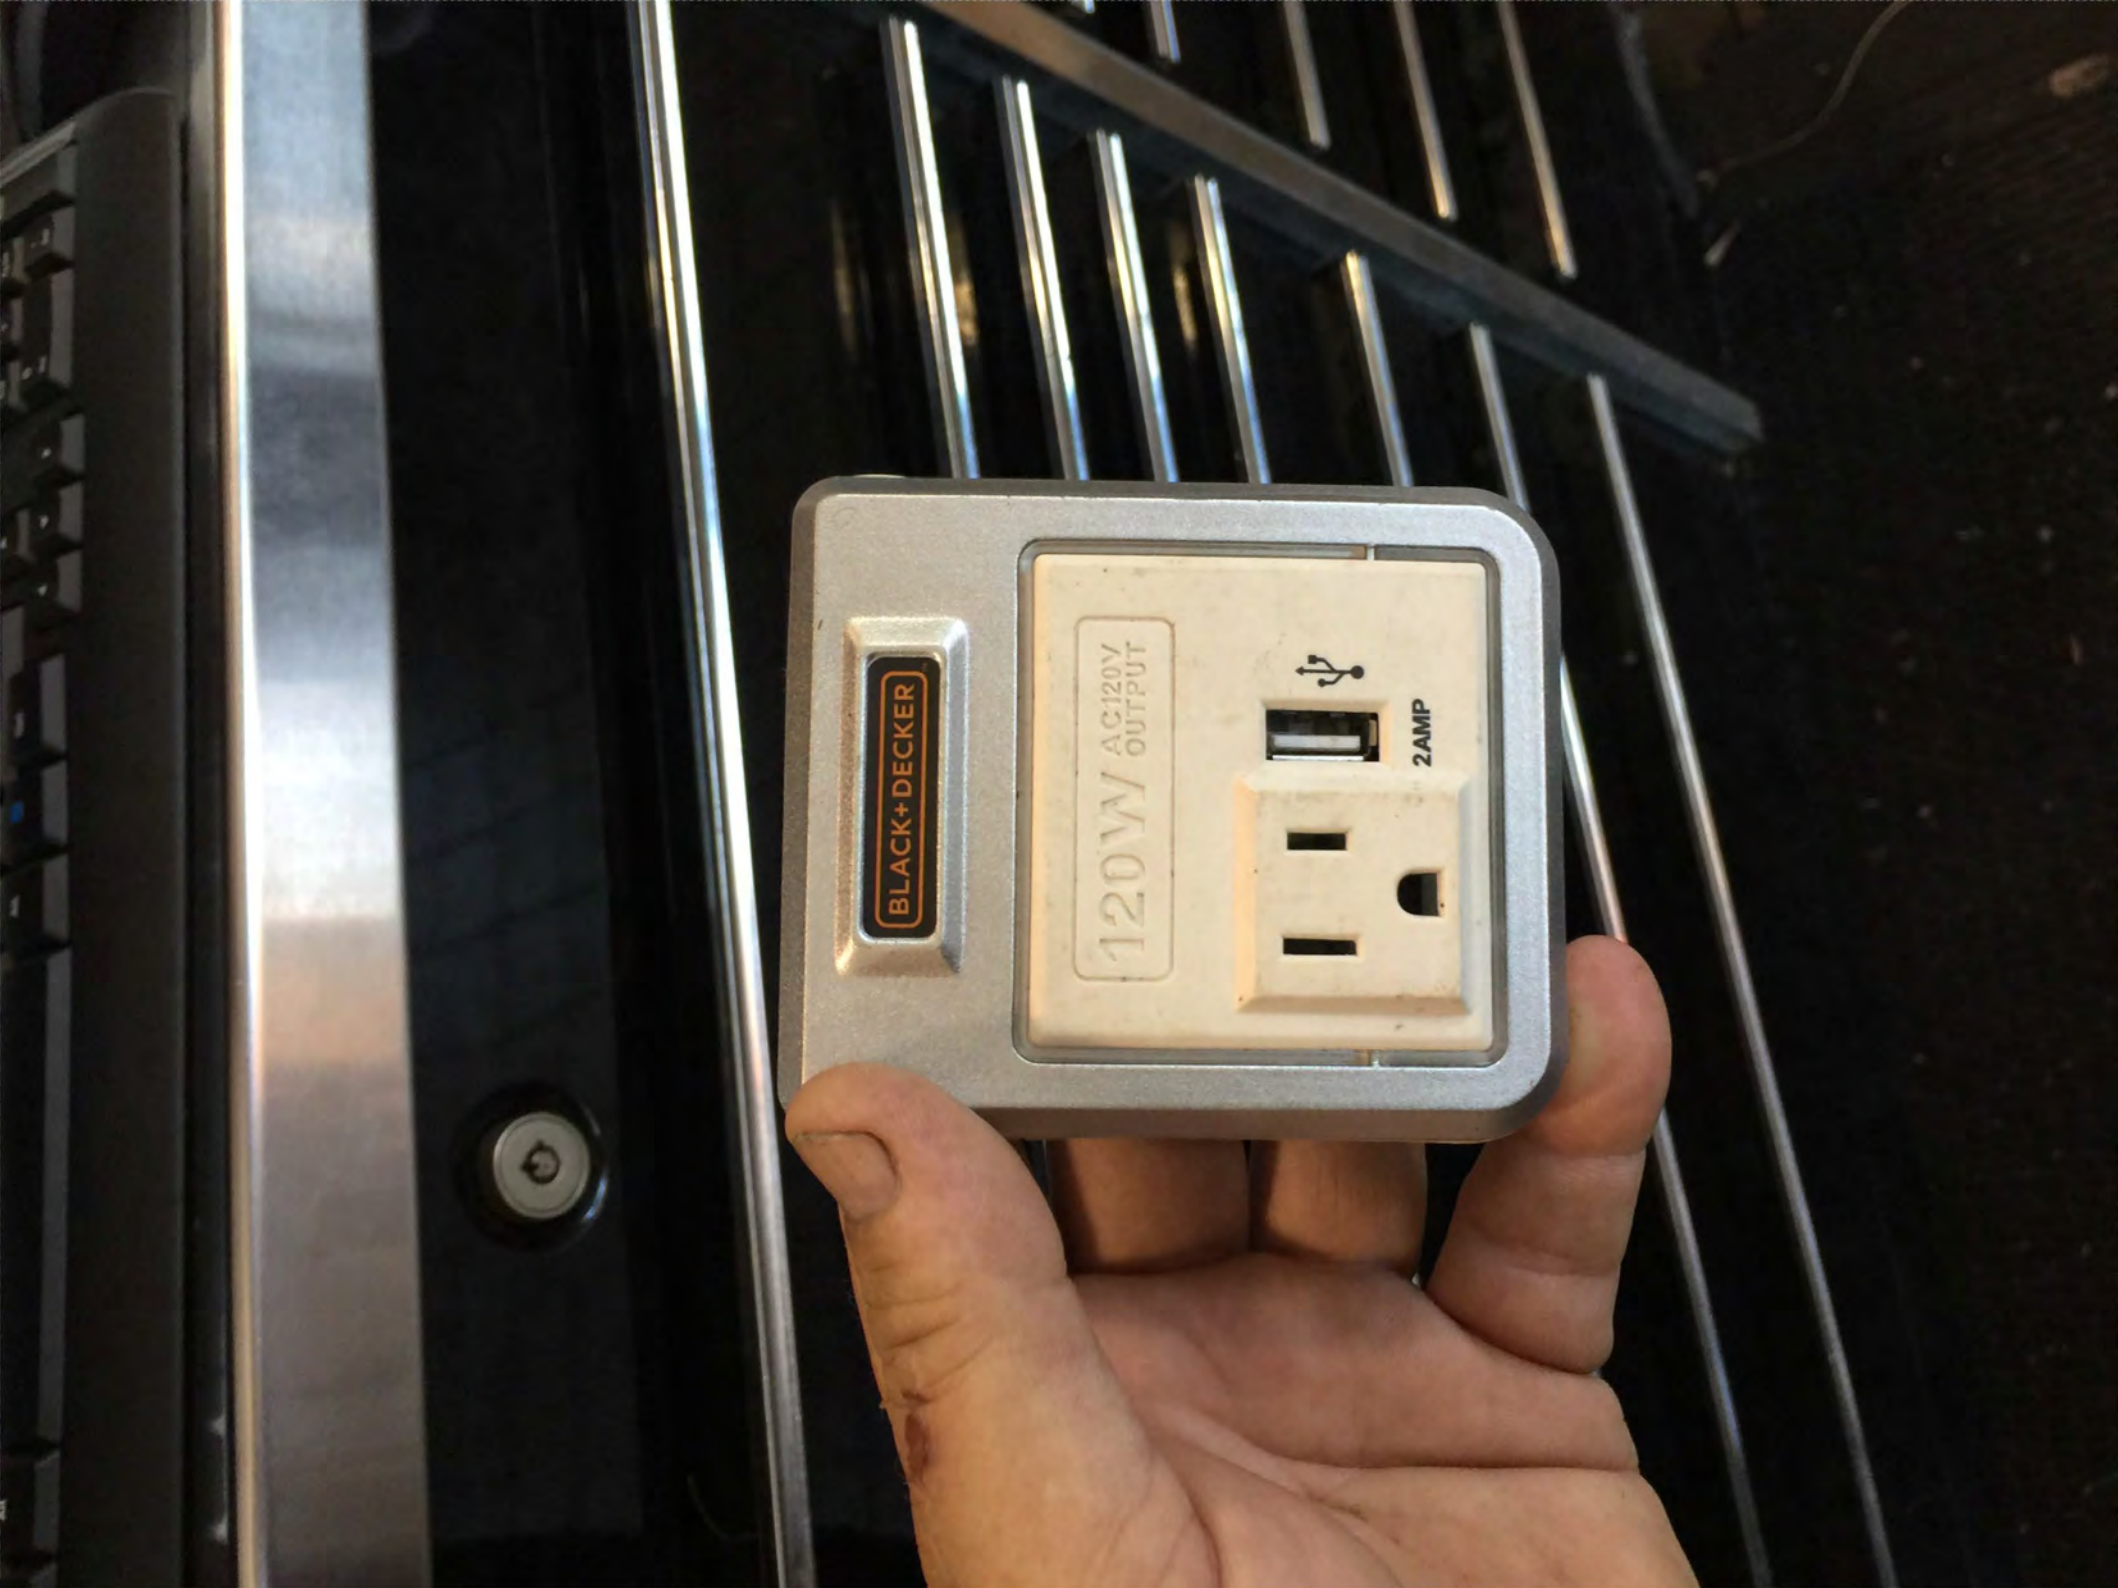
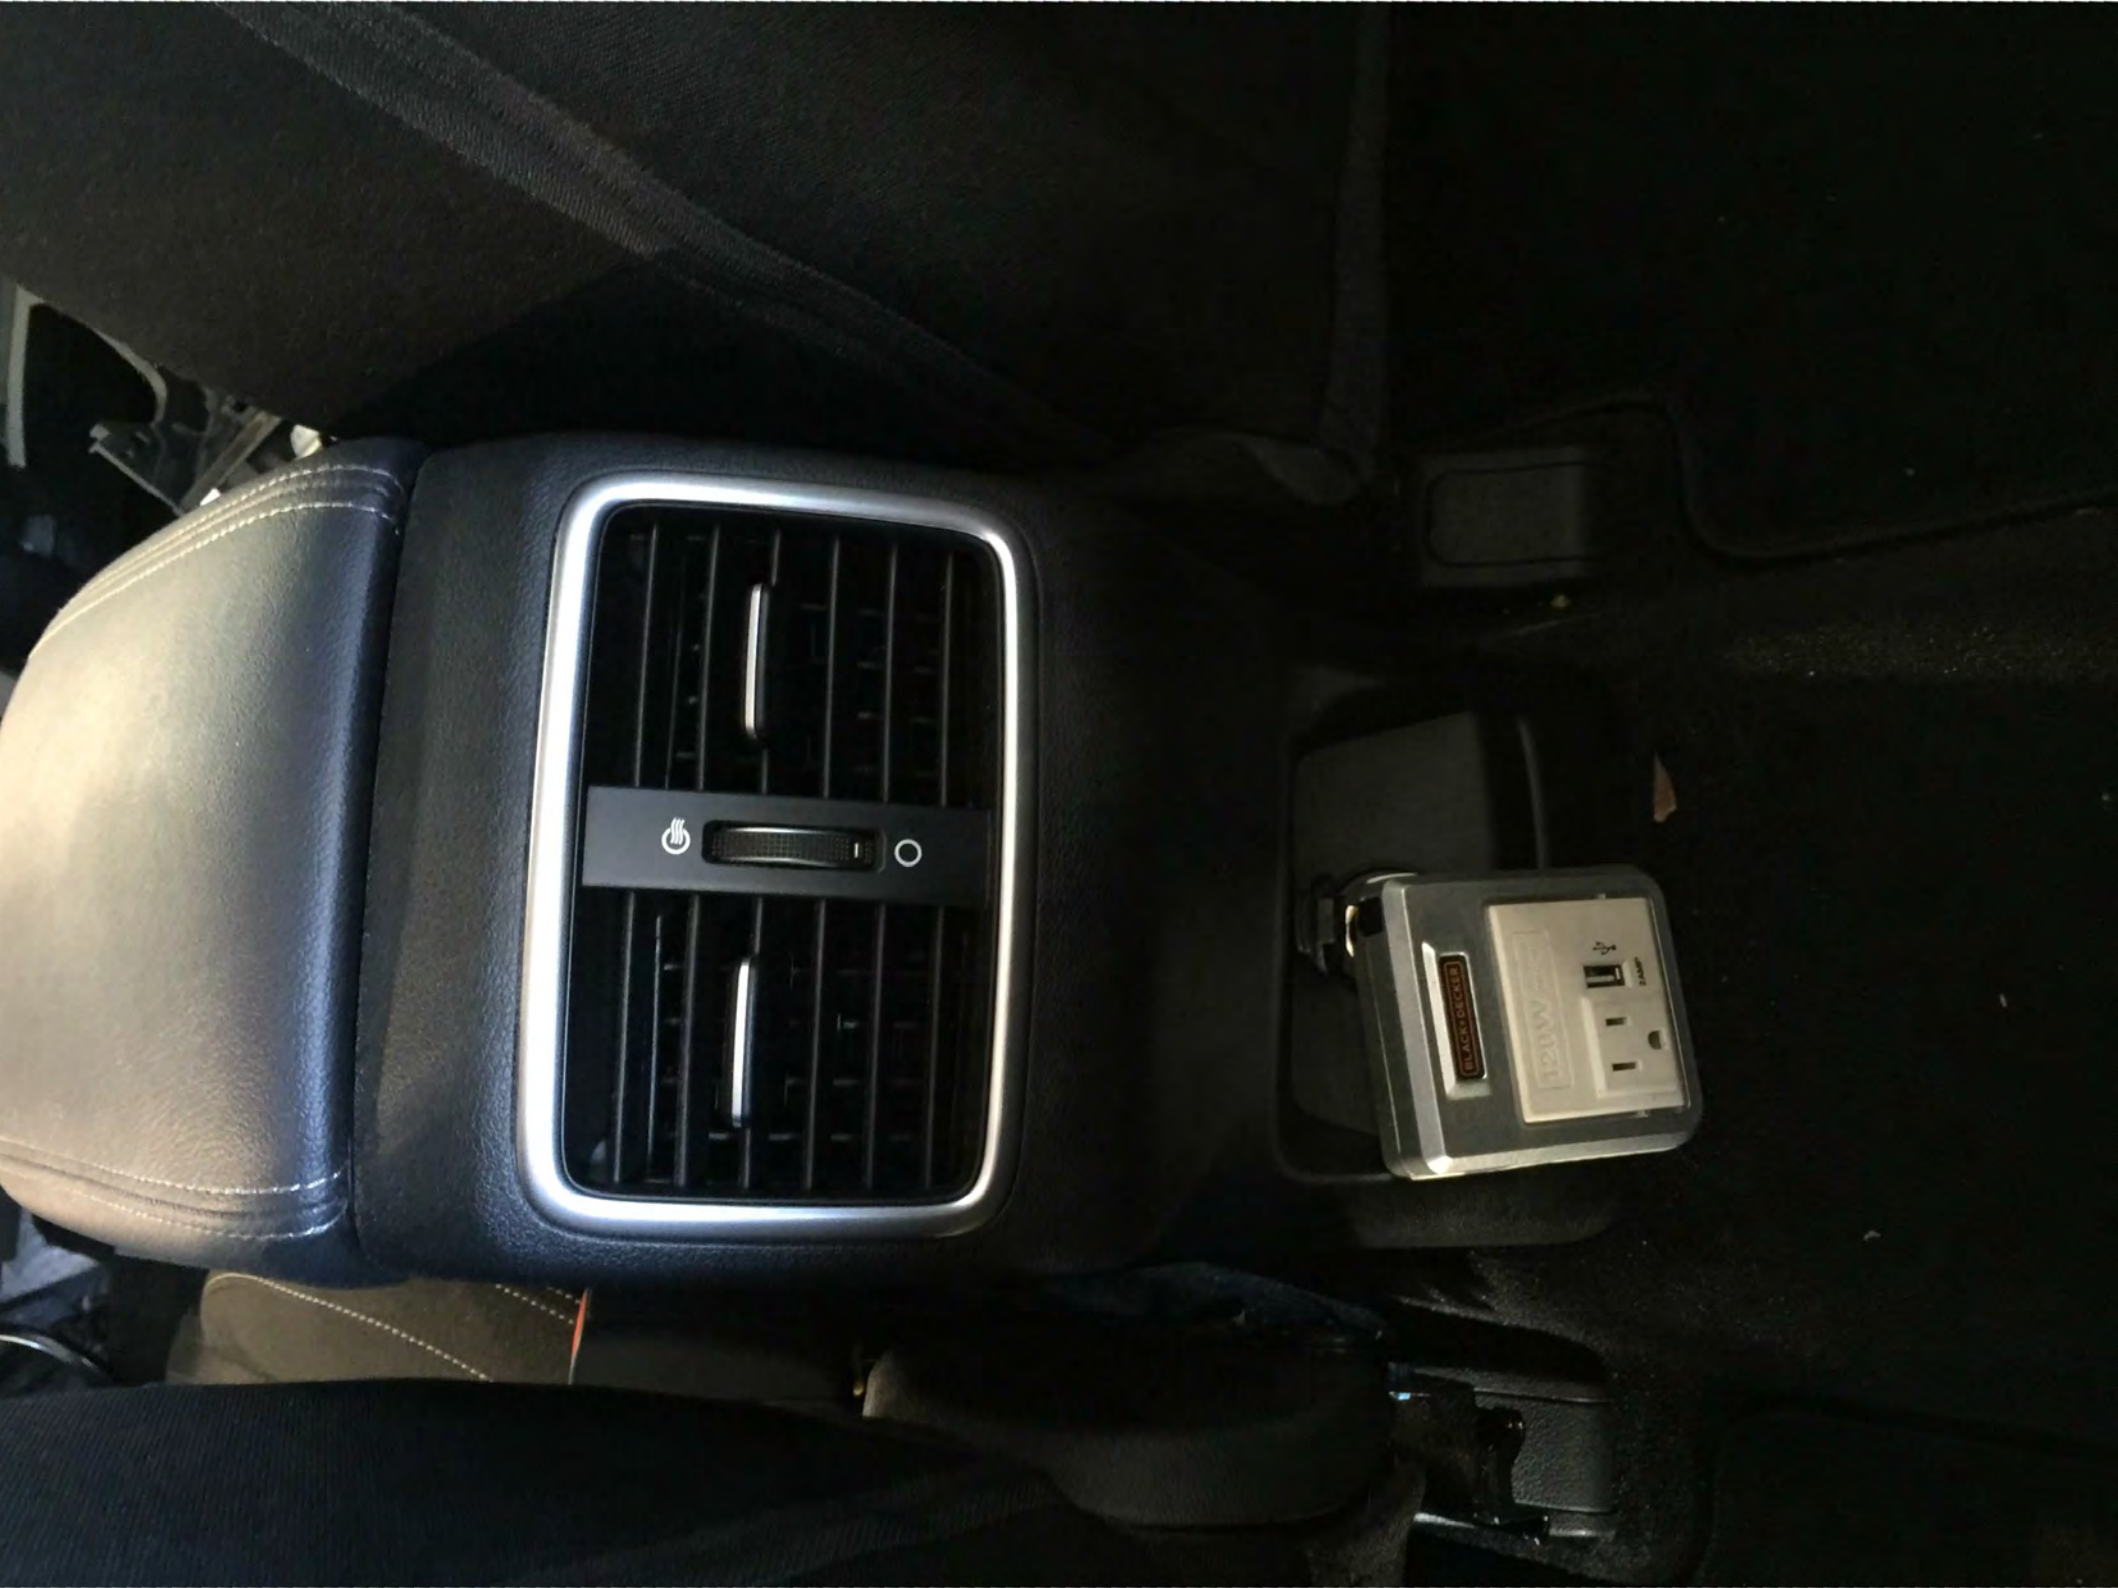
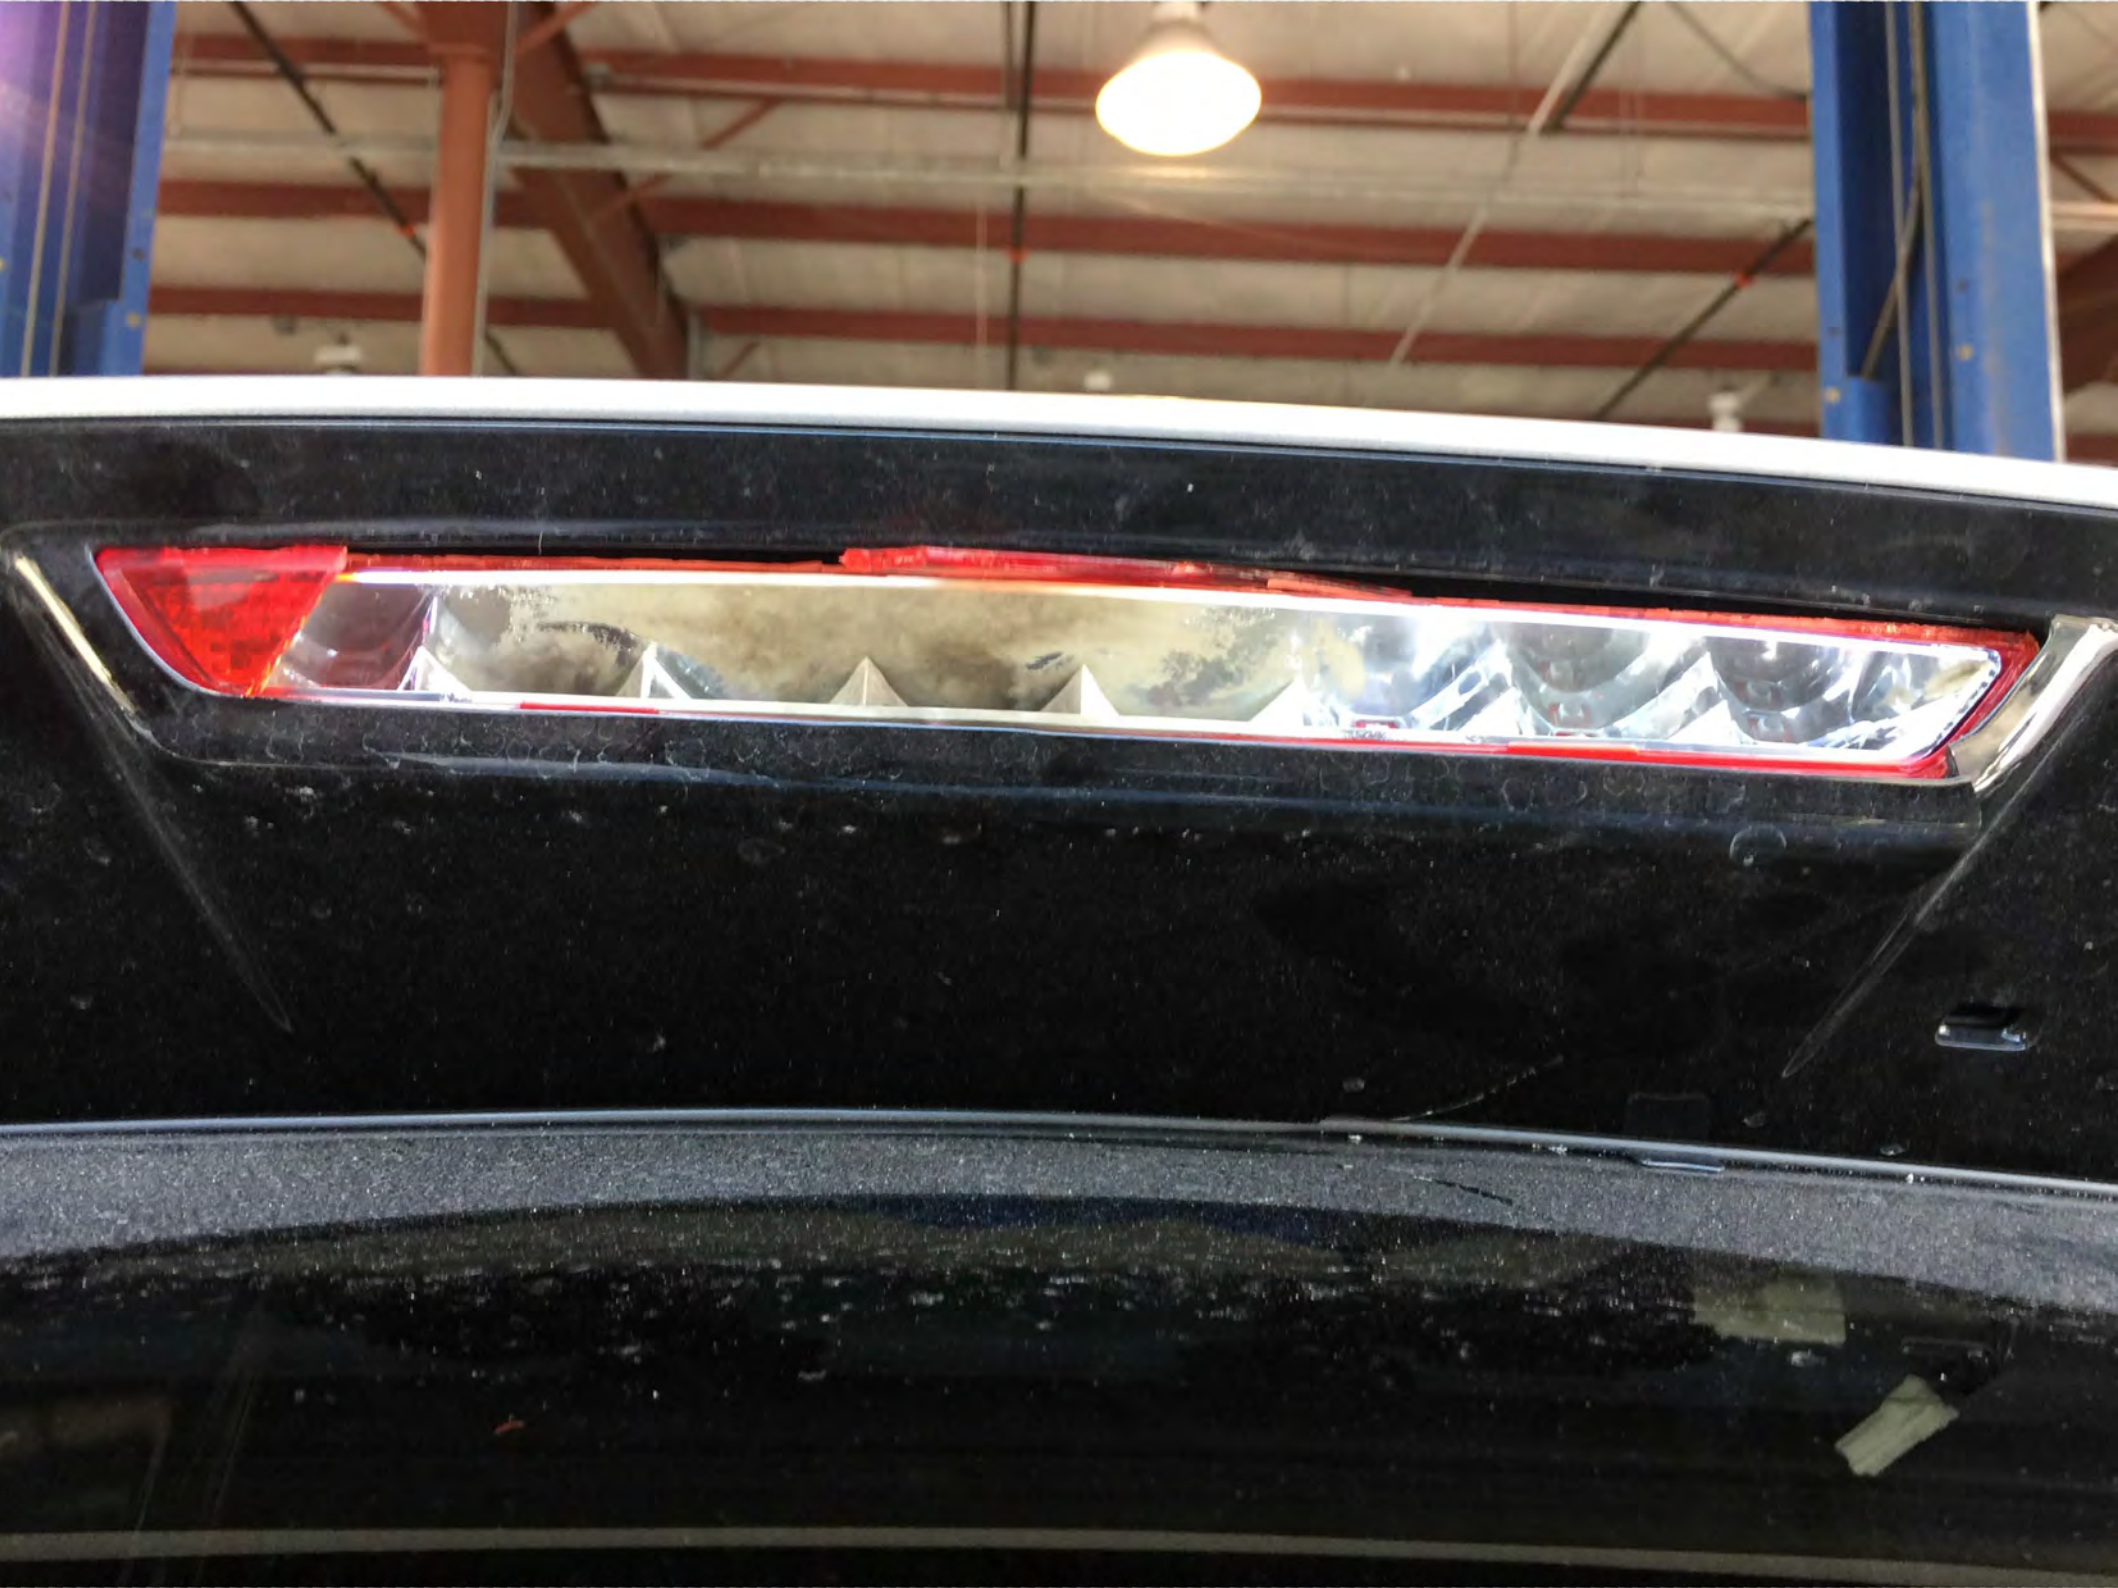
pwr inverter attached (removed) rear high mount brake light broken-now disconnected,no pwr windows or door locks,no head light operation.

Advice 1: Carl called in to review the case and stated he found burnt connectors in the smart junction box. Connectors I/P-E & I/P-F show signs of overheating and have a strong smell. I recommend to inspect the wire harness for signs of overheating or melted/burnt wires. I believe the after market power inverter overheated the electrical system and damaged the smart junction box and may have caused additional damage to other components.
