PE19-004  
KIA  
6/28/2019  
DEFECT C  
TECHLINES  
FORTE KOUP

PE19-004\_Expanded Scope\_Forte  
Koup\_Alleged Defect C

# Kia Motors America Technical Assistance Center

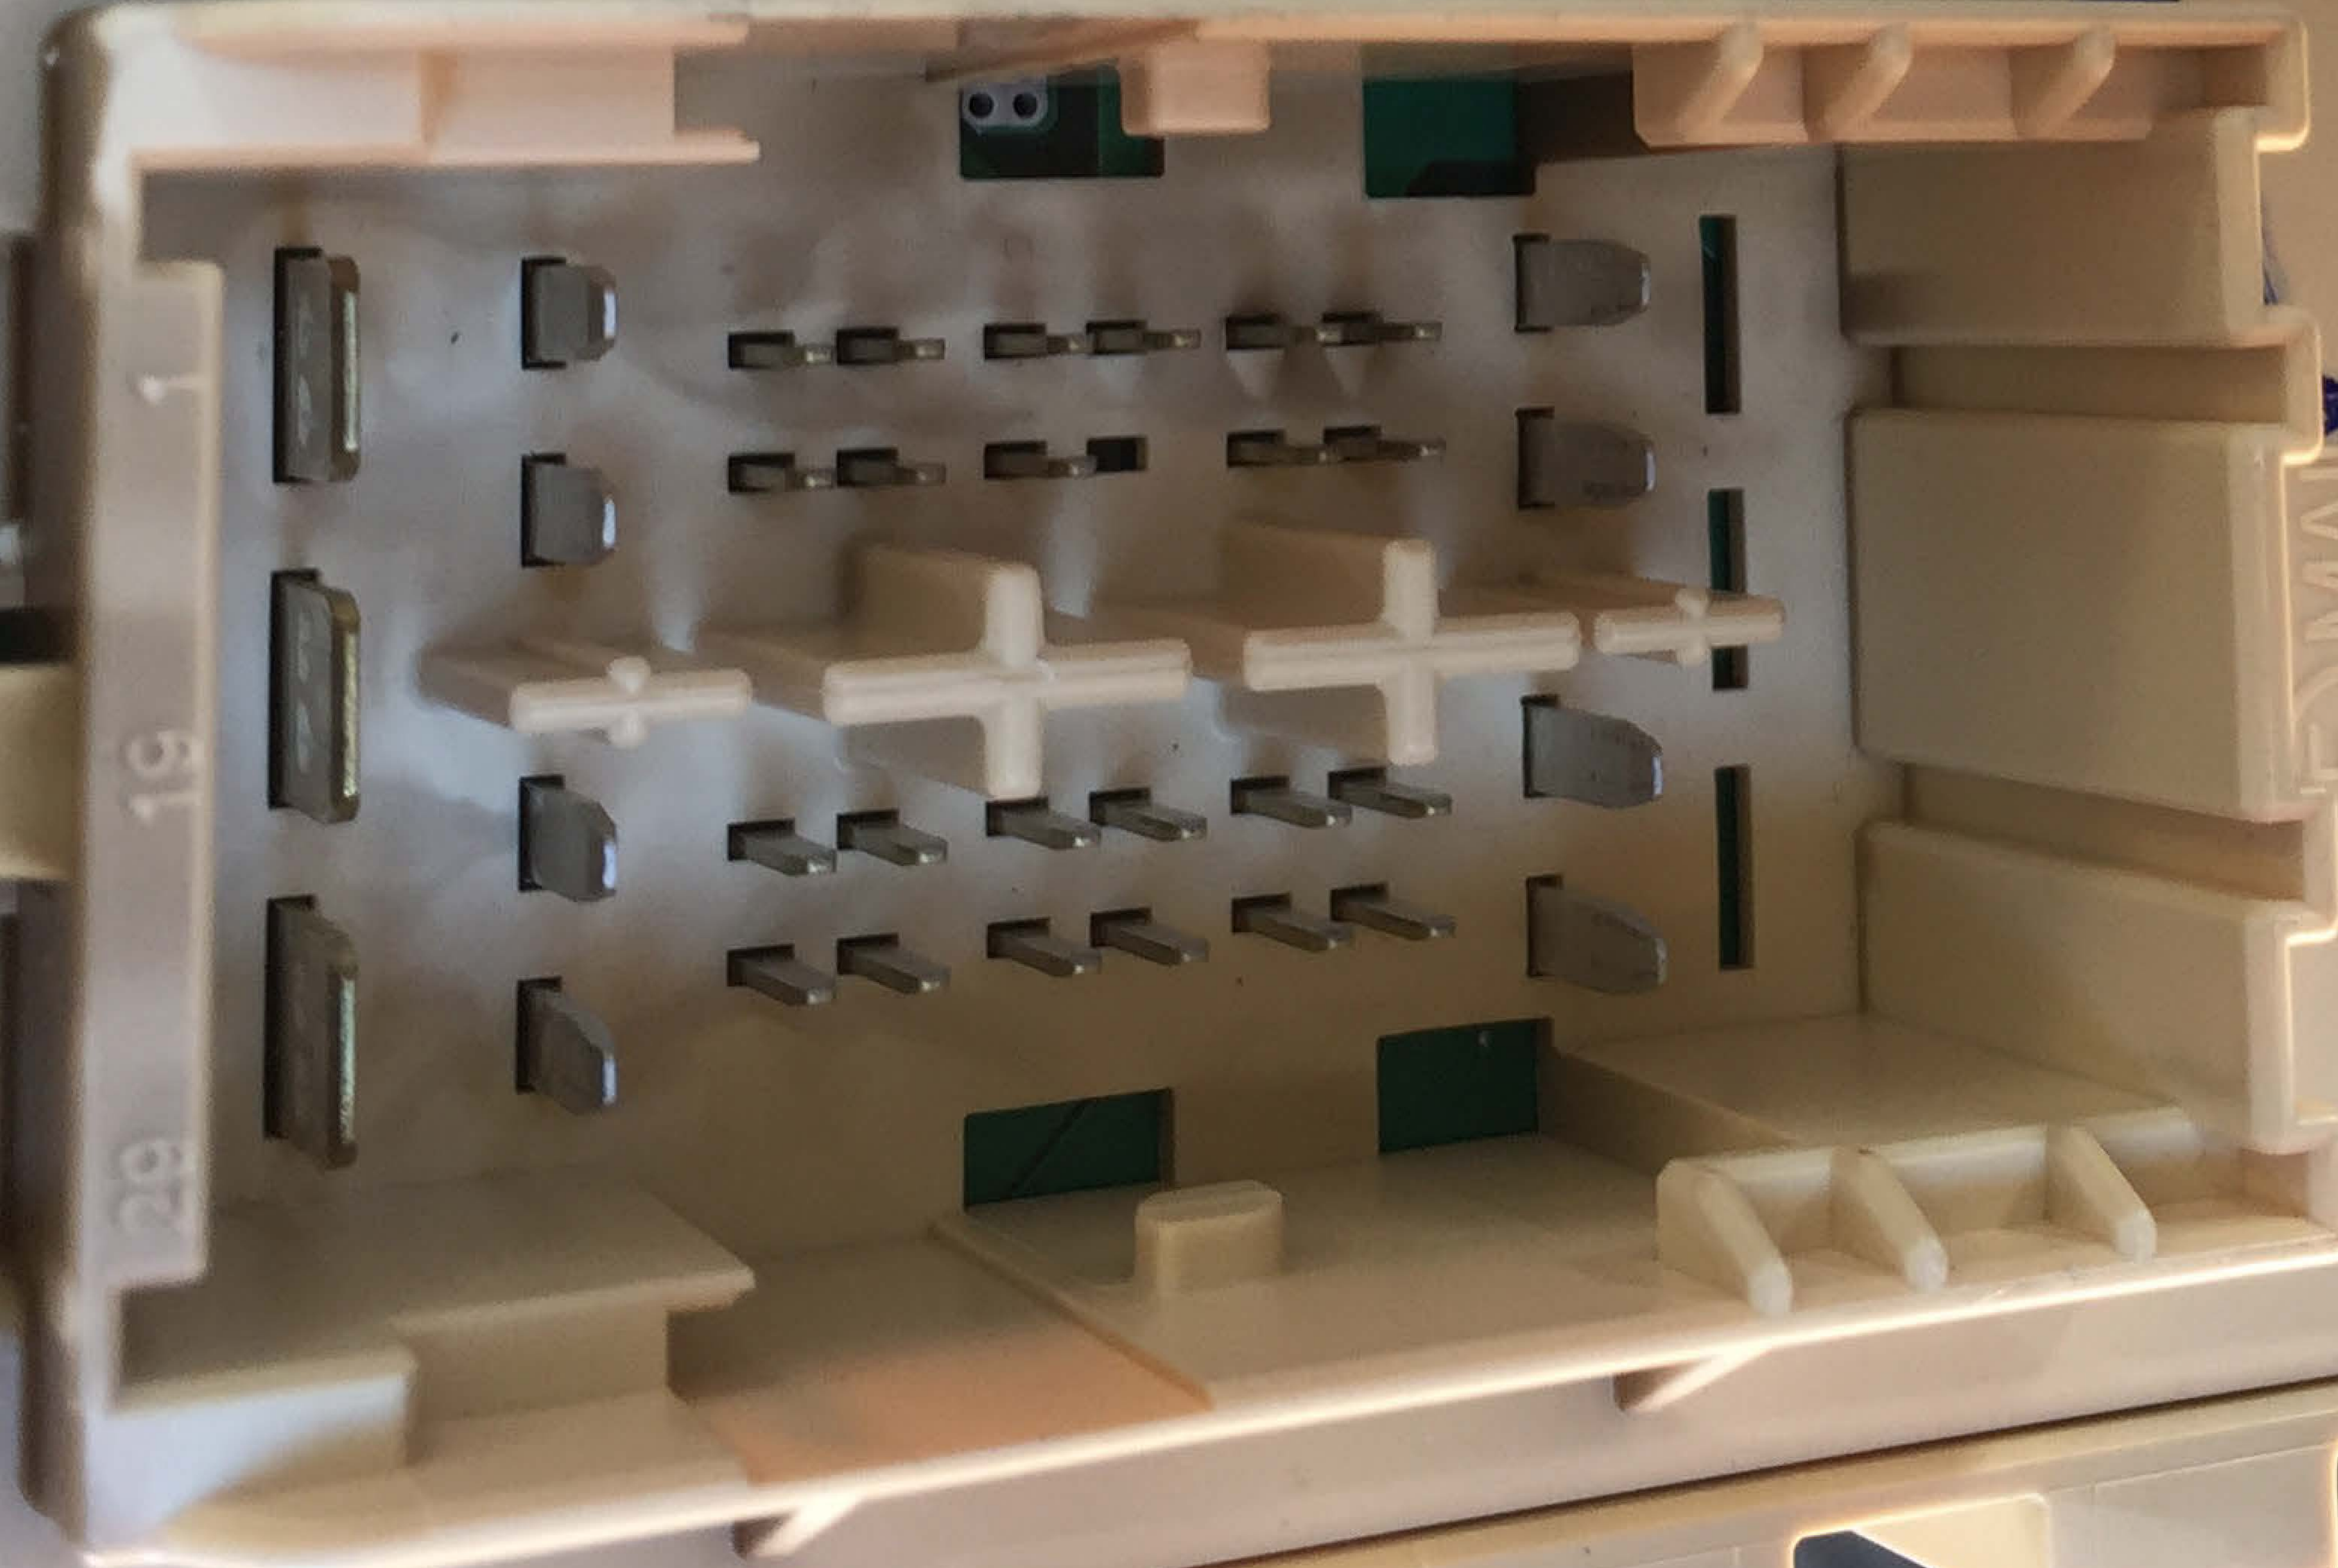
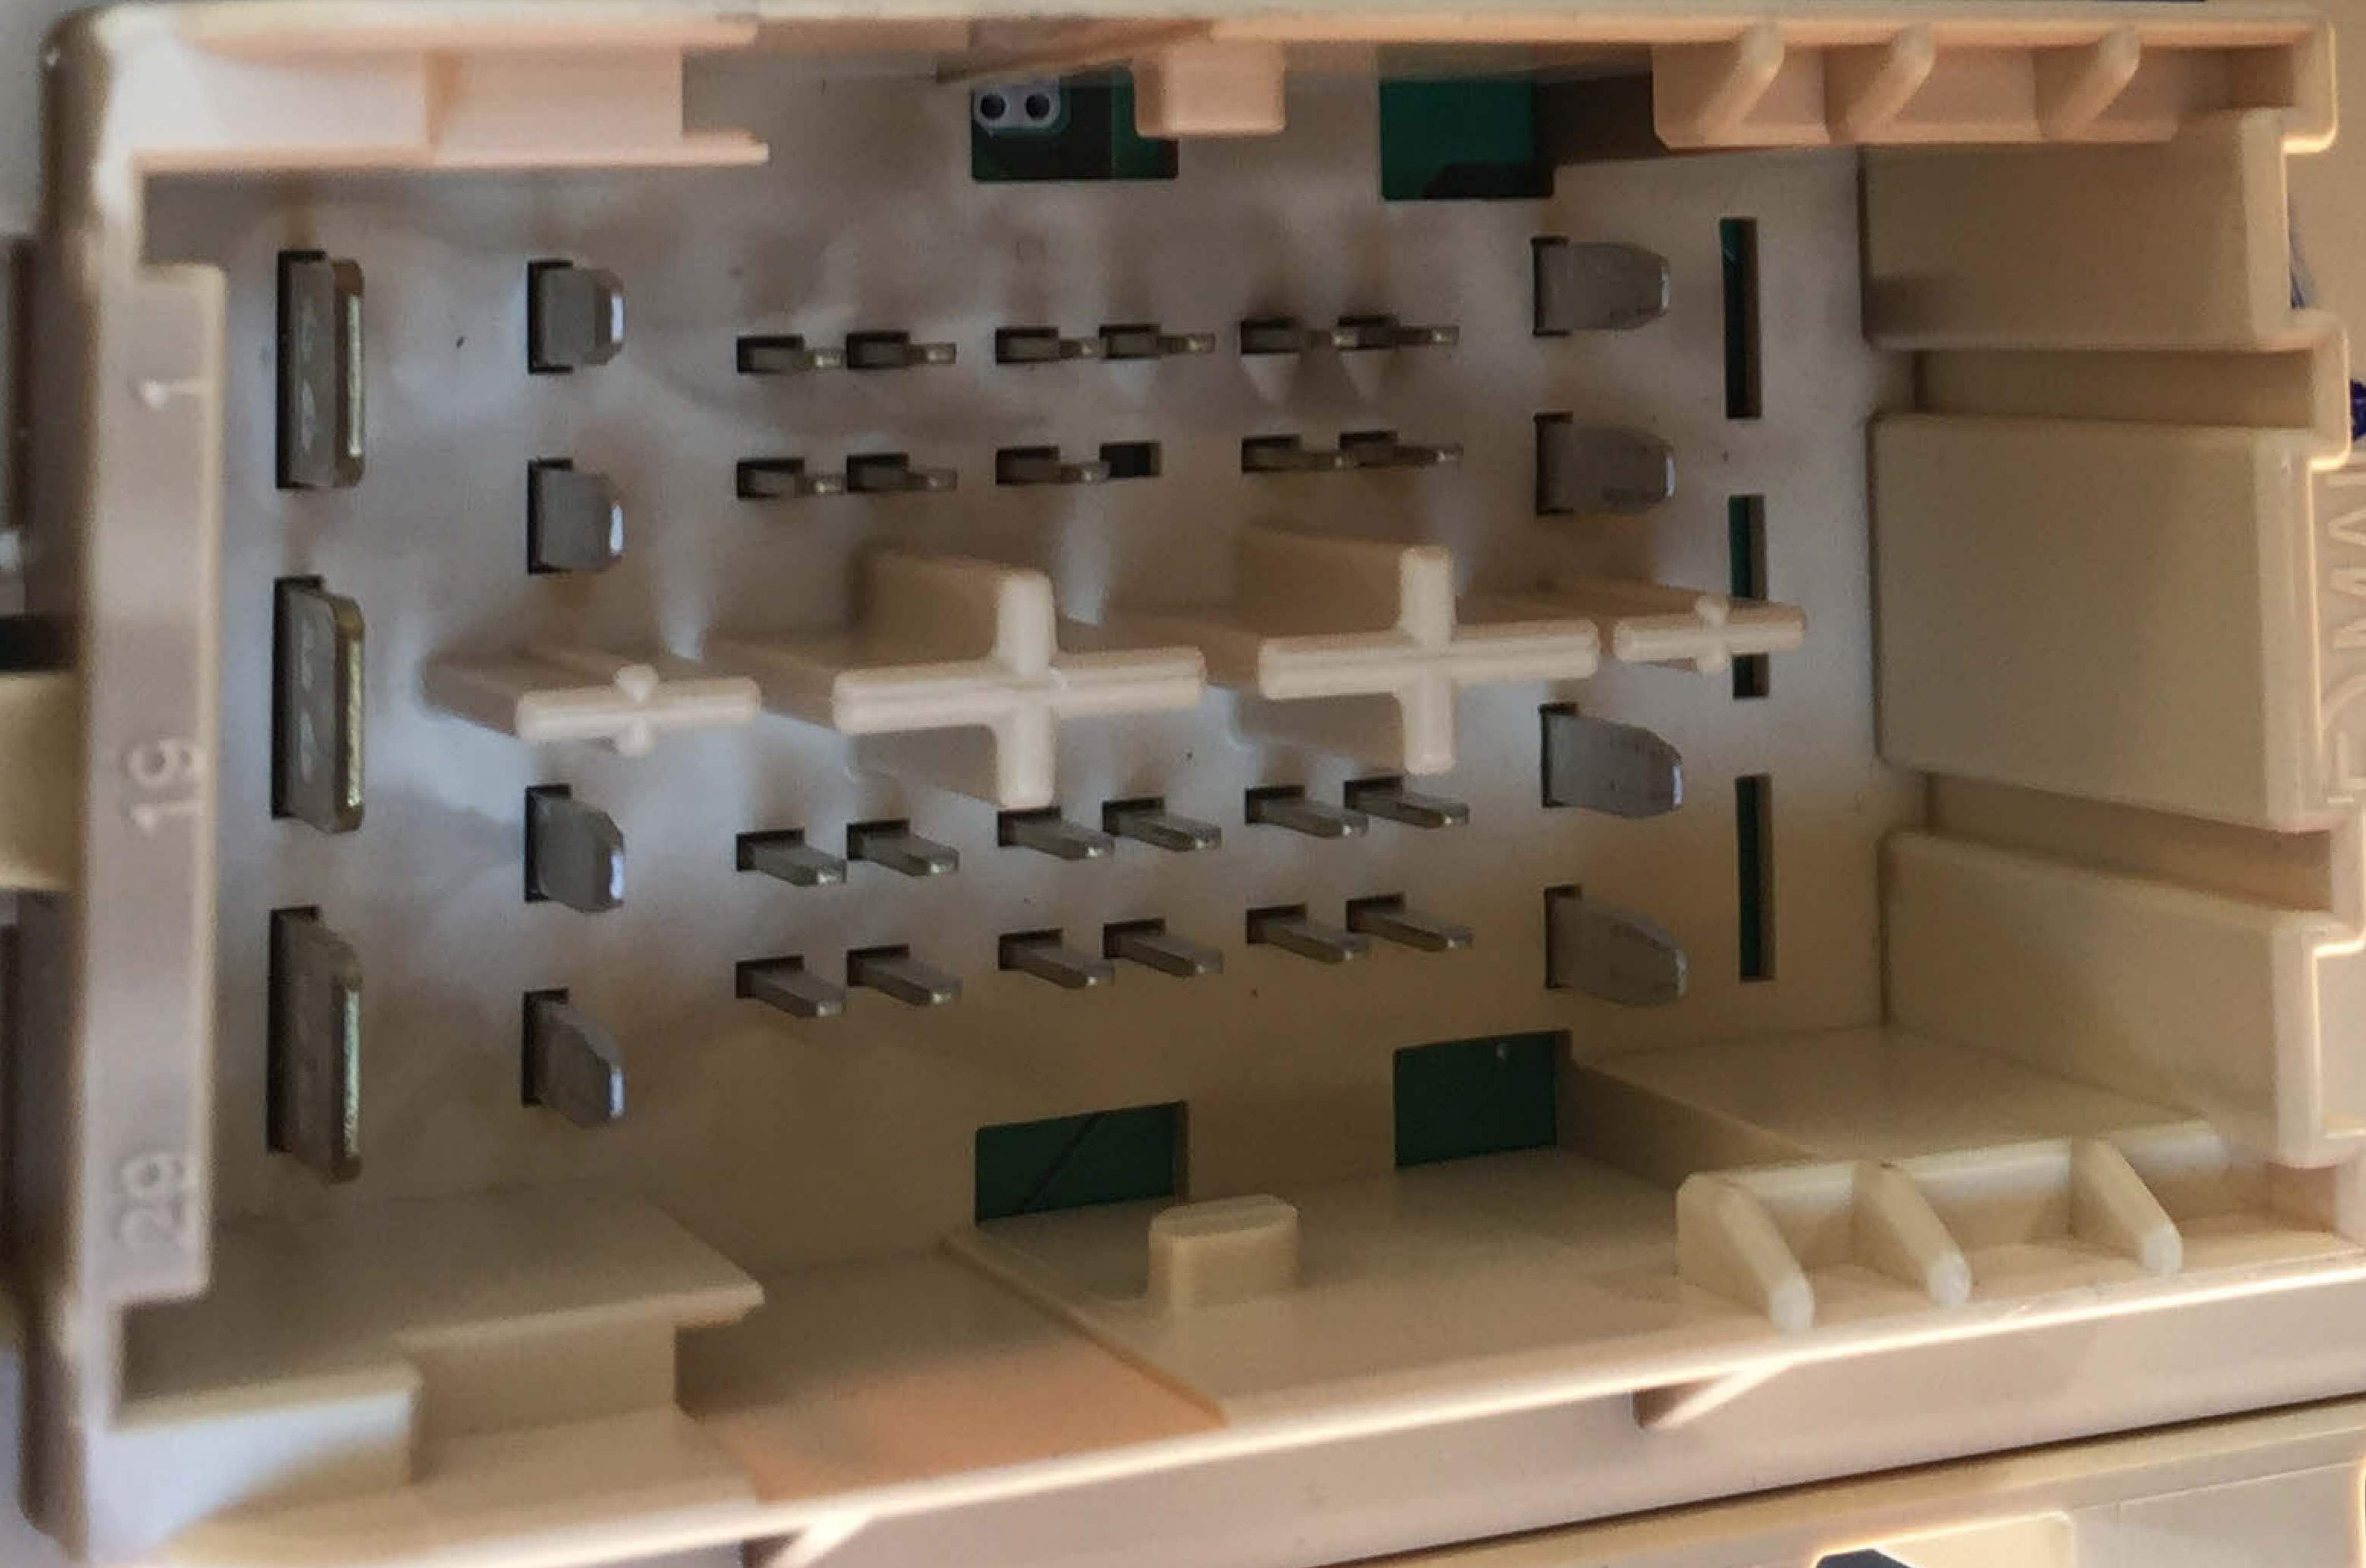
checked and found control box for trailer harness had melted, checked harness for any damage none found internal short in box.

installed new harness
