PE19-005

ISUZU

Campaign CB11-J-002 Cruise
Control Will Not Cancel

Campaign CB11-J-002 Cruise Control Will Not Cancel - Safety Recall 11V-415 (Transport Canada # TC)

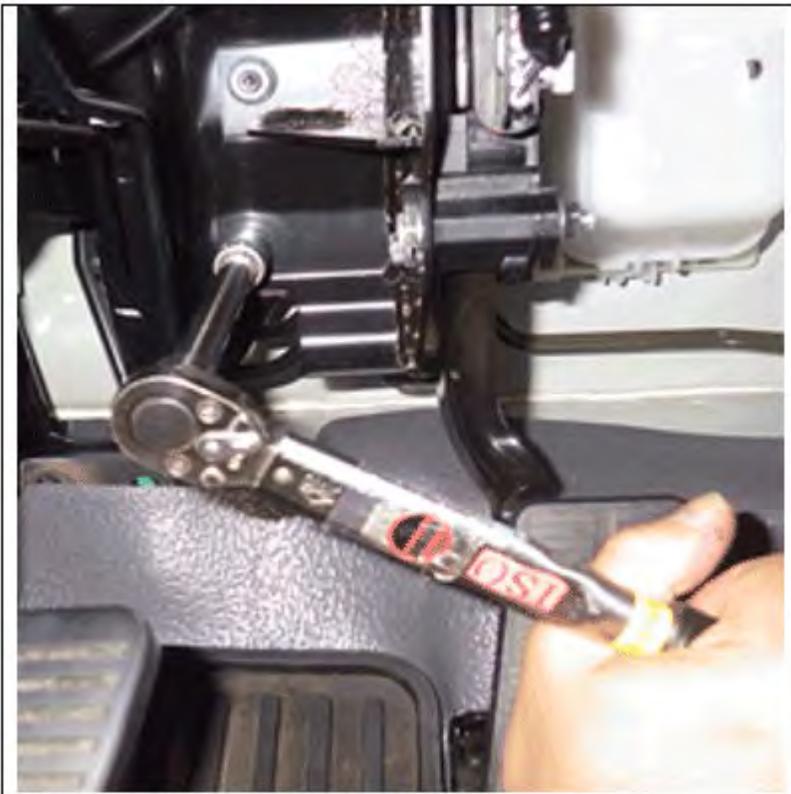
Figure 1 – Tighten Accelerator Pedal

Isuzu Motors Limited has decided that a defect, which relates to motor vehicle safety, exists in Model Year 2014-2016 Isuzu N-Series vehicles equipped with 6.0L gasoline engines. In the affected vehicles, the accelerator pedal assembly contains a steel stopper plate that is intended to stop the depression of the pedal when the plate contacts the stopper bolt that is fixed to a bracket on the floor panel. As a result of unintended lateral play, the stopper plate can be forced under the outer ridge of the stopper bolt, causing the accelerator pedal to remain in the open position. An open throttle can increase the risk of a crash.

1. Set the parking brake, remove the key from the ignition and block the front wheels in a well-lit area.
2. Tighten the two (2) accelerator pedal mounting nuts (see Figure 1) to 18 Nm (13 ft. lb.).

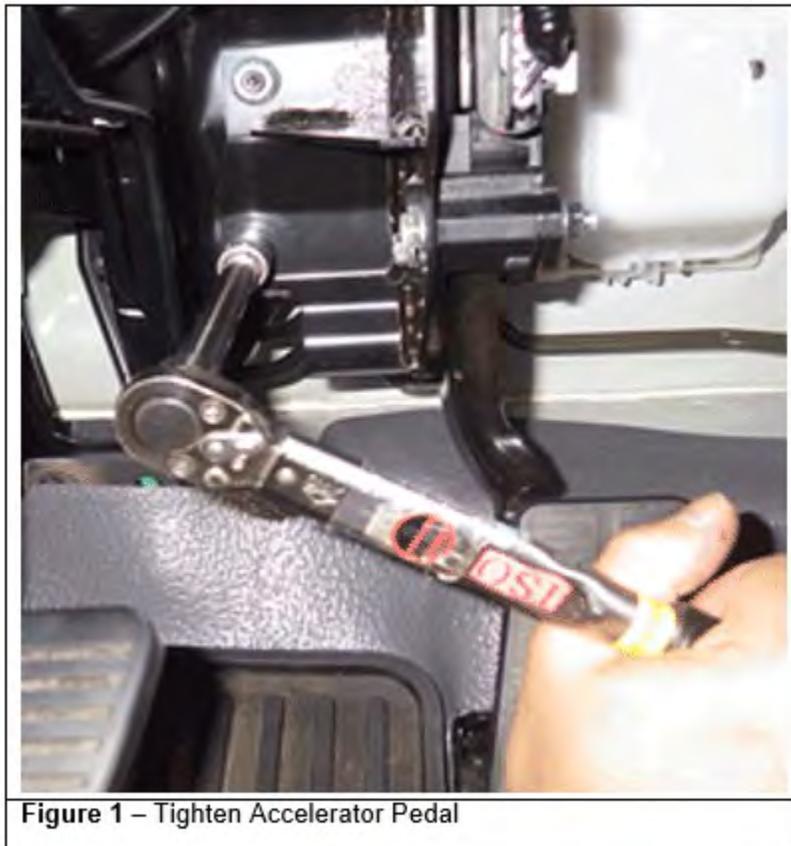
Isuzu Motors Limited has decided that a defect, which relates to motor vehicle safety, exists in Model Year 2008-2009 and 2012-2013 Isuzu N-Series and 2008-2009 Chevrolet/GMC W-Series vehicles equipped with 6.0L gasoline engines. In the affected vehicles, the accelerator pedal assembly contains a steel stopper plate that is intended to stop the depression of the pedal when the plate contacts the stopper bolt that is fixed to a bracket on the floor panel. As a result of unintended lateral play, the stopper plate can be forced under the outer ridge of the stopper bolt, causing the accelerator pedal to remain in the open position. An open throttle can increase the risk of a crash.

1. Set the parking brake, remove the key from the ignition and block the front wheels in a well-lit area.
2. Tighten the two (2) accelerator pedal mounting nuts (see Figure 1) to 18 Nm (13 ft. lb.).

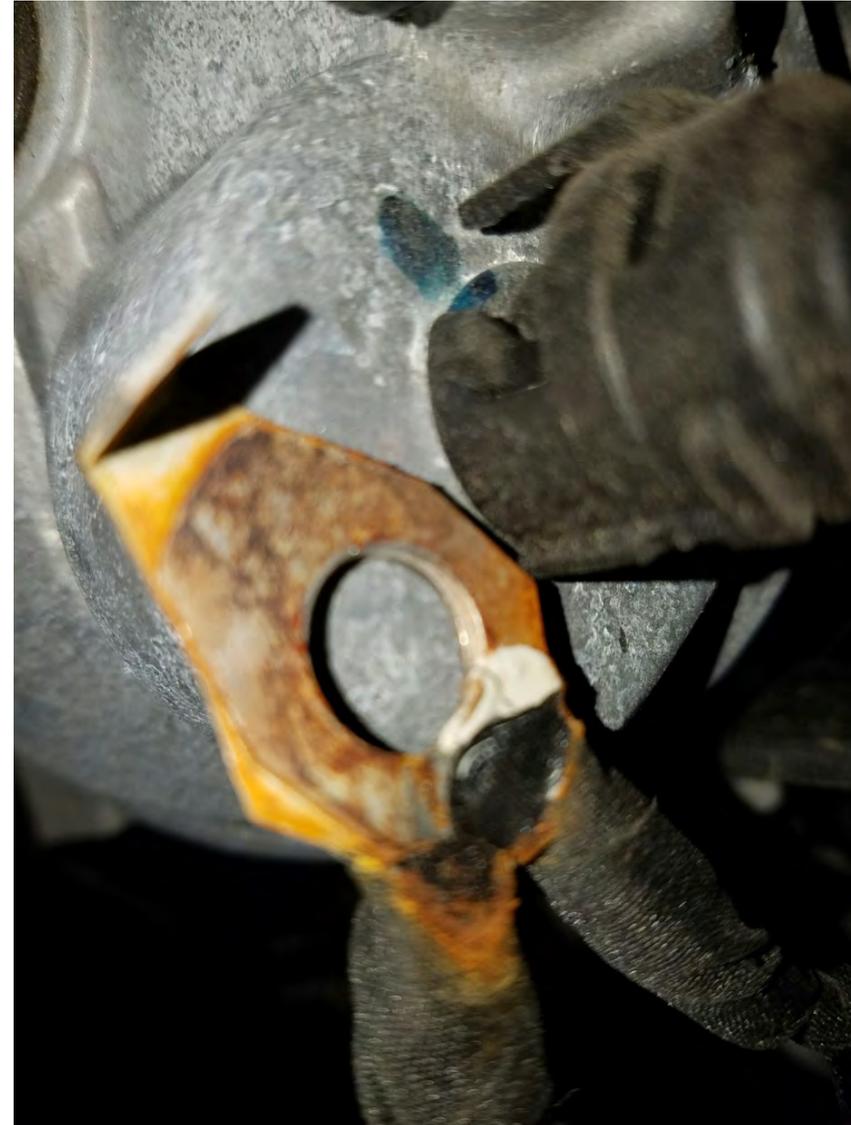
ECM Ground E-98 at the left rear of the engine block. Excessive heat shrink tubing was crushed by the bolt. That caused a poor ground and allowed corrosion to build up.

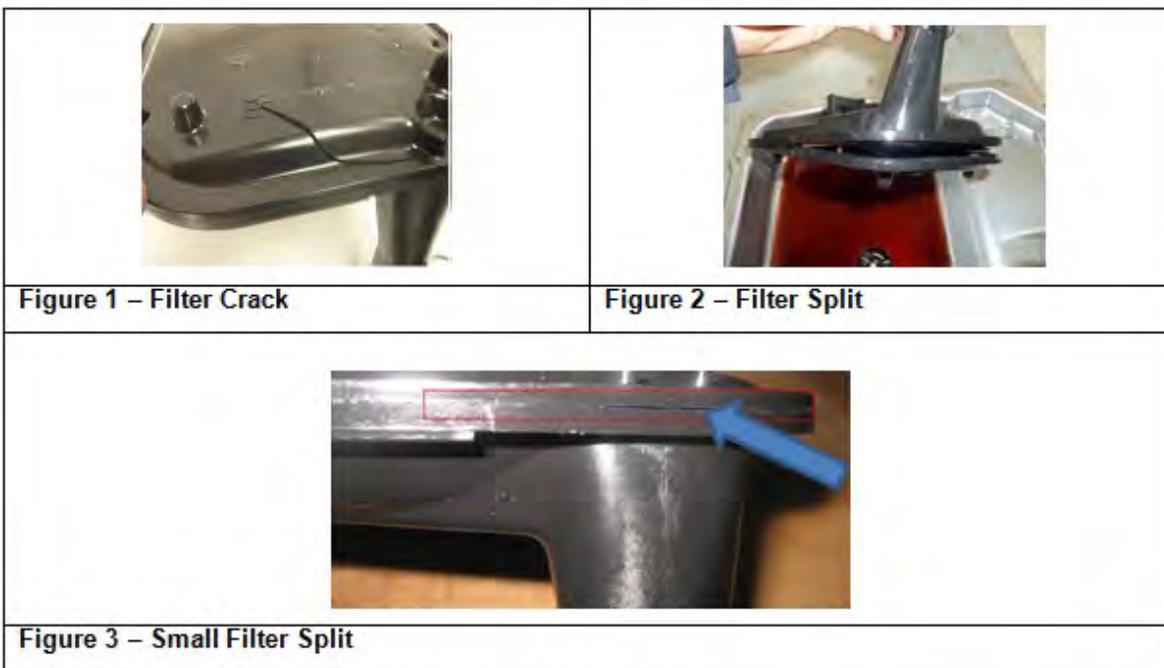
When diagnosing the condition of no forward/no reverse or slipping transmission, technicians are to thoroughly inspect the transmission fluid filter assembly. The filter may be cracked or split as shown in Figures 1, 2, and 3.

Testing and analysis of transmissions found with split or damaged filters have shown that this condition may be caused by a damaged pump, which can send a high pressure spike of fluid down the filter neck on a cold start, resulting in the filter body cracking or the filter seam splitting.

NOTE: The filter is not defective and this is not a filter quality issue.

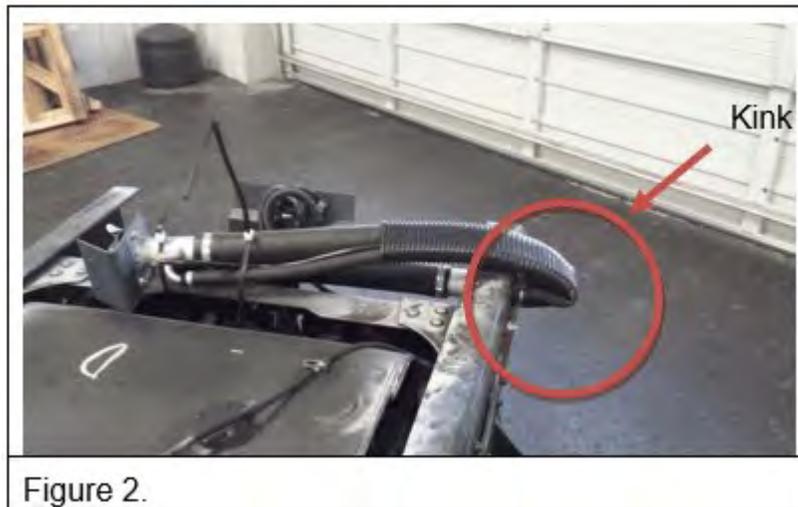
Refer to figure 2 for an illustration of improperly installed and kinked fuel tank fill and vent hoses during transport.
