# 2016 Forester B1650/B1760 QRA

# Customer states Air Bag Indicator on.

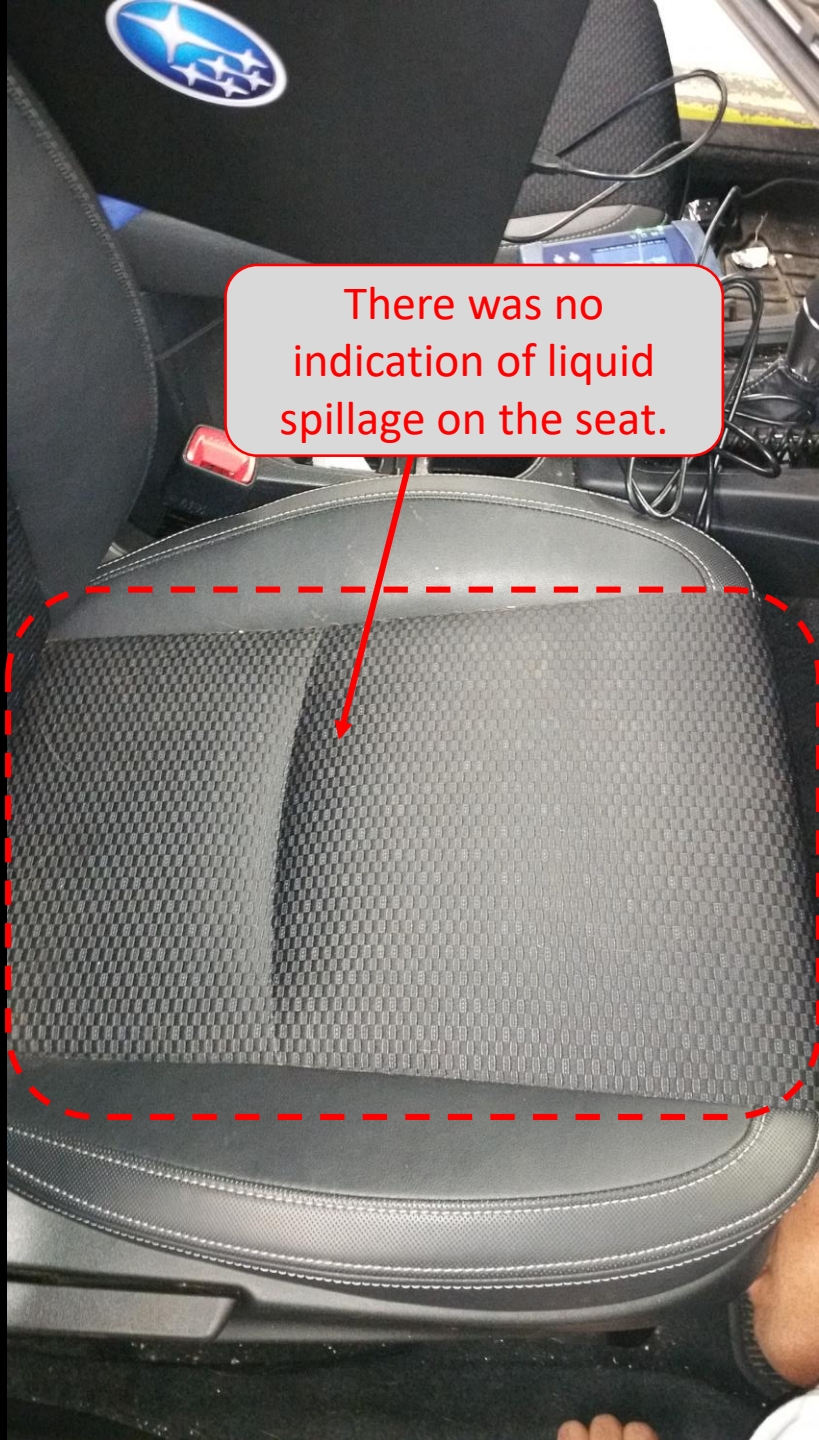
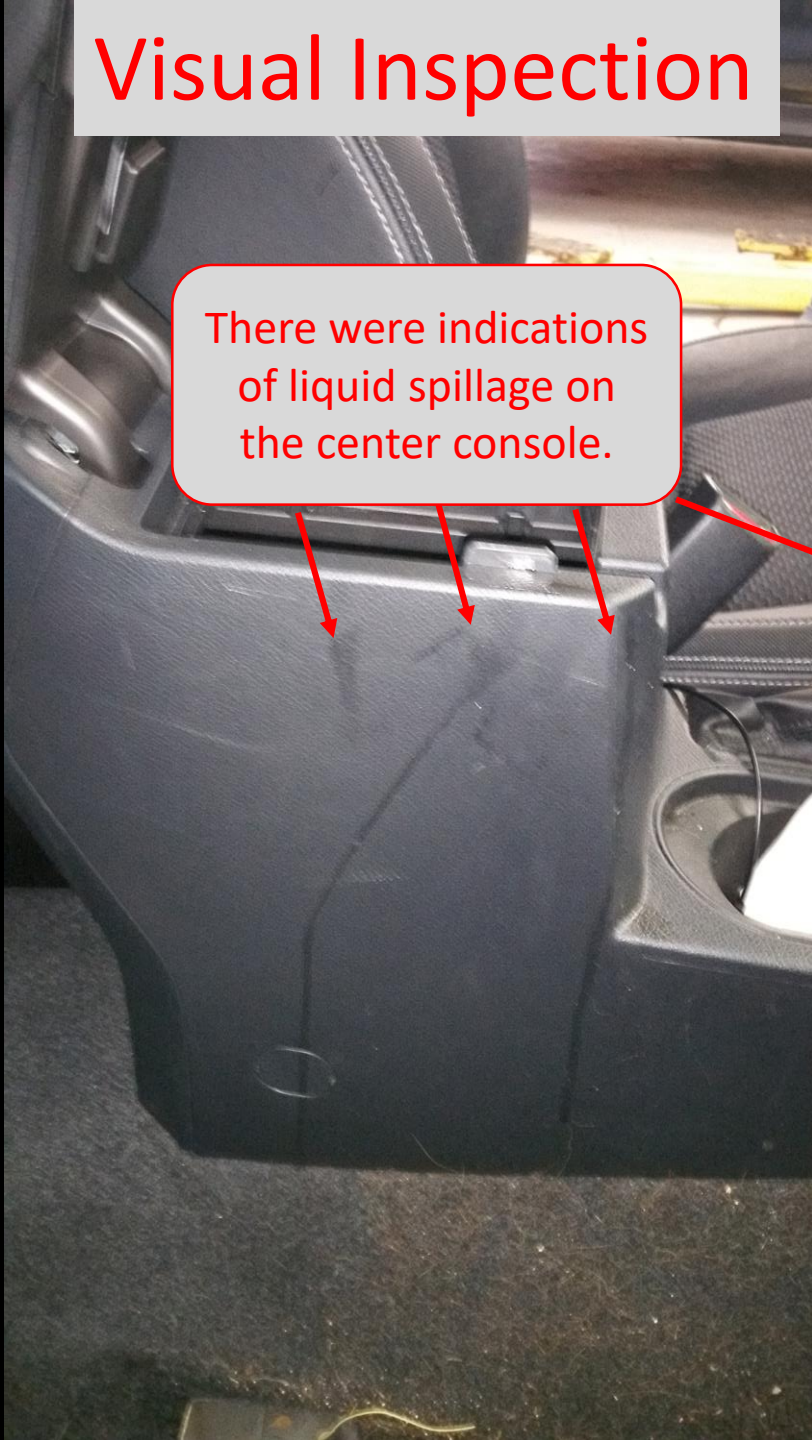
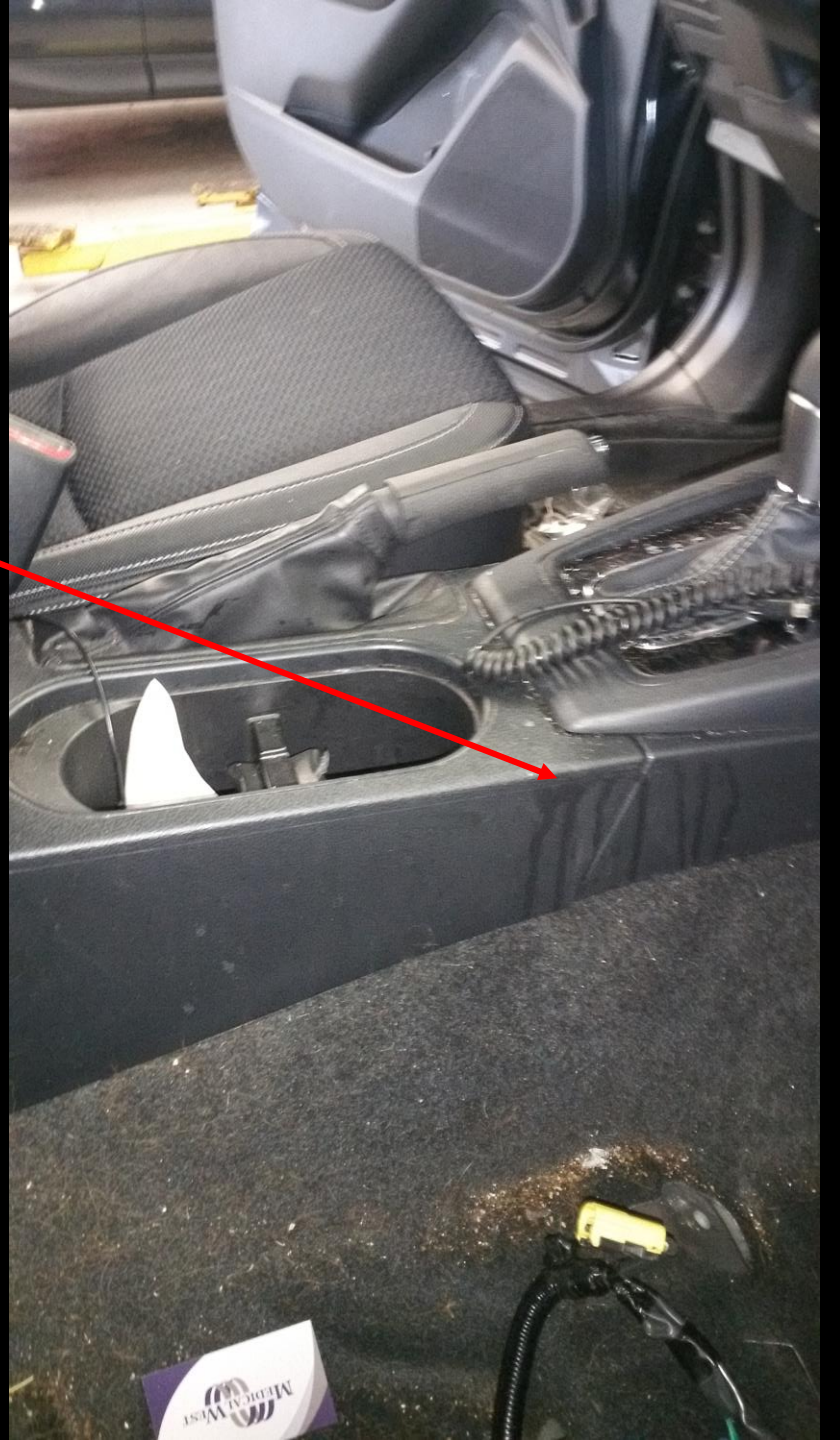
There was no indication of liquid spillage on the seat.

There were indications of liquid spillage on the center console.

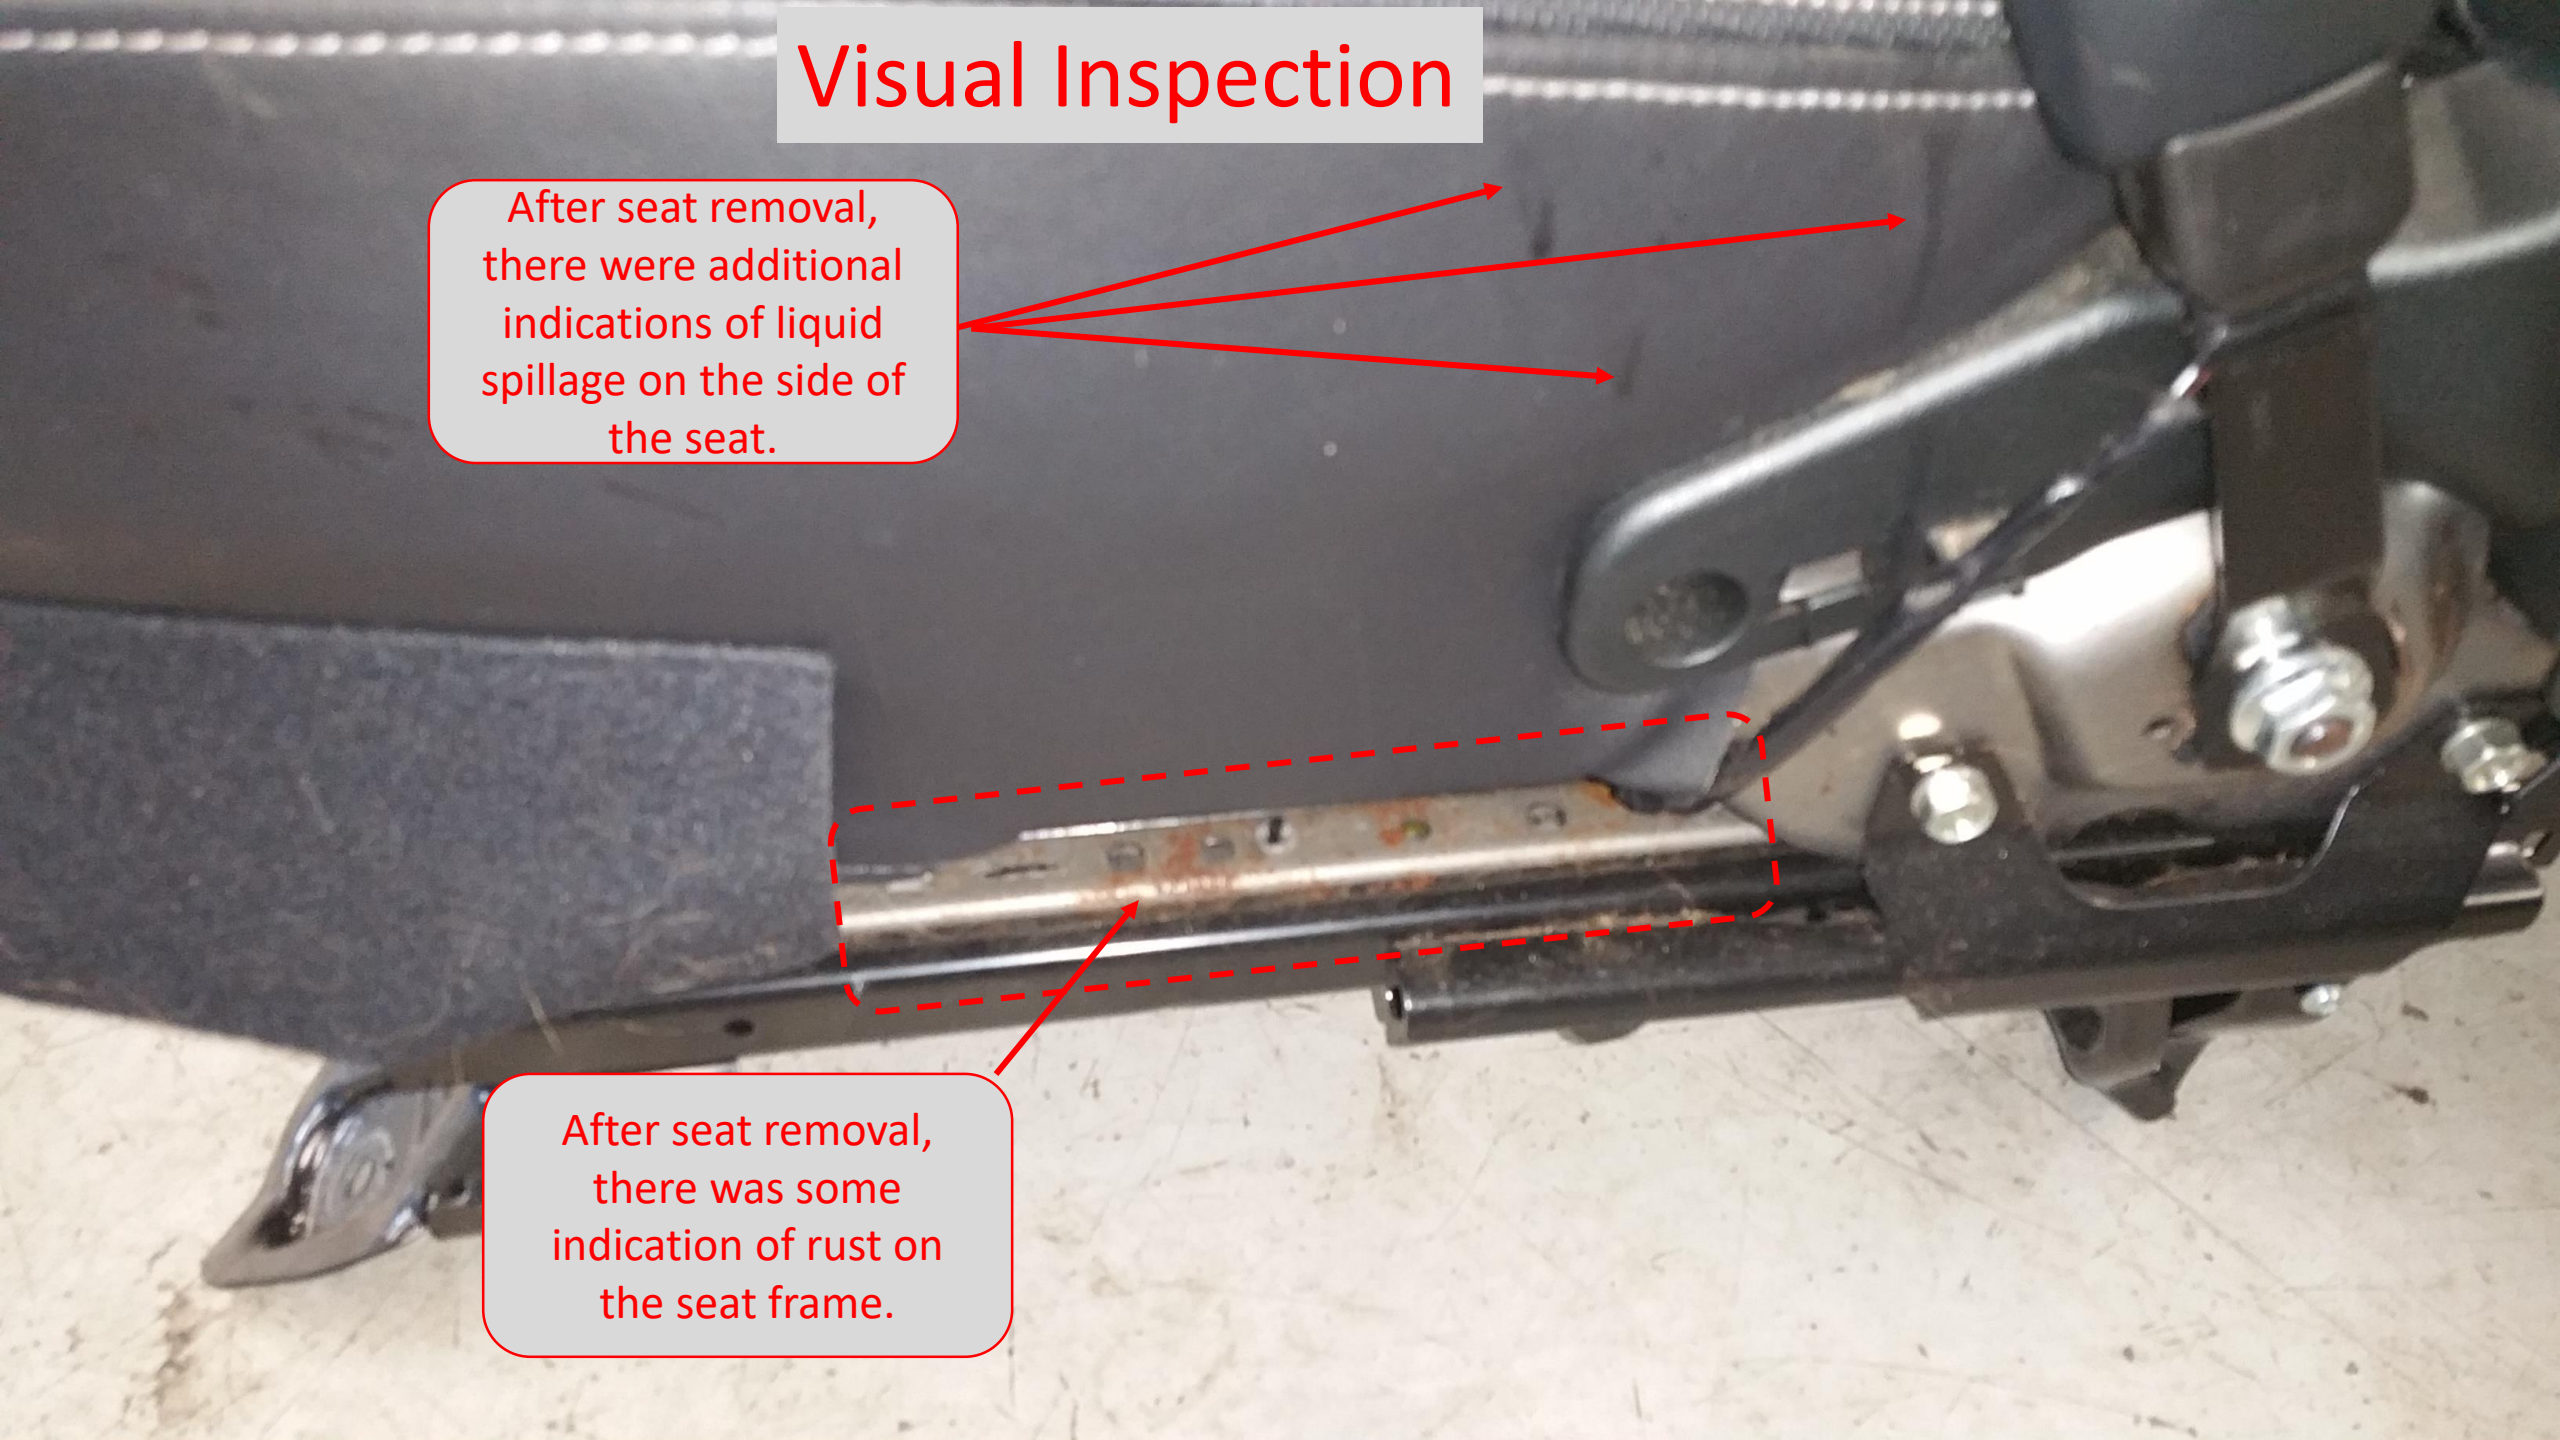
After seat removal, there were additional indications of liquid spillage on the side of the seat.

After seat removal, there was some indication of rust on the seat frame.

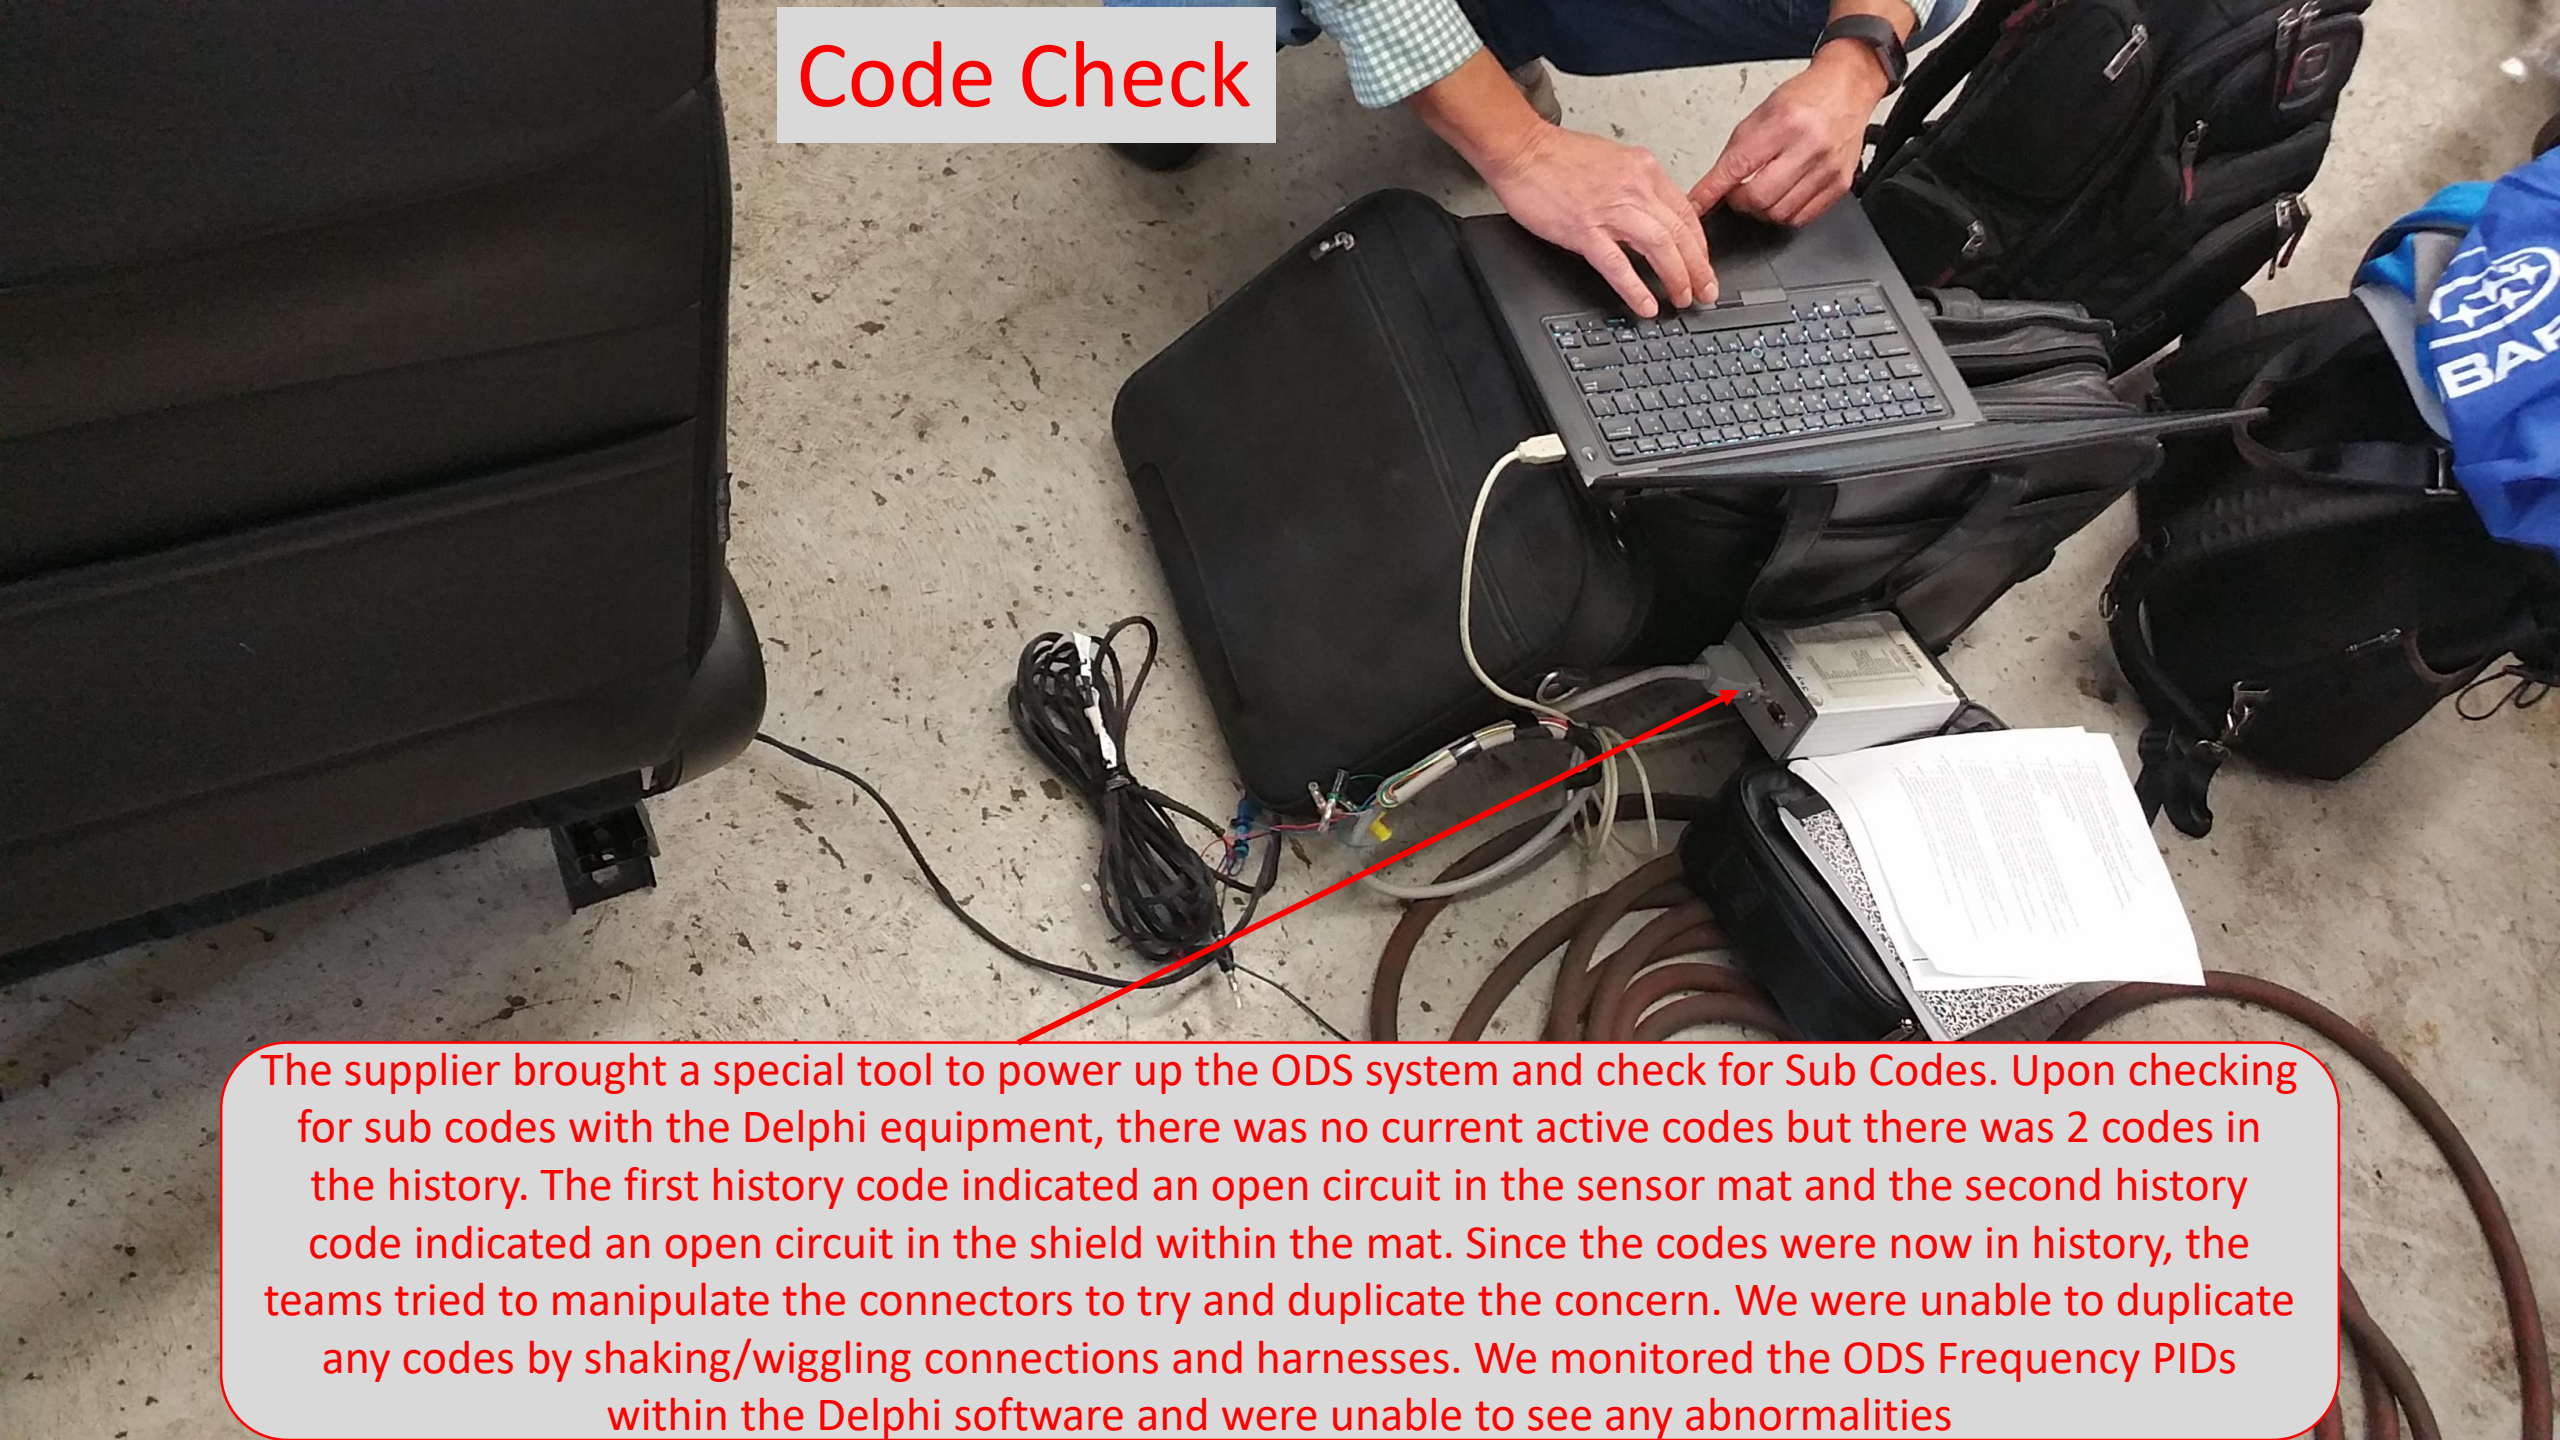
## Code Check

The supplier brought a special tool to power up the ODS system and check for Sub Codes. Upon checking for sub codes with the Delphi equipment, there was no current active codes but there was 2 codes in the history. The first history code indicated an open circuit in the sensor mat and the second history code indicated an open circuit in the shield within the mat. Since the codes were now in history, the teams tried to manipulate the connectors to try and duplicate the concern. We were unable to duplicate any codes by shaking/wiggling connections and harnesses. We monitored the ODS Frequency PIDs within the Delphi software and were unable to see any abnormalities

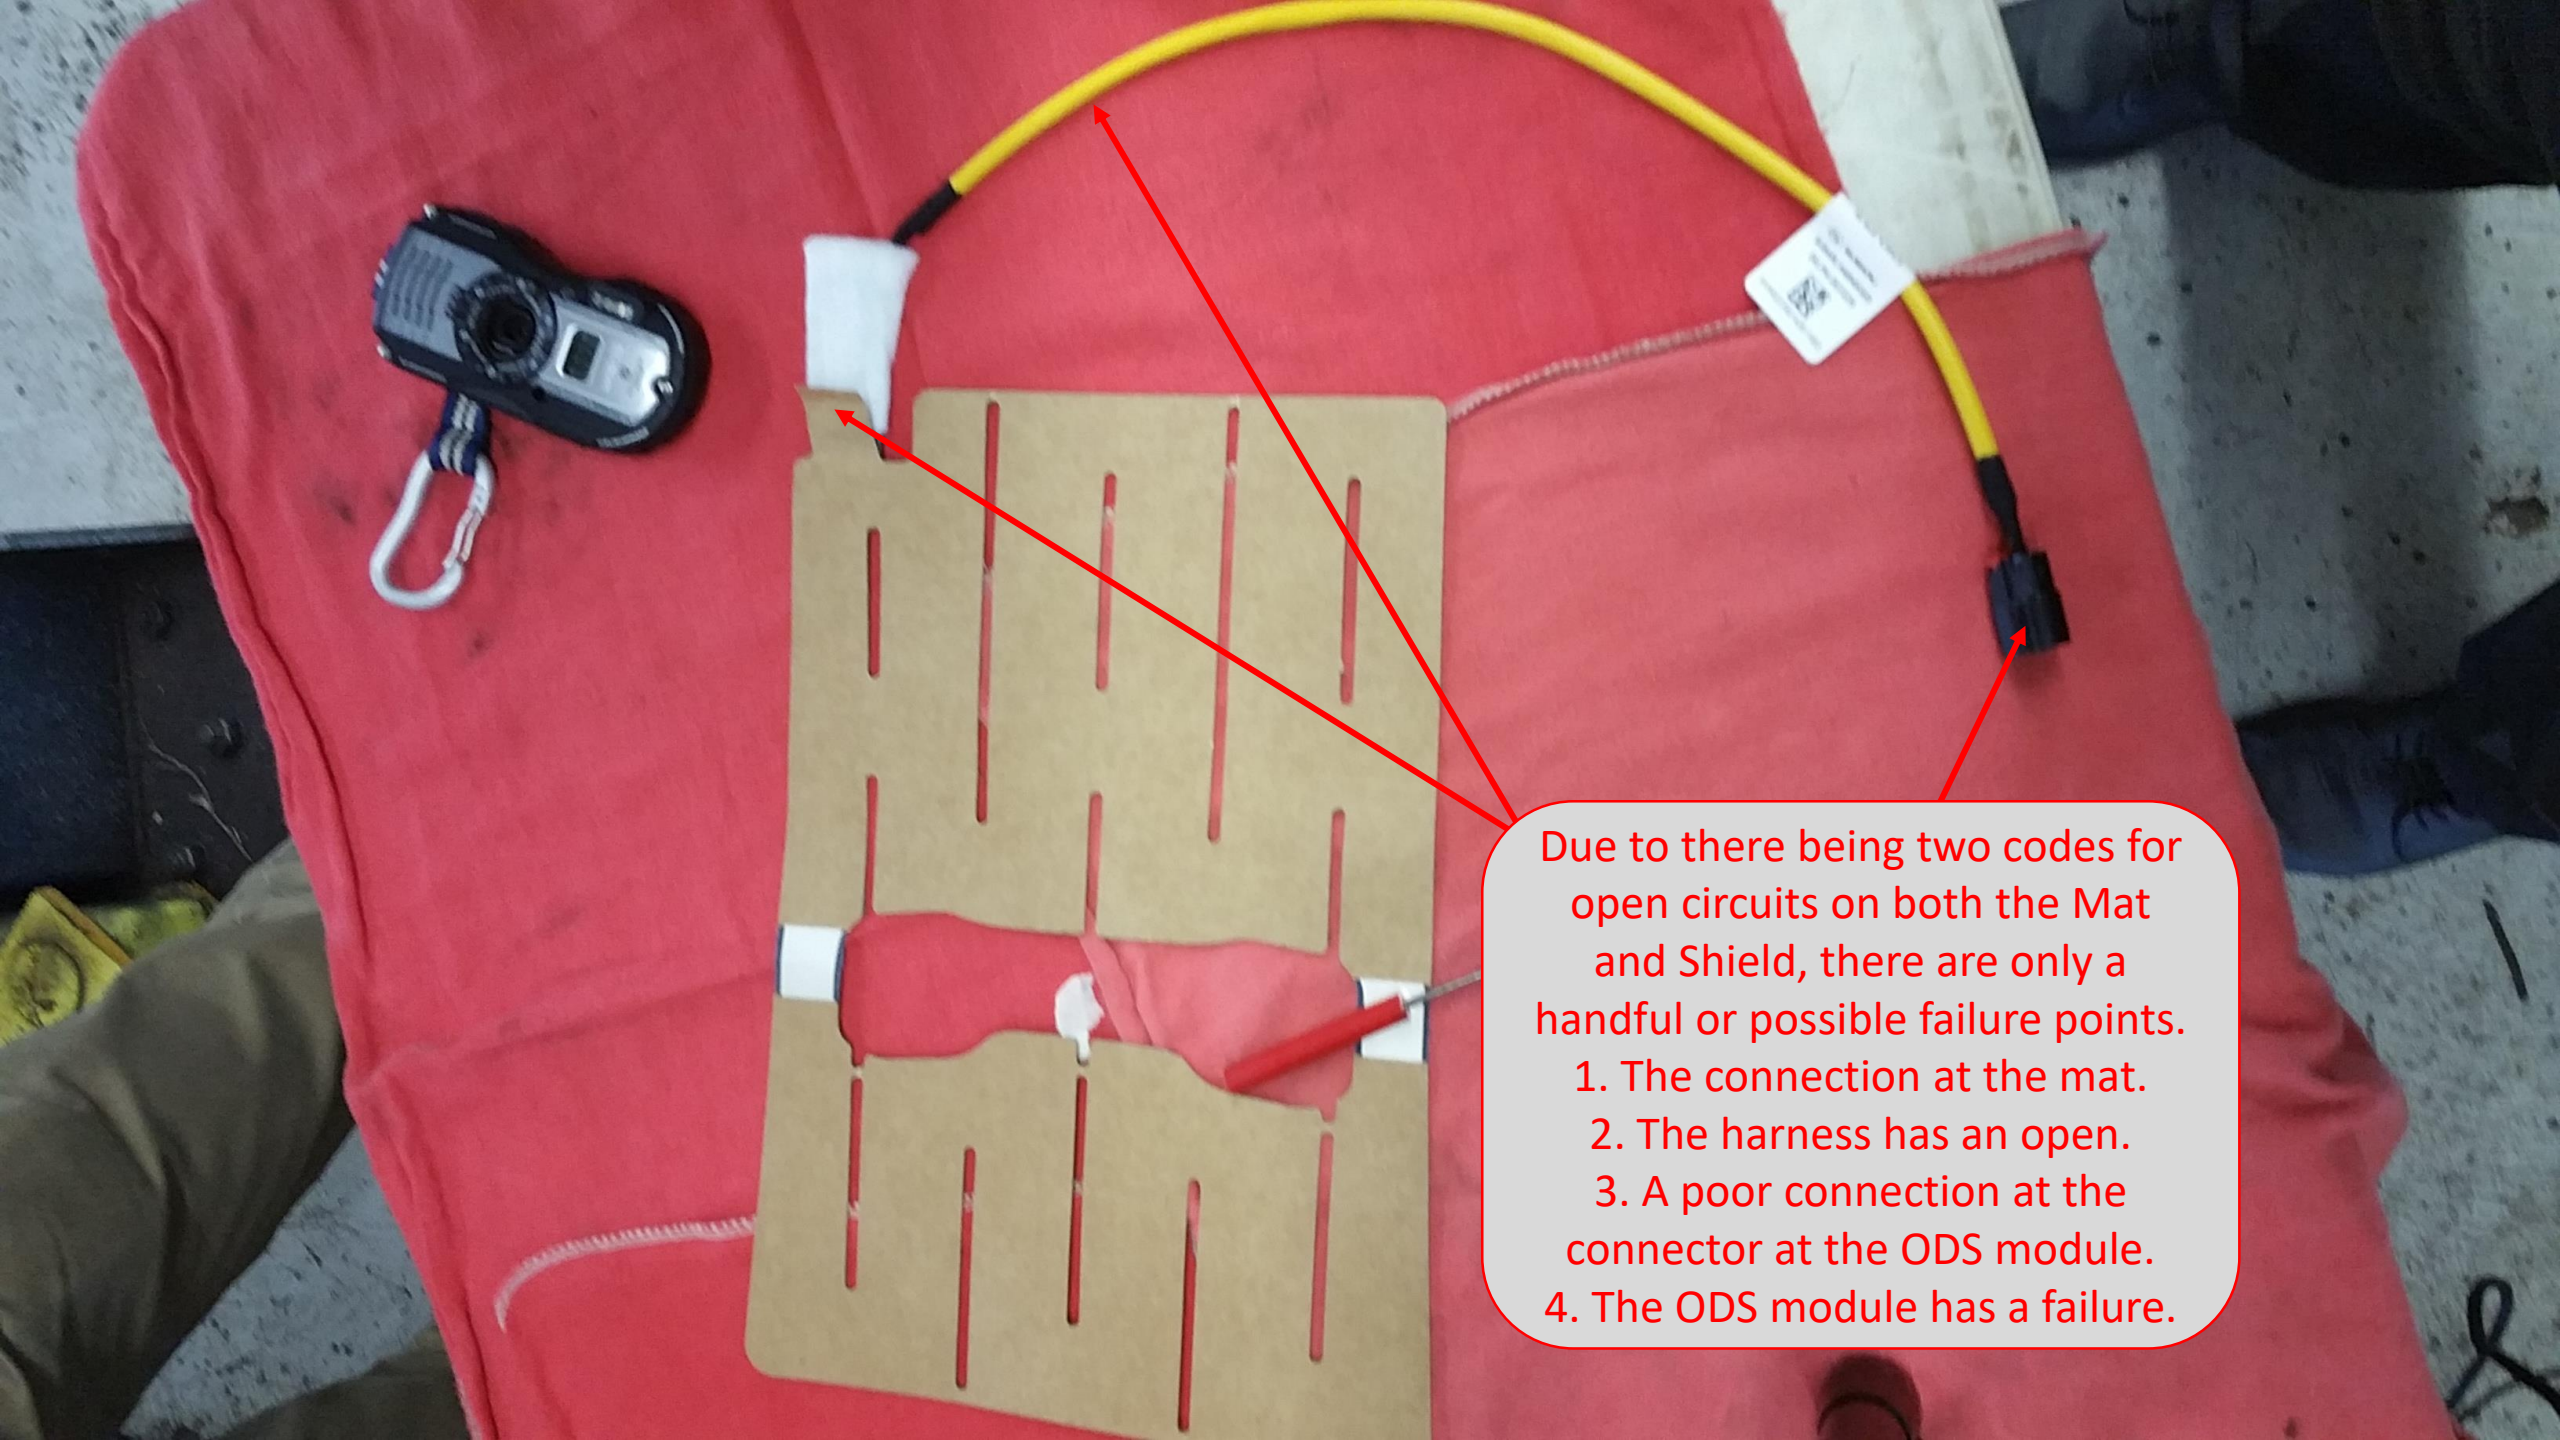
Delphi Special Tool Connector

Due to there being two codes for open circuits on both the Mat and Shield, there are only a handful of possible failure points.

1. The connection at the mat.
2. The harness has an open.
3. A poor connection at the connector at the ODS module.
4. The ODS module has a failure.
