## Service Request Activities – UCC PAR

| Cust Concern | Service air bag message | | | | | | |
| Customer Description | B0081 B0074 SYM00 SYM0D SERVICE AIR BAG | | | | | | |

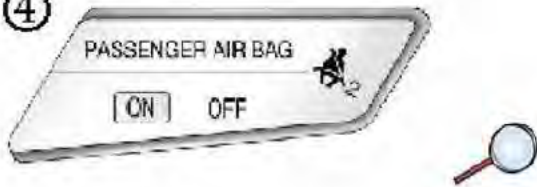
This condition occurs when the Inflatable Restraint Sensing and Diagnostic Module (SDM) setup has not been completed after reprogramming. If the Setup is not completed, the airbag indicator located in the cluster will flash continuously and the "Passenger Airbag ON" indicator will not transition to ON when a person is in the passenger seat.

**Important:** DO NOT replace the Passenger Presence Sensor or the SDM (airbag module).
